SGS MUSCOWPETUNG

ABORIGINAL CONSTRUCTION MONITORING

WEEKLY REPORT

SPREAD 5 & 6

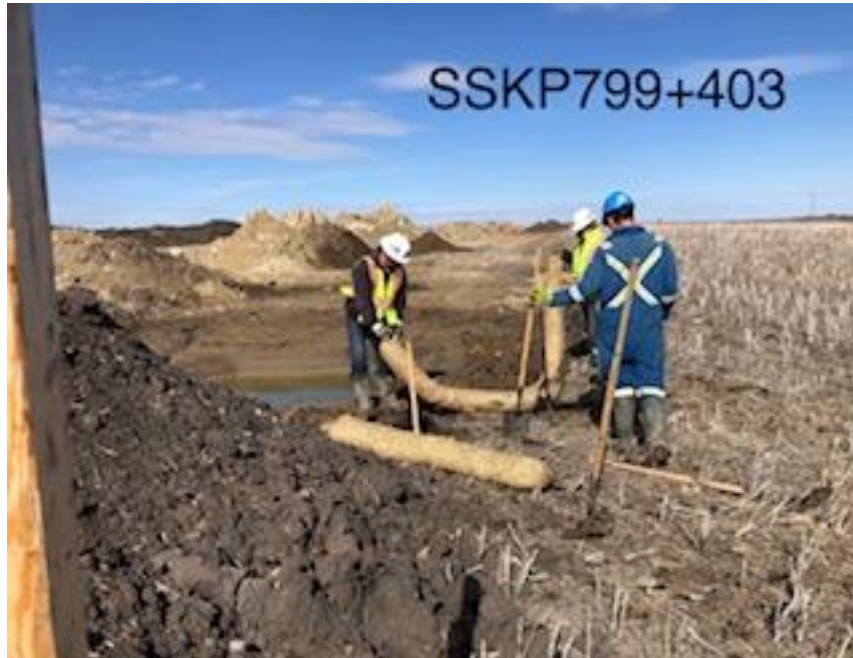
Erosion control devices – straw wattle being installed

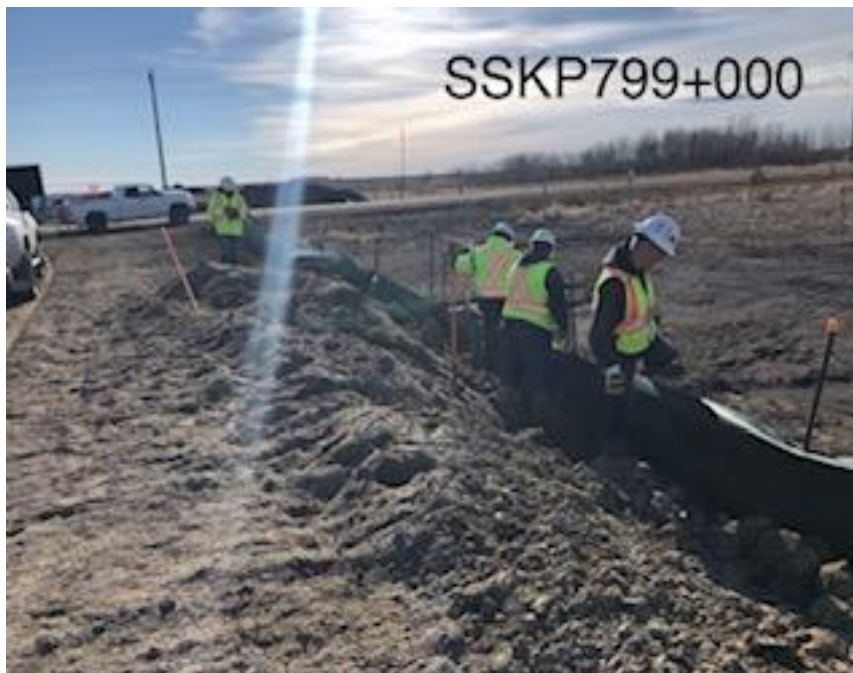
Wing wall that was down was being repaired

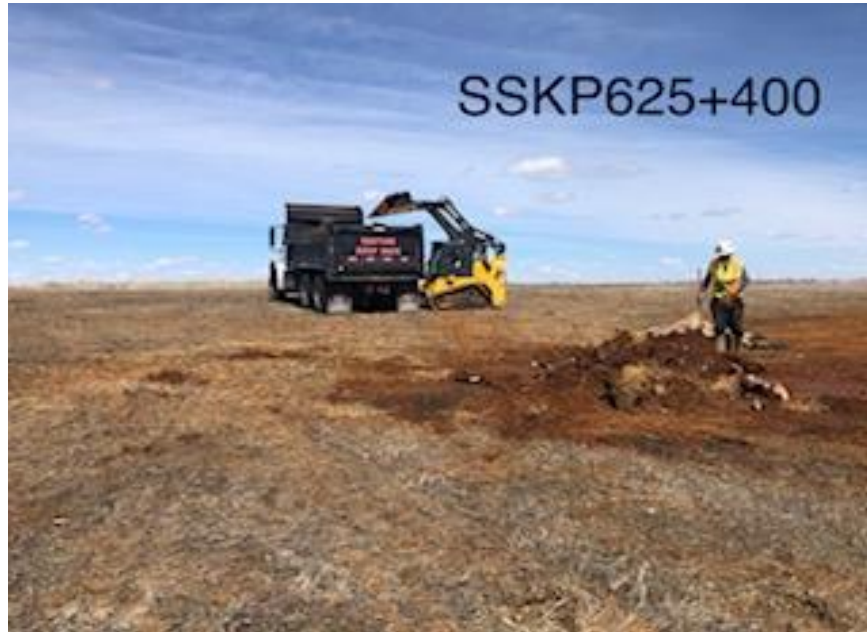
Finishing up the week on spread 5 the environmental clean-up crew was at water course crossing Chapleau Lake SK WC68, working at the dewatering site located SSKP625+400 utilizing a skid steer to move debris around before tandem trucks arrived to pick up the garbage, loose straw and remove water scale from the area.

Environmental clean-up at dewatering site

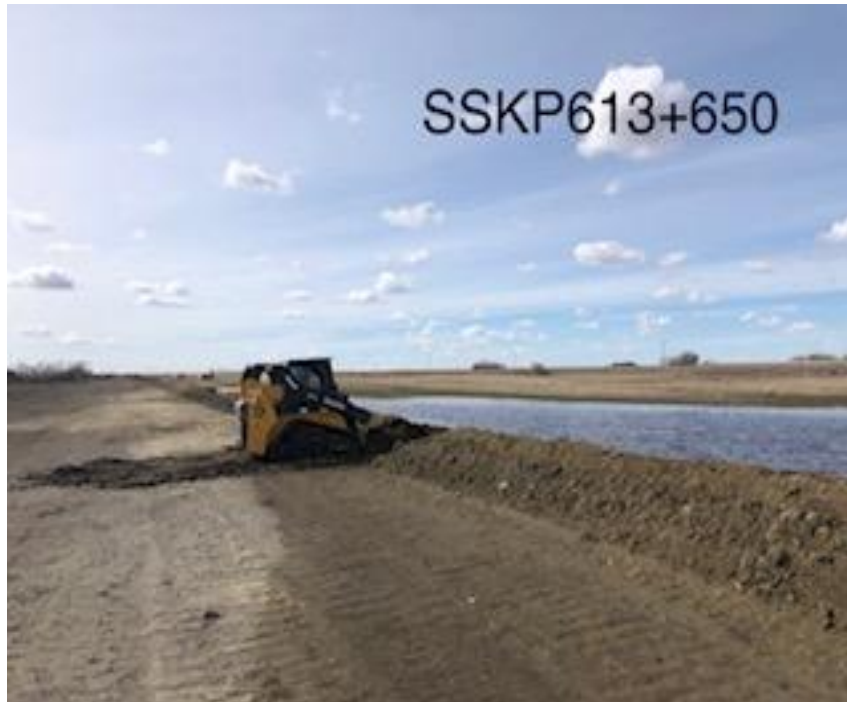
Skid steer used to create a break in roach line to enable the water to dry quicker
