SGS MUSCOWPETUNG

ABORIGINAL CONSTRUCTION MONITORING

WEEKLY REPORT

AUGUST 5TH TO AUGUST 12TH, 2018

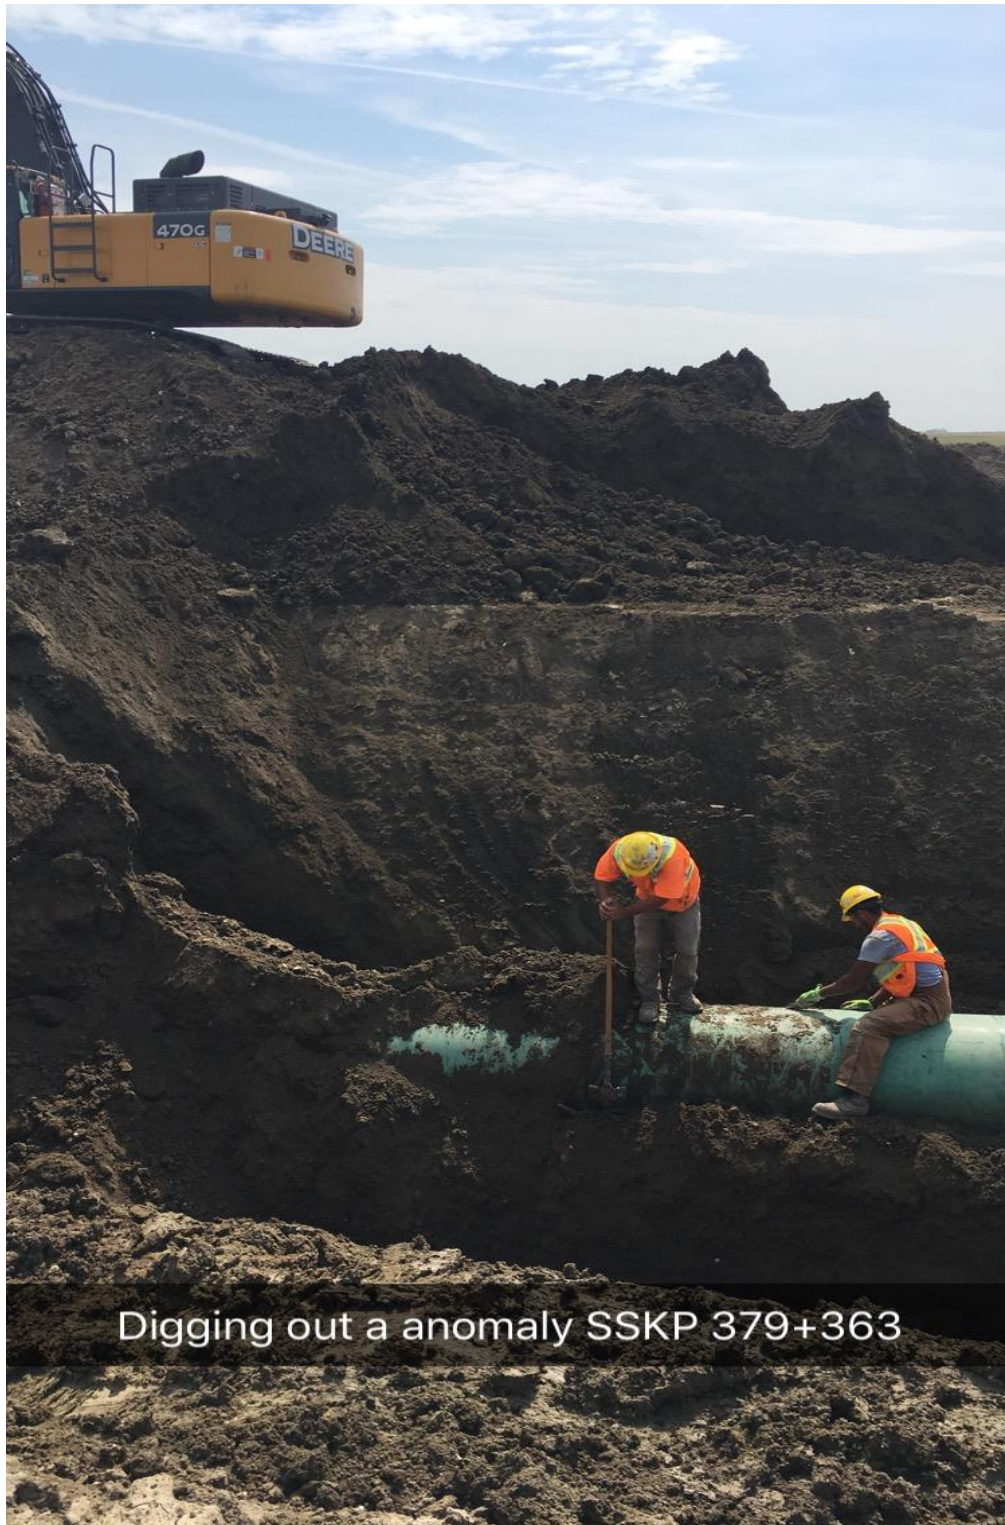
Digging out a anomaly SSKP 379+363

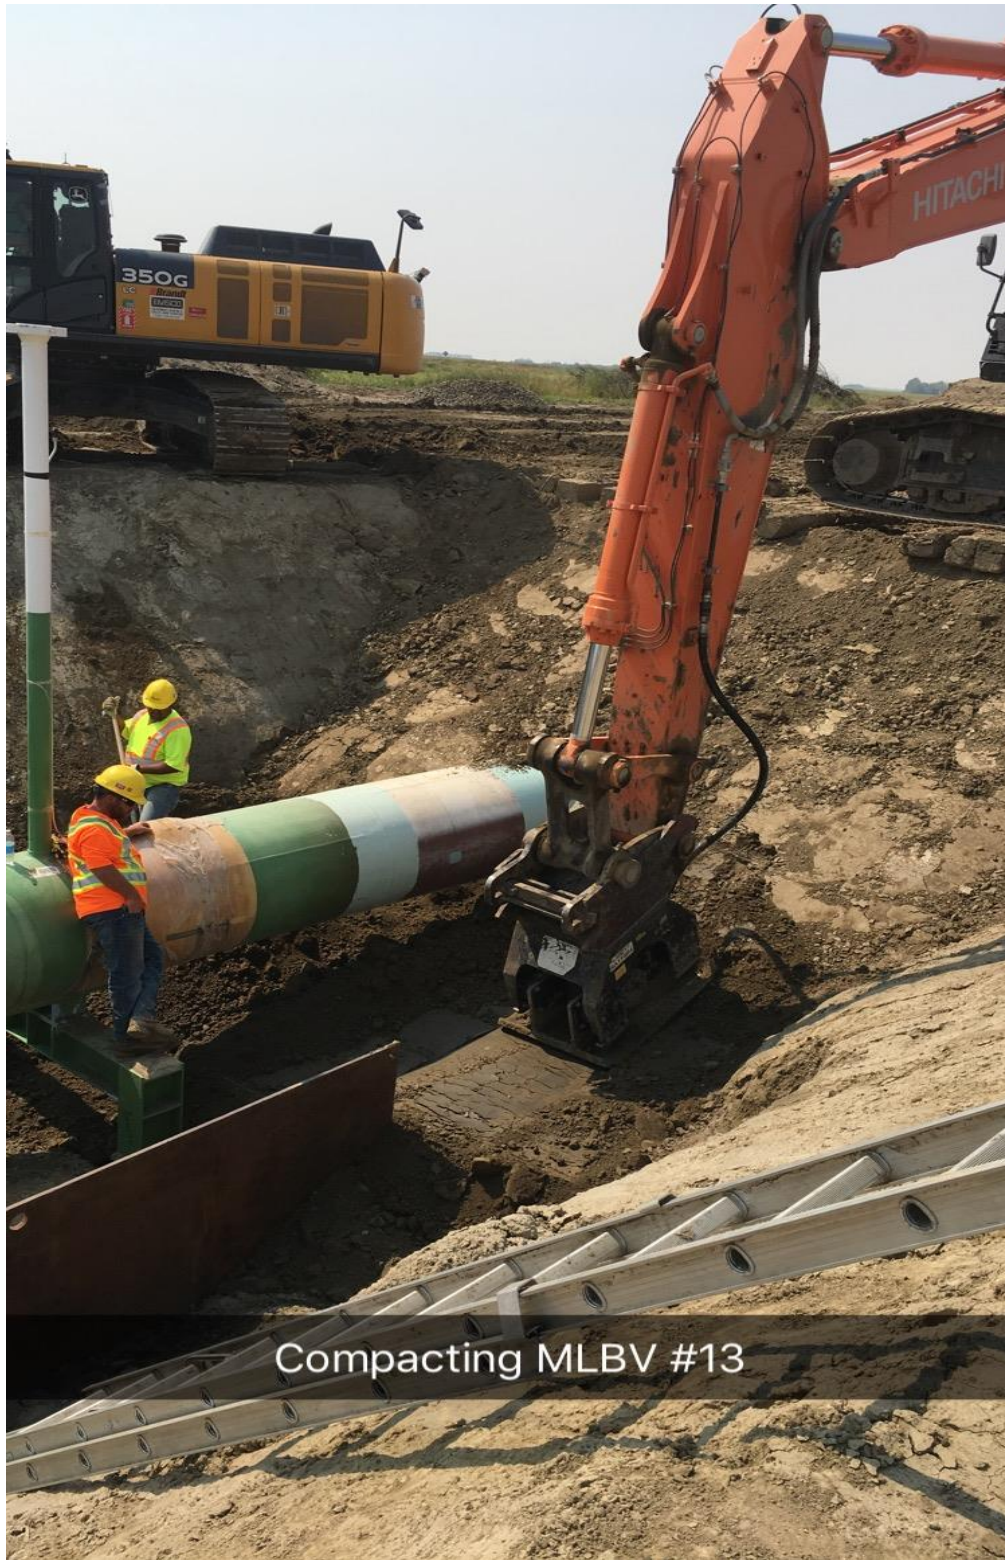
Compacting MLBV #13

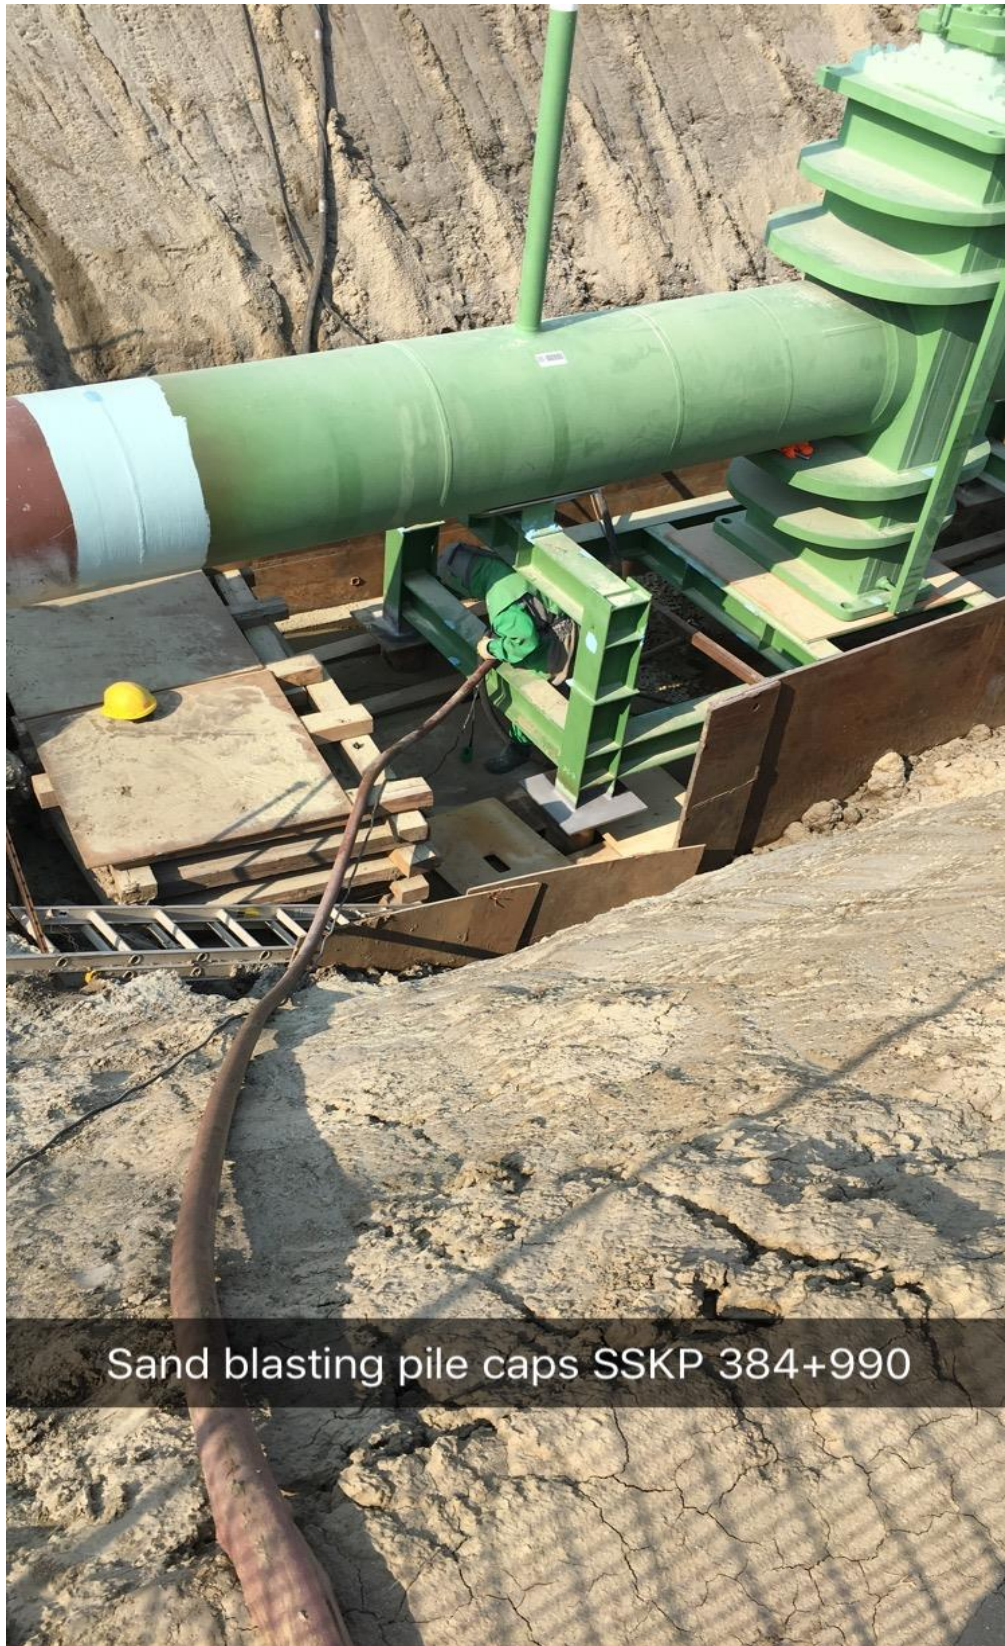
Sand blasting pile caps SSKP 384+990

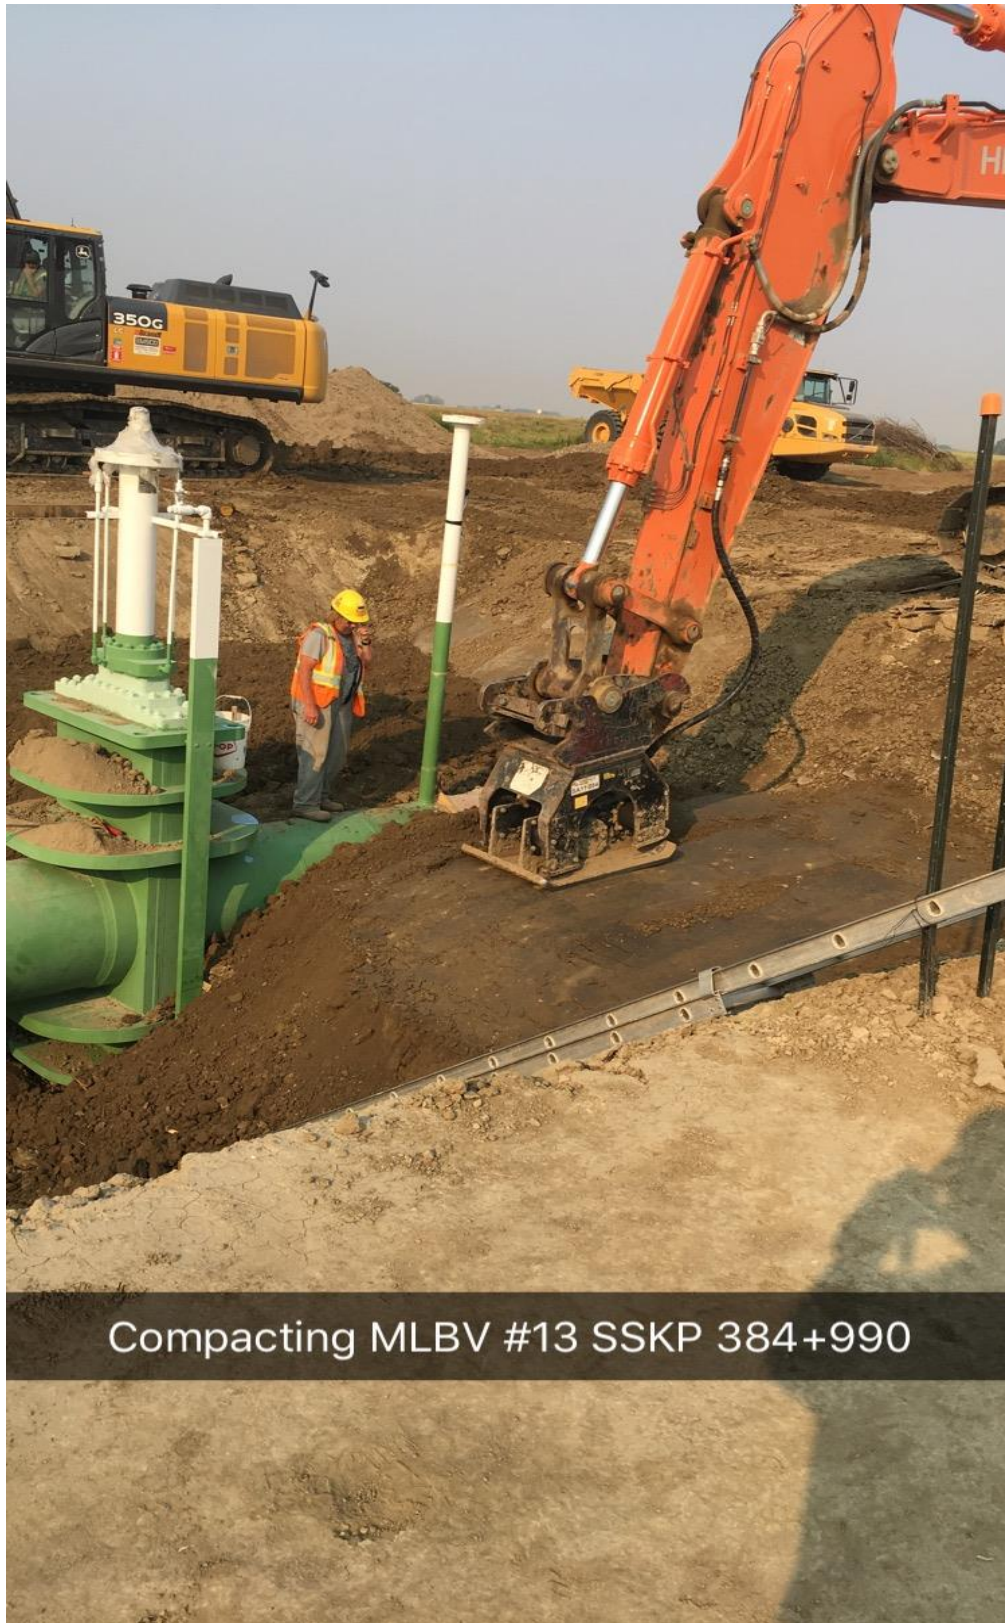
Compacting MLBV #13 SSKP 384+990

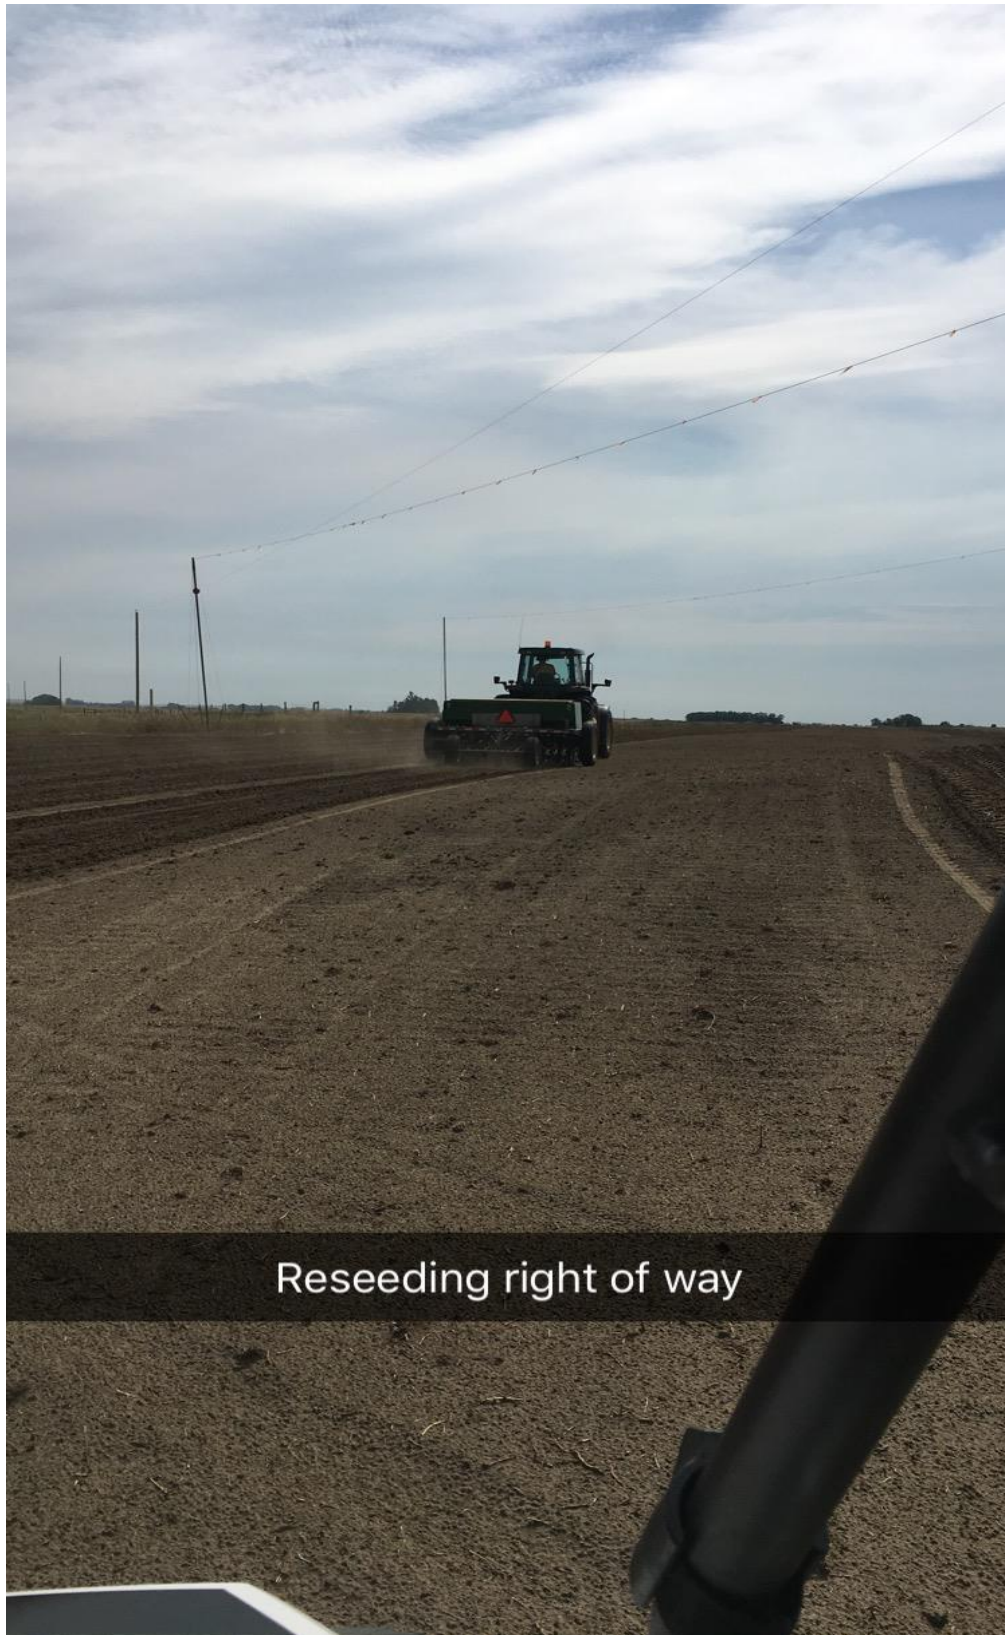
Reseeding right of way

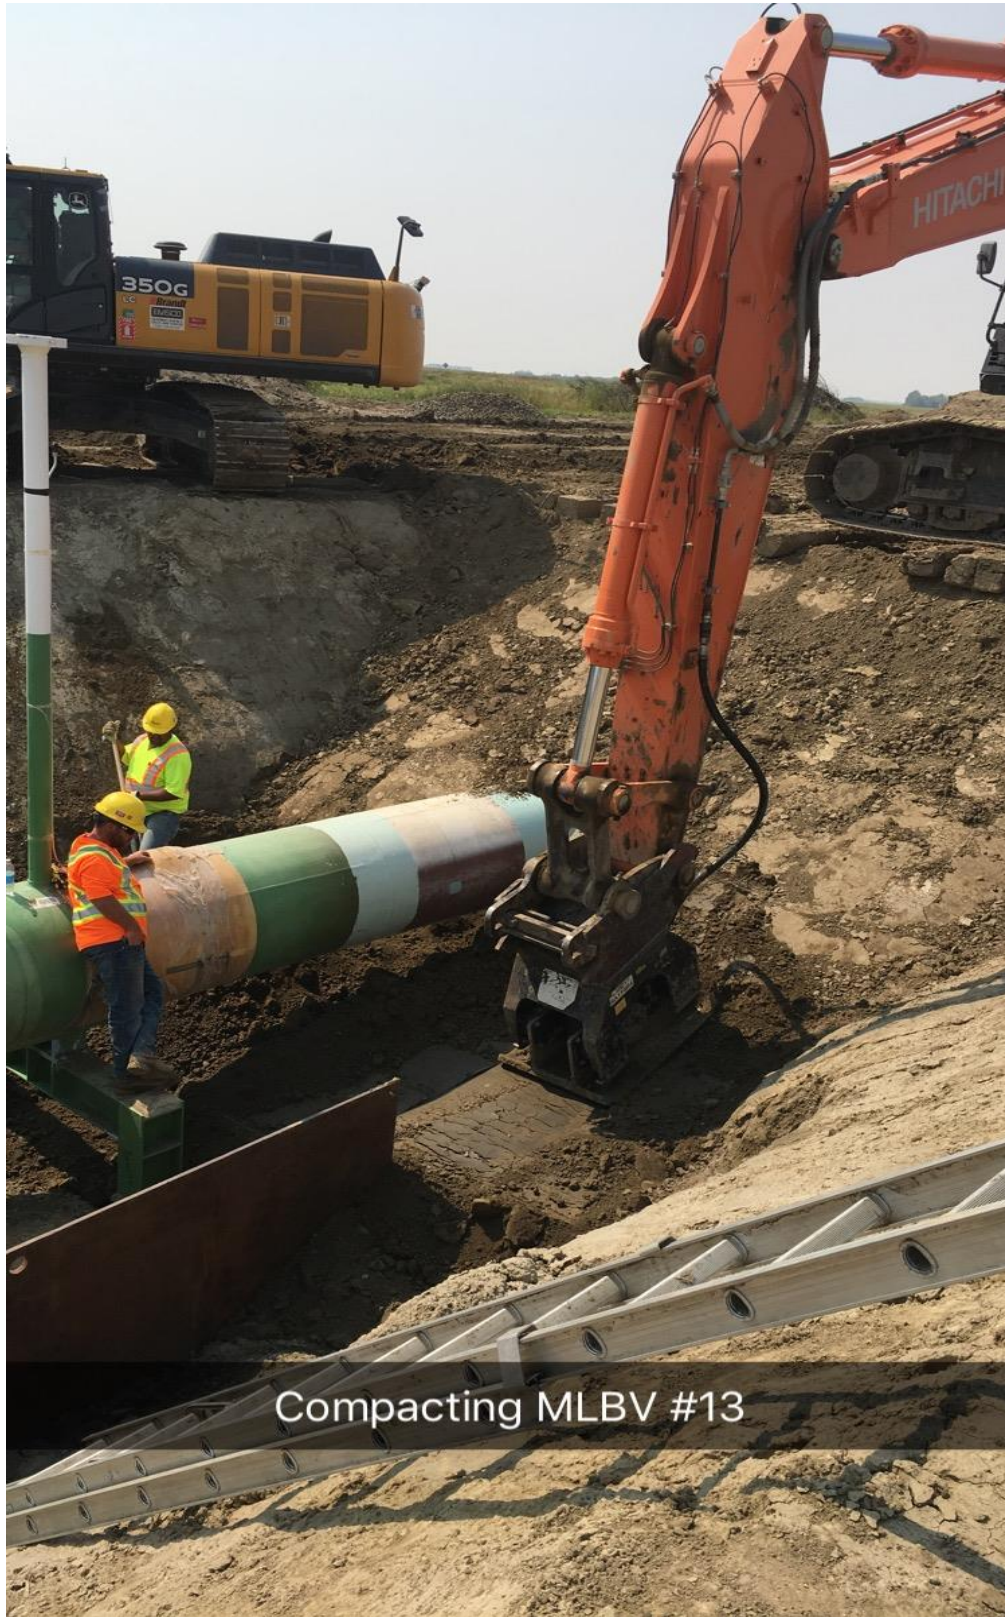
Compacting MLBV #13

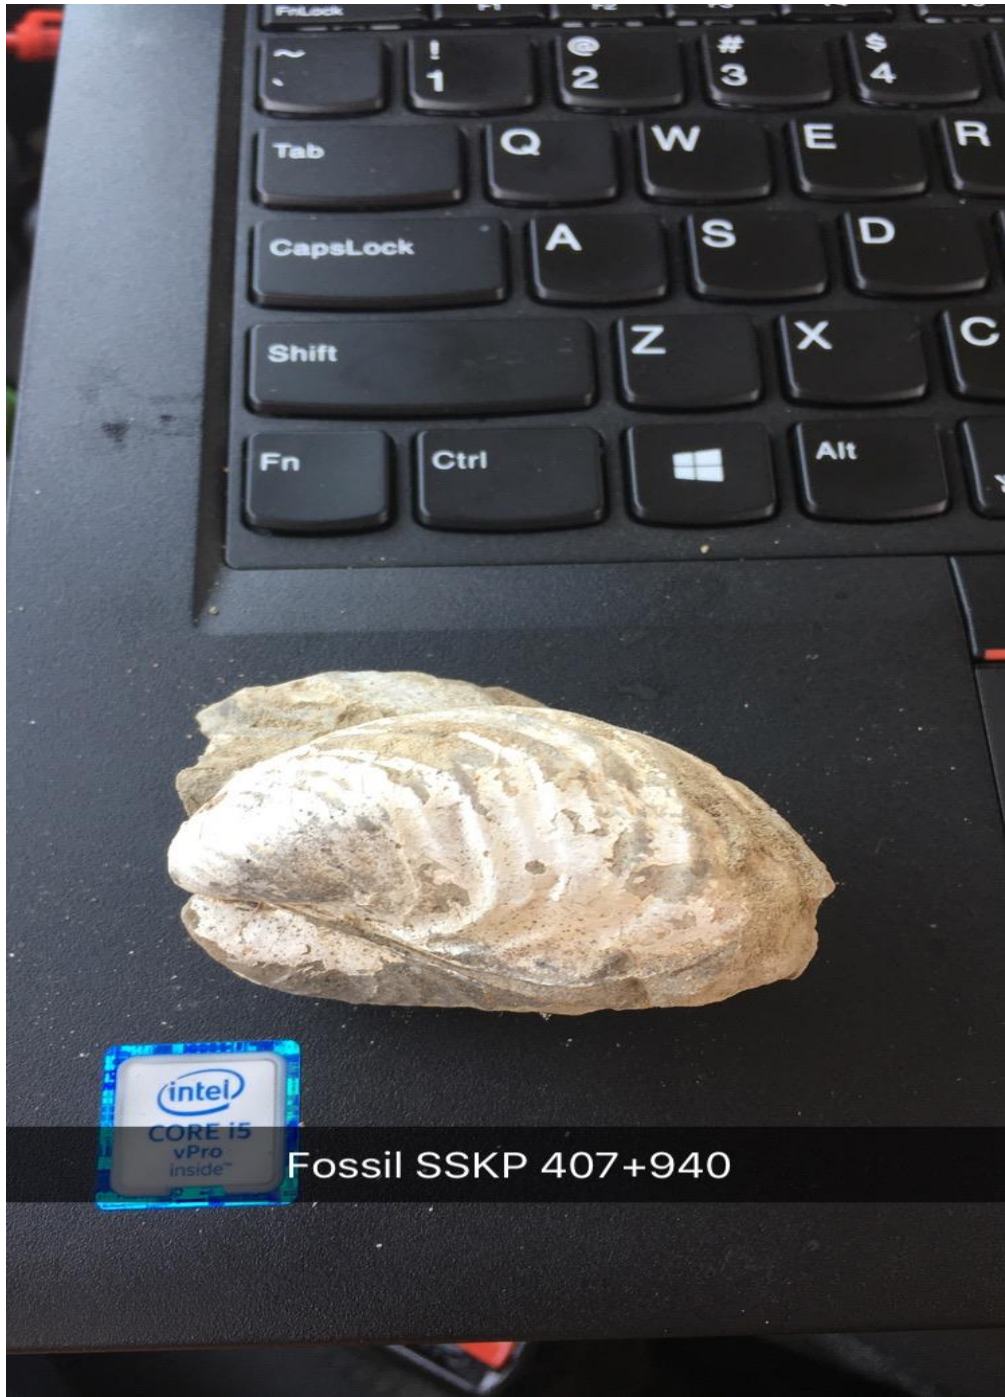
Junior monitor Calvin Pooyak found a fossil this week on the right of way. The lead environmentalist noted the location of where it was discovered.

Fossil SSKP 407+940
