**SGS MUSCOWPETUNG**

**ABORIGINAL CONSTRUCTION MONITORING**

**WEEKLY REPORT**

**JANUARY 15<sup>TH</sup> TO JANUARY 21<sup>ST</sup>, 2018**

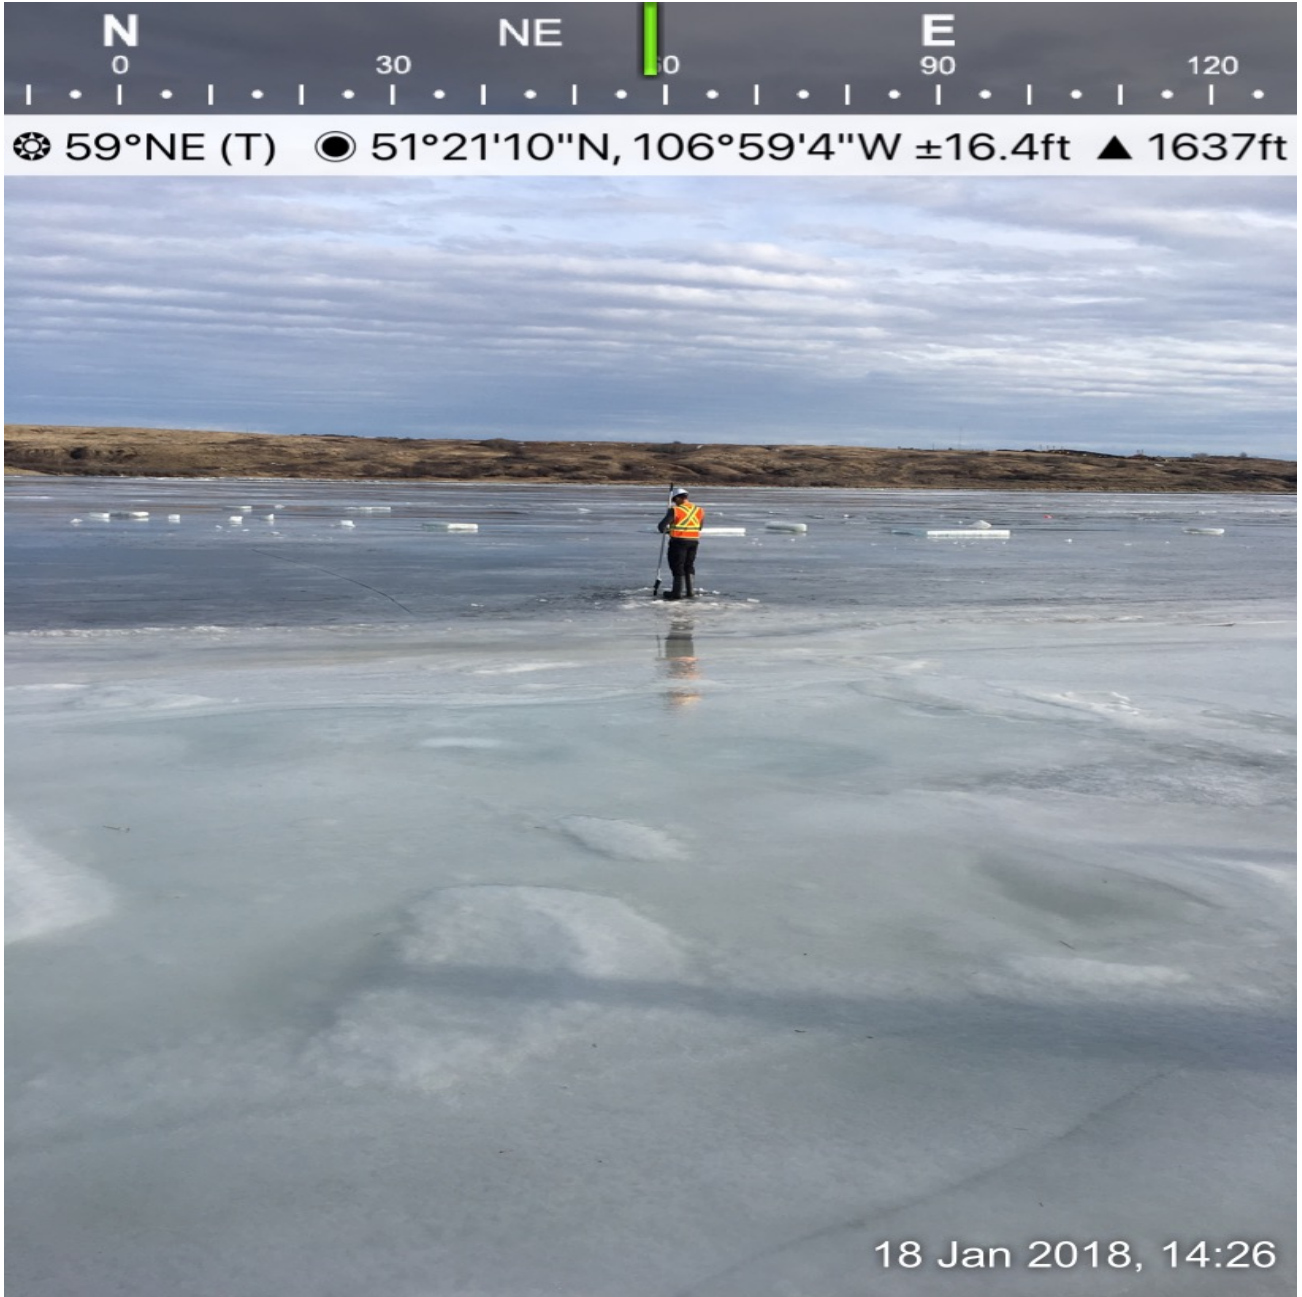
Golder Associates are still testing the turbidity of the water on the east side of the river and it has remained consistent throughout this week.

GOLDER ASSOCIATES RETRIVING WATER SAMPLES

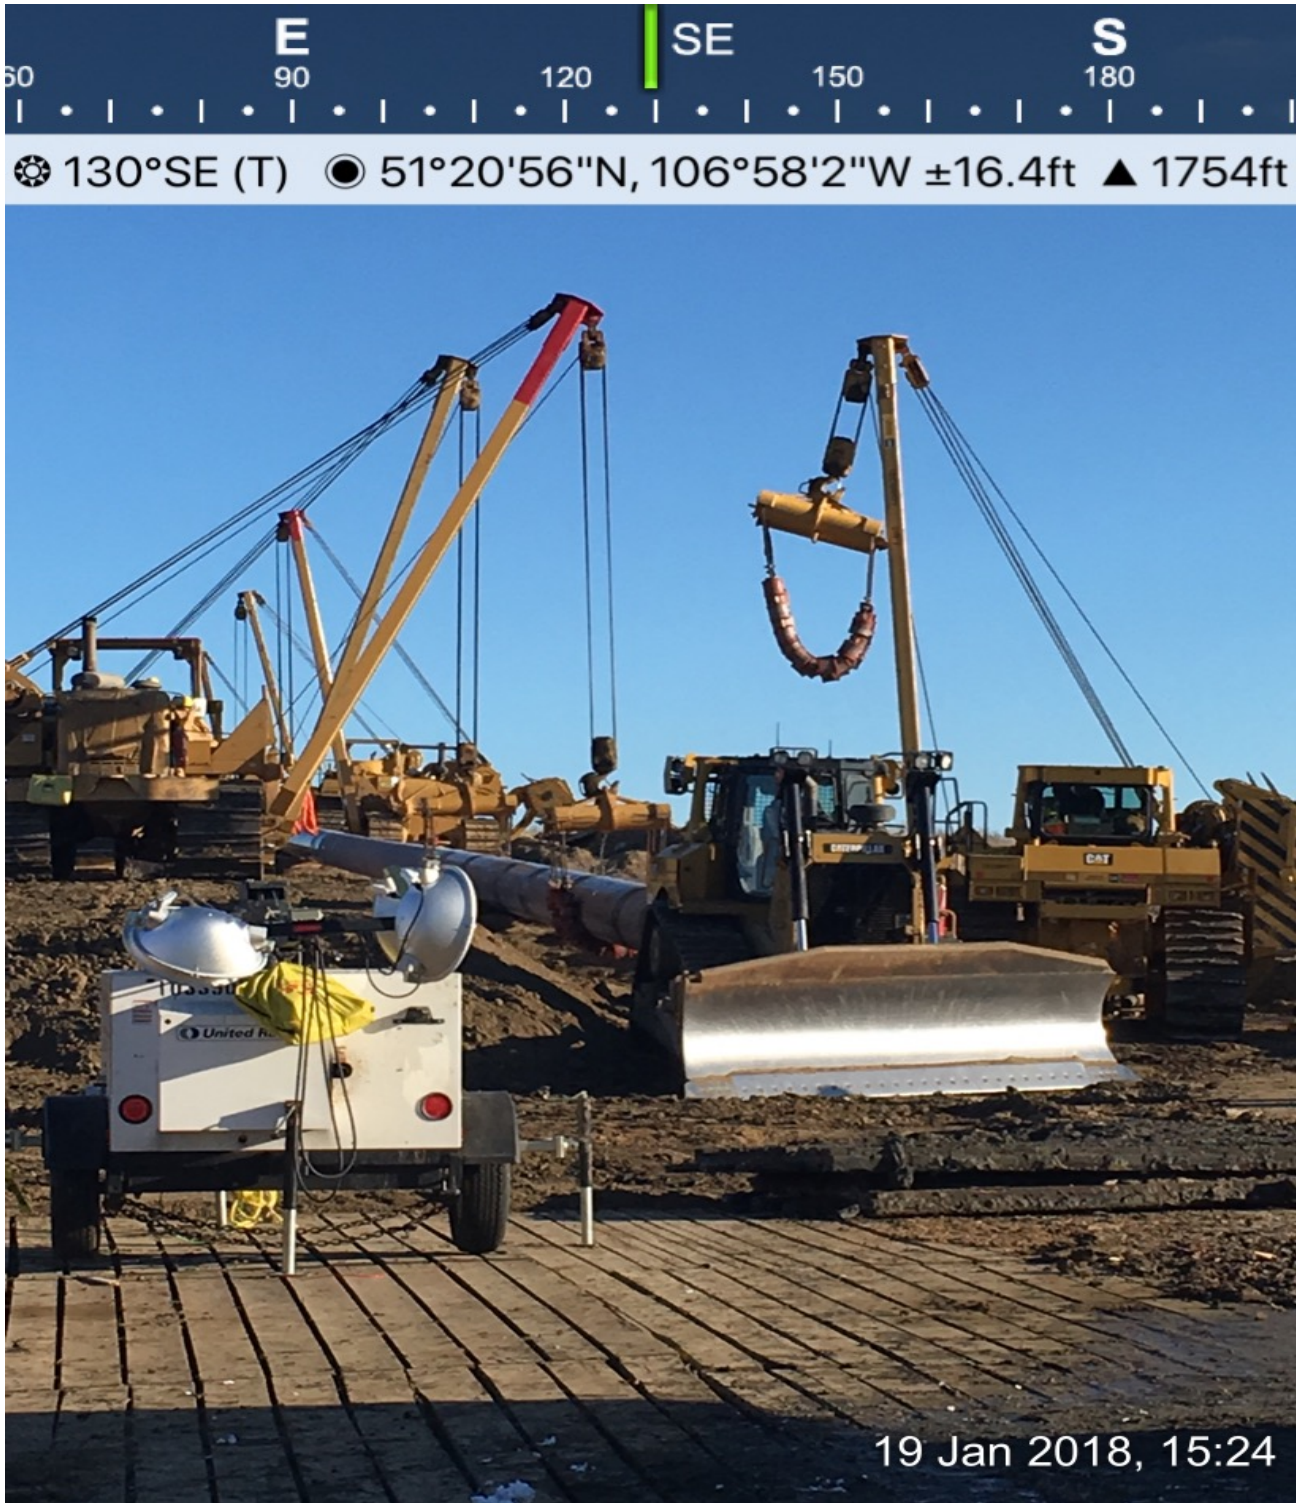
EQUIPMENT ALL SET UP FOR DRAG SECTION

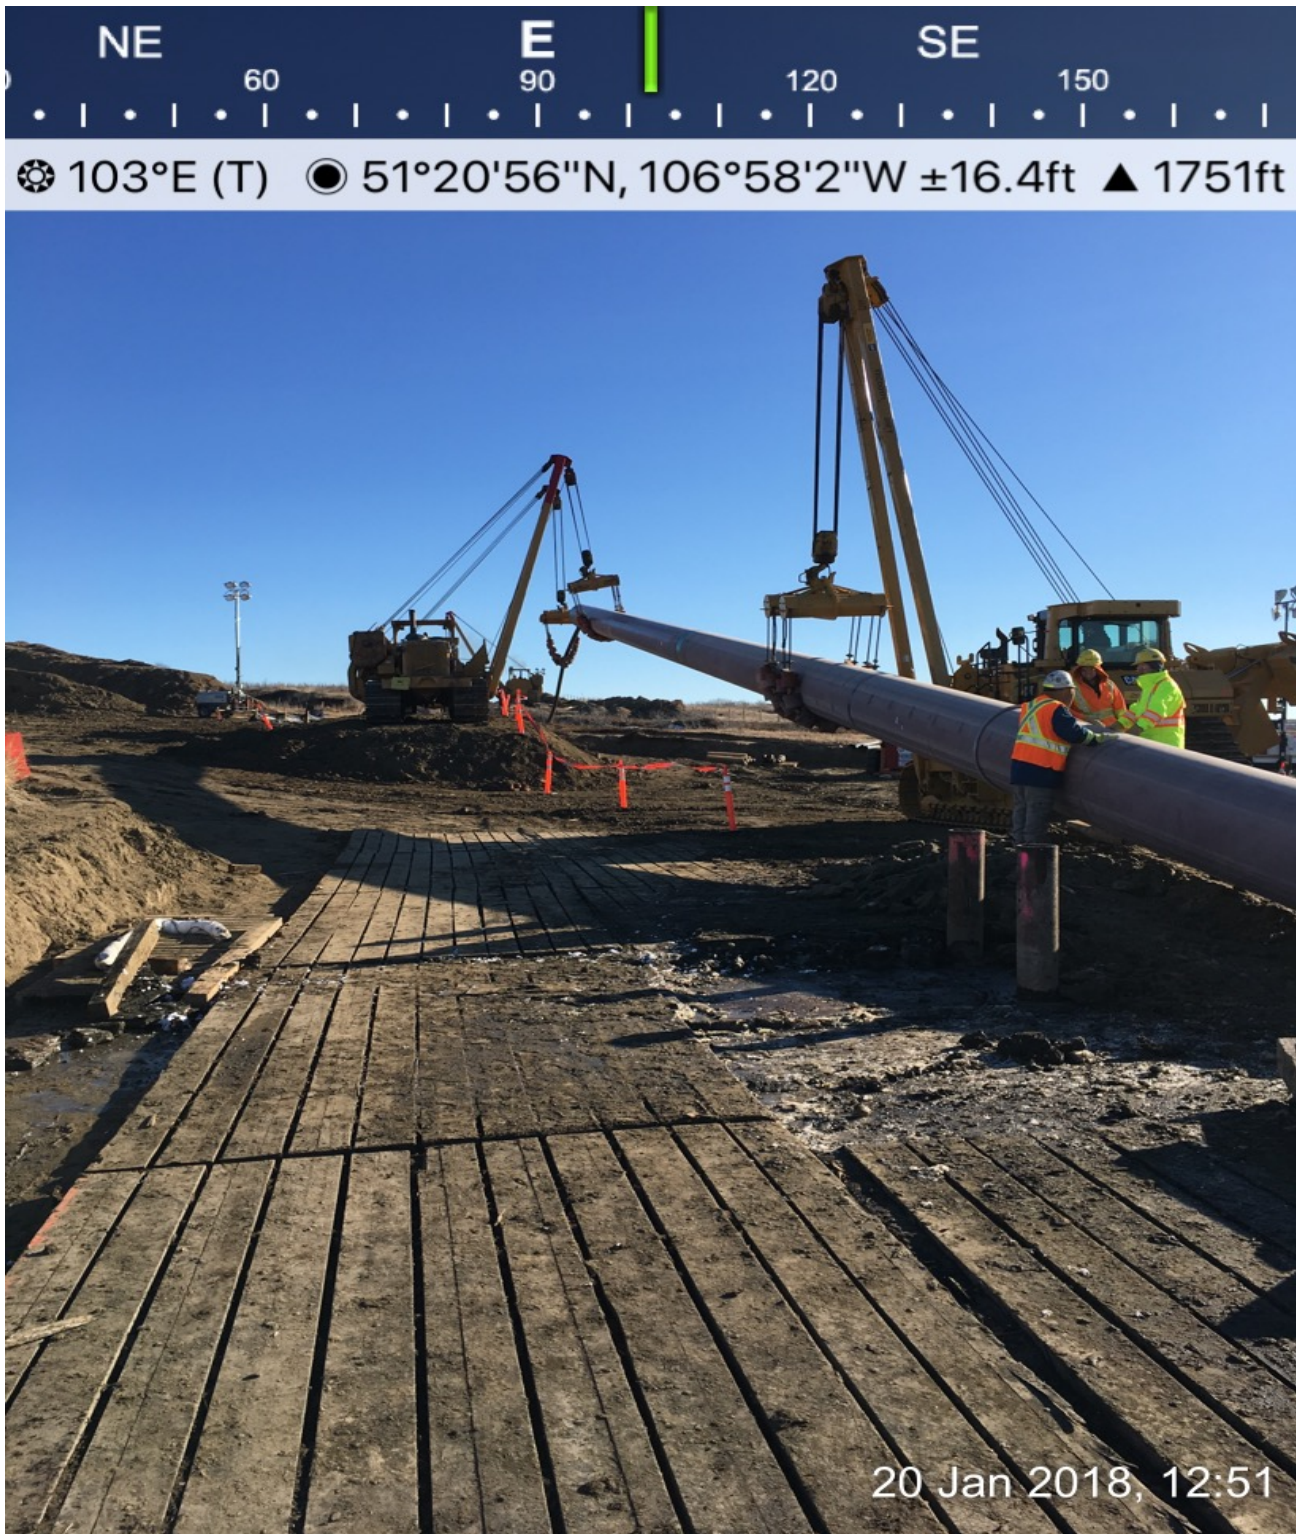
TAIL END OF THE BORE BEING PULLED

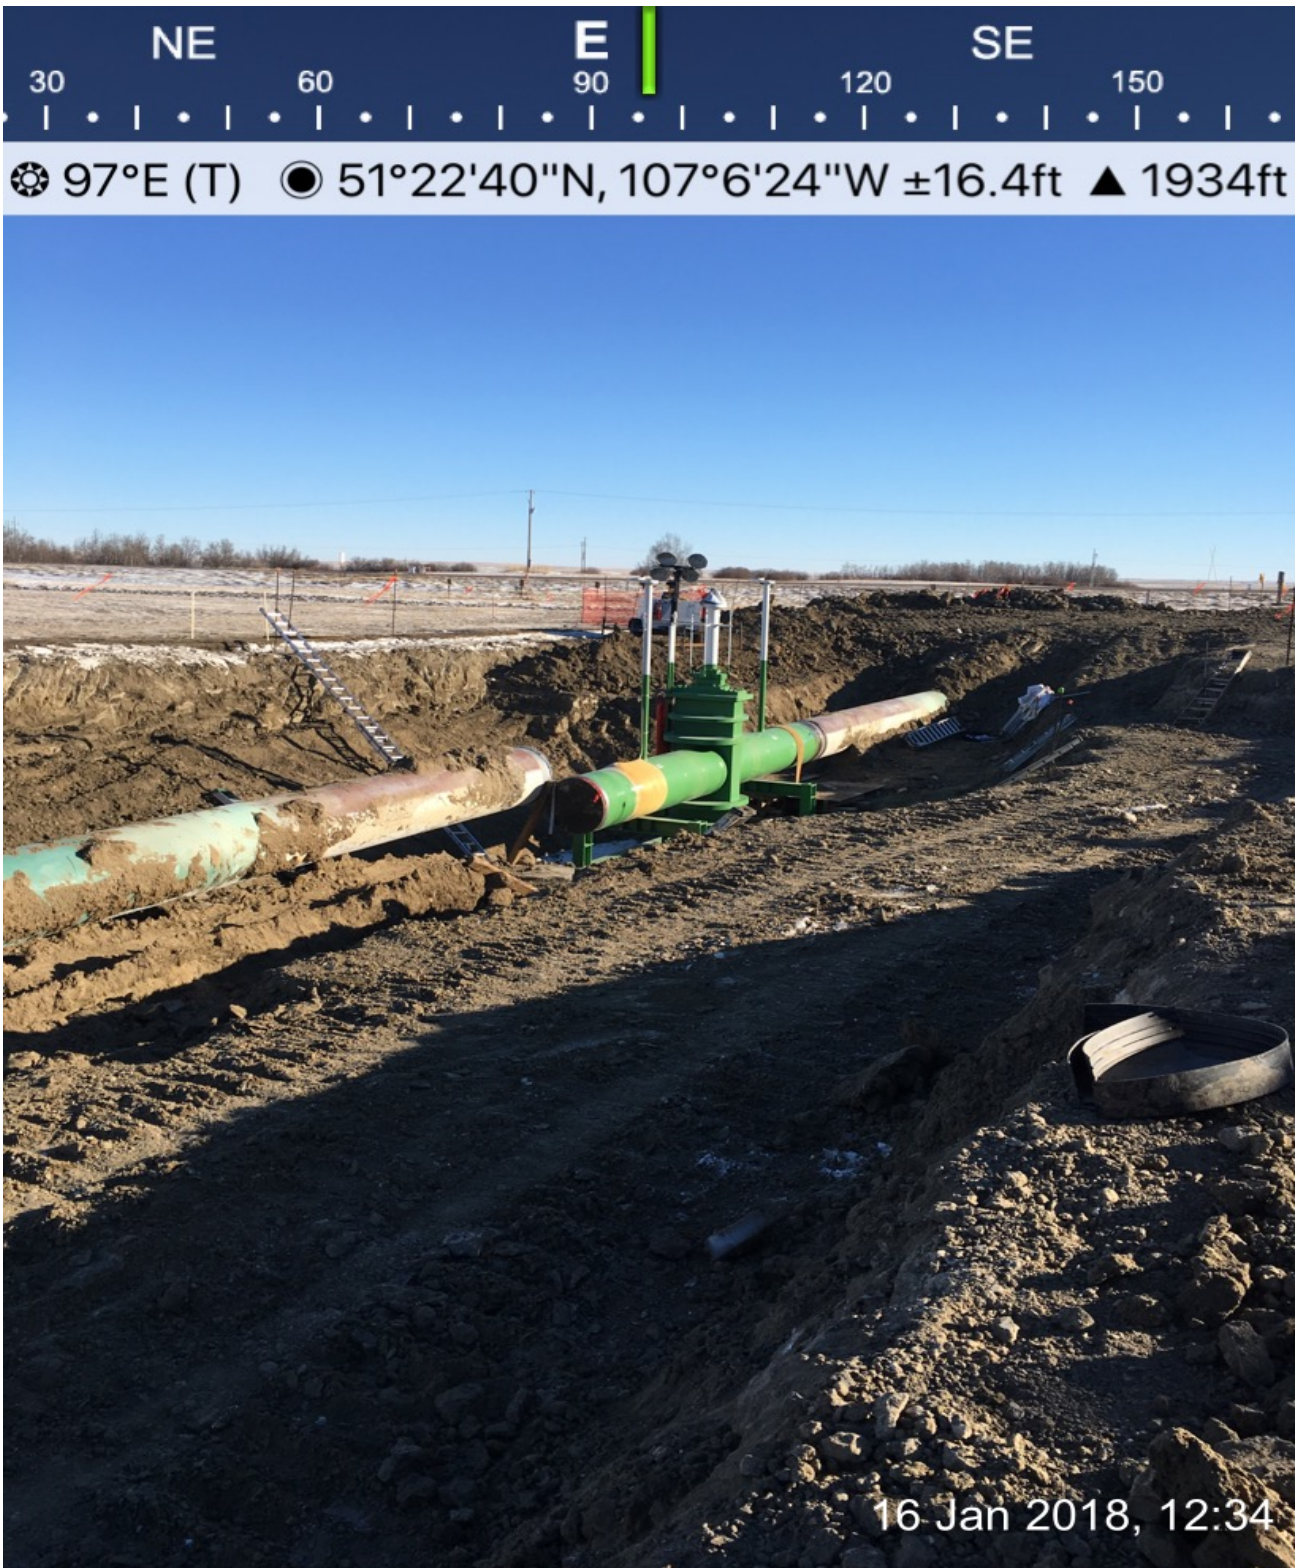
VALVE

Installation of two valves were completed they were welded and coded and currently just awaiting inspection approval then they will be buried.

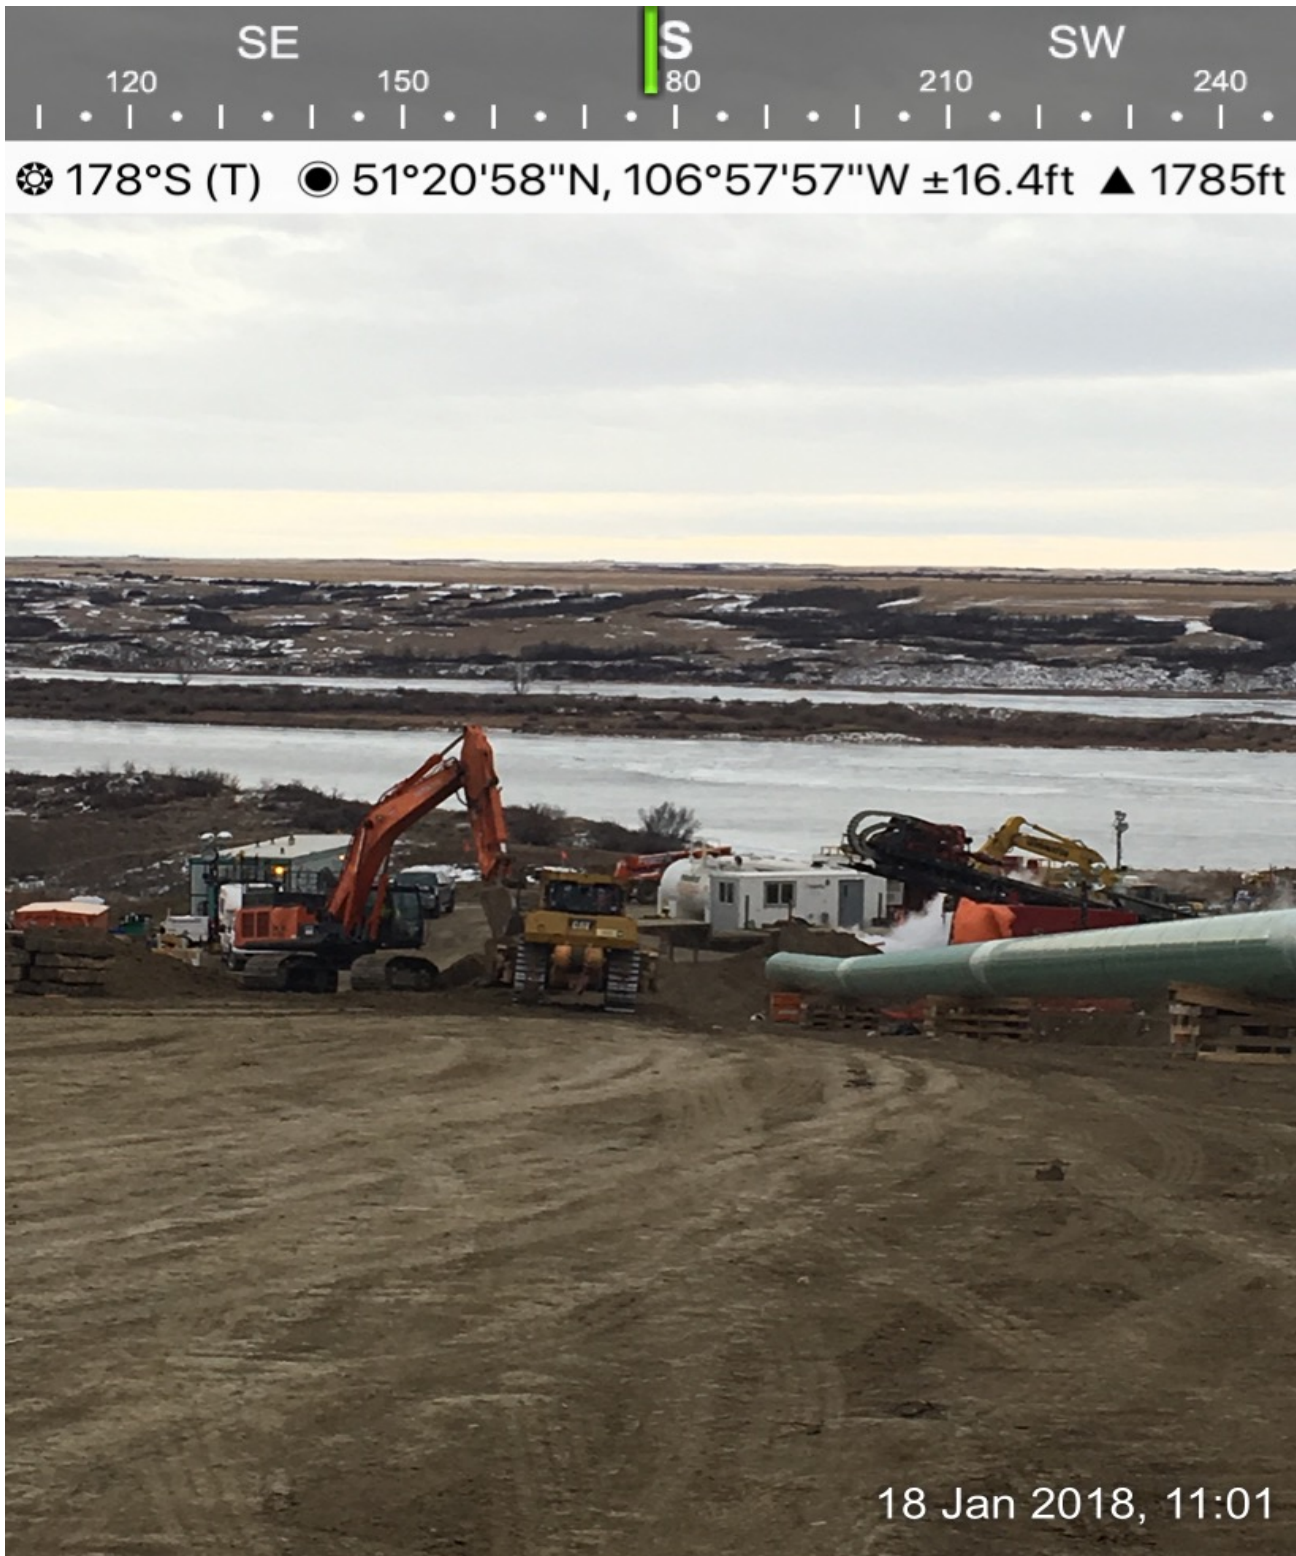
CREW MOVING SOIL PILE OUT OF THE WAY FOR DRAG SECTION

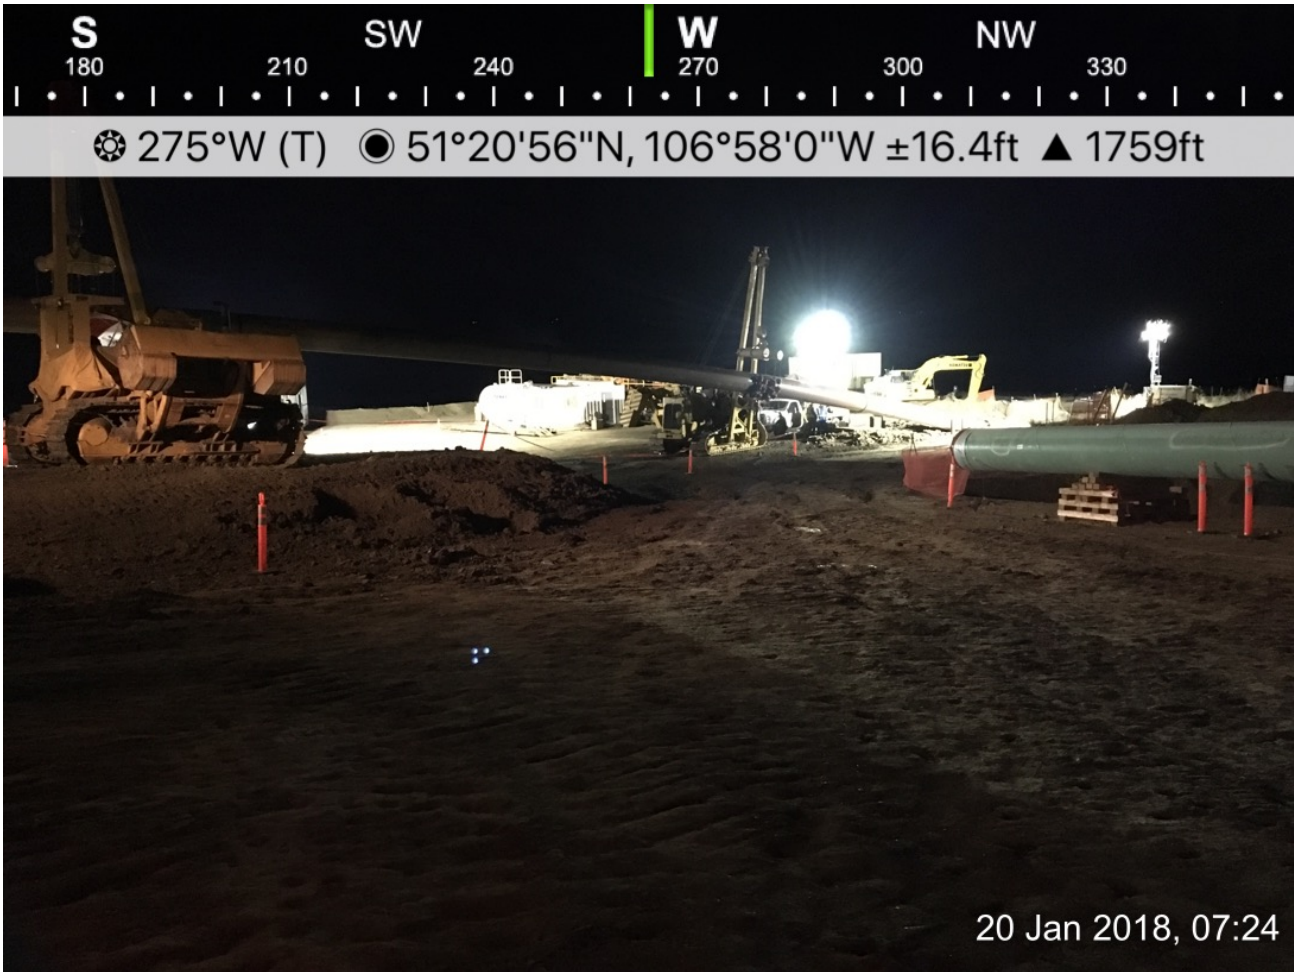
The horizontal directional drilling at the South Saskatchewan River is currently still an ongoing process. Mears group has drilled out with the 48-inch reamer and they tripped back and did a wiper clean on the bore hole. They have pulled the drag section pipe Friday and worked through the night, it took approximately 22 hours. As of yesterday, they were stuck with 30 metres left to pull. The pipe was stuck at a pipe casing at the entry point.

DRAG PULL OF PIPE

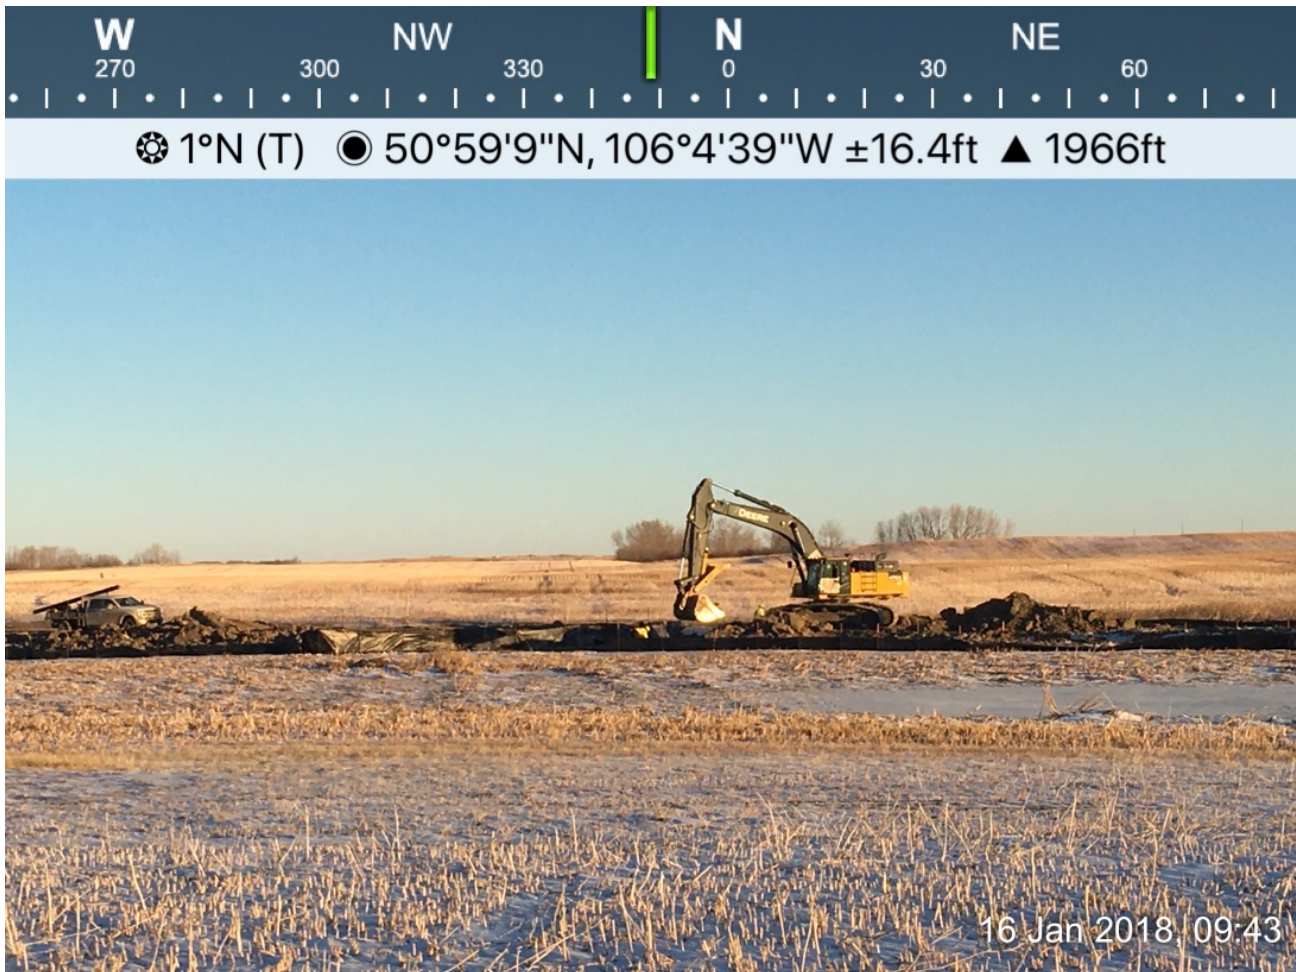
Reclamations of wetlands was ongoing all week but are currently all done on spread three. All waterways are completed where they were needed. Alley ways for cattle were installed and fences built. All access approaches that were needed to be removed have been completed. No concerns.

WET LAND RECLAMATION

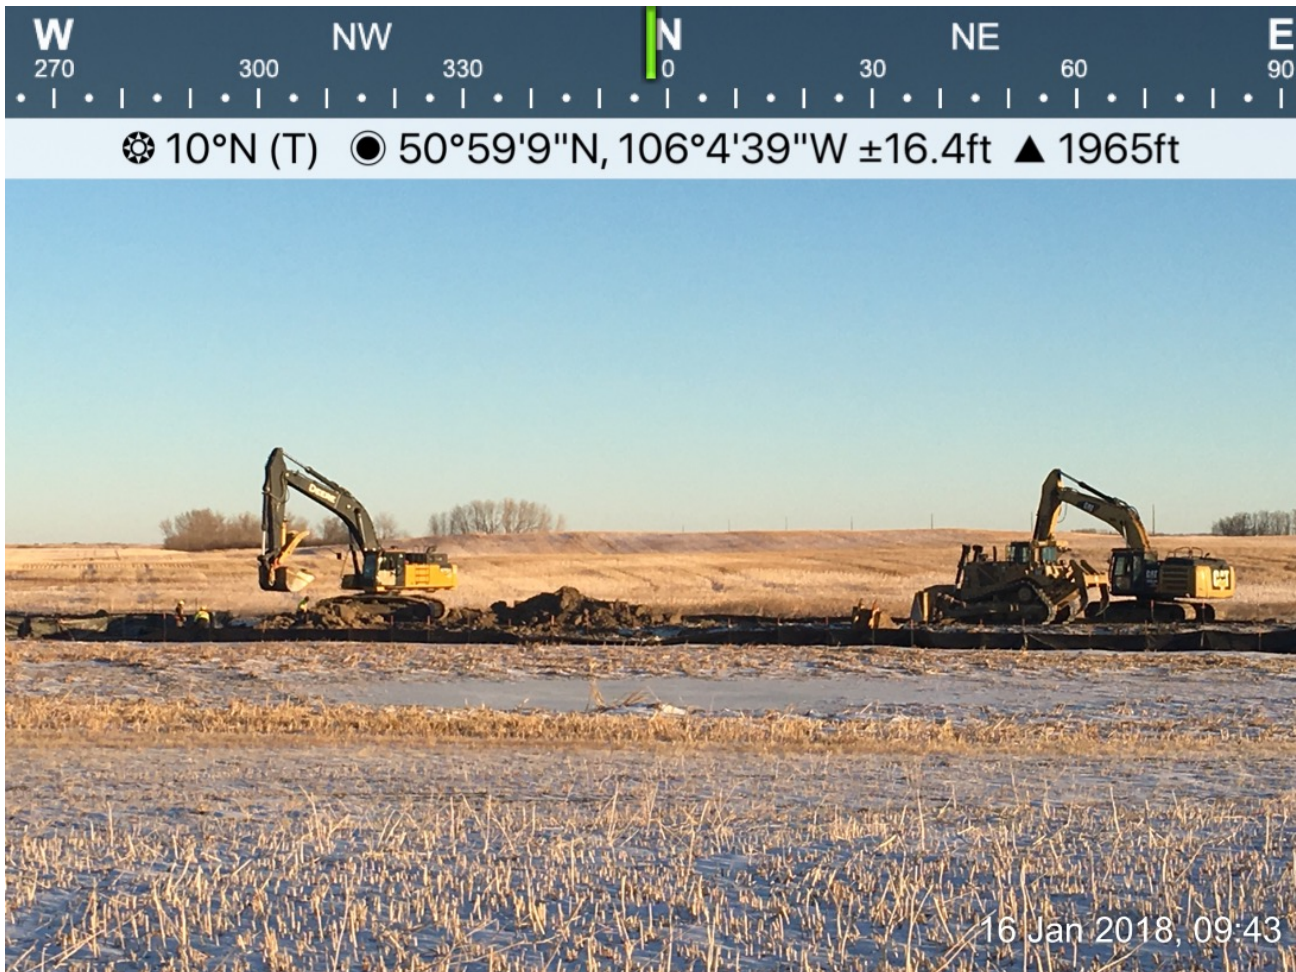
WETLAND RECLAMATION
