**SGS MUSCOWPETUNG**

**ABORIGINAL CONSTRUCTION MONITORING**

**WEEKLY REPORT**

**SPREAD 5**

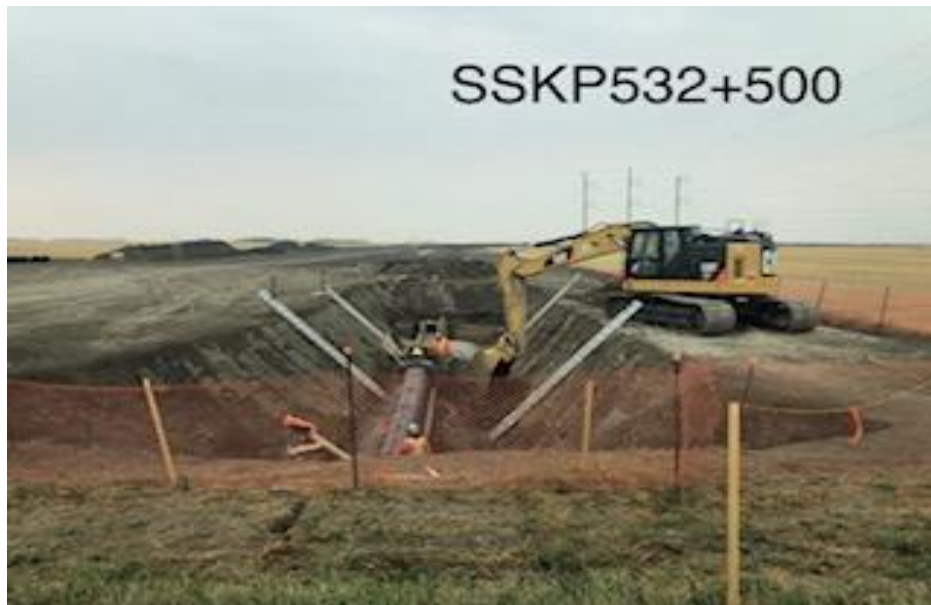
**Track bore installation at shoofly 2**

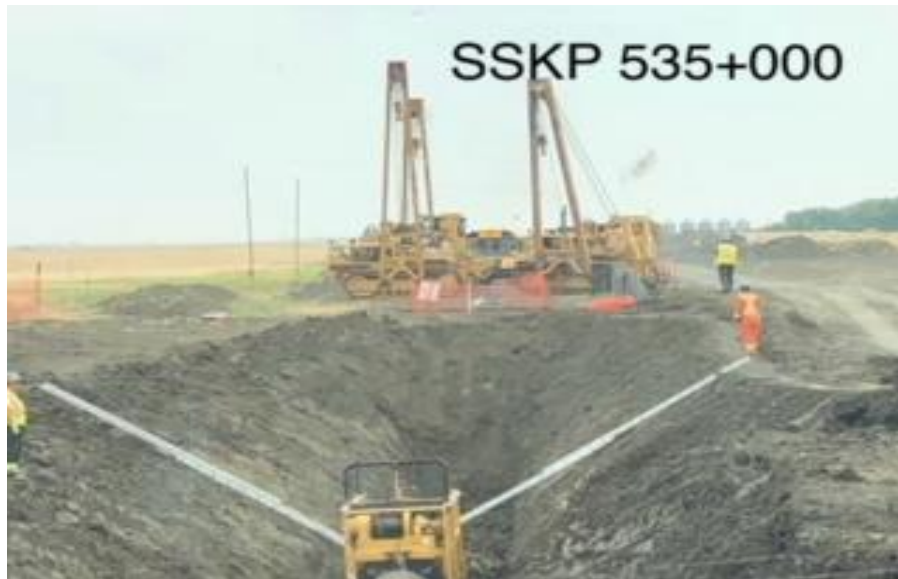
**Bore through road by track bore**

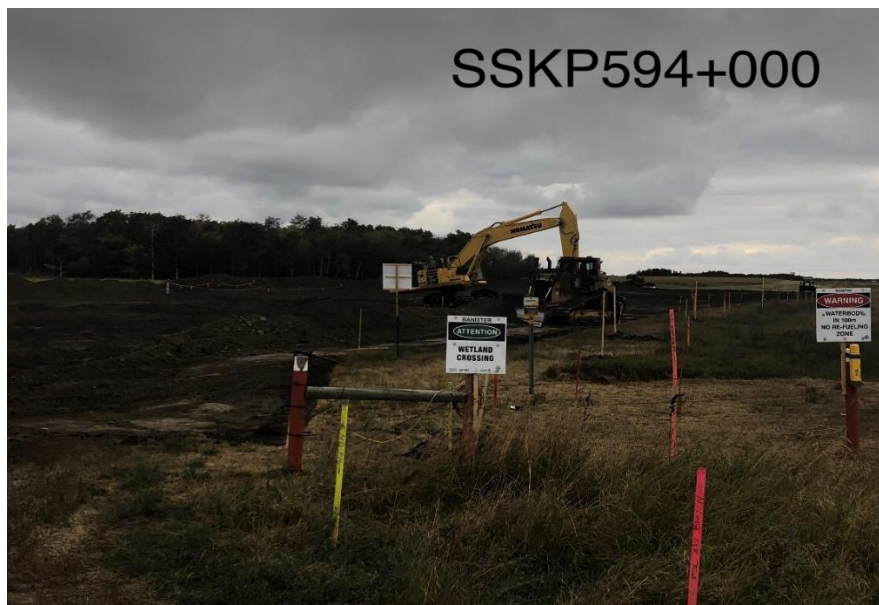
**Top soil stripping near wet land crossing**

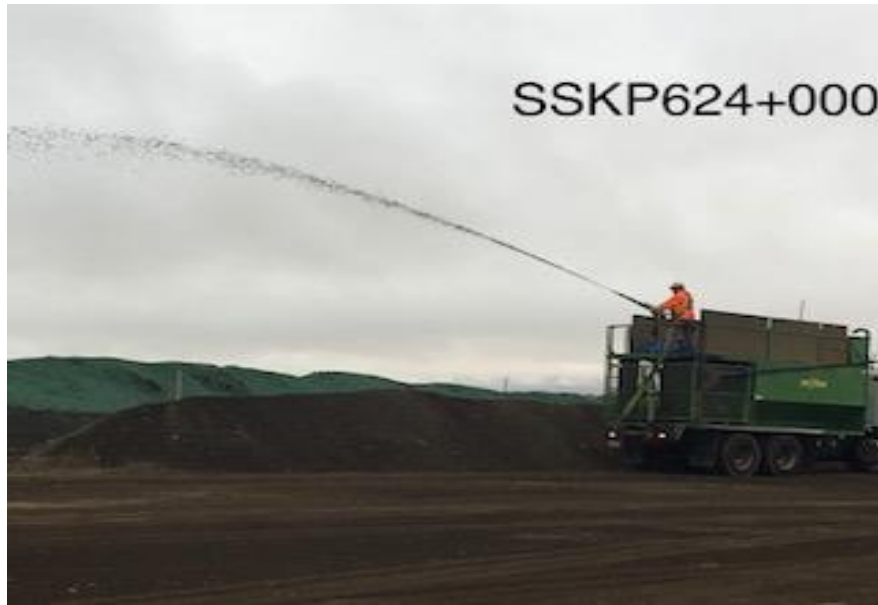
**Ditch soil separation layer being applied at Chapleau Lake**

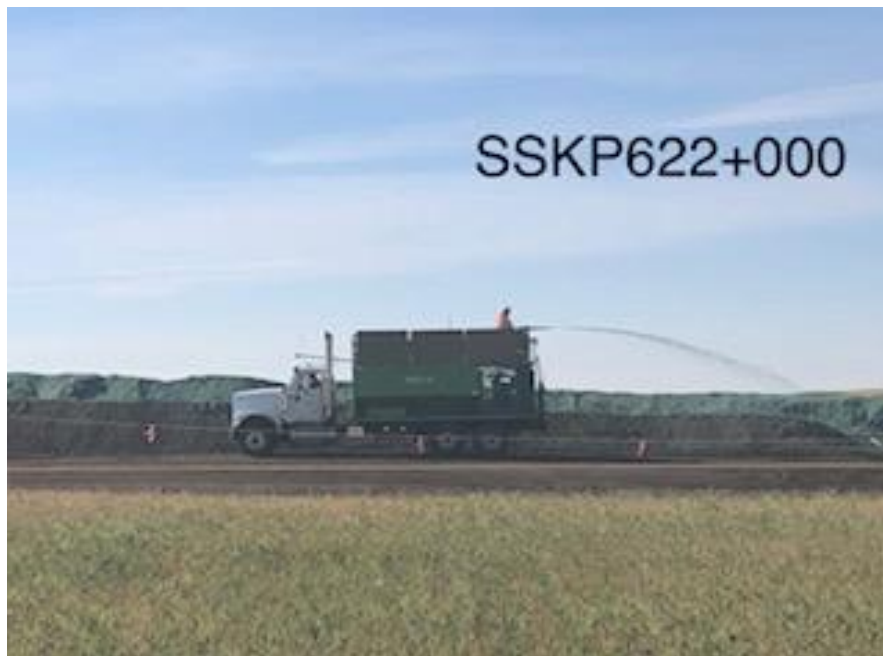
**Crews continue to apply ditch spoil separation layer**

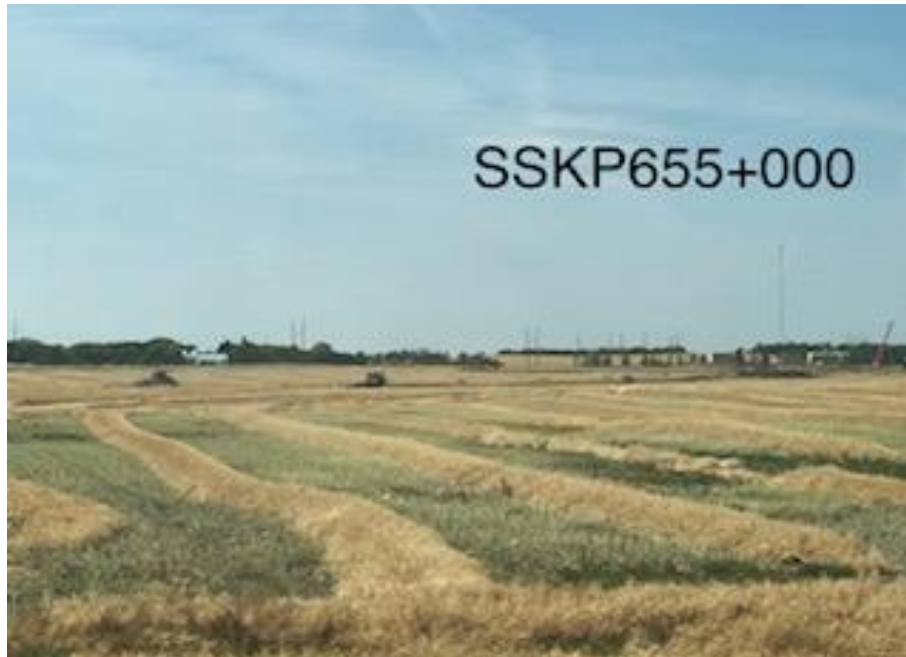
Discing past half way point on spread 5 SF70

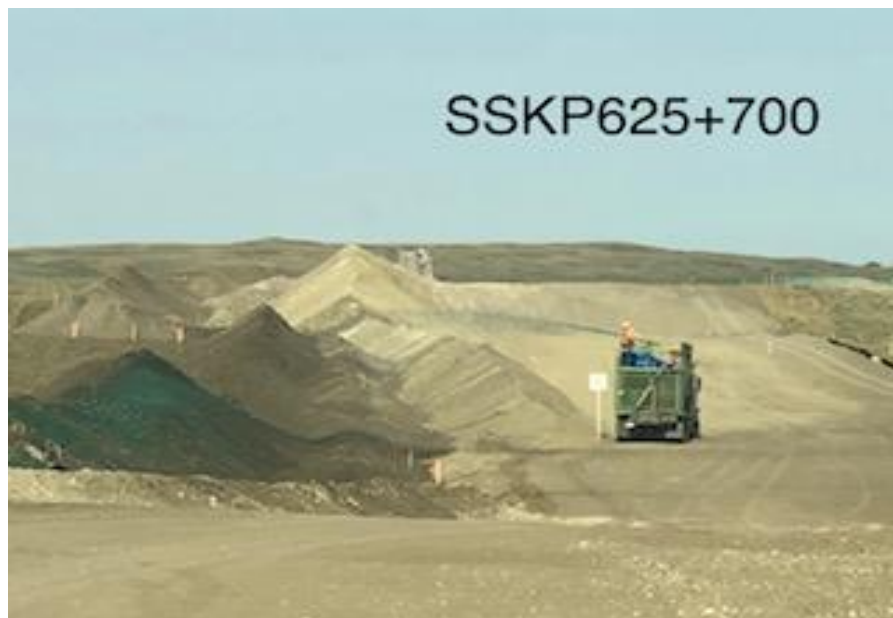
Continued ditch soil separation layer on the east side of Chapleau Lake

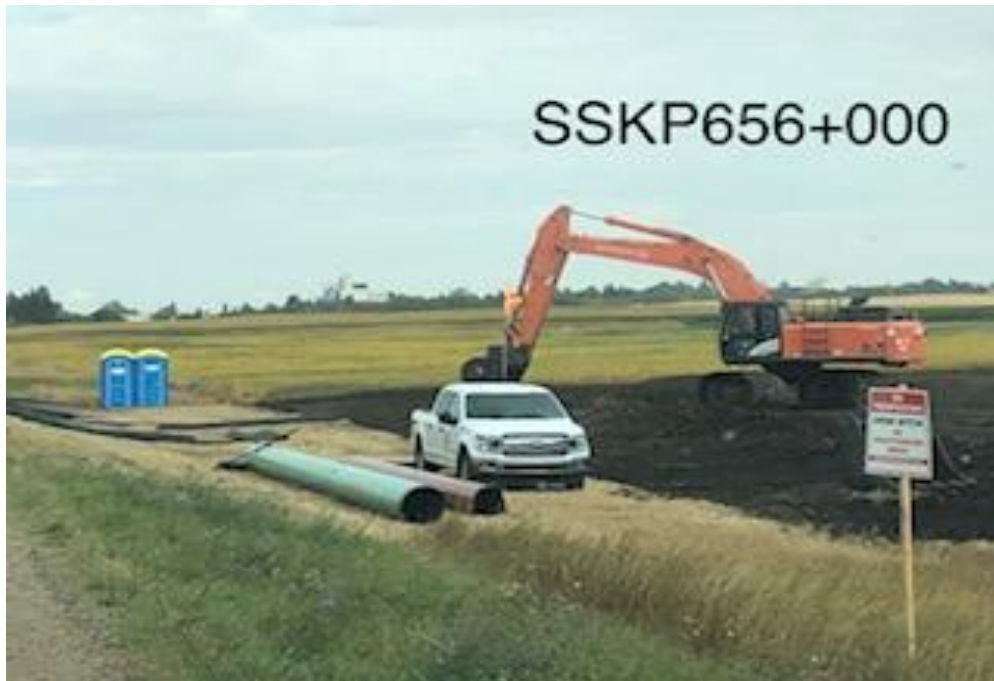
**Prepping before ramp installation at SF70**
