SGS MUSCOWPETUNG

ABORIGINAL CONSTRUCTION MONITORING

WEEKLY REPORT

SEPTEMBER 17TH TO SEPTEMBER 23RD, 2018

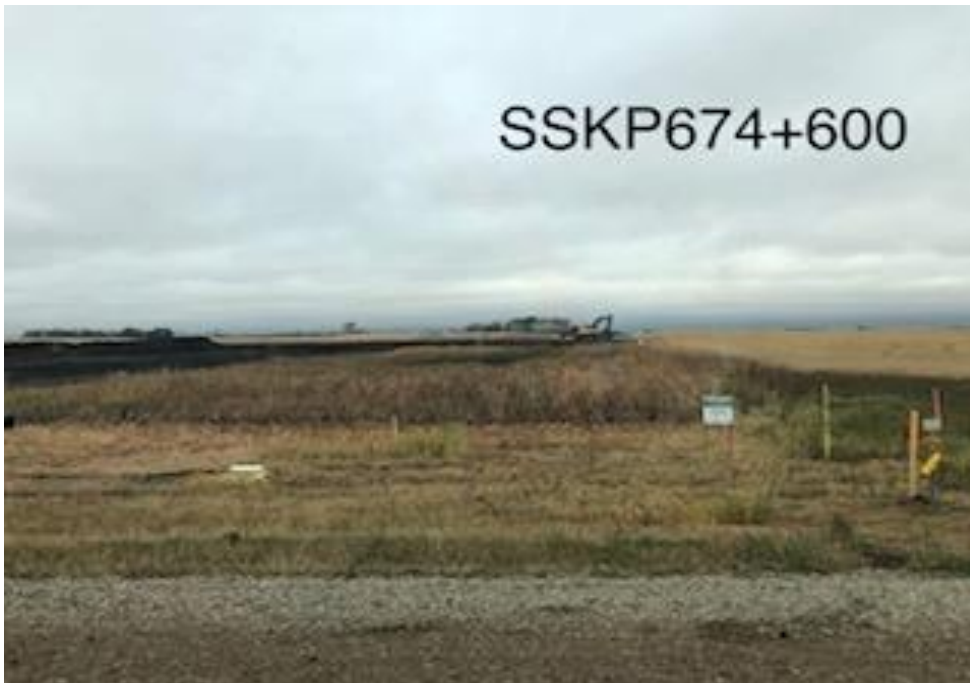
Access and Grade near Wet Land

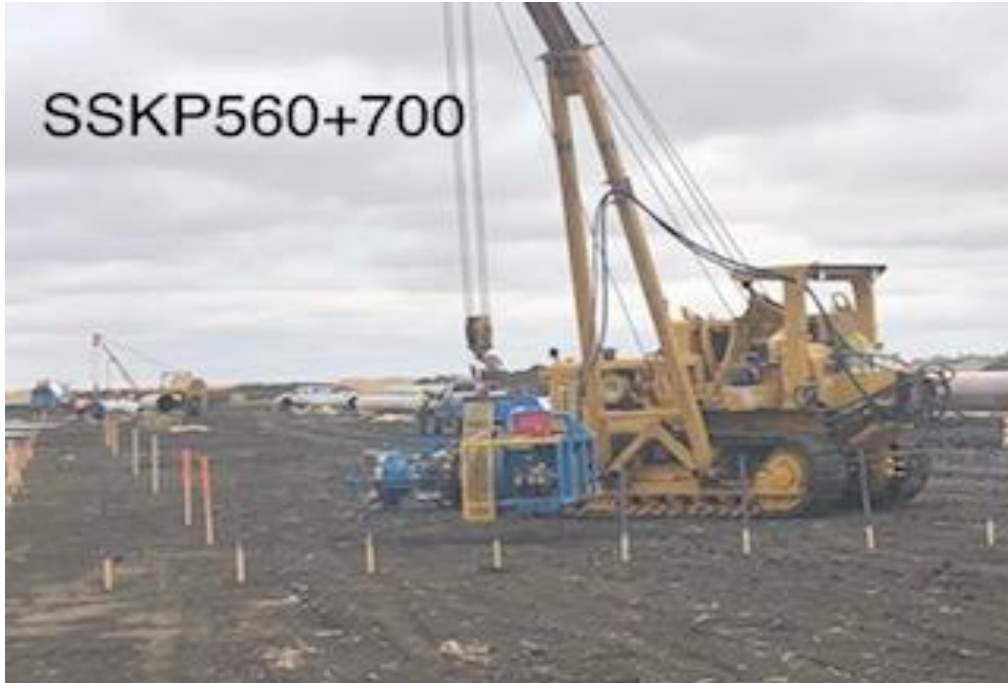
Bevelling crew prepping for welding

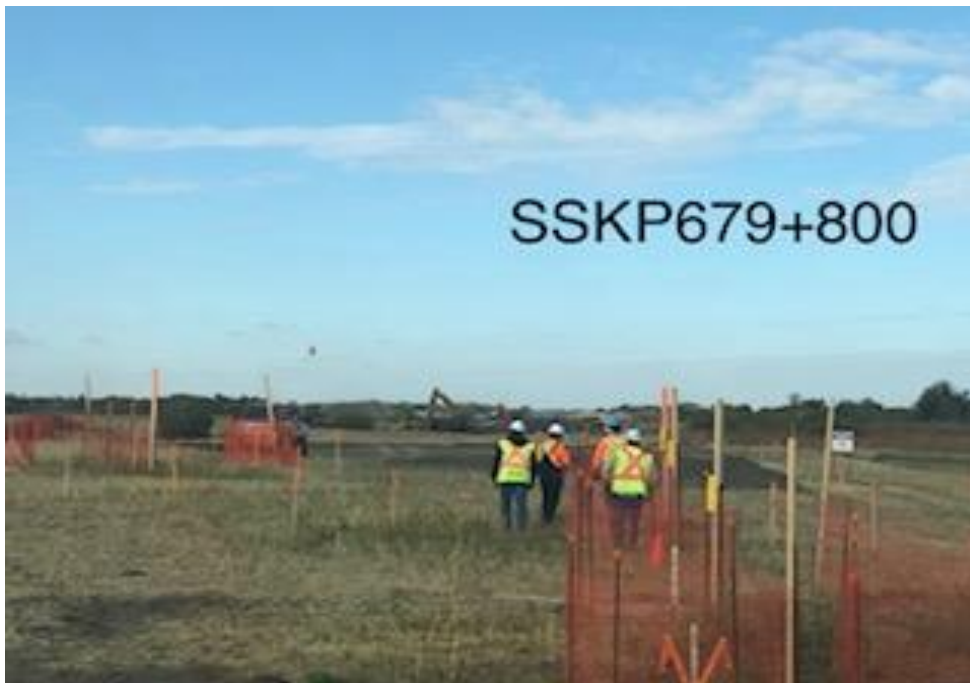
Access ramp installation near organic field

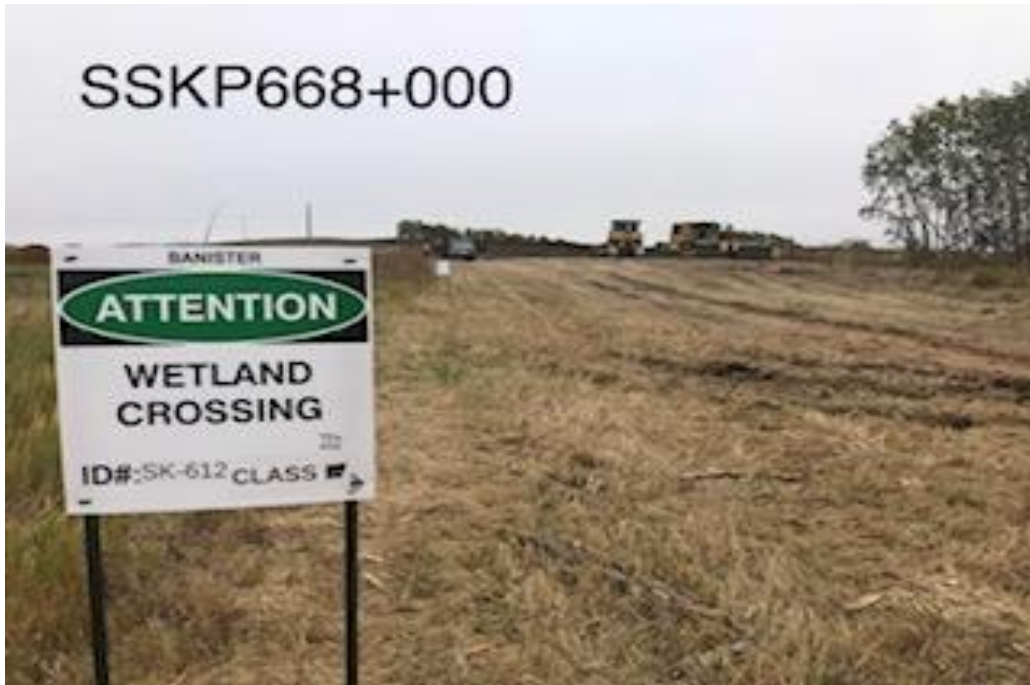
Power Dozer Near Wet Land Crossing

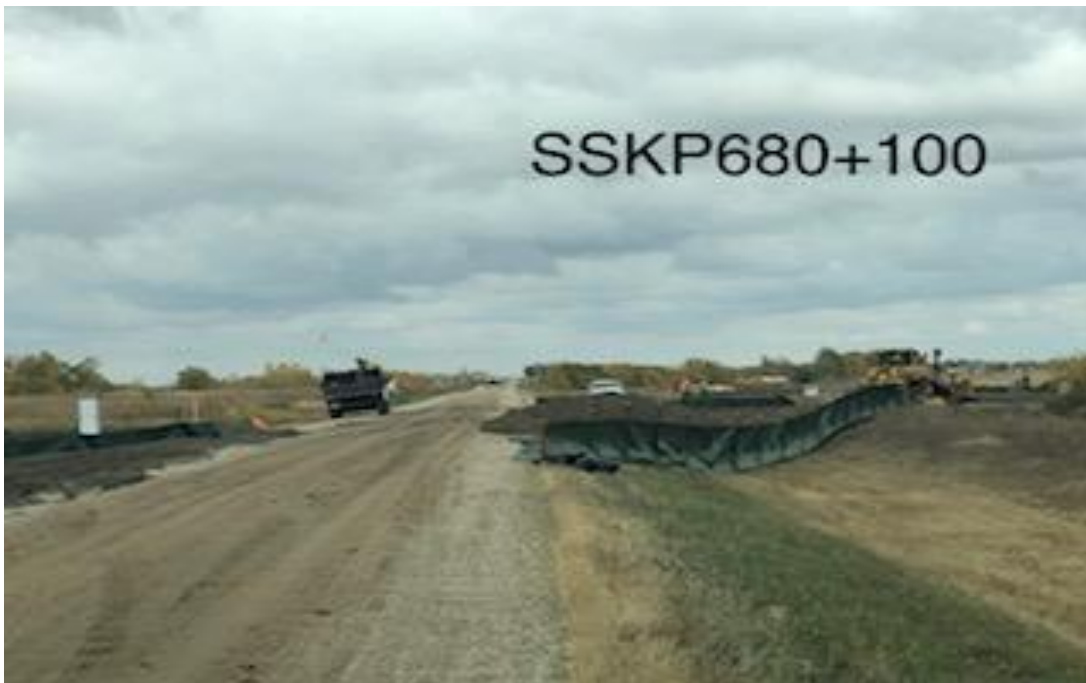
Access ramp Geotech and wingwall installation

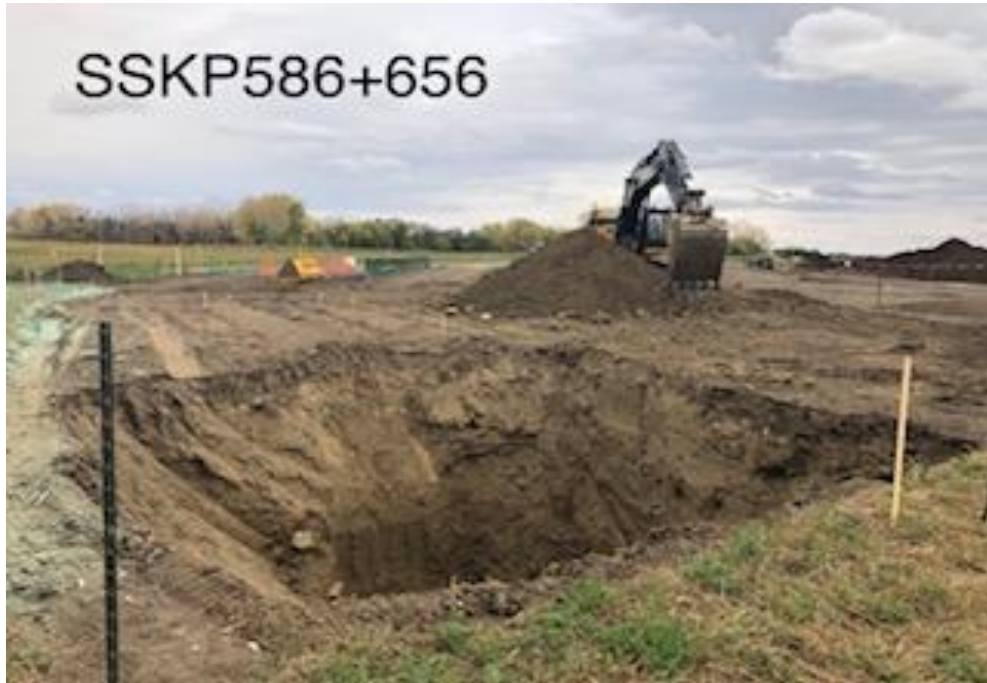
Cradle Bore excavation
