SGS MUSCOWPETUNG

ABORIGINAL CONSTRUCTION MONITORING

WEEKLY REPORT

SEPTEMBER 3RD TO SEPTEMBER 9TH, 2018

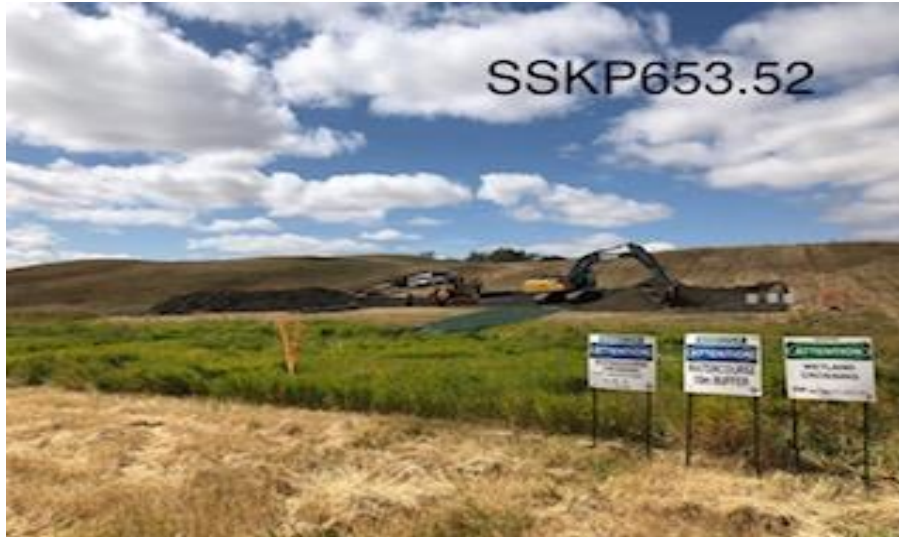
Vipond Creek Top soil stripping and soil separation

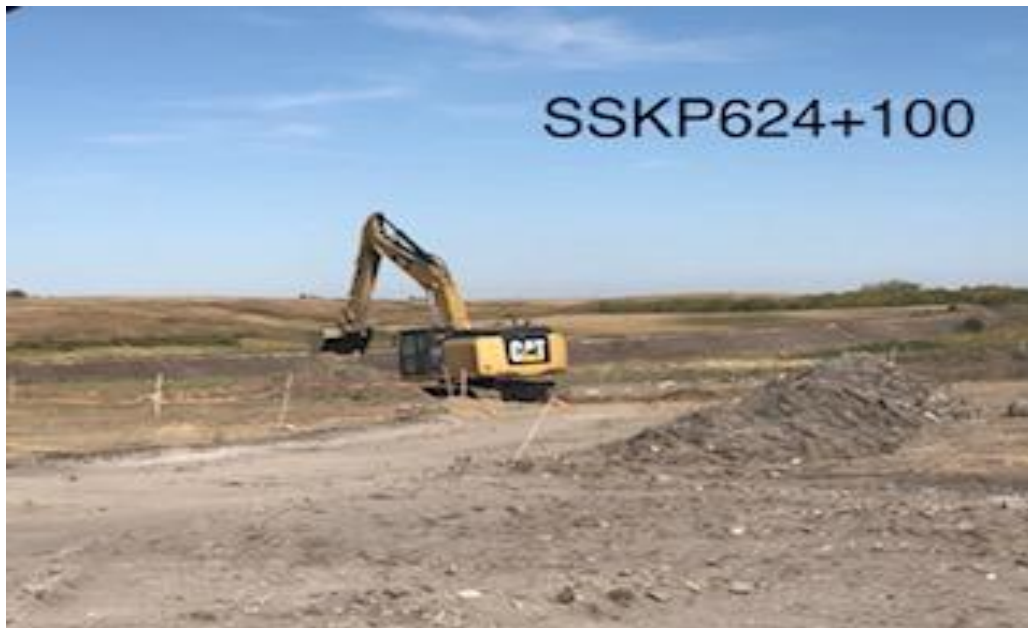
Chapleau Lake Dugout backfill

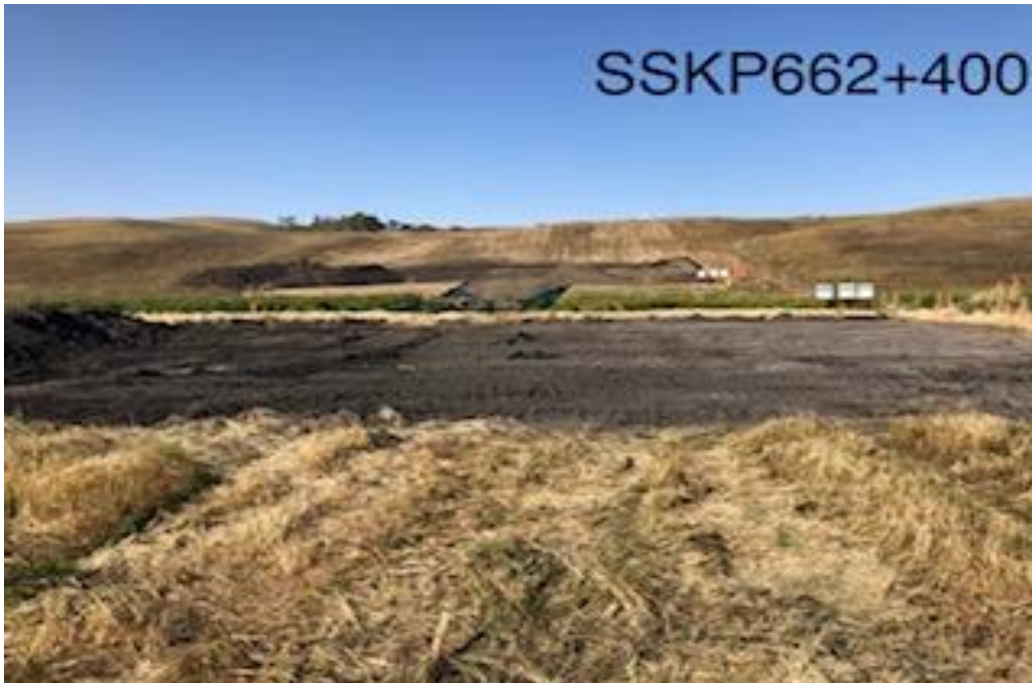
Vipond Creek Top bridge installation

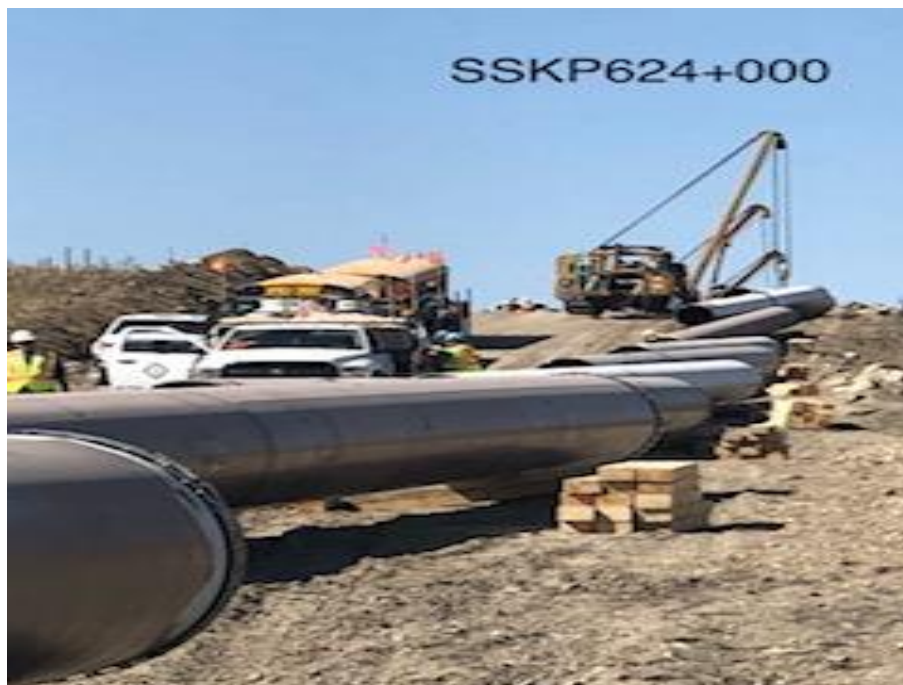
Welding crews at Chapleau Lake HDD drag section

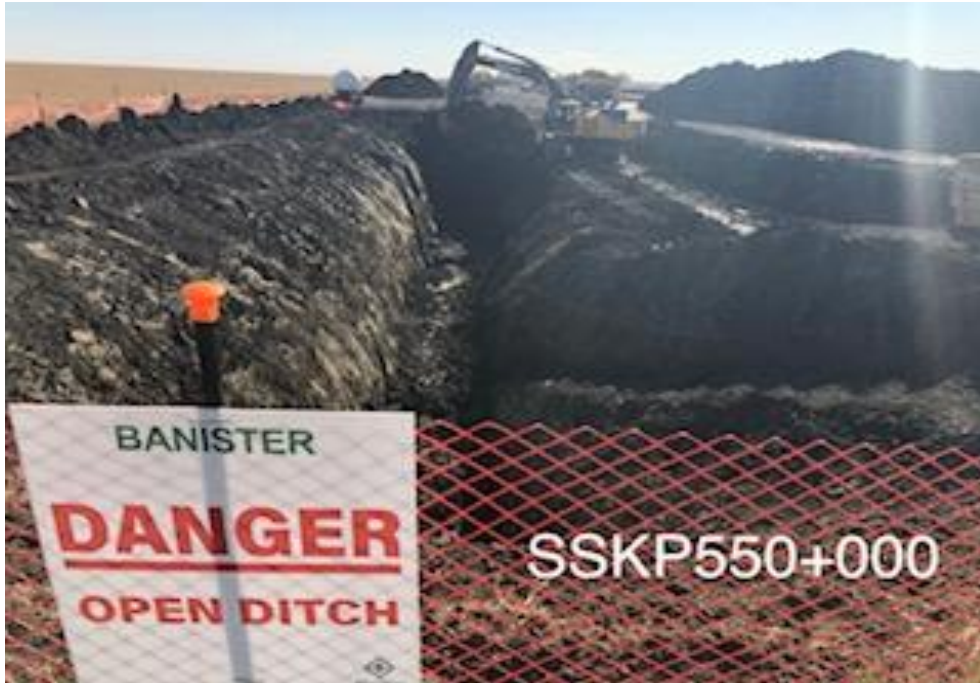
Excavation on SF10

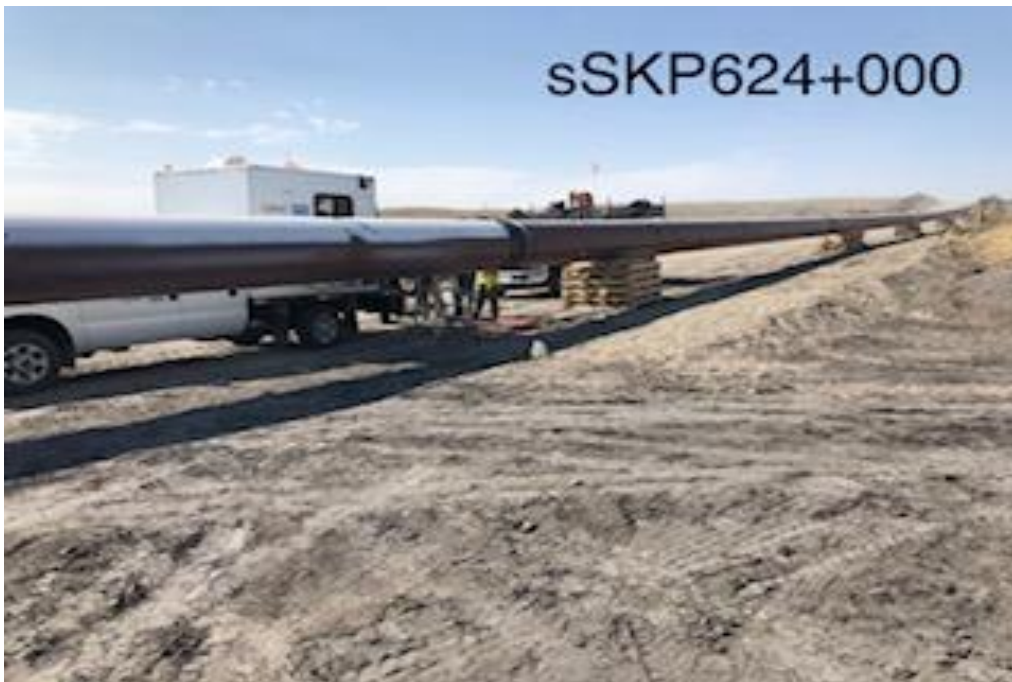
Welding crews complete drag section at Chapleau Lake

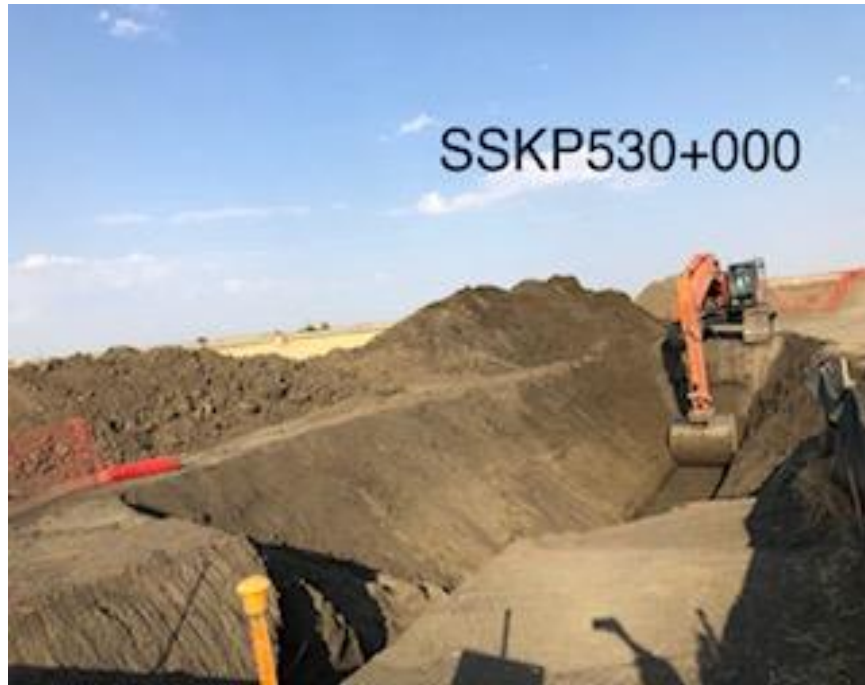
Bell hole excavation at kick off 4m deep near hotlines
