SGS MUSCOWPETUNG

ABORIGINAL CONSTRUCTION MONITORING

WEEKLY REPORT

SEPTEMBER 10TH TO SEPTEMBER 16TH, 2018

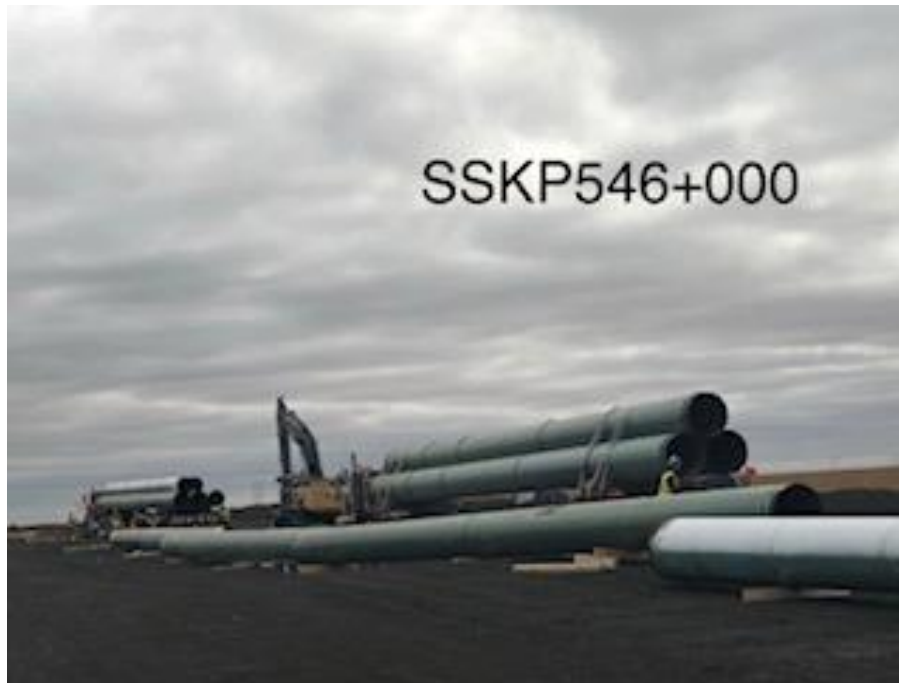
Stringing pipe along the ROW

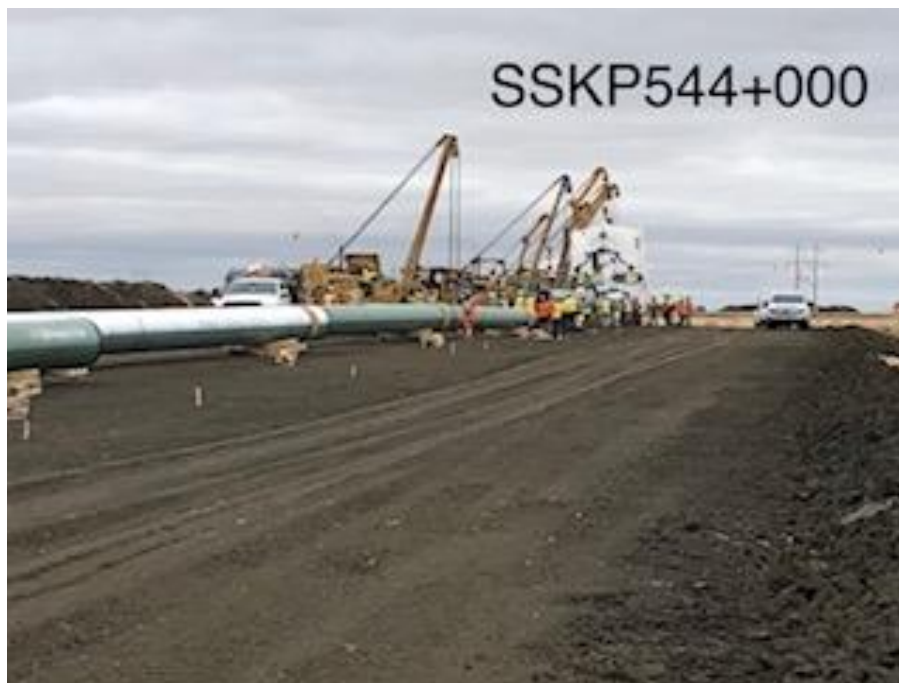
Poor boy weld crew on ROW

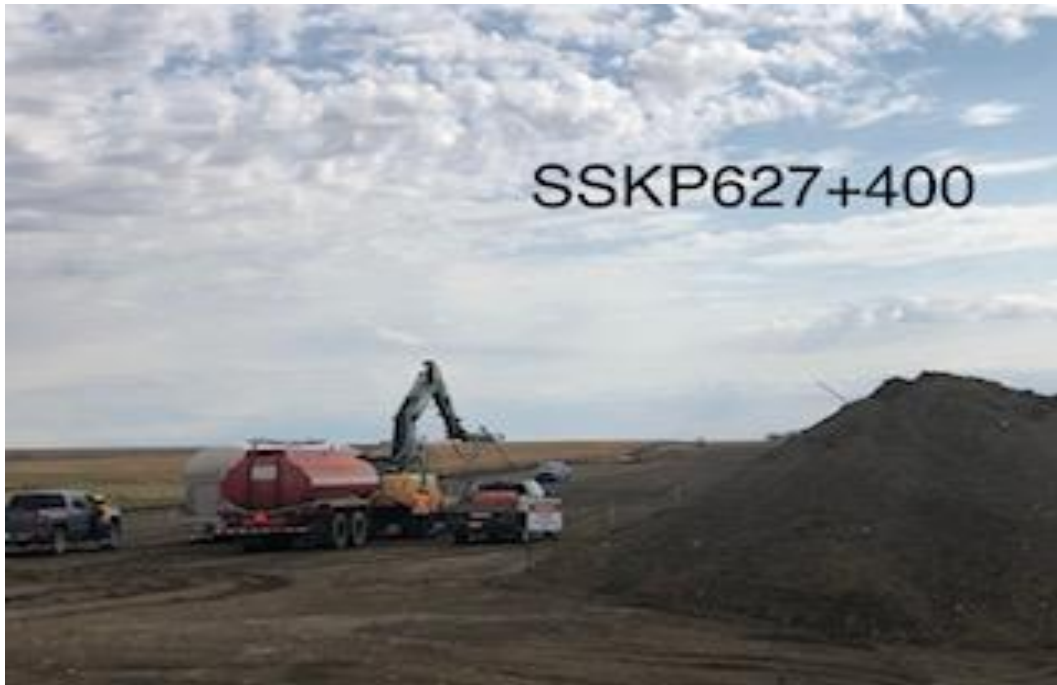
Ditch soil separation layer at Chapleau Lake

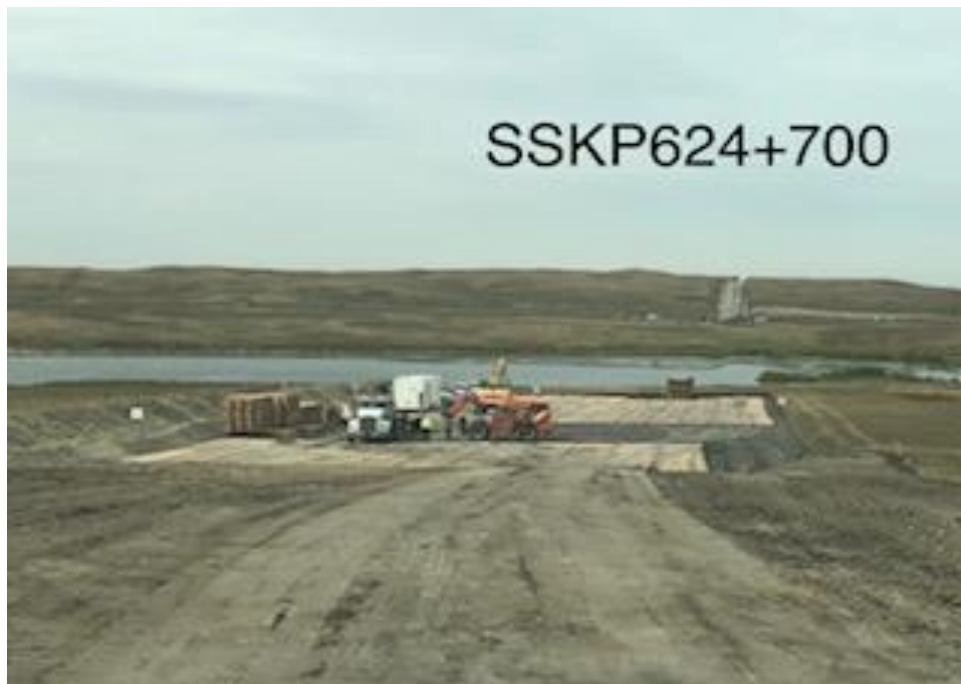
HDD ENTRY POINT

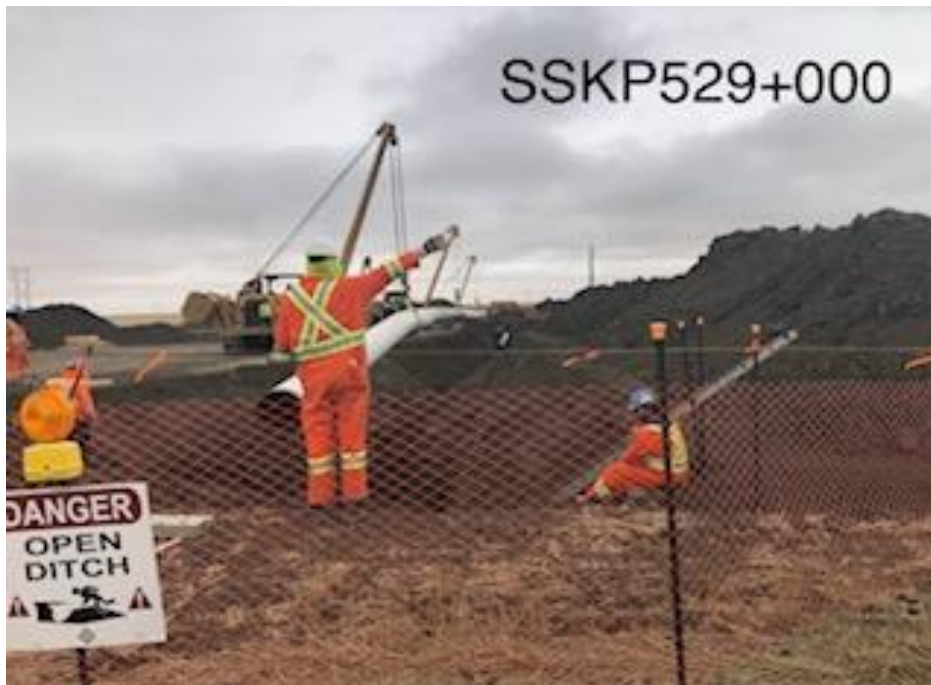
Lowering in a section near hotlines

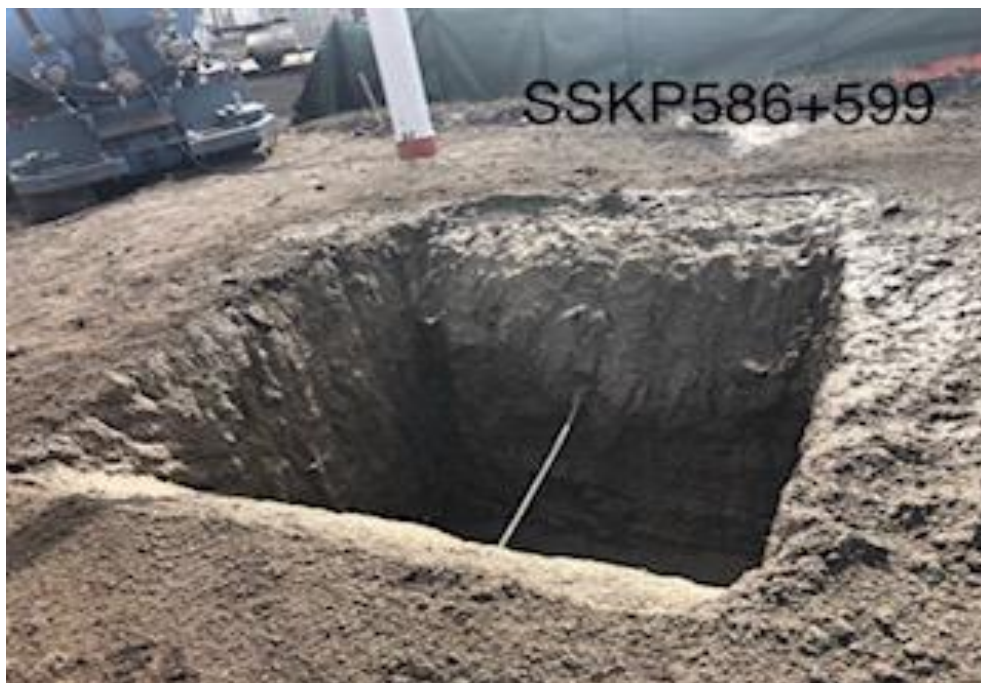
DAYLIGHTING SASK POWER CABLE
