SGS MUSCOWPETUNG

ABORIGINAL CONSTRUCTION MONITORING

WEEKLY REPORT

AUGUST 13TH TO AUGUST 19TH, 2018

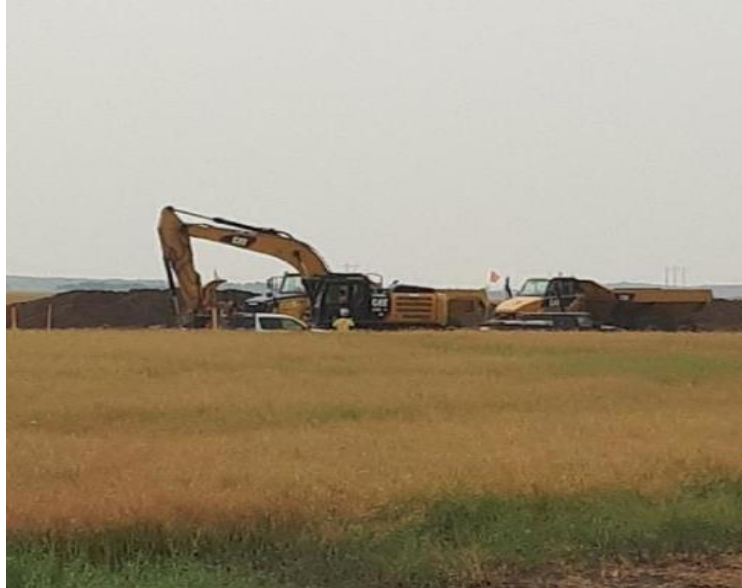
SF 58 Stripping and piling topsoil

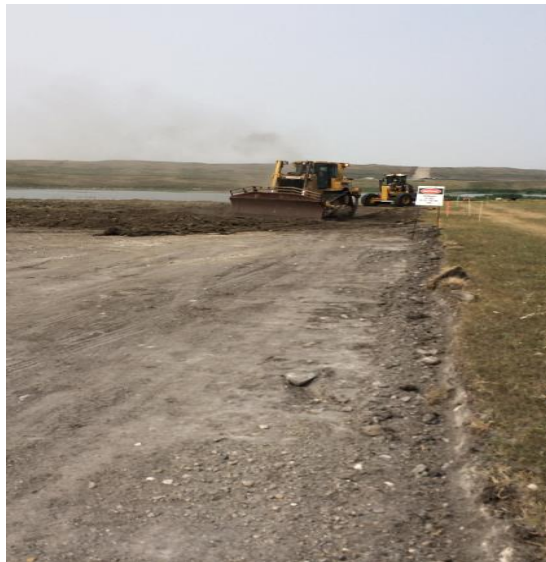
Aug 18th SF 53 625+691 Travel to Chapleau Lake monitored stripping on East side. With Archaeologist (Rob Wondrasek) Equipment Stripped top layer to extend HDD pad to 624+700 additional 30m within Areological site. Equipment stopped, and we walked the site (no archaeological or sacred site surface features were observed).

Equipment Stripped top layer to extend HDD pad to 624+700 additional 30m within Areological site.

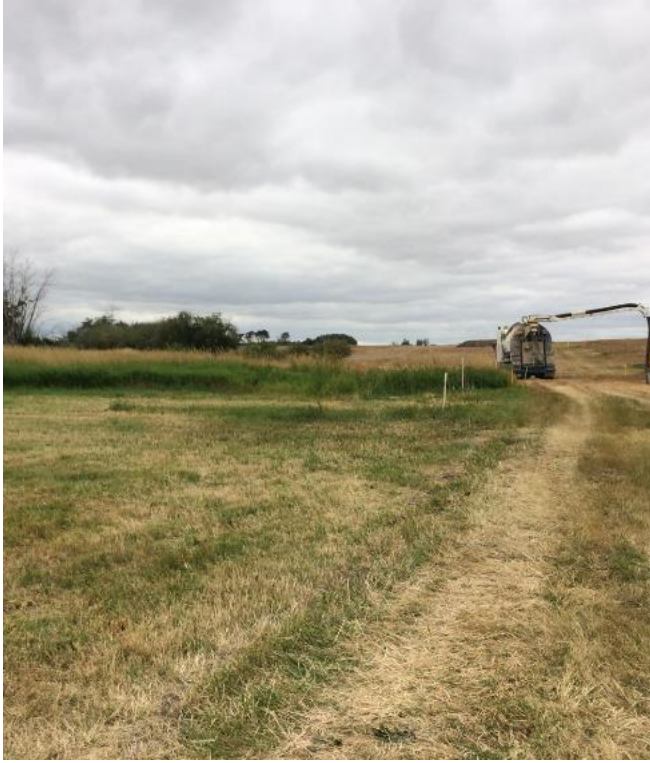
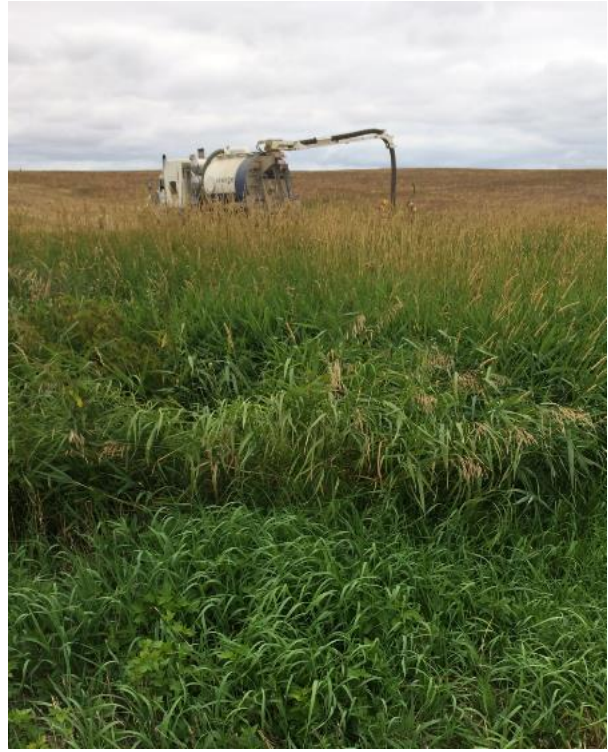
Aug 13th Our team travelled to Spread 5 SF 63 643+400 to 643+600 to monitor hydro vac at (Valley West of the old rail bed). This is one of the areas the First Nation requested monitoring, as there was potential for deeply buried cultural deposits. A pre-meeting was conducted between the crew and our monitors before the hydro vac procedure began. We Monitored three areas that had Hydro vac completed Including 643+455, Our team did not see any cultural deposits. Within the same area a ramp was constructed at 643+300. A slurry pit was dug out on the North side of the ROW. Observed the wet land (shrubby swamp) along the south of the ROW. Area was marked with large signage and (Buffer) area was clearly marked with stakes.

SF 63 643+400 to 643+600 hydro vac (Valley west of the old rail bed) Hydrovac to expose the pipe.

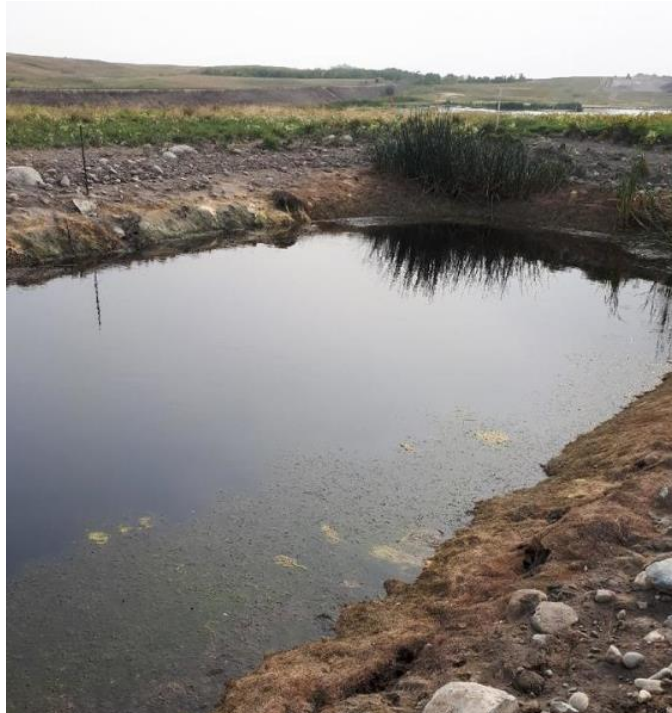
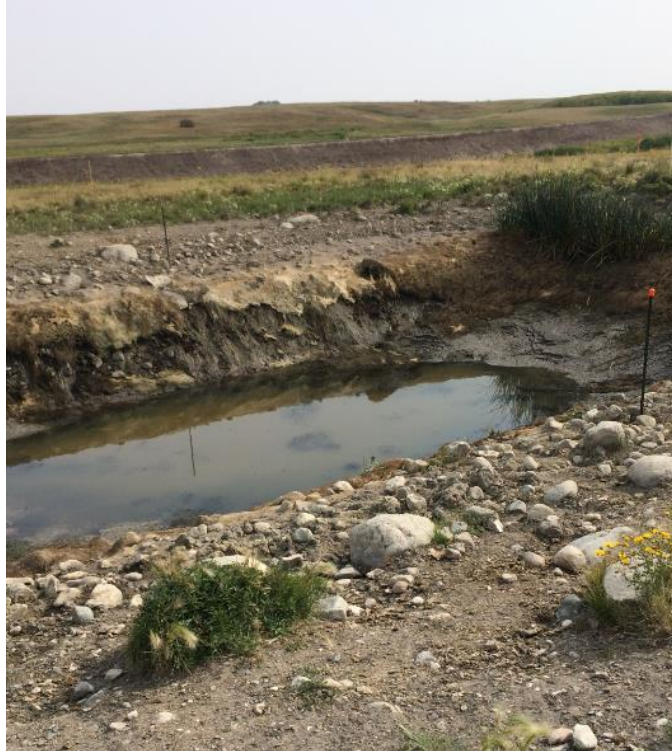
SF 51 622-223 East Chapleau lake Monitored pumping of dug out, observed silt fence put up at east corner of dug out. Spill pan was in place and hose was placed properly for non-erosion. Environment noticed fish in the dugout and pumping ceased.

SF 51 622-223 East Chapleau lake, dug out before and after pumping out
