SGS MUSCOWPETUNG

ABORIGINAL CONSTRUCTION MONITORING

WEEKLY REPORT

AUGUST 20TH TO AUGUST 26TH, 2018

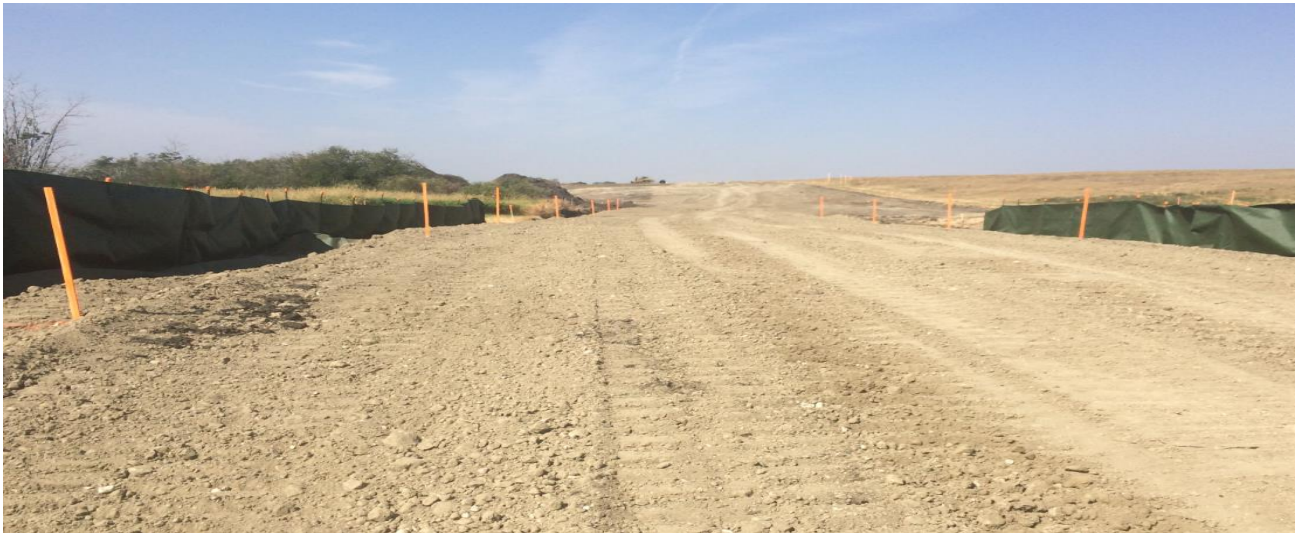
Valley west of the old rail bed 643+400 is another location our team continued to monitor this week. We monitored excavating and building of ramp over wetland. FN (First Nation) have requested monitoring in this area as there is potential for deeply buried cultural deposits. The water course crossing Wc71 SSkip 643.43 area was dry, Geo textile was installed on the walls and under the flume and the vehicle/equipment crossing was complete. (Wetlands SK 540 .class iii was properly marked with a no fuelling buffer. The willow trees that were removed were placed to the south of the ROW (right of way). Grading and piling of soil was completed.

Valley west of the old rail bed 643+400 crossing over wetland

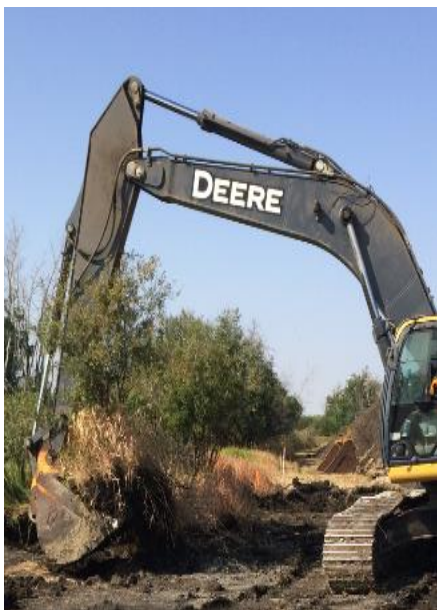
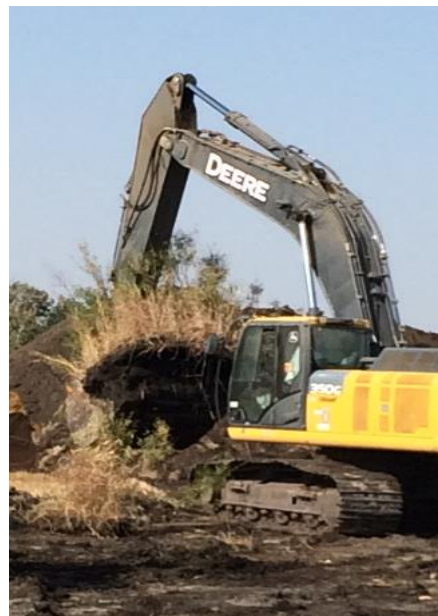
Valley west of the old rail bed 643+400 Removal of willows

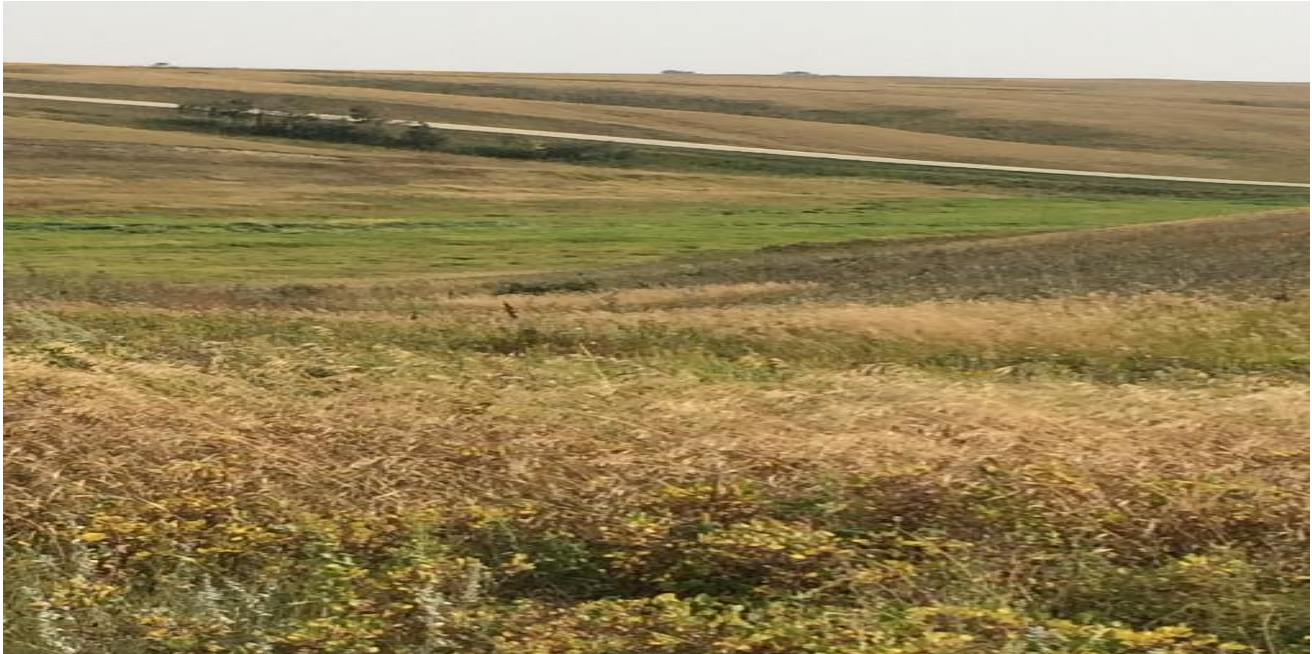
Vipond Creek Archaeological Sacred site is another area within the right of way that PRNFN has requested Monitoring during soil exposed by hydro vac catchment and pit excavations, Areas of interest included the adjacent cultivated uplands, the valley crest and the flood plain. This week we monitored all the hydro vacs within the cultivated uplands, the valley crest and the flood plains. These areas are located between station 661+132, station 661+137 Several Hydro vacs were done to expose pipe, Sask tel and hydro lines on both the west and East sides of the Valley. Forty-five hydro vac excavations were monitored Fine cleans were done before we left to site, mist spray before entering sites and rough cleans were completed between fields. We walked the area where the 2 slurry pits were on the west side, Stn 661-600 and the one on the East side stn .663-200 Clearly marked and roped off. We did observations/ visual assessments off all three slurry pits and repeated visual assessments as material was unloaded. Once the hydro vac procedure was done visual assessments were completed which concluded no signs of artefacts or cultural buried deposits. Any assessments of interest were forwarded to the Archaeologist. On one occasion archaeologist confirmed a rock within one of the excavated holes was natural not cultural. Our team will continue to monitor this area through various stages of construction.

Vipond Creek Archaeological Sacred site Picture taken looking East

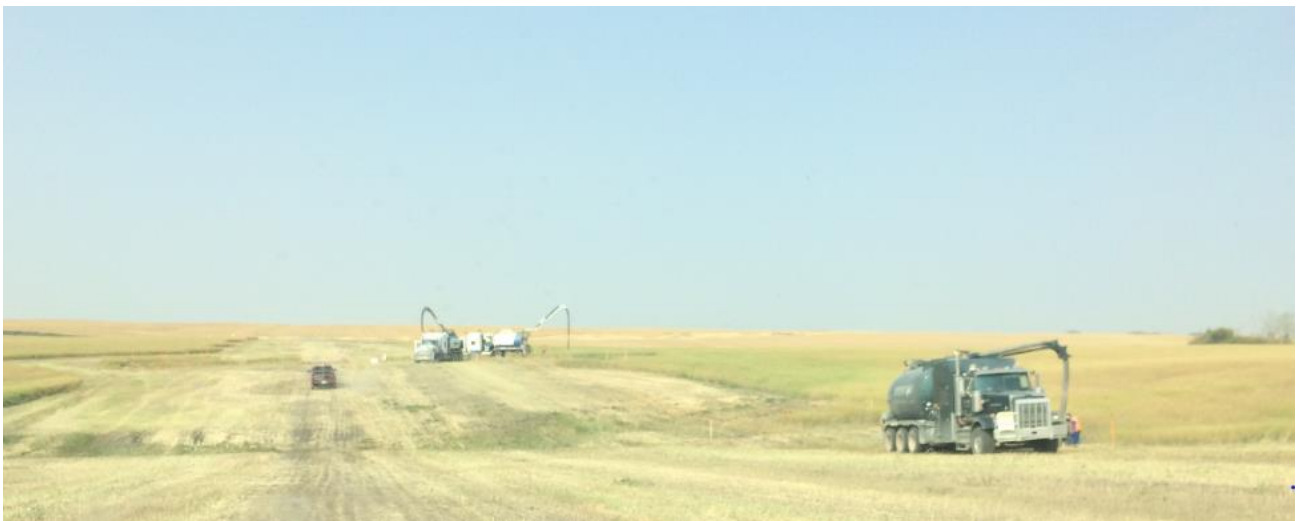
Vipond Creek upper adjacent cultivated uplands - Hydrovacs

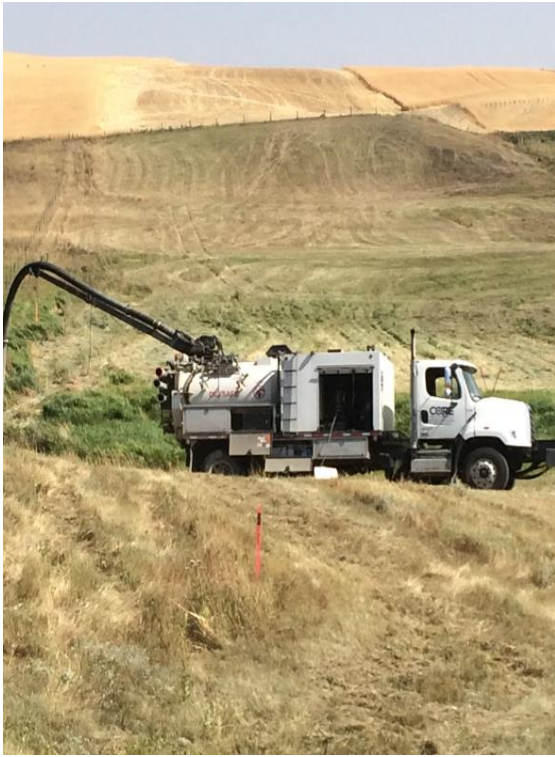
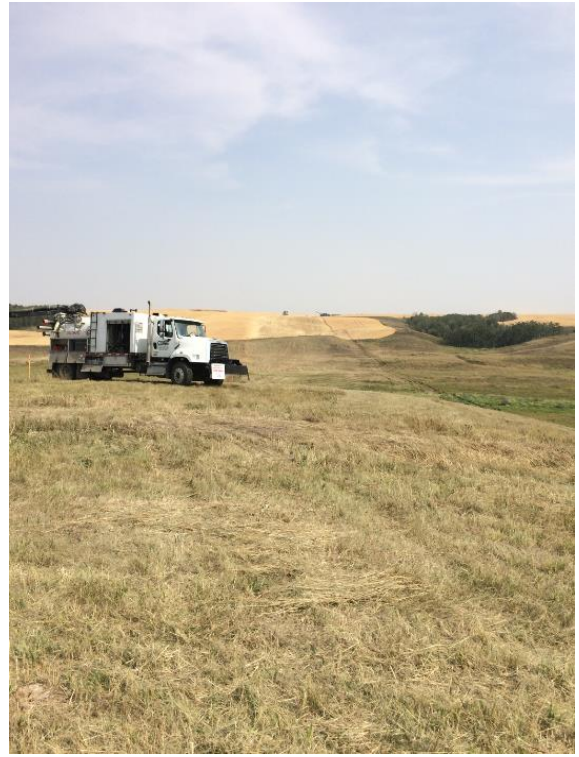
Vipond Creek upper adjacent cultivated uplands – Hydrovacs

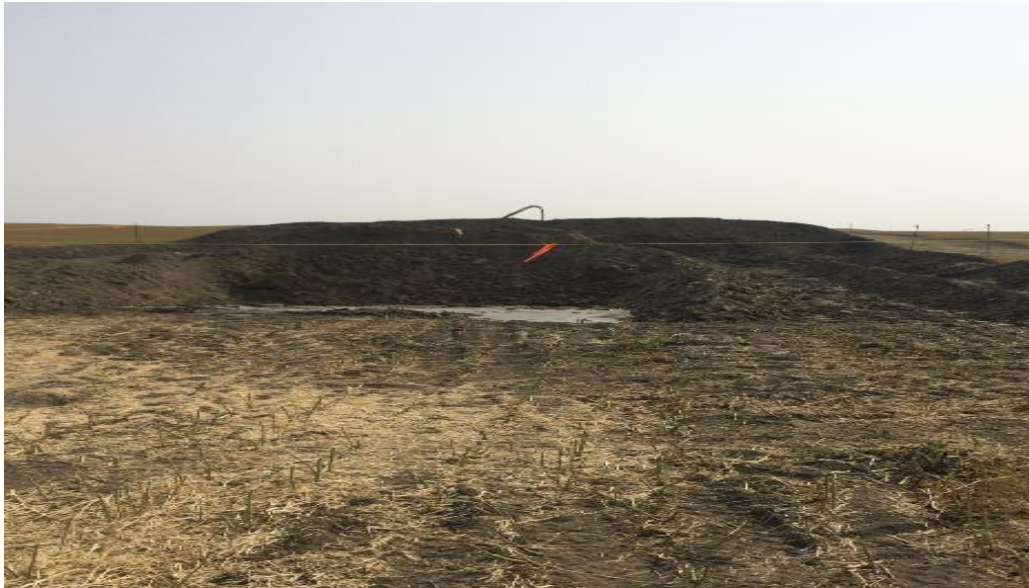
Vipond Creek upper adjacent cultivated uplands – slurry pit excavation
