**SAMSON CREE NATION – MATRIX SOLUTIONS INC.
PARTNERSHIP**

ABORIGINAL CONSTRUCTION MONITORING

WEEKLY REPORT

AUGUST 14TH TO AUGUST 20TH

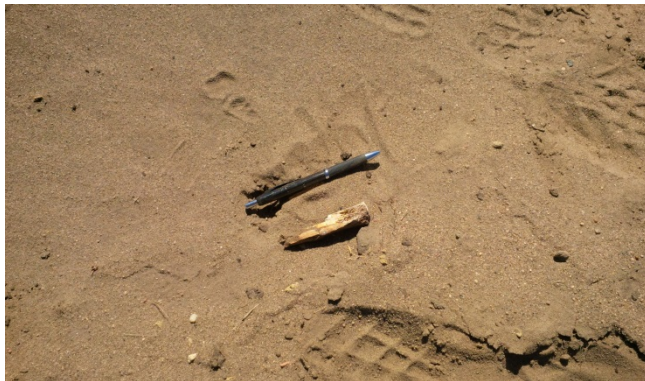
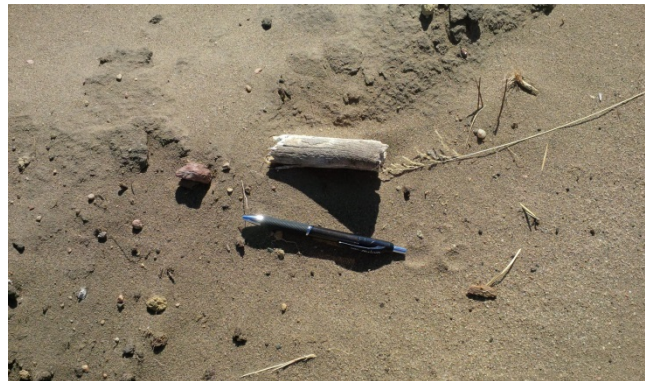
Field Observation	# of occurrences	Description and Mitigation Measures	Mitigation Status	Further Action Required (Yes/No)
Medicinal or Cultural Plants	N/A			
Aquatic Life	N/A			
Animal Observations or Burrows	1	Animal bones were observed – found at Km 1+500.	Reported	No
Bird Nests	N/A			
Trees (Red Willow)	N/A			
Wetlands	N/A			
Watercourse Crossing	N/A

1. Bone found at Km 1+500 – Aug 17, 2017

2. Bone found at Km 1+500 – Aug 17, 2017

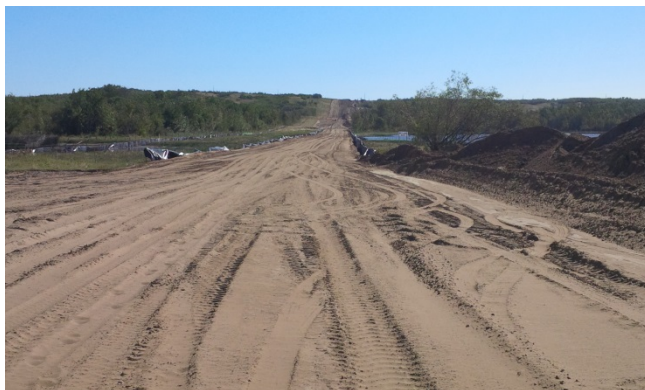
3. At Km 1 looking east at the ROW – Aug 17, 2017

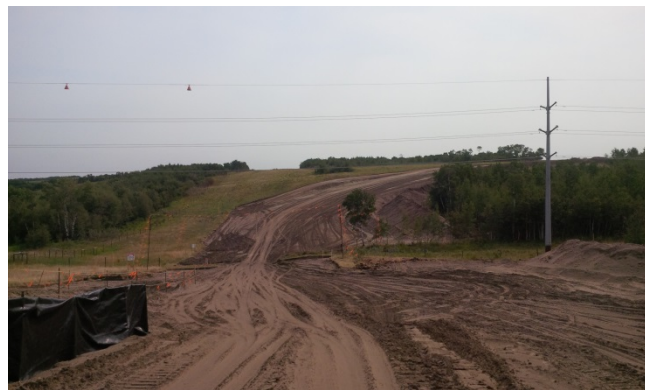
4. At Km 2+300 looking east at the ROW – Aug 17, 2017
