**SAMSON CREE NATION – MATRIX SOLUTIONS INC.
PARTNERSHIP**

ABORIGINAL CONSTRUCTION MONITORING

WEEKLY REPORT

AUGUST 20TH TO AUGUST 25TH

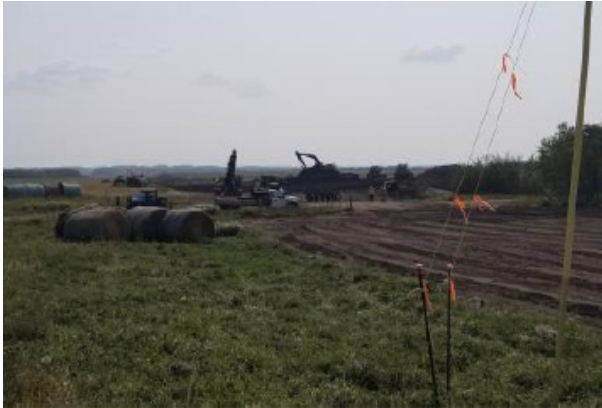
Crews working – SF 16-17, Aug 20, 2018

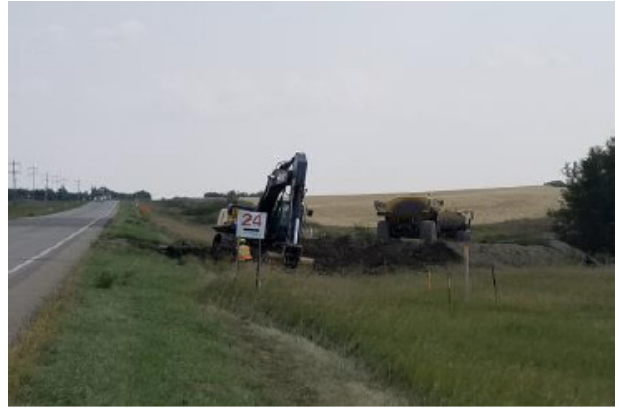
Excavator narrowing the road – SF 24– Aug 20, 2018

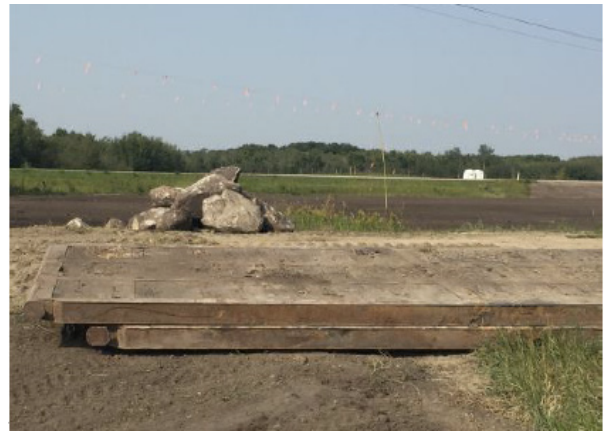
Rocks and rig mats on access road – km 17+750 –
Aug 20, 2018

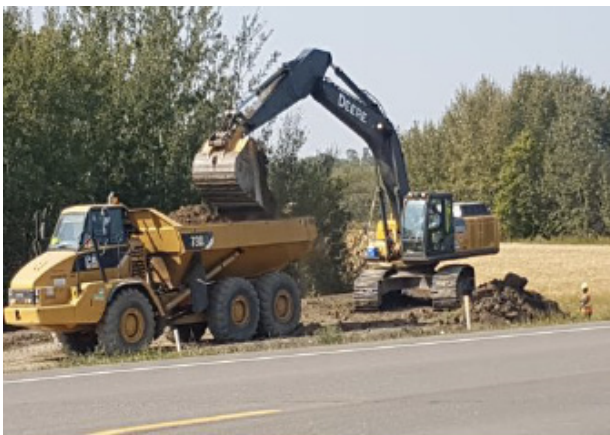
Excavator spreading topsoil - km34+000– Aug 21, 2018

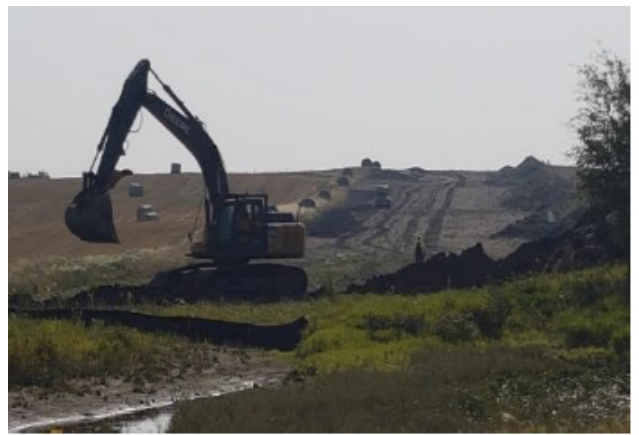
Excavaor roach and compaction – km36+400-Aug 21, 2018

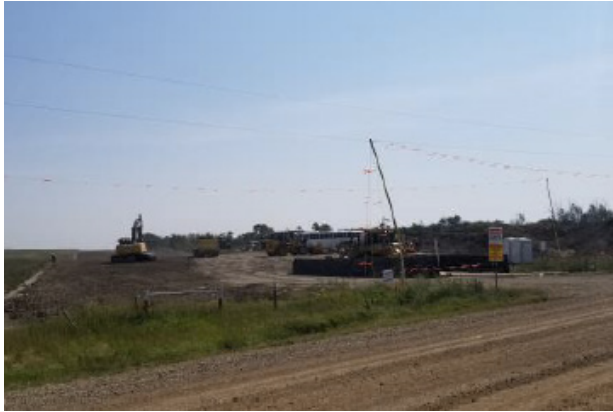
Dozer being cleaned – SF 18 – Aug 21, 2018

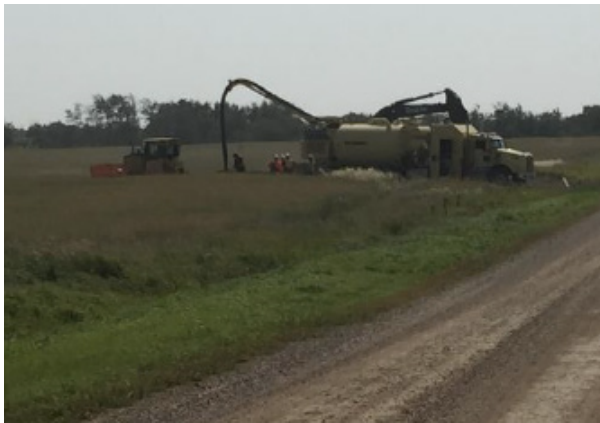
Hydro vac bore hole – km 14+100 – Aug 21, 2018

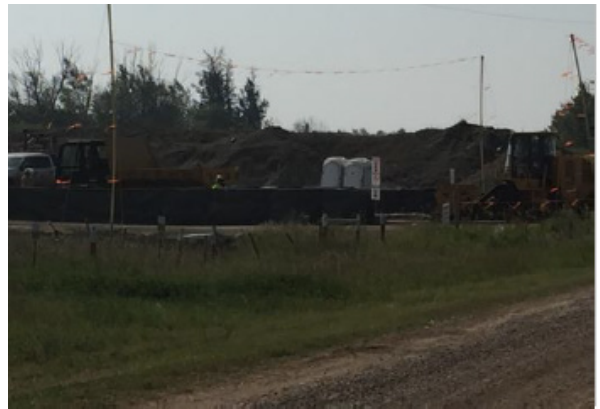
Air clean station – km 25+500 – Aug 21, 2018

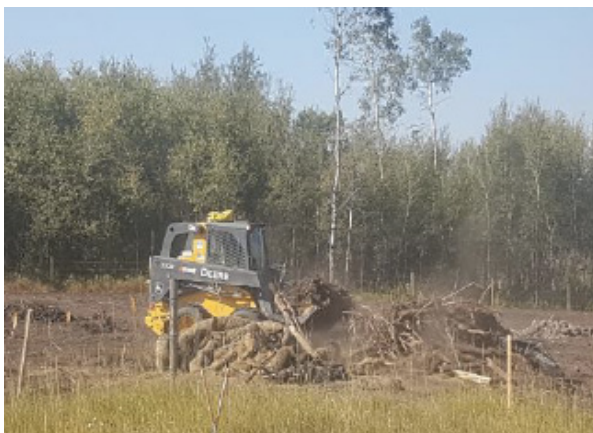
Loading debris for disposal – SF 11 – Aug 22, 2018

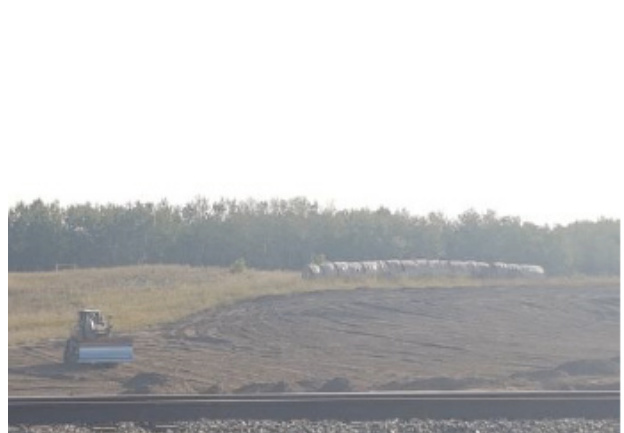
Dozer moving topsoil on ROW – SF 17 – Aug 22, 2018

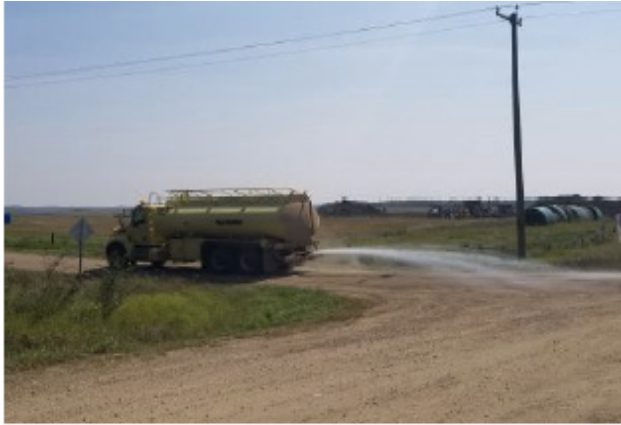
OJ water truck on dust control - SF 15 - Aug 22, 2018

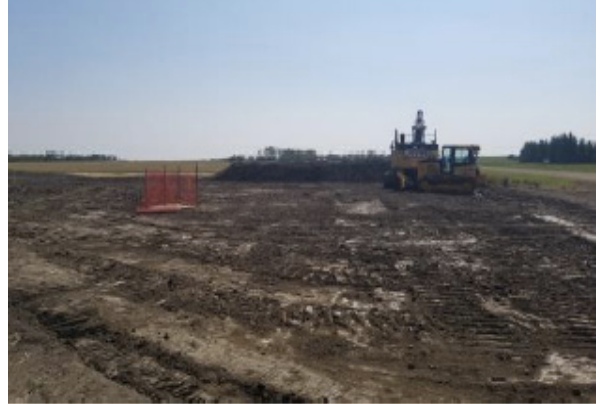
Day lighted pipe fenced in – SF 10 – Aug 22, 2018

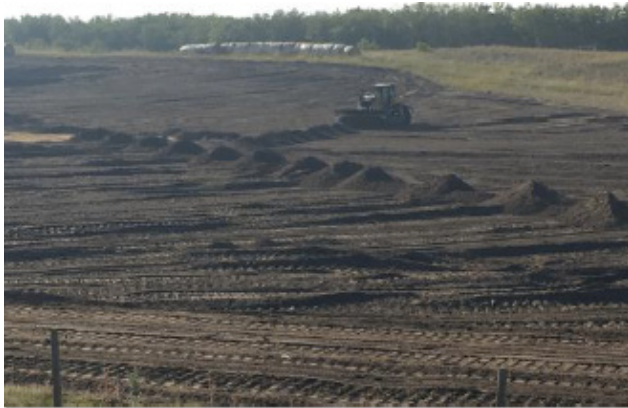
Dozer spreading seconds on topsoil – km 108+500 – Aug 22, 2018

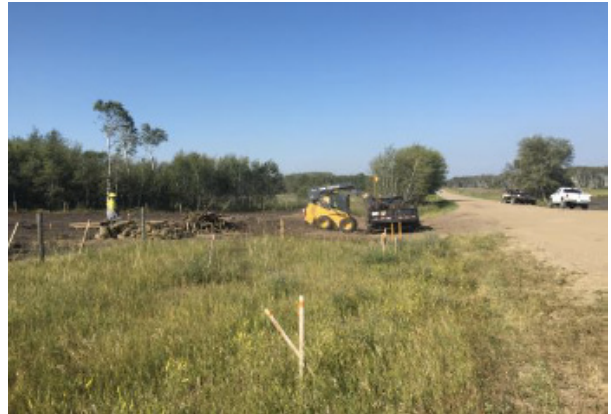
Skid steer loading wood debris– SF 11 – Aug 22, 2018

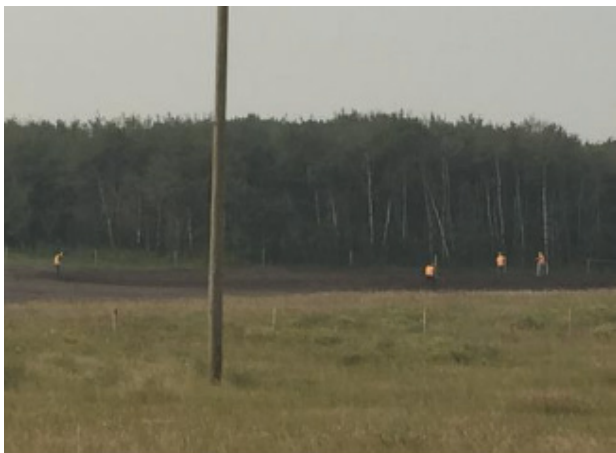
Utility crew picking rock and wood debros– km 17+500 – Aug 23, 2018

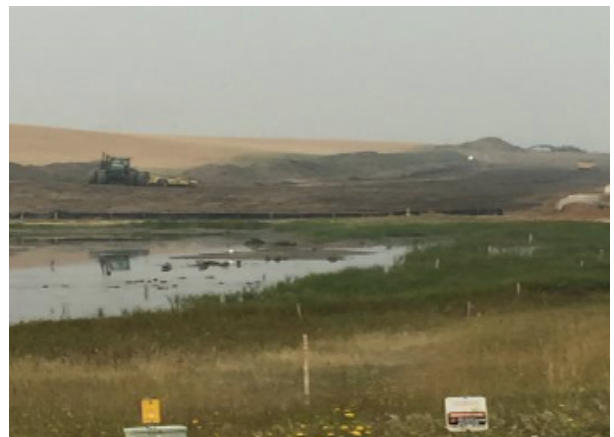
Discing and grading– km 108+650 - Aug 23, 2018

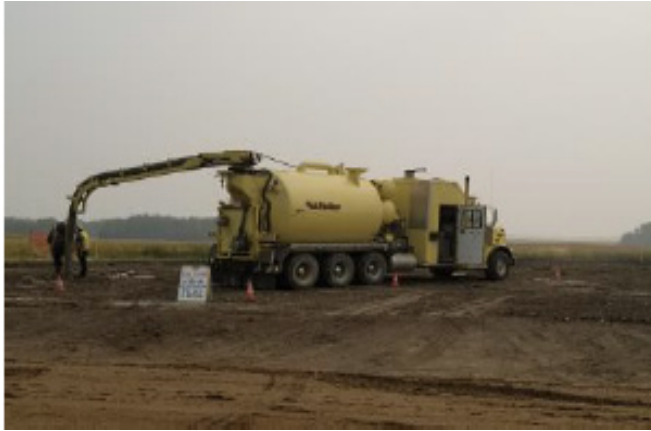
Hydrovac daylighting pipe – SF 10 – Aug 23, 2018

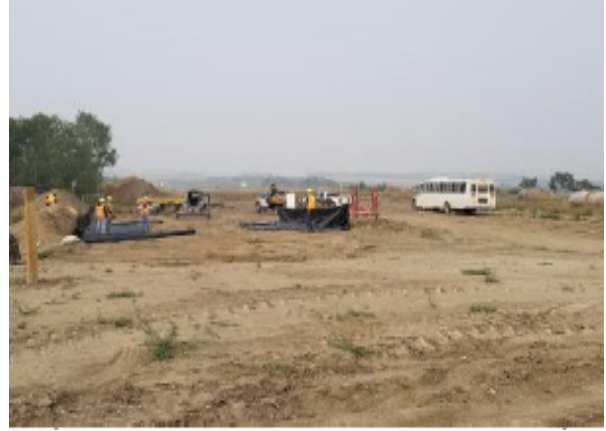
Wash bay construction – SF 21 – Aug 23, 2018

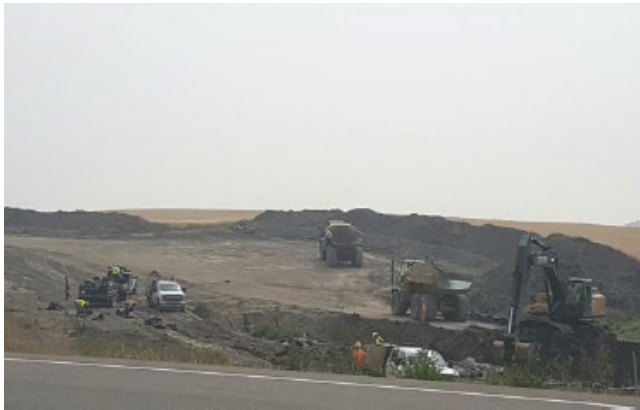
Ramp removal – SF 24 – Aug 23, 2018

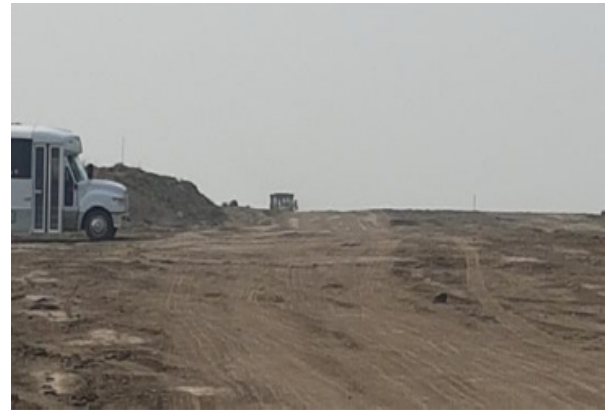
Reclamation on ROW – SF 25 – Aug 23, 2018

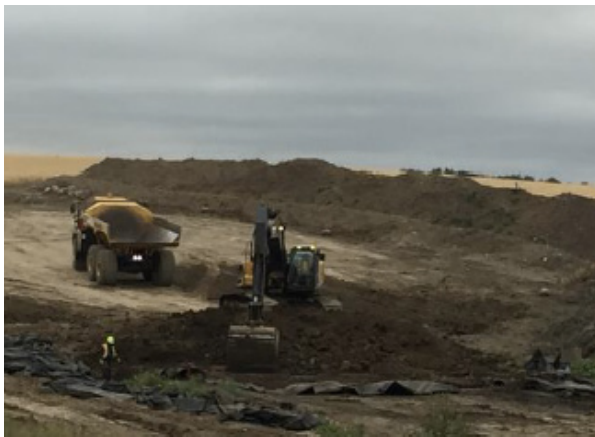
Excavator ramp removal – km 34+000 – Aug 24, 2018

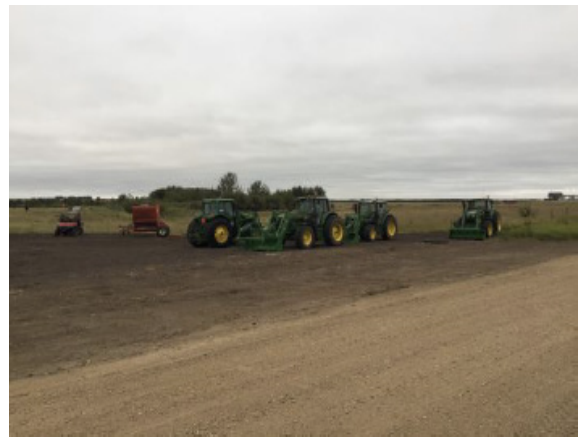
Crimpers shut down – SF 9 – Aug 24, 2018

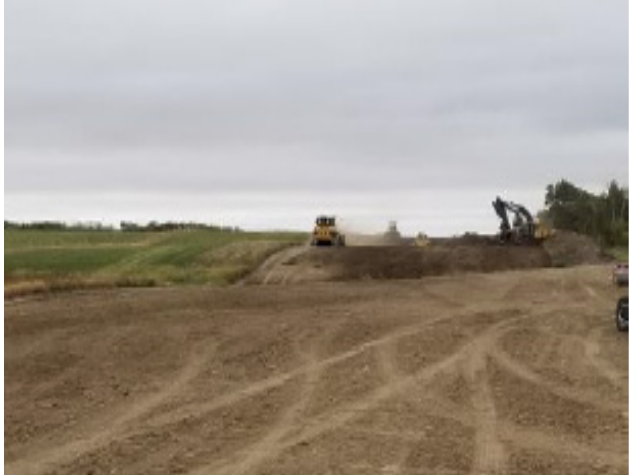
Equipment working on ROW – SF 19 – Aug 24, 2018

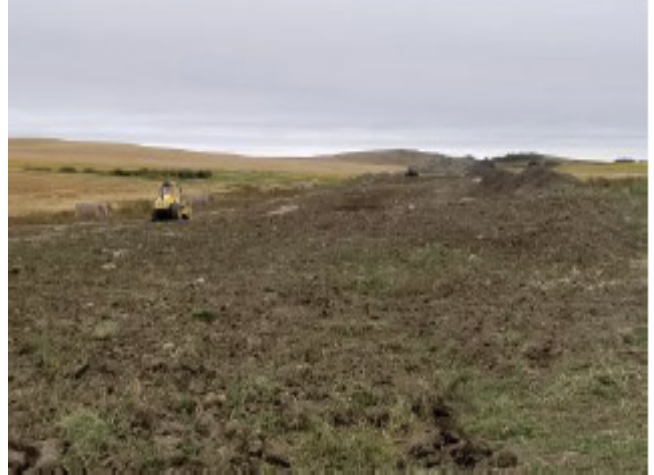
Tractor ripping on ROW – SF 21 – Aug 24, 2018

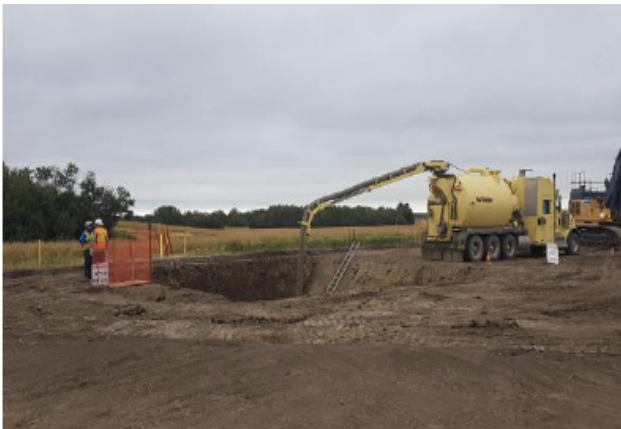
Hydrovacating bell hole - SF 10 – Aug 24, 2018

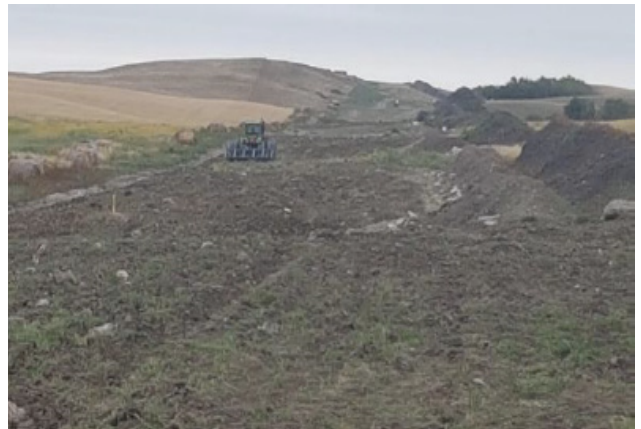
Harrowing on ROW – SF 21 – Aug 24, 2018

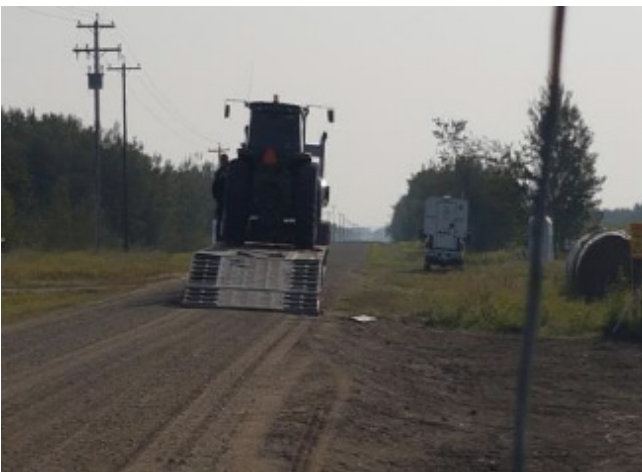
Unloading tractor – SF 9 – Aug 25, 2018

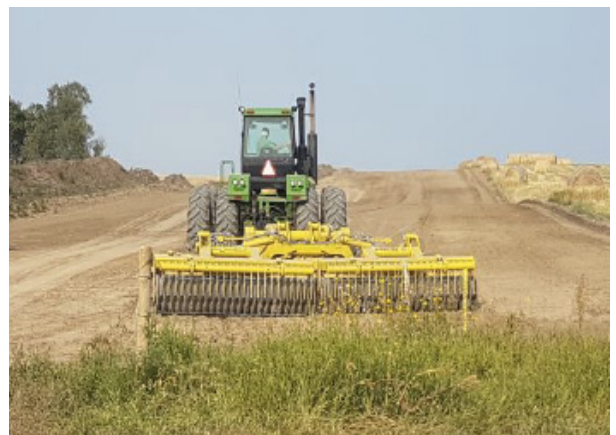
Tractor harrowing – SF 20 - Aug 25, 2018

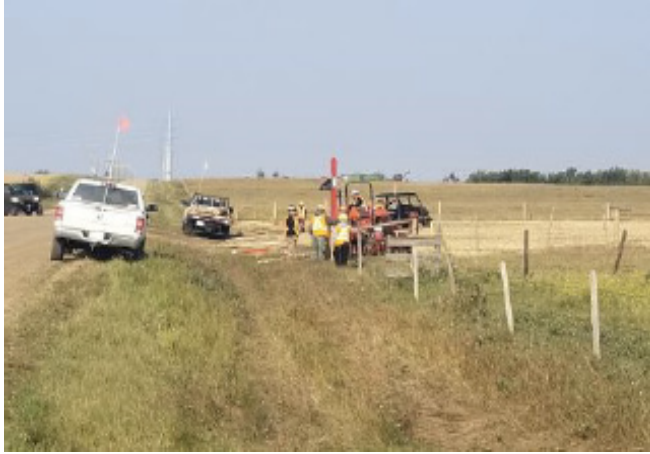
Crew building fence – SF 3 – Aug 25, 2018

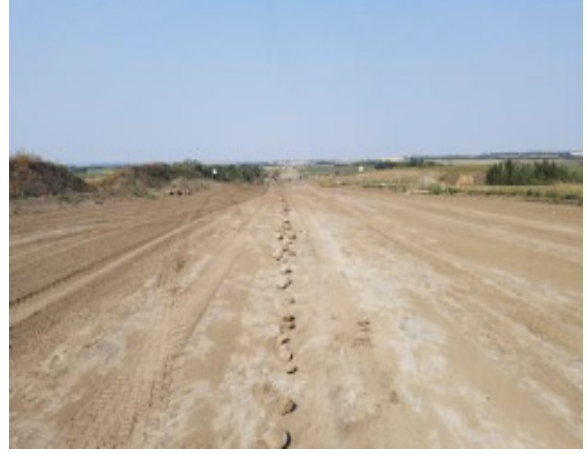
Crew rock picking – SF 21 - Aug 25, 2018

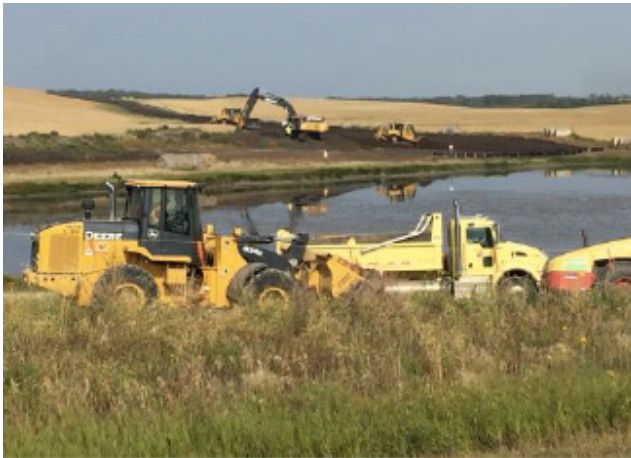
Hauling rock – km13+000 – Aug 25, 2018

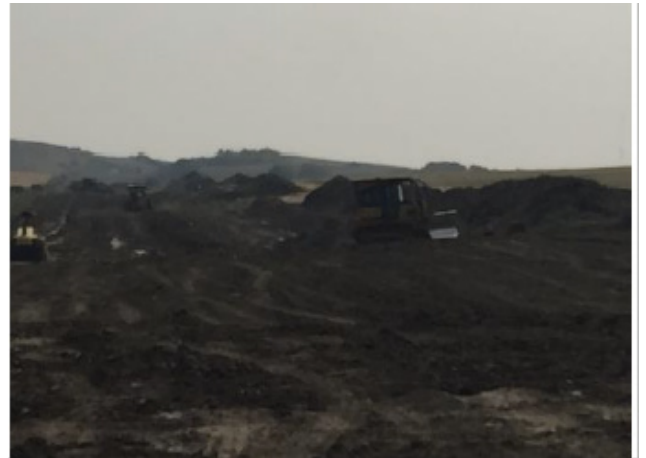
Grader and dozer – SF 21– Aug 25, 2018
