**SAMSON CREE NATION – MATRIX SOLUTIONS INC.
PARTNERSHIP**

ABORIGINAL CONSTRUCTION MONITORING

WEEKLY REPORT

JANUARY 15TH TO JANUARY 21ST

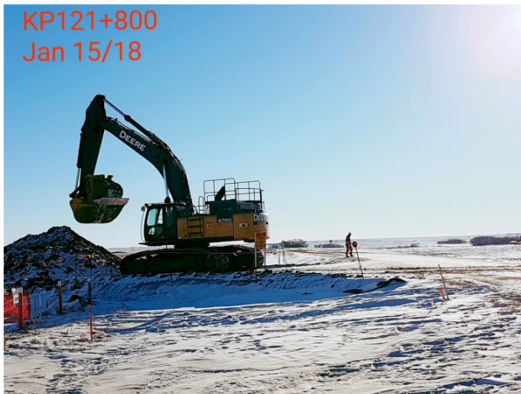
1. Excavator working on dirt piles- Km 121+800 – Jan 15, 2018

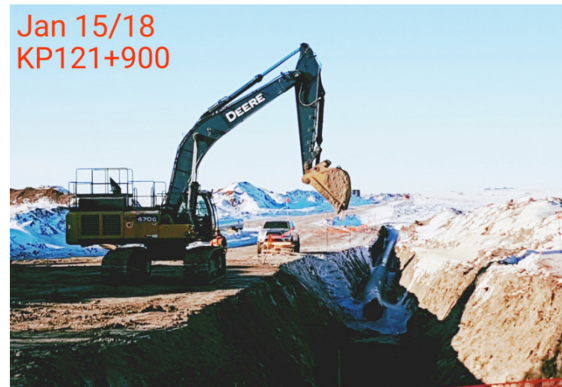
2. Excavator – Km 121+900 – Jan 15, 2018

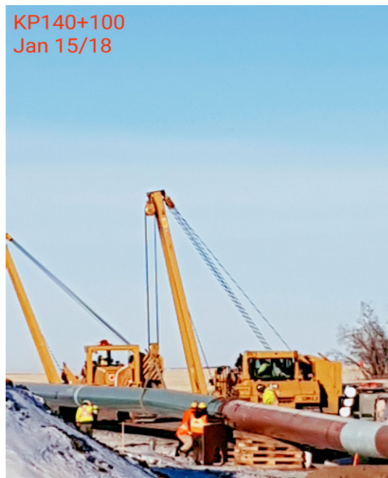
On January 15, the monitors headed to km 143+900 where NDT testing was taking place. Tie-in work was noted at km 140+100; additionally, excavators were digging bell holes at km 140+300 and 140+400. At km 136+600, side booms were loading boring pipe onto transport truck. Backfilling was noted at km 122+400, excavators were working the dirt piles at km 121+800/900, and another excavator was crossing the road to begin digging in the bell hole. The hydrovac was at km 121+000, and at km 119+200, tie-in work was monitored. Excavators were backfilling at km 118+100.

3. Tie-in– Km 140+100 – Jan 15, 2018

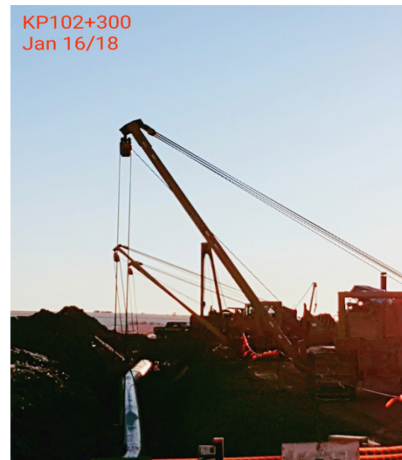
On January 16, the monitors set out to km 102+300 where welding tie-in was observed, as booms were holding pipe in the ditch for the welders. Tie-in work occurred at 102km+100, backfilling was taking place at km 102+075, and at km 103+300 booms were holding pipe for tie-in. At km 100+250, the excavator was moving dirt and a truck was loading a flat bed. Backfilling and dozer work was noted at km 97+500 and the hydrovac was present at km 121+000.

4. Welding tie-in – km 102+300 – Jan 16, 2018

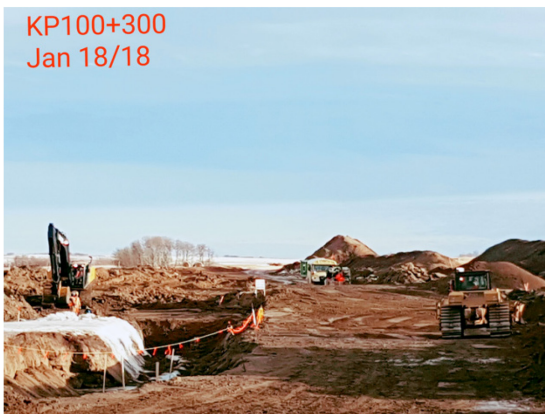
5. Dozer crossing – Km 100+300 – Jan 18, 2018

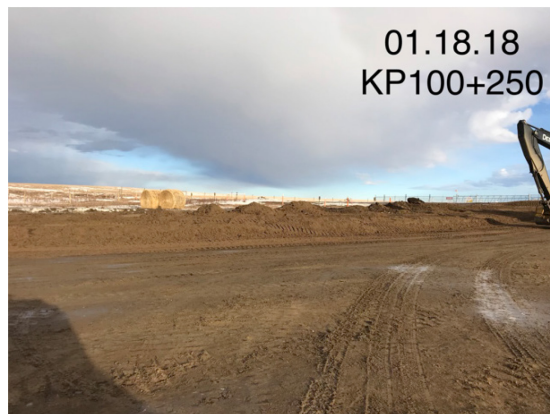
6. Excavator – km 100+250 – Jan 18, 2018

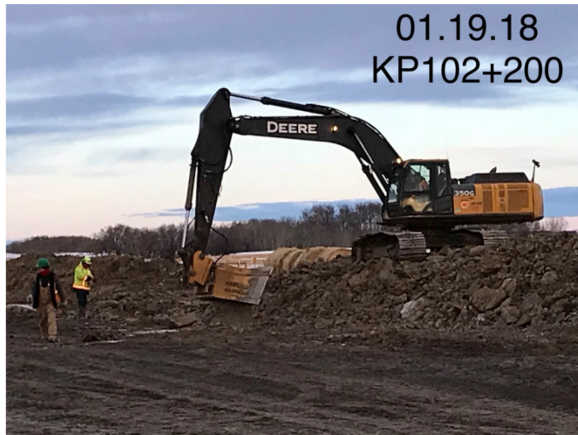
On January 19, the excavator was monitored at location km 102+200, it was putting dirt around pipe using its sift bucket. Tie-in was going on in the above area and booms were holding pipe in the ditch for welders. Dozers were moving dirt for backfill. In general the area was very busy, O.J trucks were driving on and off of the ROW.

7. Excavator with sift bucket – Km 102+200 – Jan 19, 2018

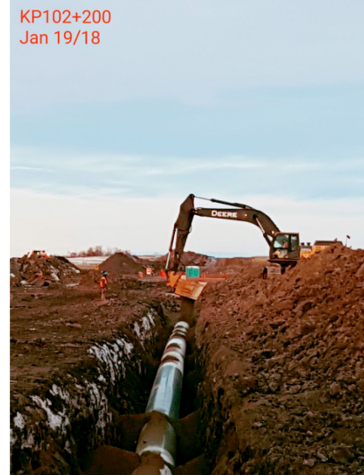
8. Excavator - Km 102+200 – Jan 19, 2018

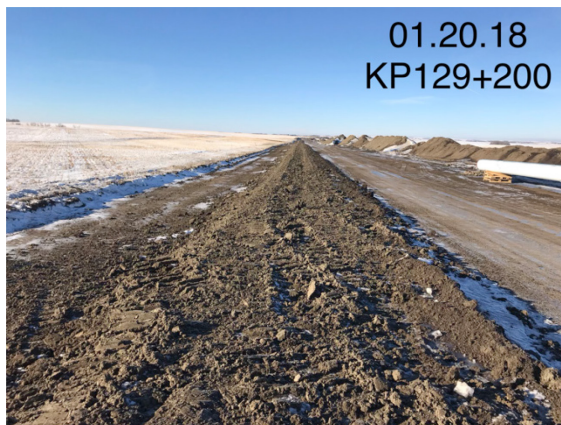
9. Backfilled mainline - Km 129+200 – Jan 20, 2018

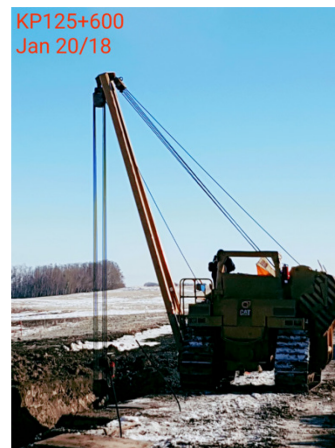
10. Tie-in – Km 125+500 – Jan 20, 2018

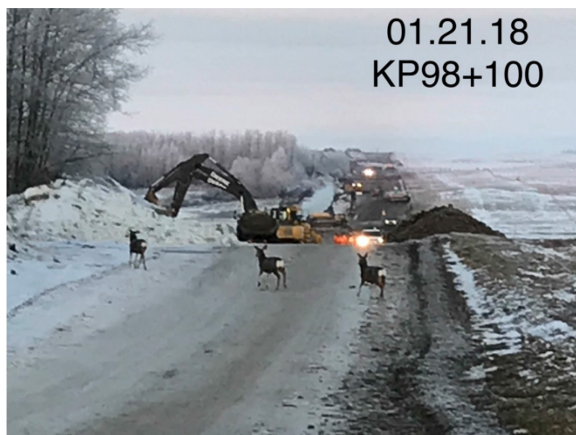
On January 21, excavators and dozers were prepping and the grader was grading the mainline at km 98+350. Three deer was observed crossing the ROW at km 98+100. Bridge removal was taking place at km 97+500, excavators and dozers were removing dirt and clean up was on going. Tie-in welding was observed at km 113+100, booms

11. Deer crossing ROW – Km 98+100 – Jan 21, 2018

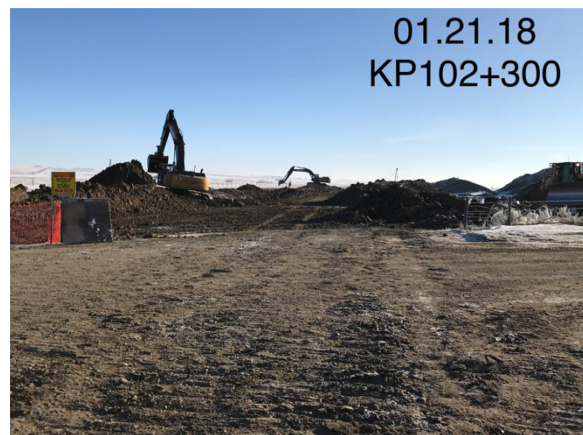
12. Excavators and dozers – Km 102+300 – Jan 21, 2018

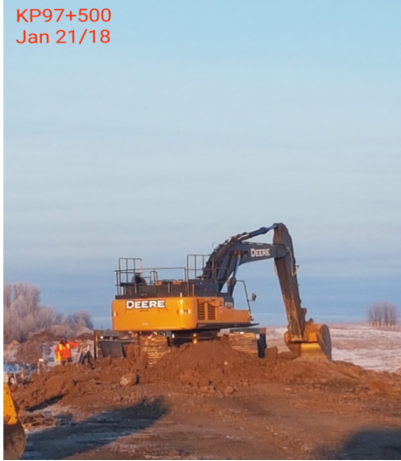
KP97+500
Jan 21/18

3. Bridge removal – Km 97+500 – Jan 21, 2018

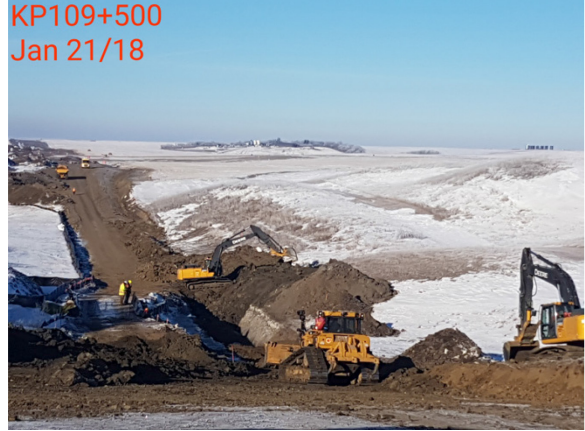
KP109+500
Jan 21/18

were holding pipe in the ditch for welders. Sandblasters were on the ROW at km 111+700. At km 109+500, excavator and dozer backfilling was taking place at the ravine (water crossing). Also, excavator and dozer was moving dirt at km 102+300.

14. Backfill at ravine – 109km+500 – Jan 21, 2018

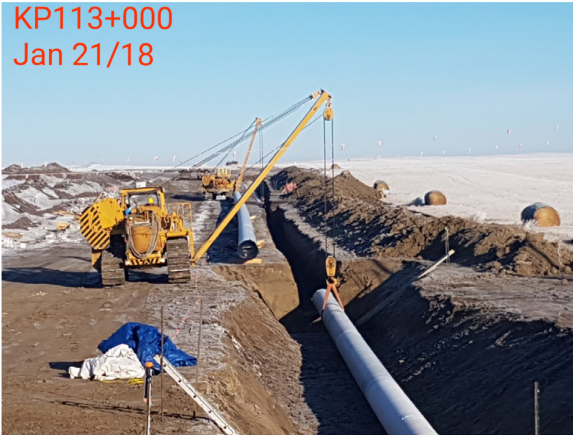
KP113+000
Jan 21/18

15. Tie-in welding – km113+000 – Jan21, 2018
