**SAMSON CREE NATION – MATRIX SOLUTIONS INC.
PARTNERSHIP**

ABORIGINAL CONSTRUCTION MONITORING

WEEKLY REPORT

SPREAD 1

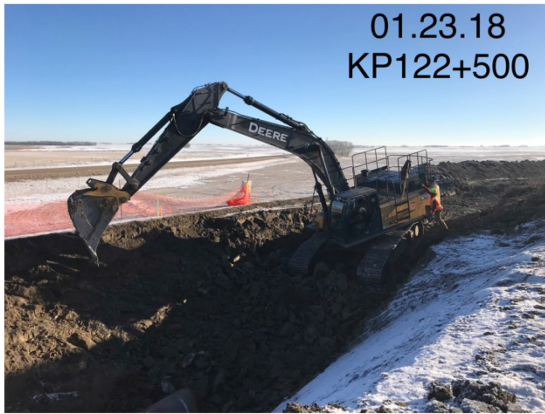
1. Excavator digging tie-in ditch- Km 122+550 – Jan 23, 2018

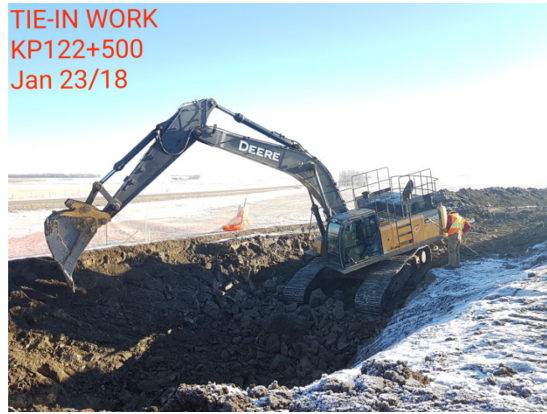
2. Tie-in – Km 122+500 – Jan 23, 2018

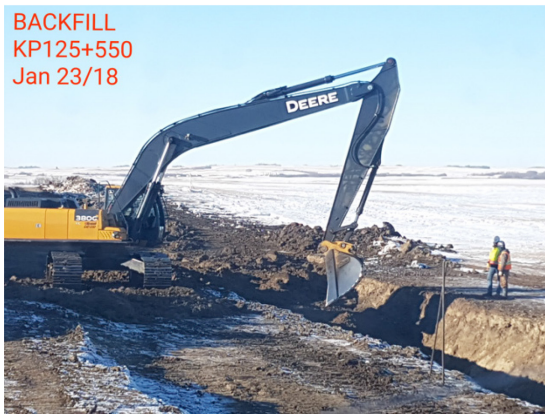
3. Backfill – Km 125+550 – Jan 23, 2018

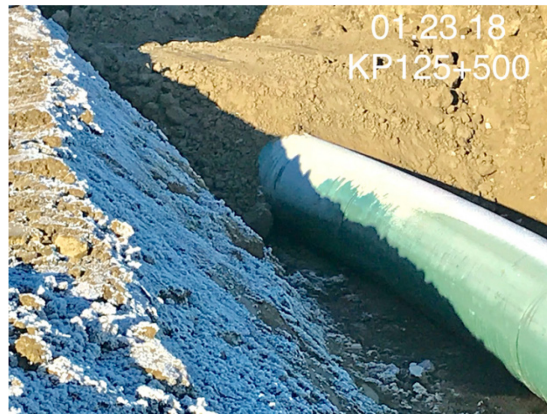
On January 23, the monitors were informed to keep a keen eye on backfilling. There are concerns about the operators rushing to backfill, as rushing the work can cause potential damage to the pipelines, if it's covered with uncrushed dirt and rocks. The monitors entered the ROW at km 118+100 (SF 72). Welding, tie-in, and lowering in were noted at km 120+800. Backfilling was taking place at km 121+650; and, at km 122+500 (SF75), the excavator was digging out the ditch for tie-in. Later, the monitors met with Gord Moffat and Wayne Rhyason, regarding the concerns with backfilling. The monitors were given a summary of what to look out for, and to call immediately should they suspect that the work is being rushed. At km 122+500 an excavator was working alone with a spotter, crushing of dirt and backfill was monitored. At km 125+500, excavator was seen crushing dirt with bucket and tracks and backfilling over pipe in tie-in ditch. Congestion was noted at SF 78, they drove to SF 76 and monitored backfill for the remainder of the day.

4. Chunk of dirt next to pipe – km 125+500 – Jan 23, 2018

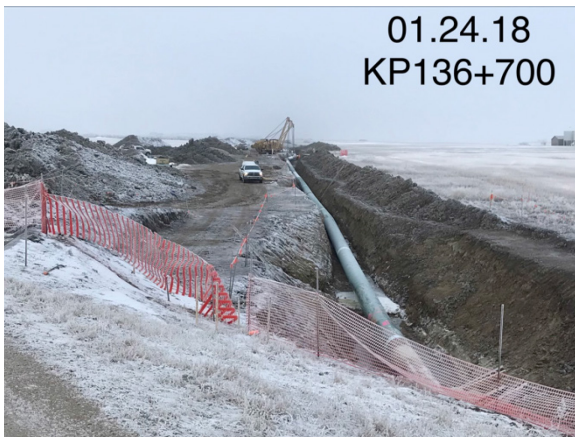
5. Tie-in ditch – Km 136+700 – Jan 24, 2018

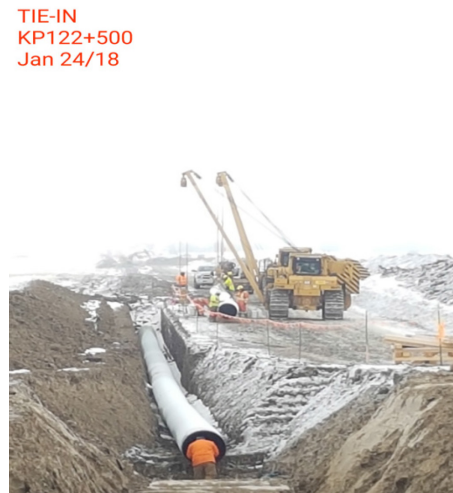
6. Tie-in – km 122+500 – Jan 24, 2018

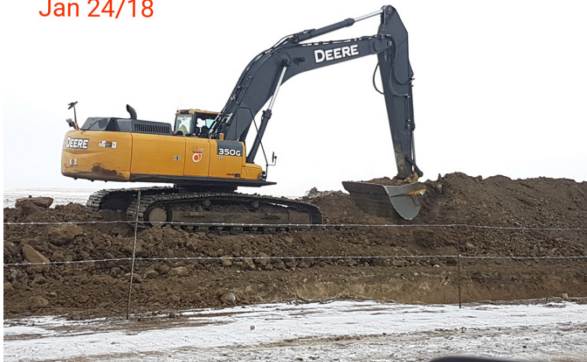
BACKFILL
KP114+900
Jan 24/18

7. Backfill – Km 114+900 – Jan 24, 2018

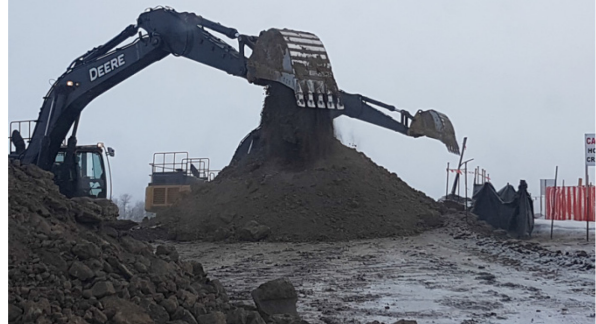
DIGGING
KP124+100
Jan 25/18

8. Digging - Km 124+100 – Jan 25, 2018

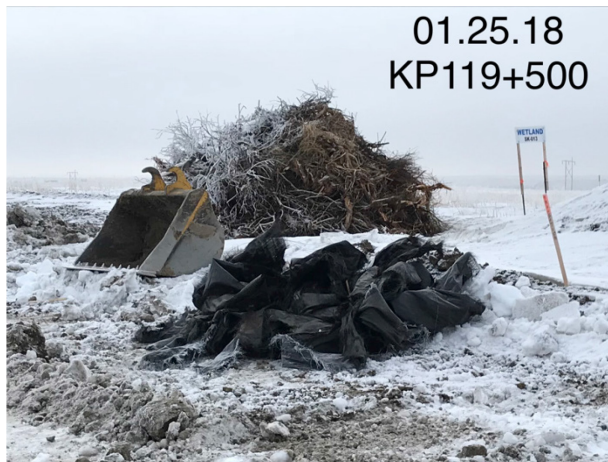
01.25.18
KP119+500

9. Brush pile (black material for wetland area)- Km 119+500 – Jan 25, 2018

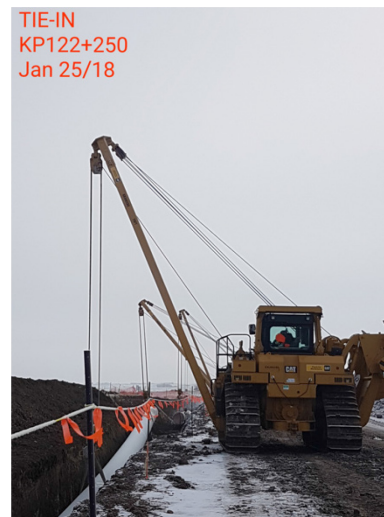
TIE-IN
KP122+250
Jan 25/18

10. Tie-in – Km 122+250 – Jan 25, 2018

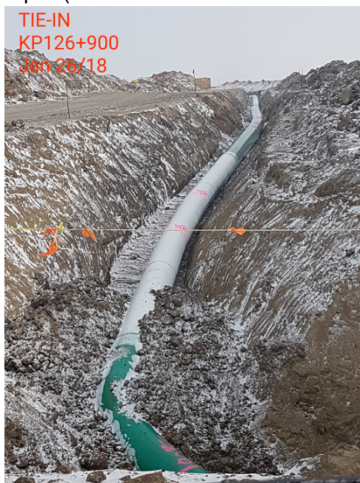
TIE-IN
KP126+900
Jan 26/18

11. Tie-in – Km 126+900 – Jan 26, 2018

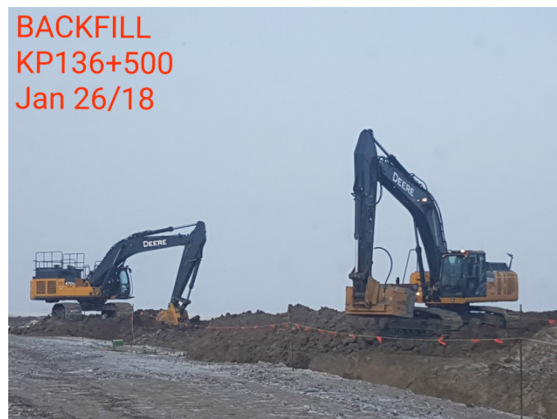
BACKFILL
KP136+500
Jan 26/18

12. Backfill – Km 136+500 – Jan 26, 2018

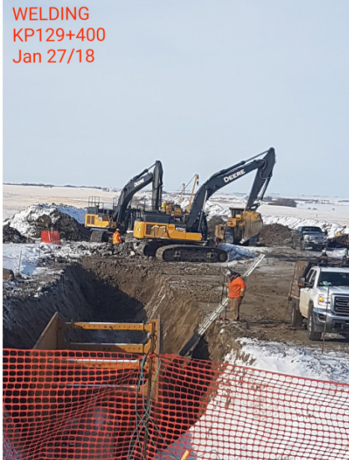
WELDING
KP129+400
Jan 27/18

13. Welding– Km 129+400 – Jan 27, 2018

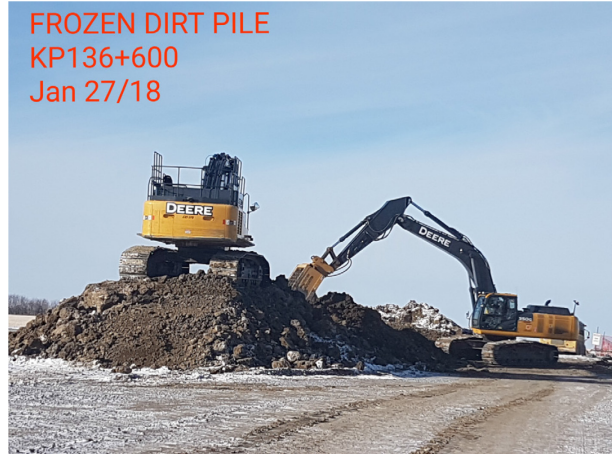
FROZEN DIRT PILE
KP136+600
Jan 27/18

14. Frozen dirt pile – 136km+600 – Jan 27, 2018
