**SAMSON CREE NATION – MATRIX SOLUTIONS INC.
PARTNERSHIP**

ABORIGINAL CONSTRUCTION MONITORING

WEEKLY REPORT

JANUARY 4TH TO JANUARY 6TH

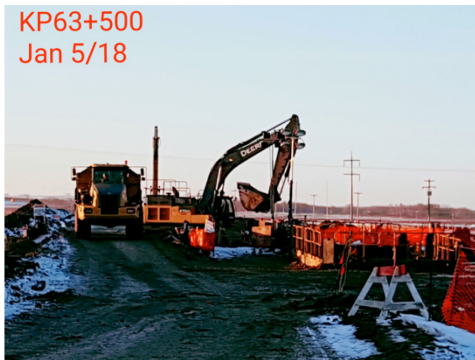
1. Excavator digging in bell hole - Km 63+500 – Jan 5, 2018

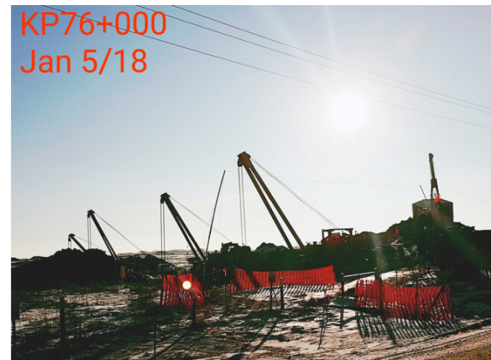
2. Tie-in – Km 76+000 – Jan 5, 2018

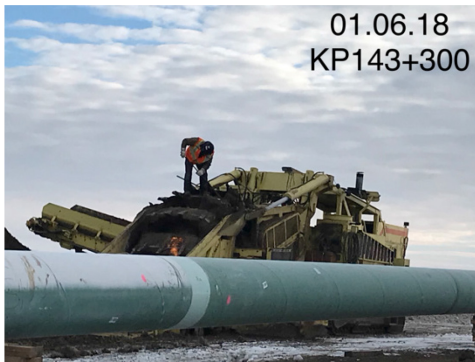
On January 6, the crew watched mainline lowering in and backfill at km 140+500. Booms were lifting finished pipe and lowering into the ditch (km140+700) and track hoes moving dirt to fill in the ditch. Excavators were seen crossing the road at km 140+400 (SF 86). They drove to km 143+300 and monitored the ditcher. The ditcher then stopped to remove rock and a worker was seen climbing on the dislodged rock.

3. Ditcher maintenance – Km 143+300 – Jan 6, 2018

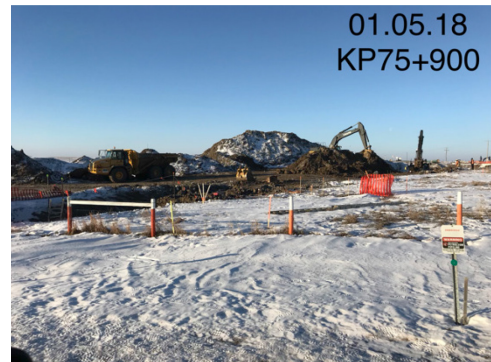
4. Tie-in – km 75+900 – Jan 5, 2018

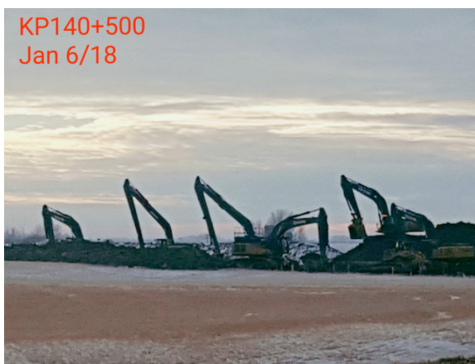
5. Backfill – Km 140+500 – Jan 6, 2018

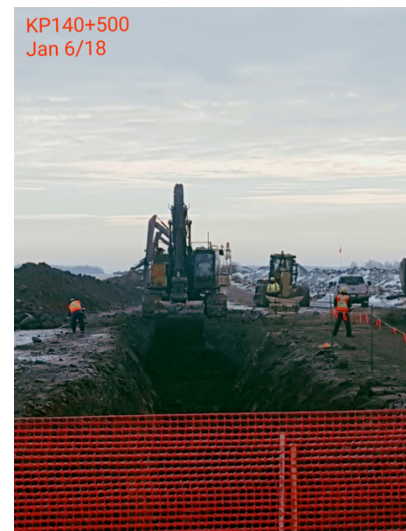
6. Mainline lowering in - Km 140+500 – Jan 6, 2018

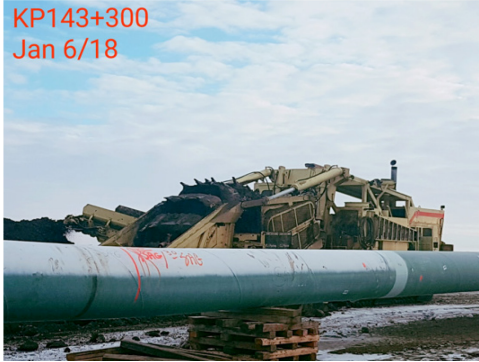
7. Ditcher – Km 143+300 – Jan 6, 2018
