**SAMSON CREE NATION – MATRIX SOLUTIONS INC.  
PARTNERSHIP**

**ABORIGINAL CONSTRUCTION MONITORING**

**WEEKLY REPORT**

**JANUARY 8<sup>TH</sup> TO JANUARY 13<sup>TH</sup>**

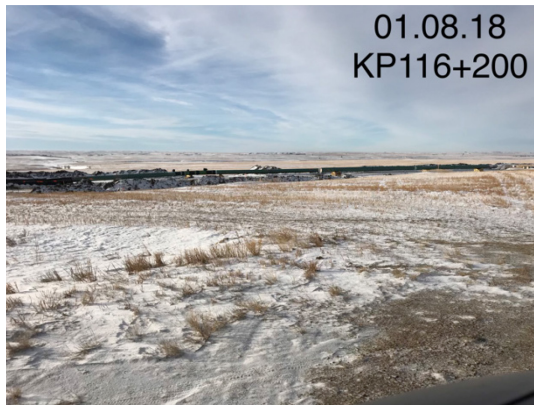
1. Pipe on skids - Km 116+200 – Jan 8, 2018

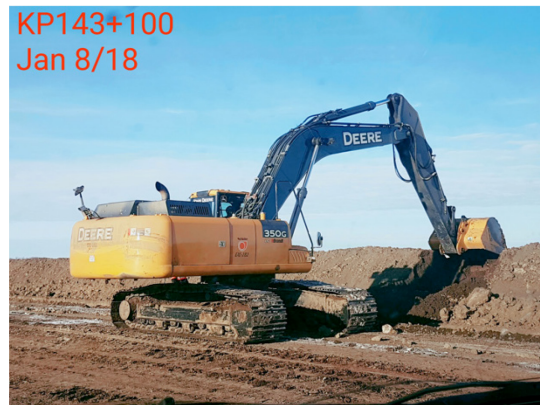
2. Backfill – Km 143+100 – Jan 8, 2018

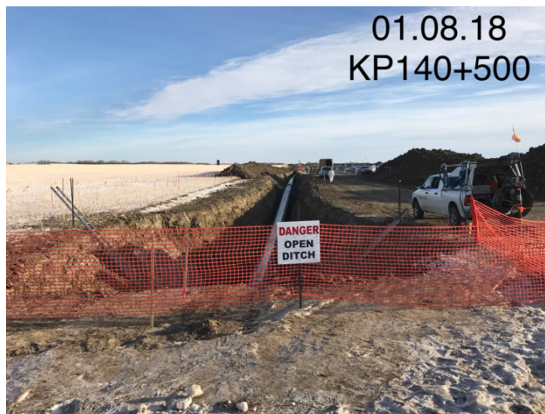
3. Welding Test – Km 140+500 – Jan 8, 2018

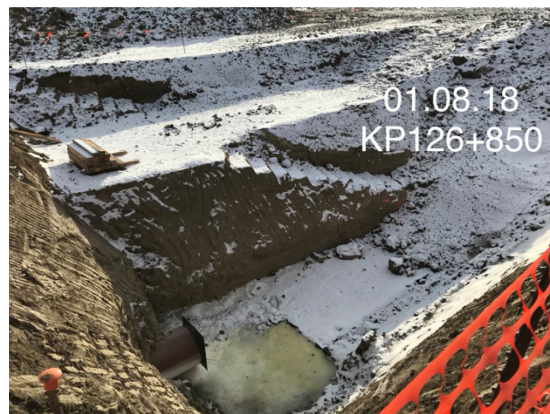
On January 8, the monitors headed to km 116+300 where tie-in backfill was taking place and two track hoes and dozer was working on piles. A frozen bell hole was noted at km 126+850, the area is mostly backfilled mainline and some tie-in work to be completed. At km144+150 mainline ditching and lowering in is complete at Spread 1 (Ditcher was parked at Spread 2). Side booms were setting up at Spread 2. Welding (NDT) testers were observed at km 140+500. At km143+000 backfilling was taking place, hydro vac was observed at km 141+700 and tie-in work being done at km 137+000 (side booms connected to pipe). At SF 83, backfilling tie-in was observed and clean up crew was pilling skids at km 135+750.

4. Bell hole – km 126+850 – Jan 8, 2018

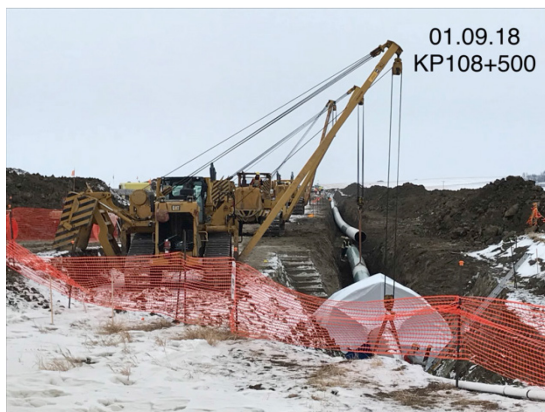
5. Tie-in welding – Km 140+500 – Jan 9, 2018

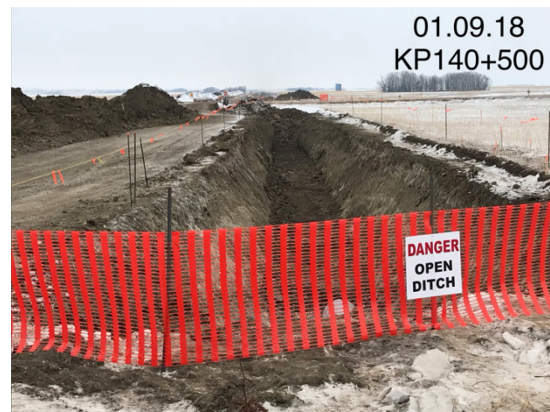
6. Tie-in ditch - Km 140+500 – Jan 9, 2018

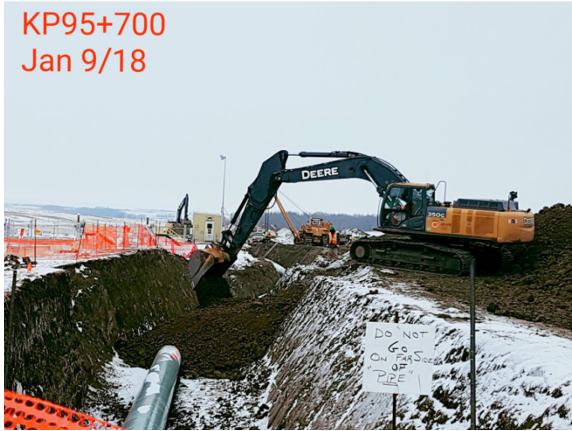
KP95+700  
Jan 9/18

7. Track hoe backfill – Km 95+700 – Jan 9, 2018

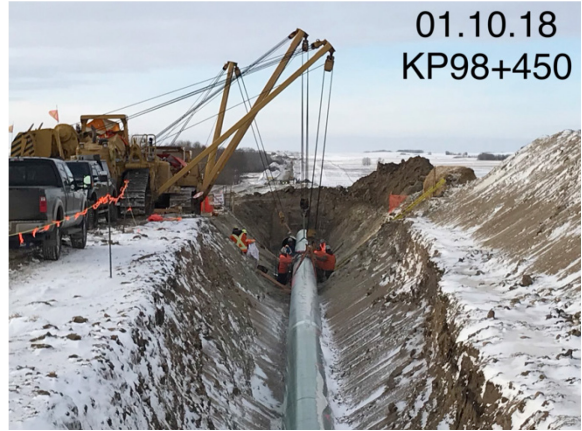
01.10.18  
KP98+450

8. Tie-in backfill – km 98+450 – Jan 10, 2018

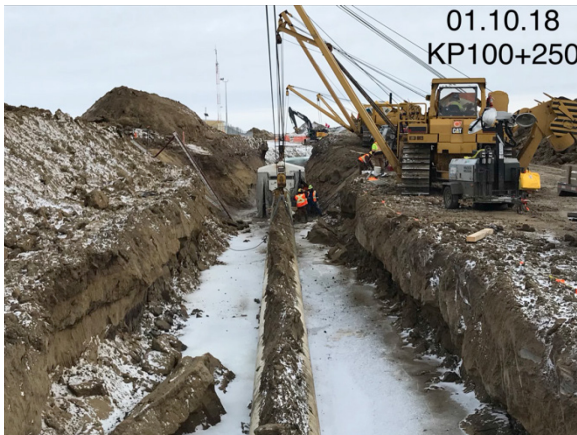
01.10.18  
KP100+250

On January 10, the crew watched tie-in backfill at km 95+800 and tie-in welding at km 96+500. At km102+300 the track hoe was observed digging in bell hole. At km100+250, tie-in welding was observed and it has been noted that the pipe was in ditch, and backfilled and then re-excavated. Welders were in the ditch at km98+450. Water dams were removed and filled with dirt at km 97+450 (Wetland bridge). Welders were working on tie-in at km 110+000 and tie-in work also noted at km 108+600 and km 76+200. At km 108+000, dozer was seen clearing dirt piles and at km75+900, excavators were working on dirt piles.

9. Re-excavated tie-in – Km 100+250 – Jan 10, 2018

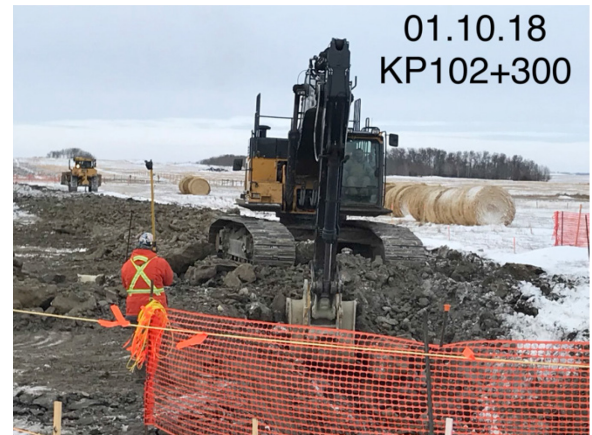
01.10.18  
KP102+300

10. Digging in bell hole – Km 102+300 – Jan 10, 2018

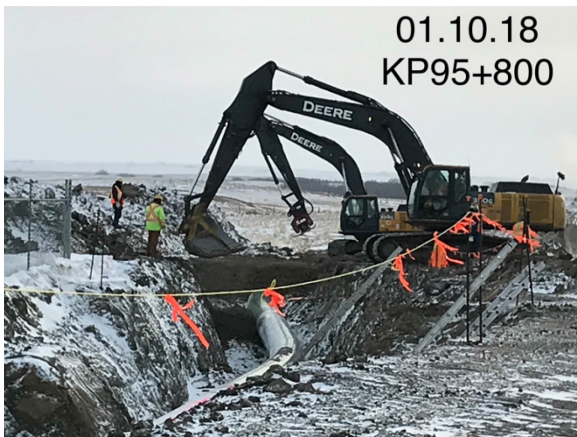
01.10.18  
KP95+800

11. Backfill – Km 95+800 – Jan 10, 2018

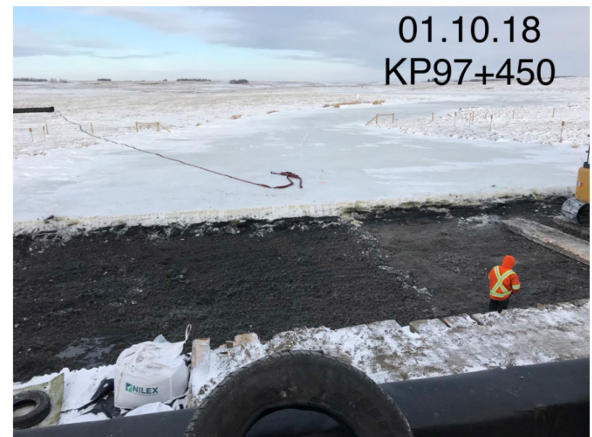
01.10.18  
KP97+450

12. Removal of aqua dams – Km 97+450 – Jan 10, 2018

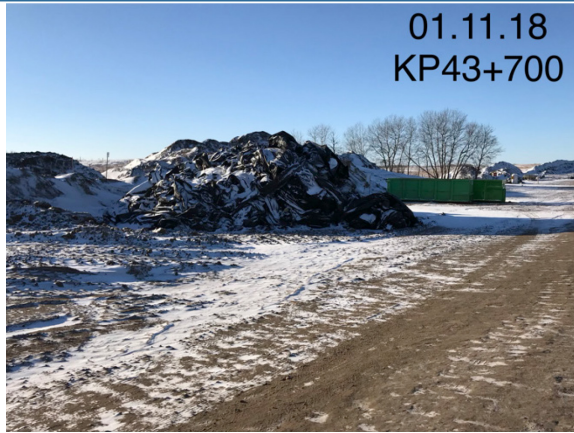
13. Aqua dam debris – Km 43+700 – Jan 11, 2018

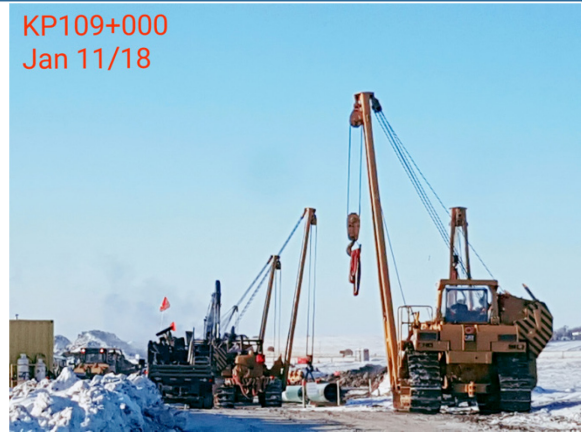
14. Tie-in – 109km+000 – Jan 11, 2018

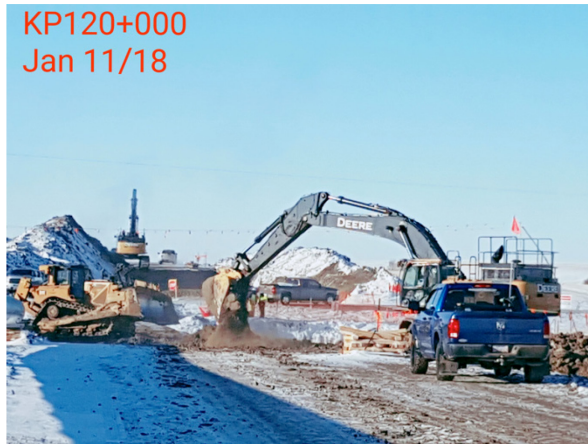
15. Dozer clearing dirt piles – km120+000 – Jan11, 2018

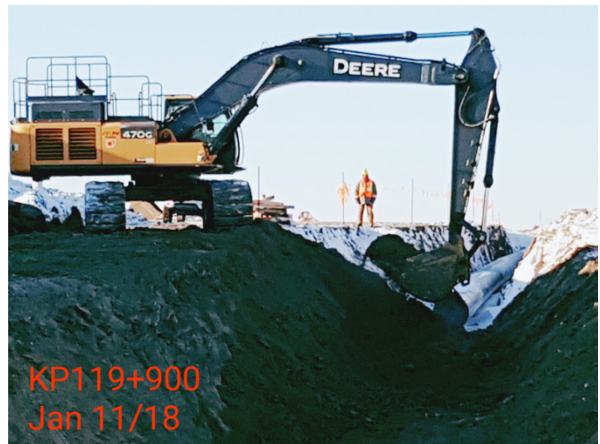
16. Excavating – Km 119+900 – Jan 11, 2018

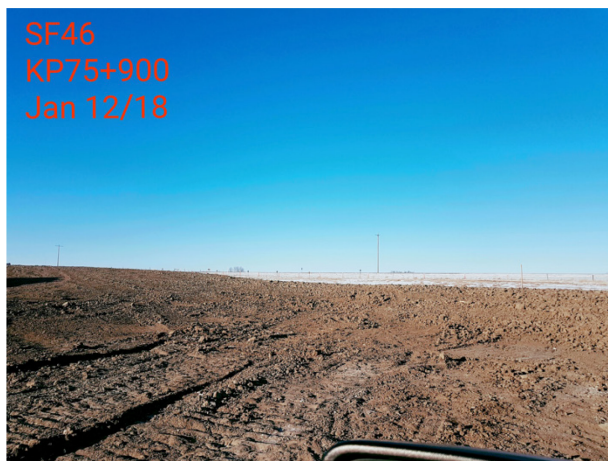
17. Tie –in Backfill – Km 75+900 – Jan 12, 2018

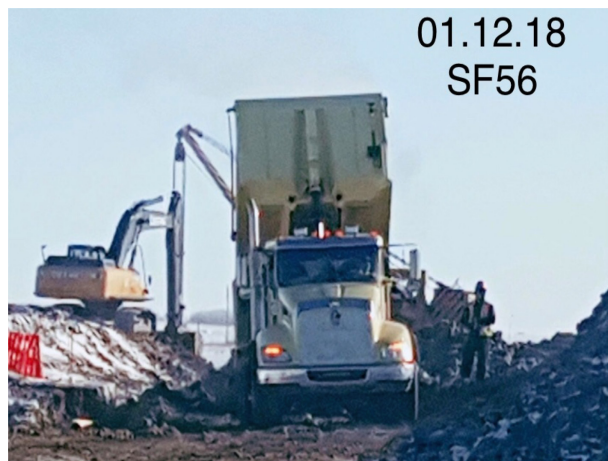
18. Tie-in Backfill – SF 56 – Jan 12, 2018

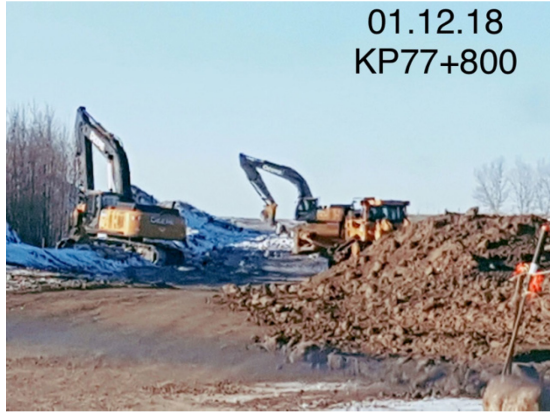
01.12.18  
 KP77+800

19. Tie-in work – Km 77+800 – Jan 12, 2018

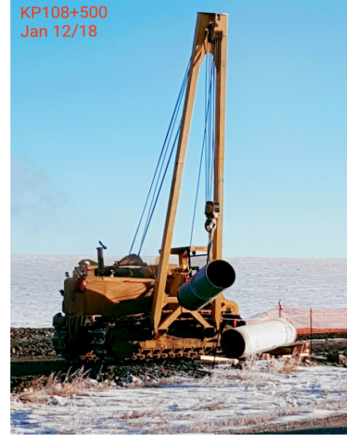
KP108+500  
 Jan 12/18

20. Machinery crossing – Km 108+500 – Jan 12, 2018

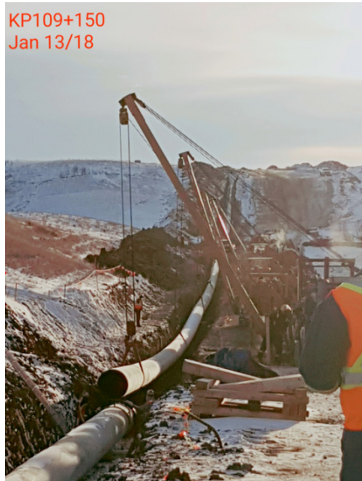
KP109+150  
 Jan 13/18

21. Booms picking up pipe - km 109+150 – Jan 13, 2018

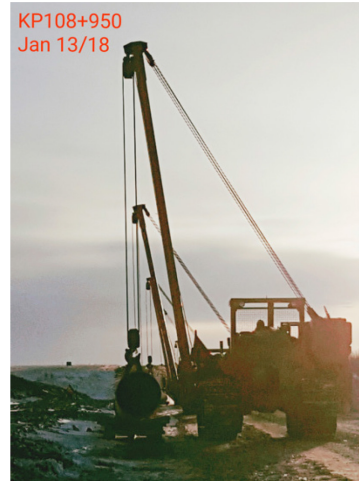
KP108+950  
 Jan 13/18

22. Side booms moving pipe – km 108+950 – Jan 13, 2018

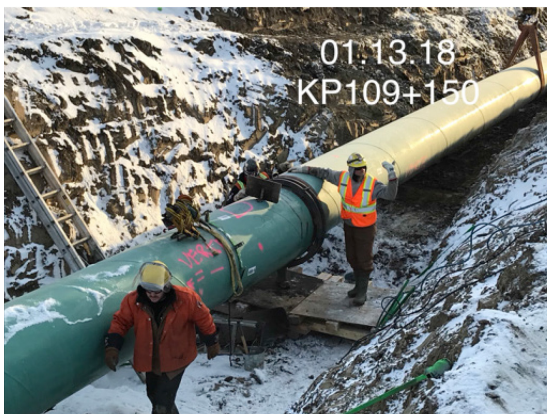
01.13.18  
 KP109+150

23. Prepping for tie-in – Km 109+150 – Jan 13, 2018

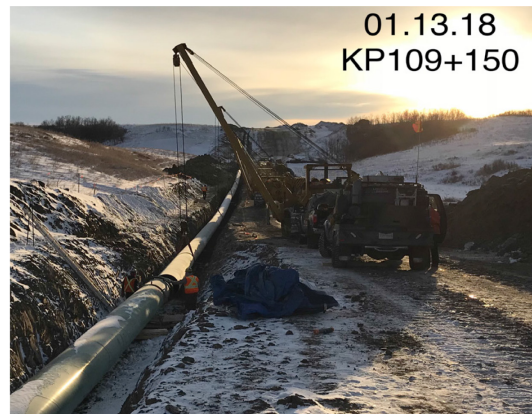
01.13.18  
 KP109+150

24. Lowering pipe into ditch – km 109+150 – Jan 13, 2018
