**SAMSON CREE NATION – MATRIX SOLUTIONS INC.
PARTNERSHIP**

ABORIGINAL CONSTRUCTION MONITORING

WEEKLY REPORT

NOVEMBER 13TH TO NOVEMBER 19TH

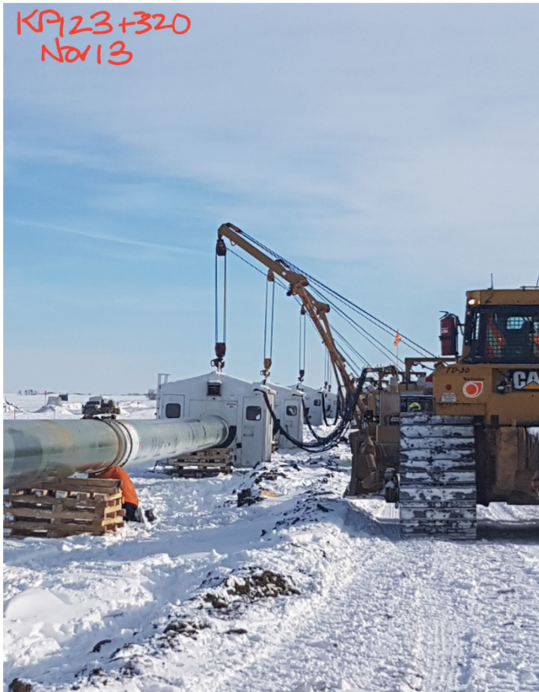
1. Welding Crew – Km123+320 – Nov 13, 2017

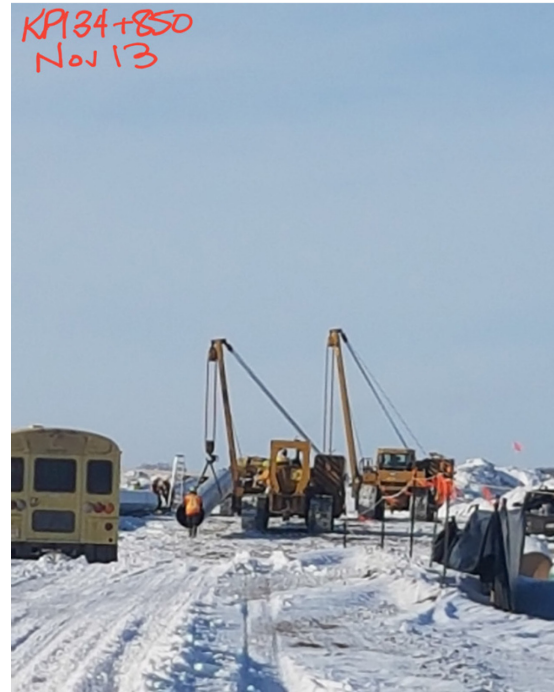
2. Bending Crew – Km 134+850 – Nov 13, 2017

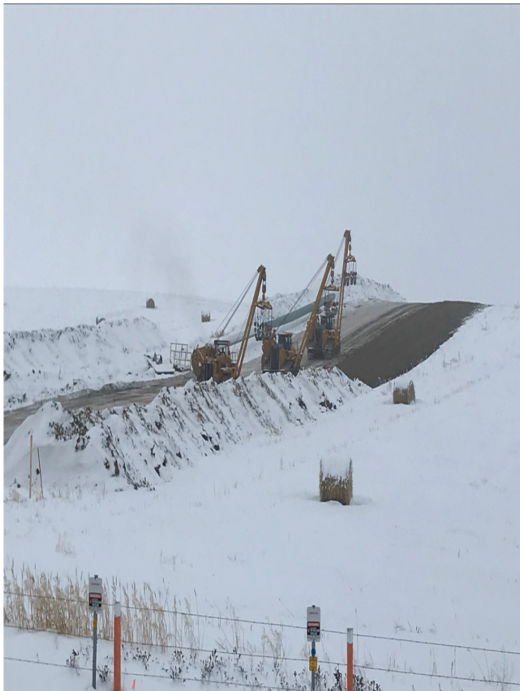
3. Lowering-in Crew – Km64+550 – Nov 13, 2017

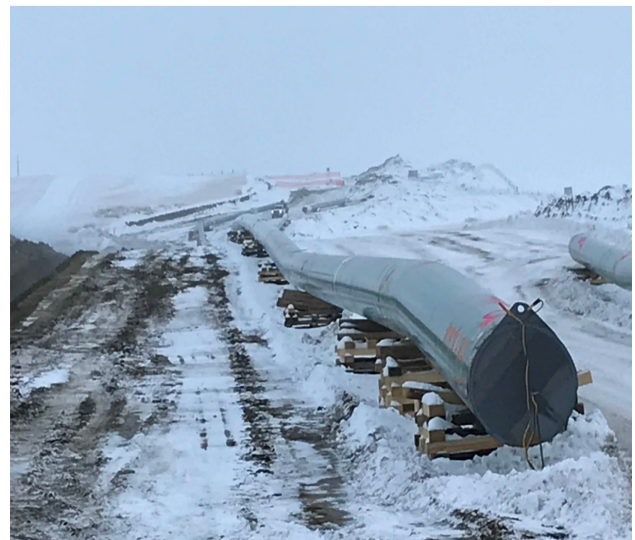
4. Welded pipe on skids – Km 68+400 – Nov 13, 2017

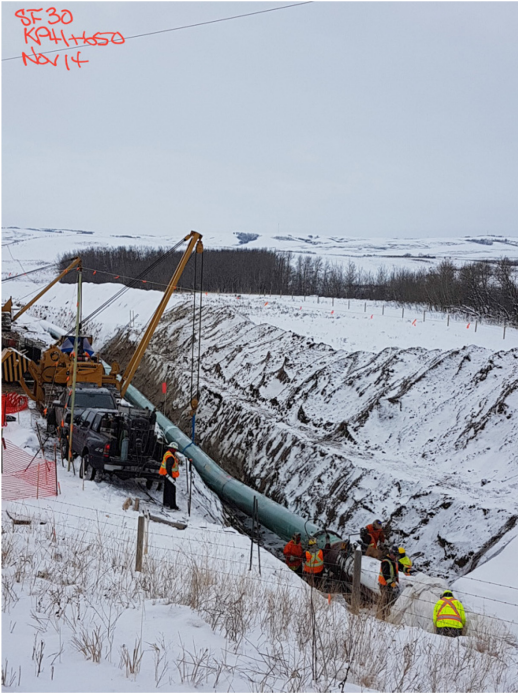
5. Tie-in – Km 41+650 – Nov 14, 2017

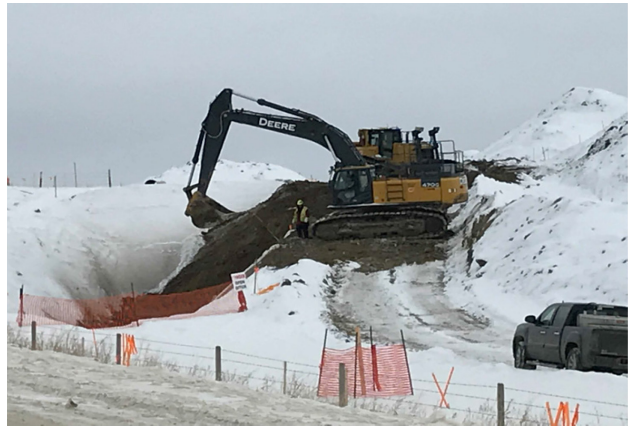
6. Tie-in Backfill – Km 41+650 – Nov 14, 2017

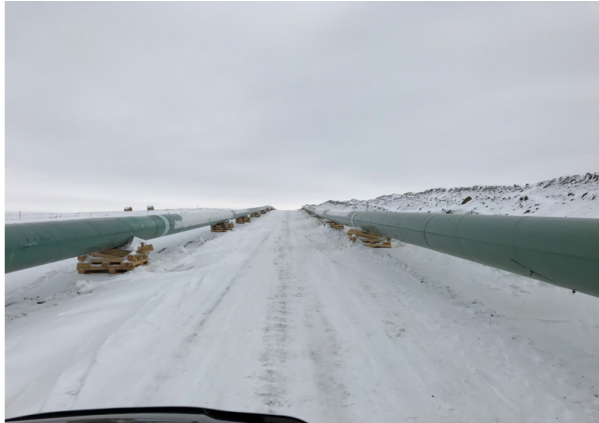
7. Welded Pipe on Skids – Km 74+750 – Nov 14, 2017

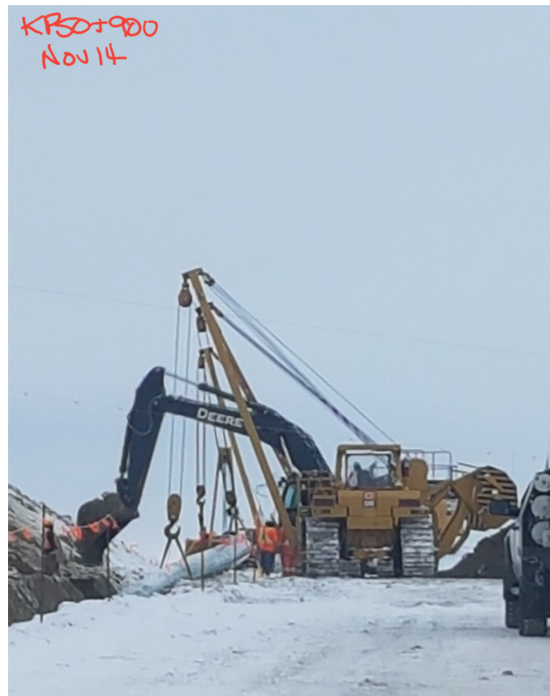
8. Pipe lowering – Km 50+900 – Nov 14, 2017

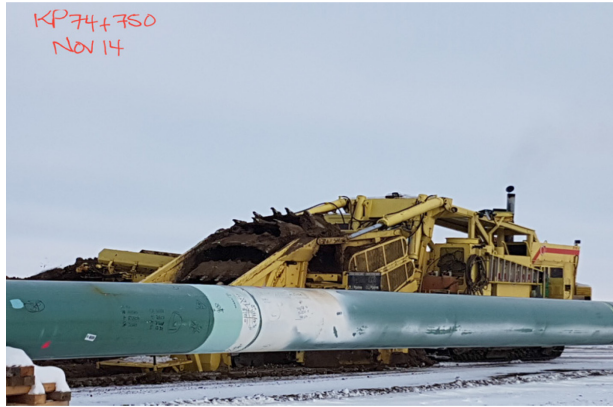
9. Ditcher activity – Km74+750 – Nov 14, 2017

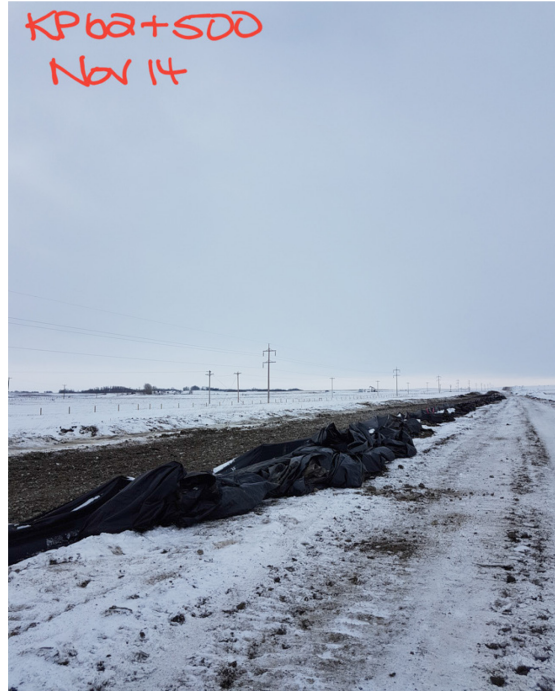
10. Pipe in the ground – km 62+500- Nov 14, 2017

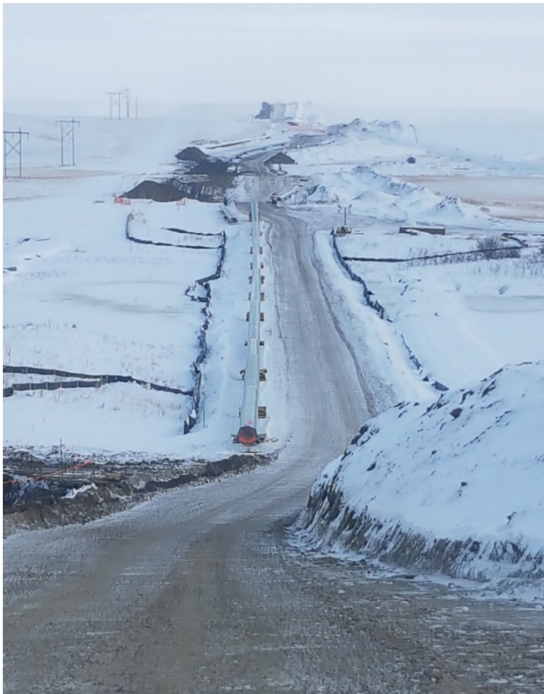
11. Waiting to lower pipe – km 68+400 – Nov 15, 2017

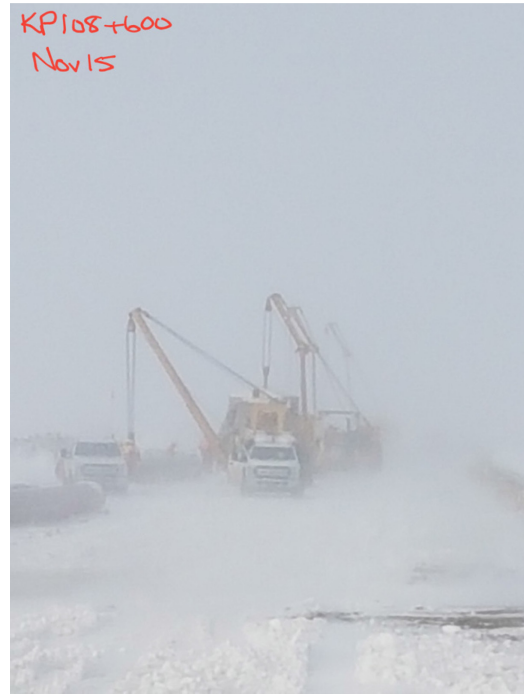
12. Welding (Low visibility) – km 108+600 – Nov 15, 2017

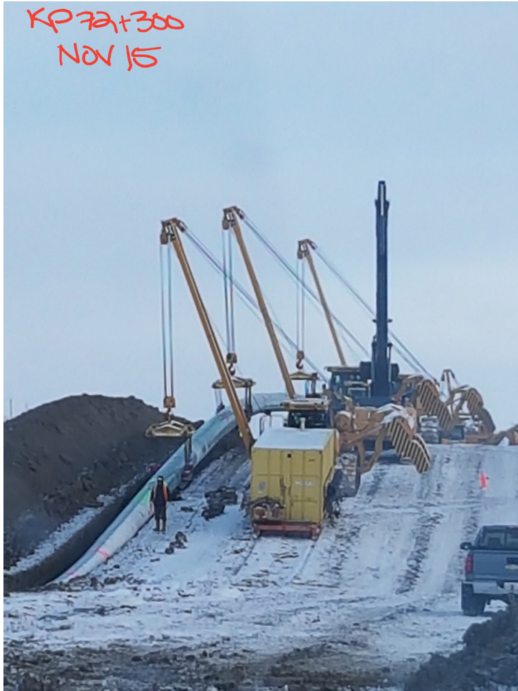
13. Pipe lowering – km 72+300 – Nov 15, 2017

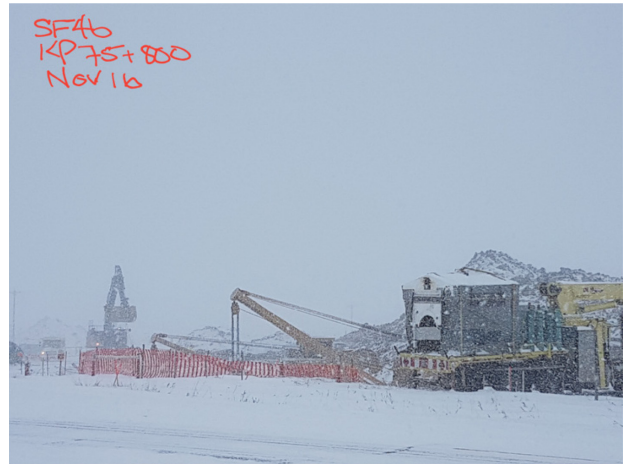
14. Tie-in activity – Km 75+800 – Nov 16, 2017

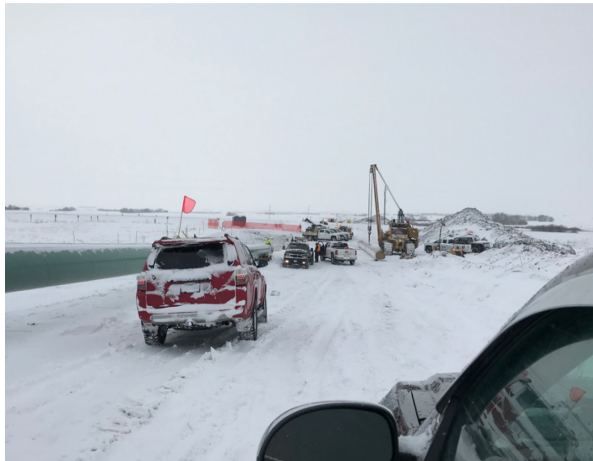
15. Tie-in – Km 81+450 – Nov 17, 2017

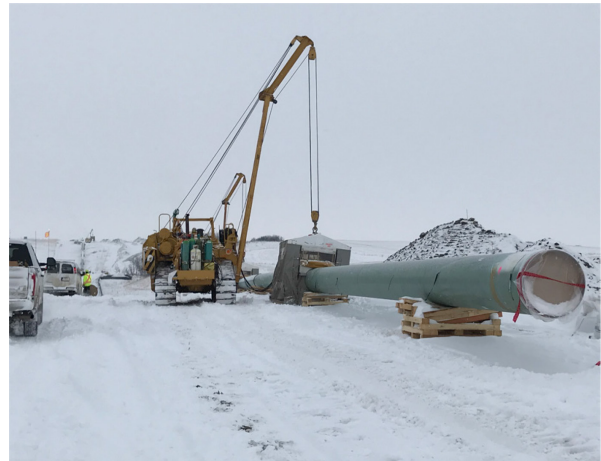
16. Off side welding – km 109+50 – Nov 17, 2017

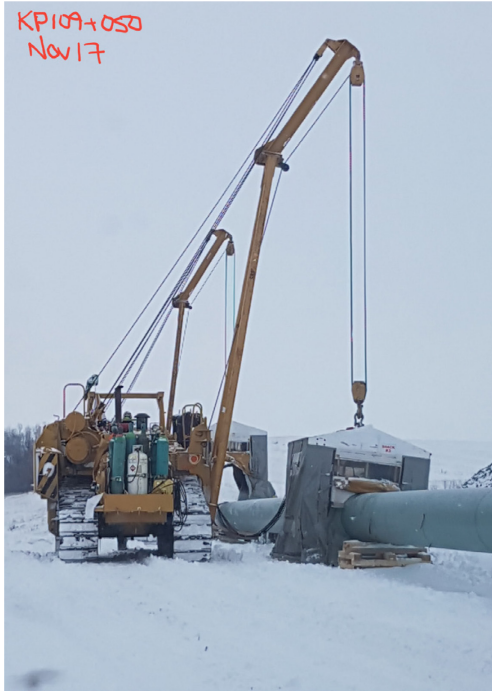
17. Off side welding – Km109+50 – Nov 17, 2017
