**SAMSON CREE NATION – MATRIX SOLUTIONS INC.  
PARTNERSHIP**

**ABORIGINAL CONSTRUCTION MONITORING**

**WEEKLY REPORT**

**NOVEMBER 13<sup>TH</sup> TO NOVEMBER 17<sup>TH</sup>**

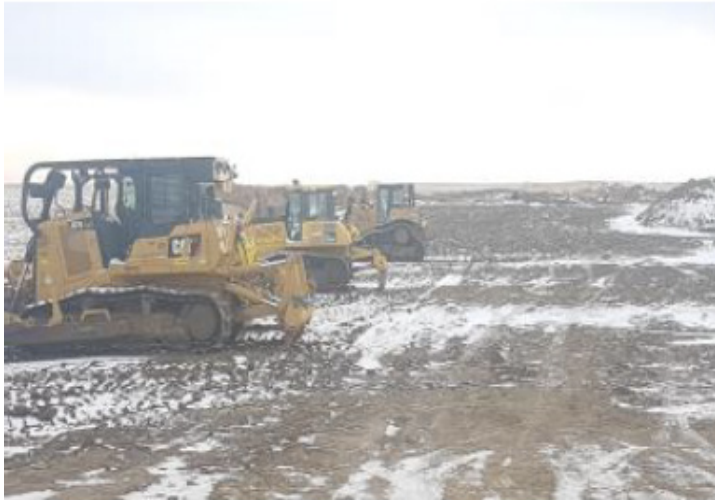
Equipment ready for removal – SF 44 – Nov 13, 2018

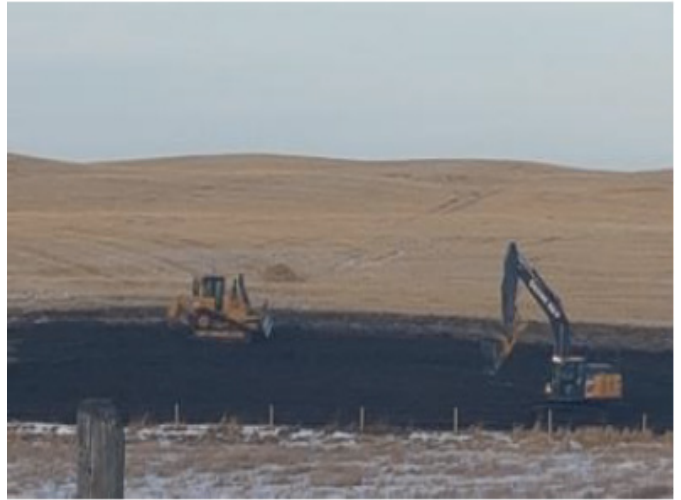
Dozer and excavator backfilling ovality dig– SF 75 – Nov 13, 2018

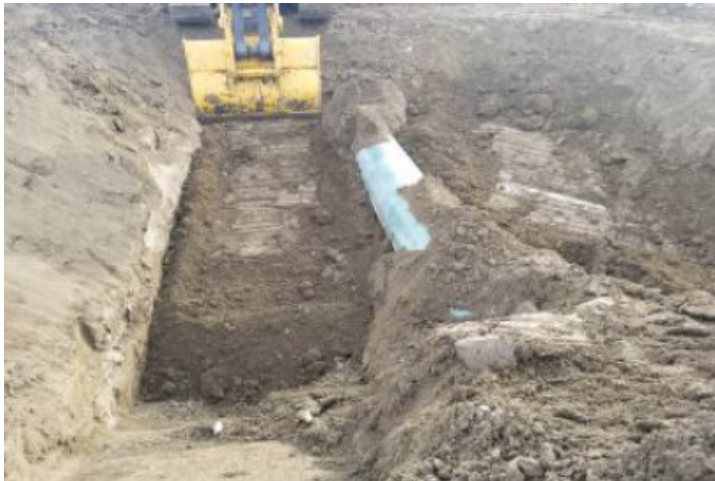
Excavator shading pipe – SF 22 – Nov 13, 2018

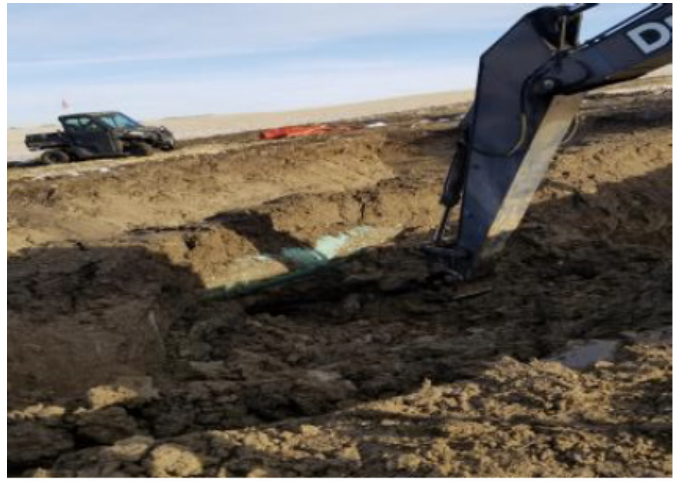
Excavator spooning under pipe – SF 22 - Nov 13, 2018

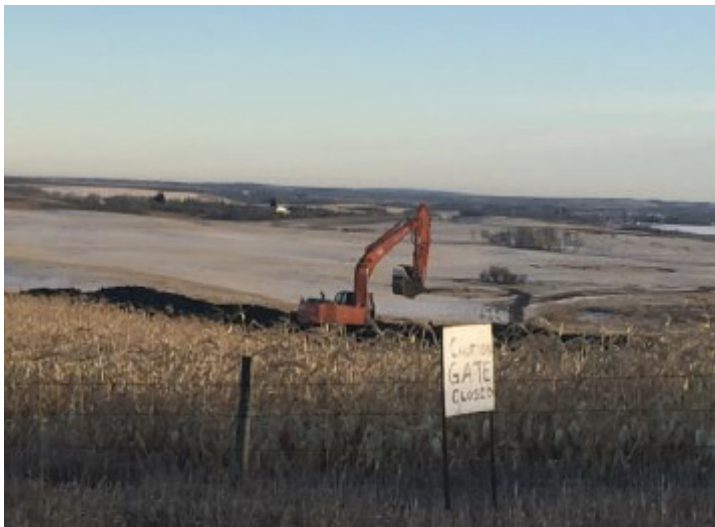
Ovality dig - SF 21 – Nov 13, 2018

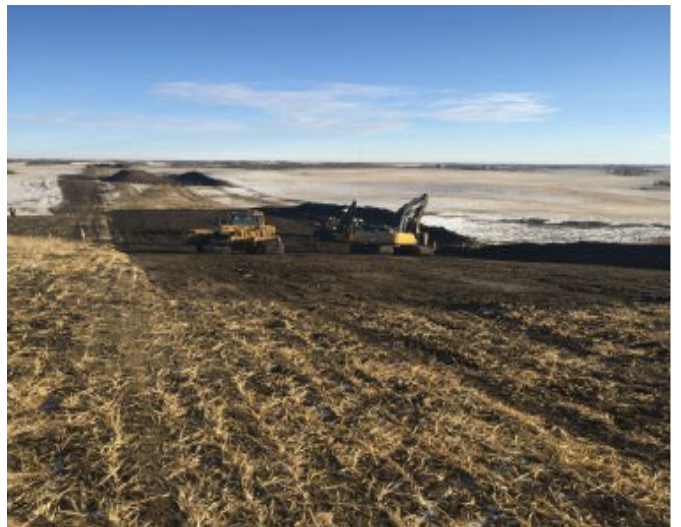
Replacing backfill– SF 22 – Nov 13, 2018

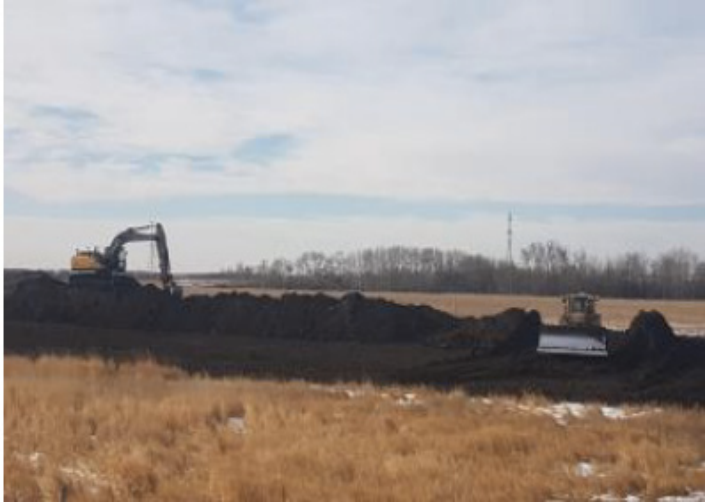
Excavator and dozer replacing topsoil – SF 34 – Nov 14, 2018

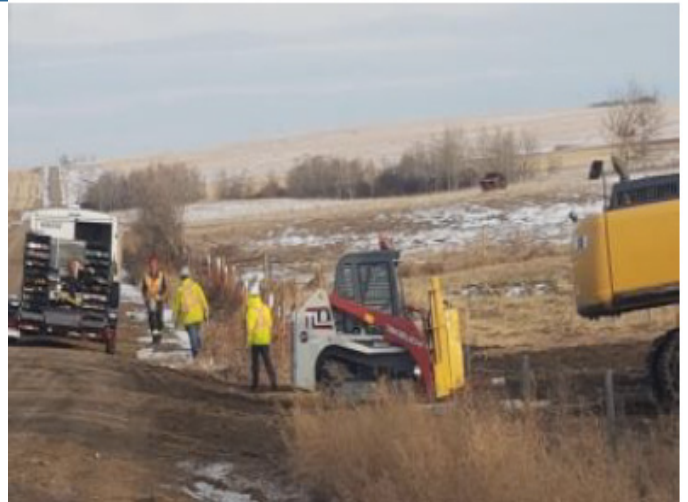
Fencing crew putting up posts and wire – SF 52 – Nov 14, 2018

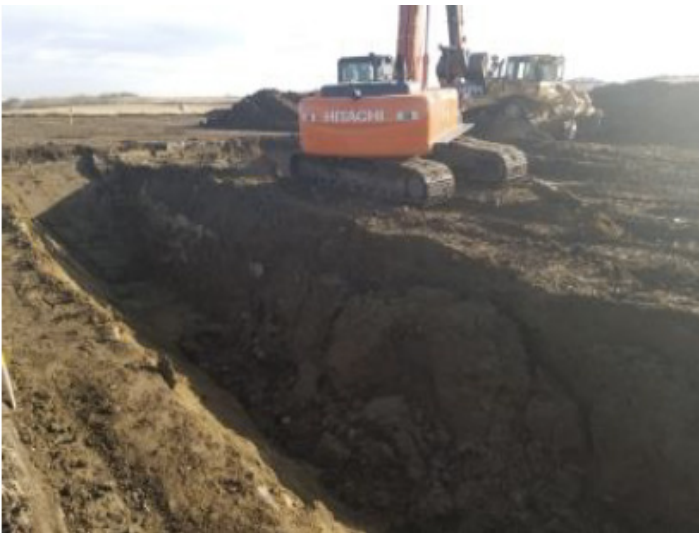
Excavator digging ditch for ovality – SF 25 – Nov 14, 2018

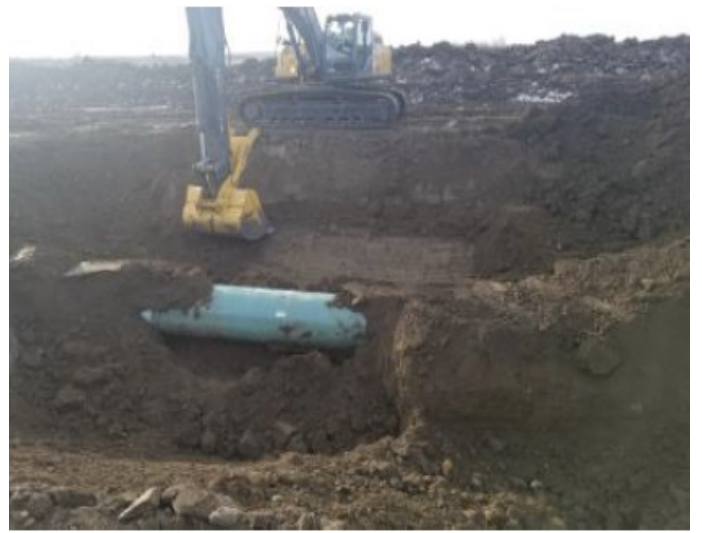
Excavator shading pipe – SF 23 – Nov 14, 2018

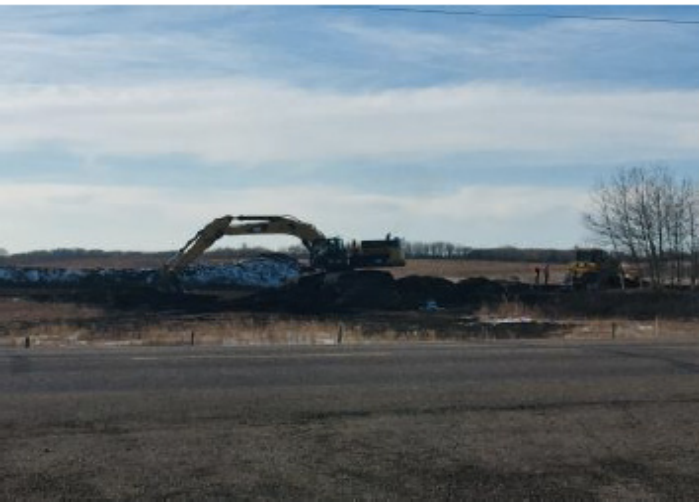
Transition topsoil replacement – SF 17 – Nov 14, 2018

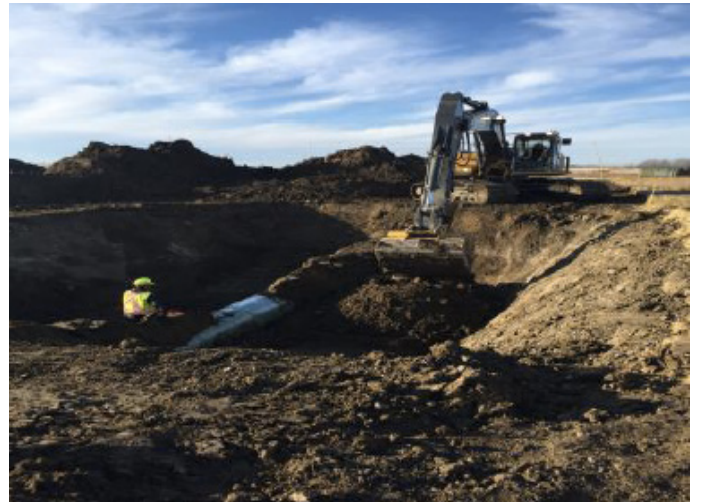
Ovality backfill – SF 24 – Nov 14, 2018

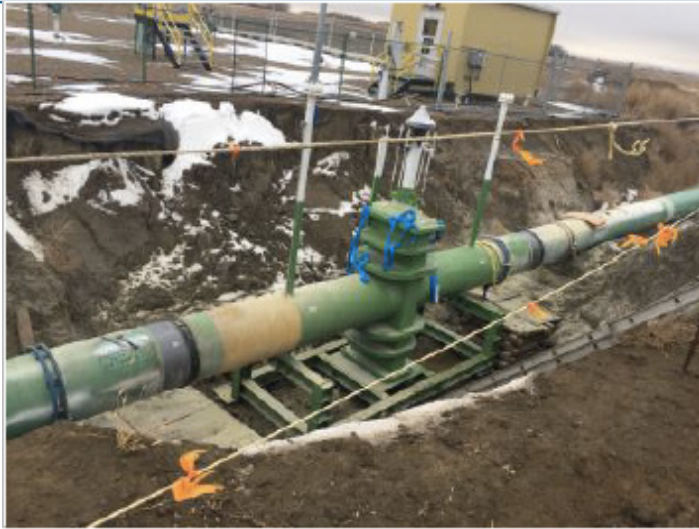
completed, and UT inspection of welds in process. At SF 61, crane arrived with a load of sheet pilings for bell hole excavators.

UT inspection site – SF 59 – Nov 15, 2018

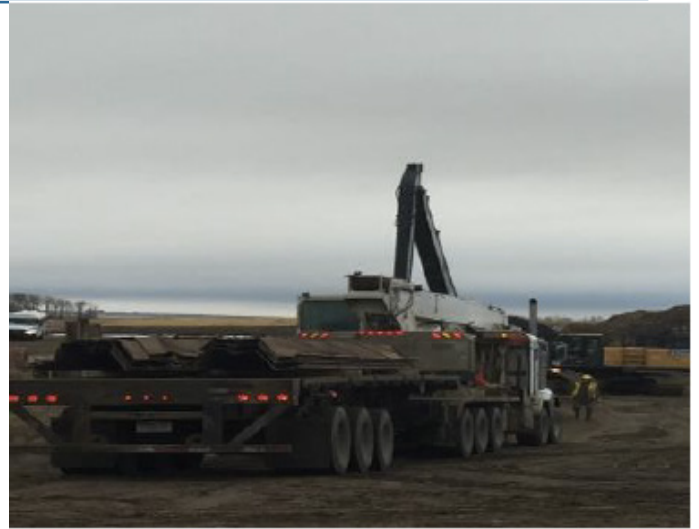
Valve tie-in sheet piling delivered – SF 61 – Nov 15, 2018

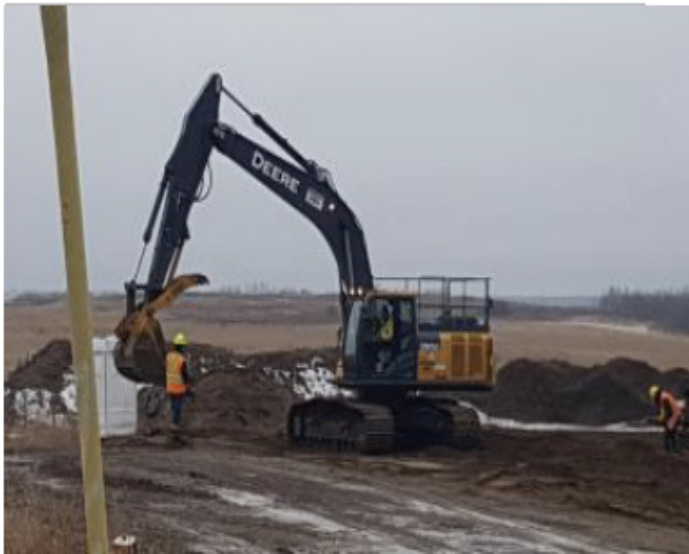
Excavator pulling topsoil back on ROW – SF 17 - Nov 15, 2018

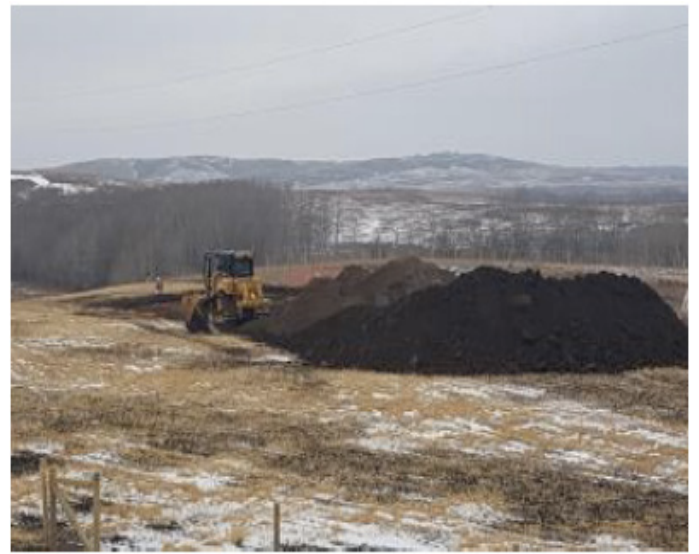
Ovality completed – SF 29 – Nov 15, 2018

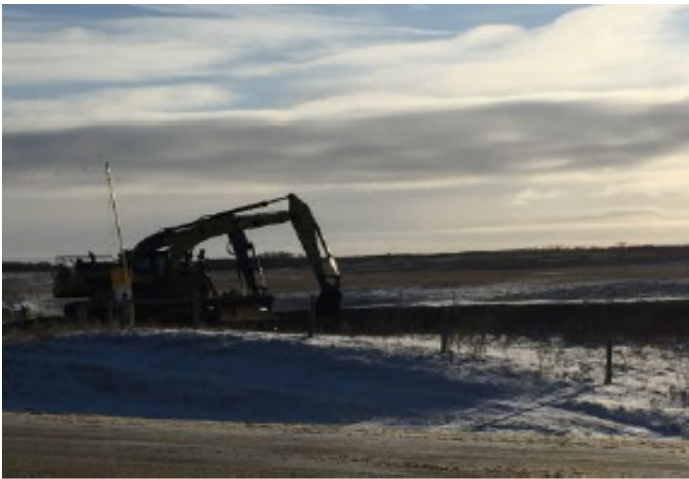
Clean up complete - SF 17 – Nov 16, 2018

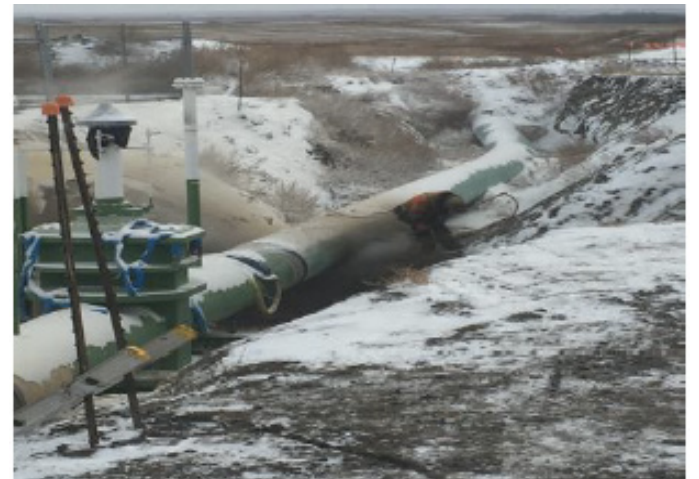
Hydro vac cleaning work area– SF 59 – Nov 16, 2018

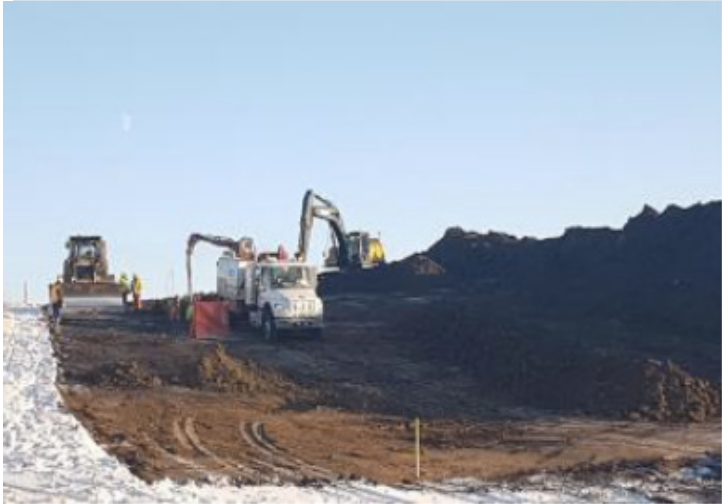
Hydro vac locating pipe – SF 30 – Nov 16, 2018

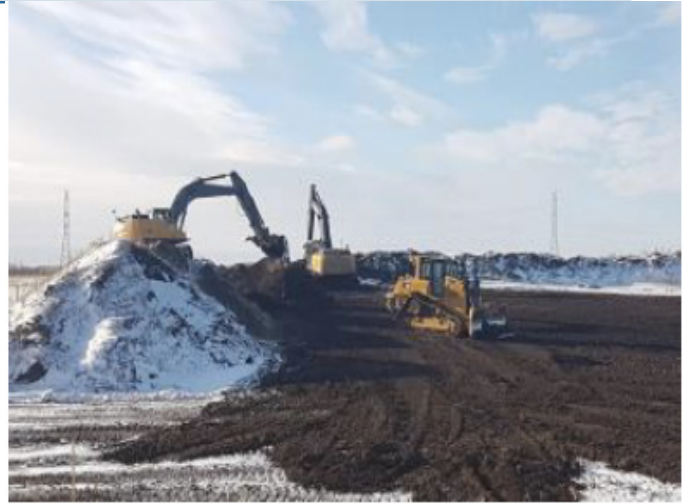
Excavator and dozer spreading top soil – SF 34 – Nov 16, 2018

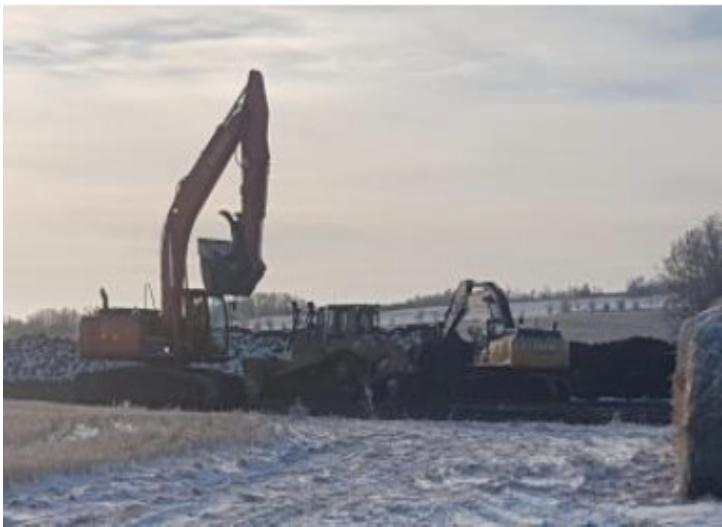
Dozer and excavator spreading and compacting– SF 25 – Nov 17, 2018

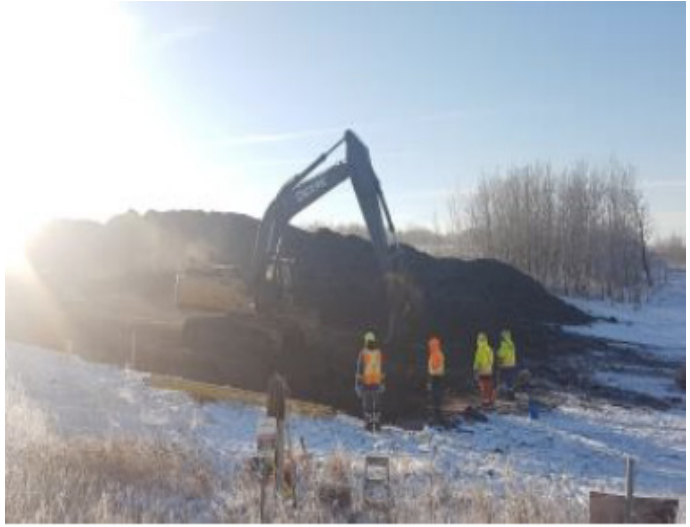
Excavator digging bell hole– SF 30– Nov 17, 2018

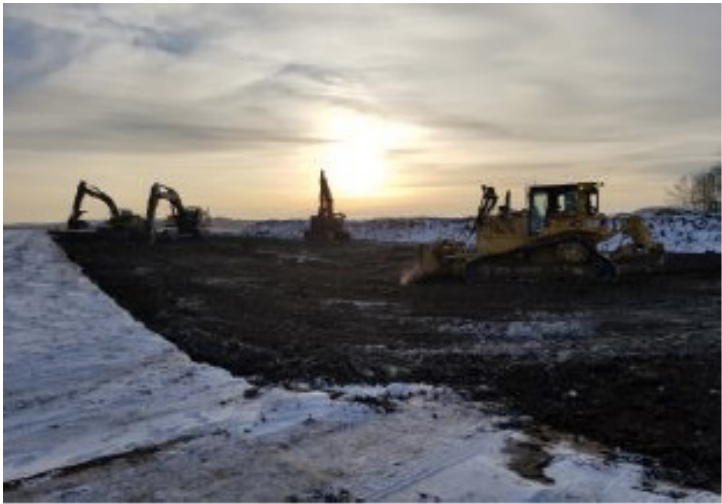
Excavator bailing ovality cuts to dozer - SF 25 – Nov 17, 2018

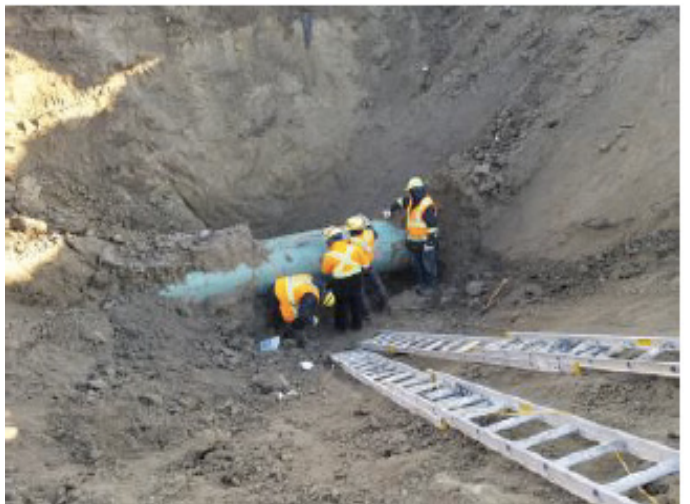
Laborers cleaning pipe – SF 27 - Nov 17, 2018
