**SAMSON CREE NATION – MATRIX SOLUTIONS INC.  
PARTNERSHIP**

**ABORIGINAL CONSTRUCTION MONITORING**

**WEEKLY REPORT**

**NOVEMBER 19<sup>TH</sup> TO NOVEMBER 23<sup>RD</sup>**

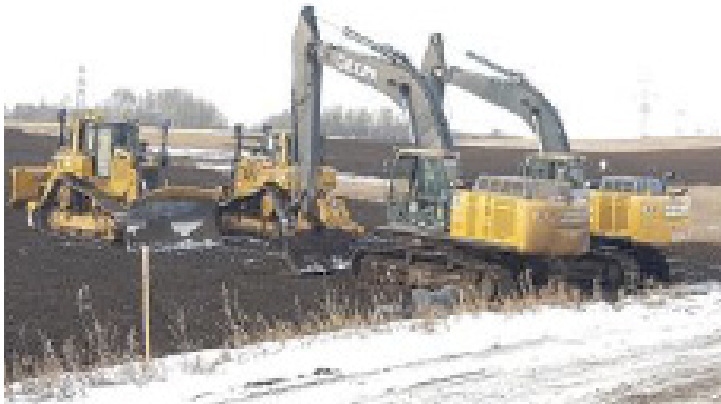
Geotec, dozers and excavators at access – SF 34 – Nov 19, 2018

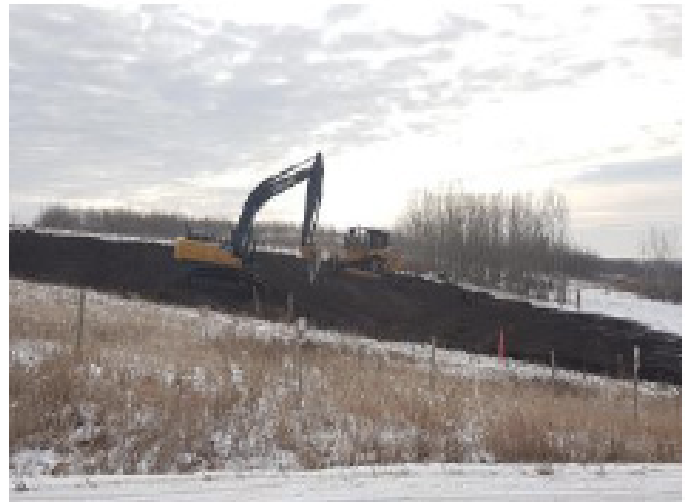
Replacing topsoil from ovality dig– SF 30 – Nov 19, 2018

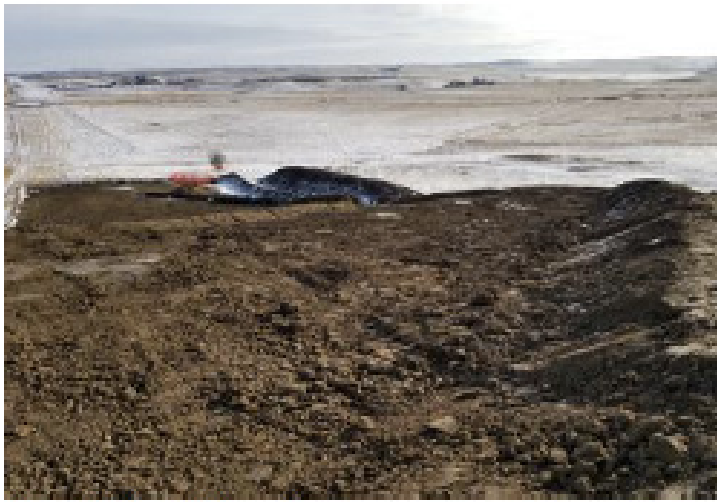
Diversion berms – SF 27 – Nov 19, 2018

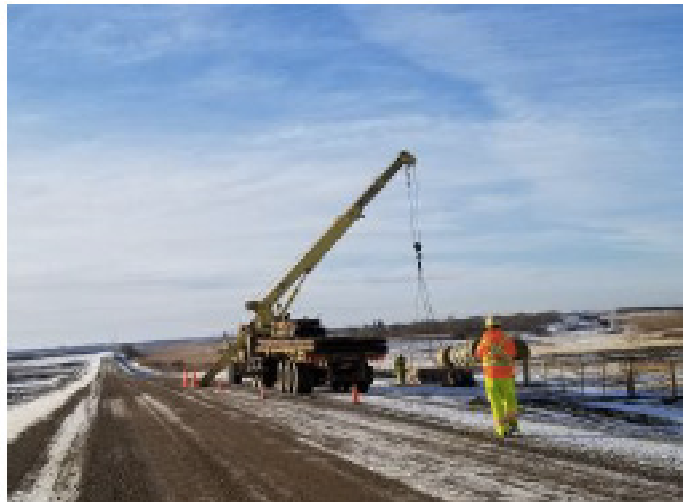
Crane removing rig matting from ditch – SF 19 - Nov 19, 2018

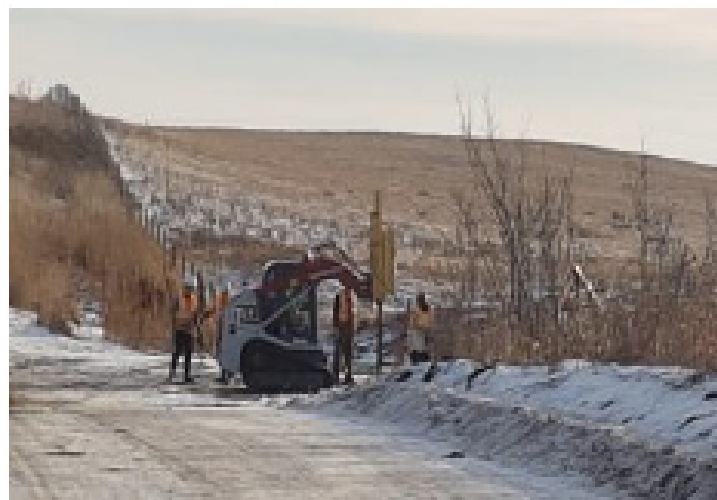
Fencing crew pounding in fence posts - SF 30 – Nov 20, 2018

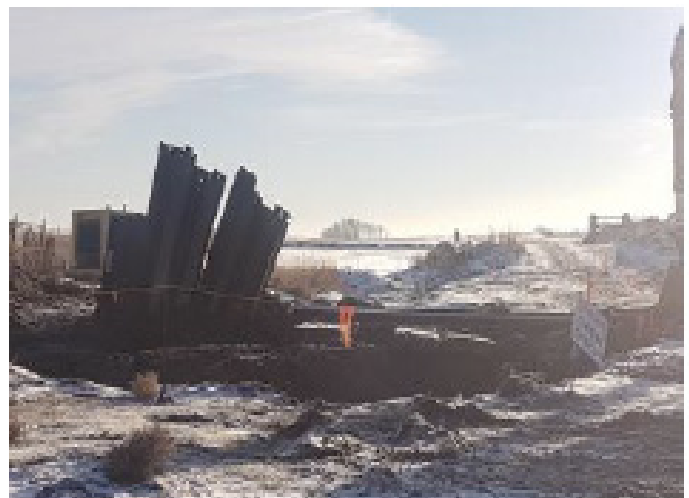
Open bellhole for valve – SF 61 – Nov 20, 2018

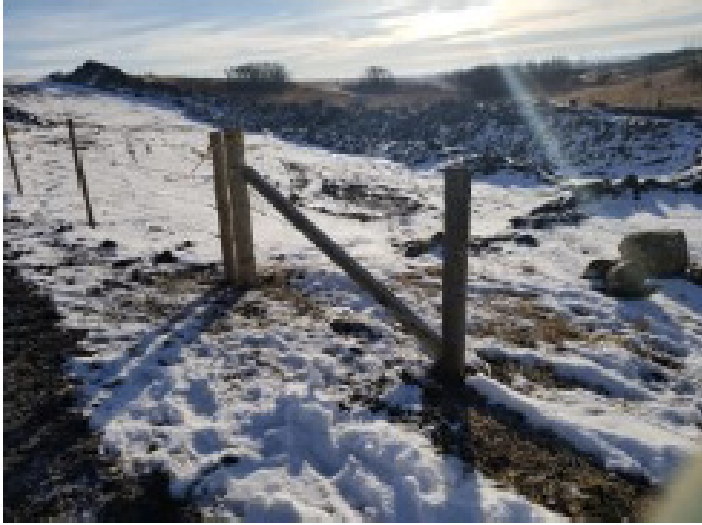
Broken fence (hazard) – SF 22 – Nov 20, 2018

mats were left at the access for removal. At SF 31, fences have been installed. At SF 30, fencing crew was onsite. At SF 25, rig mats have been removed from the ROW, and dozers were parked onsite to be moved to O.J yard. At SF 22, fence has been repaired, and broken posts have been fixed. At SF 20, garbage pile was beside ROW access.

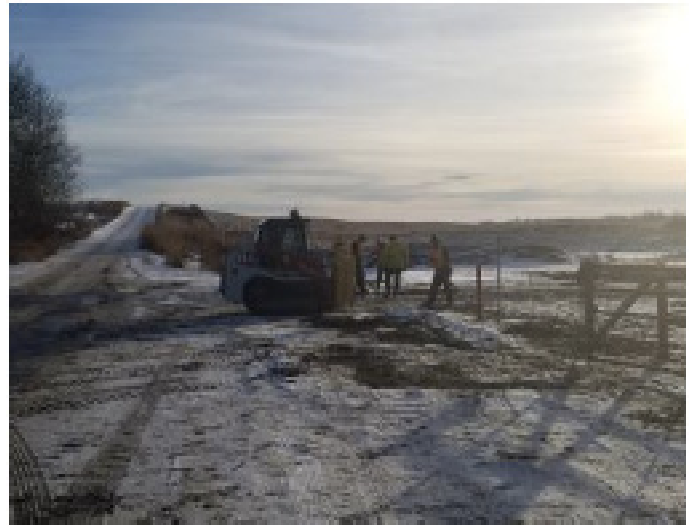
Fencing crew installing fence – SF 31 – Nov 20, 2018

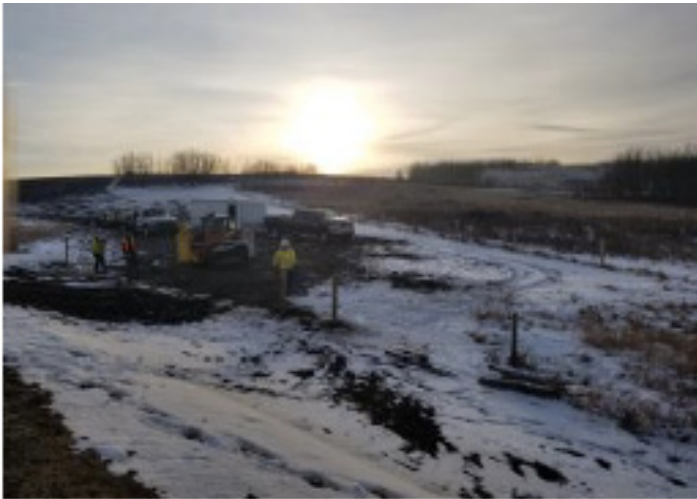
Fencing crew fixing deficiencies – SF 30 – Nov 21, 2018

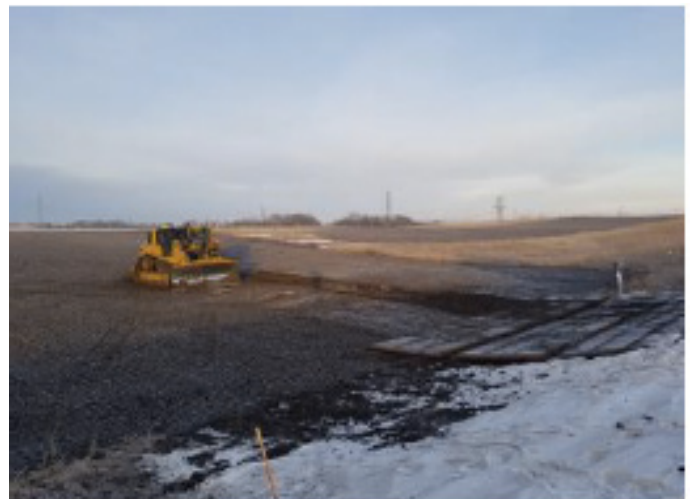
November 21, the safety theme was drive according to the weather conditions. The weather was overcast and windy. At SF 43, rig mats were ready to be removed from the access. At SF 35, dozers were removed from the ROW, topsoil has been replaced, and flaggers were on the road. At SF 34, equipment was demobbed from the ROW, and rig

Dozers left for transport, soils are replaced – SF 35 – Nov 21, 2018

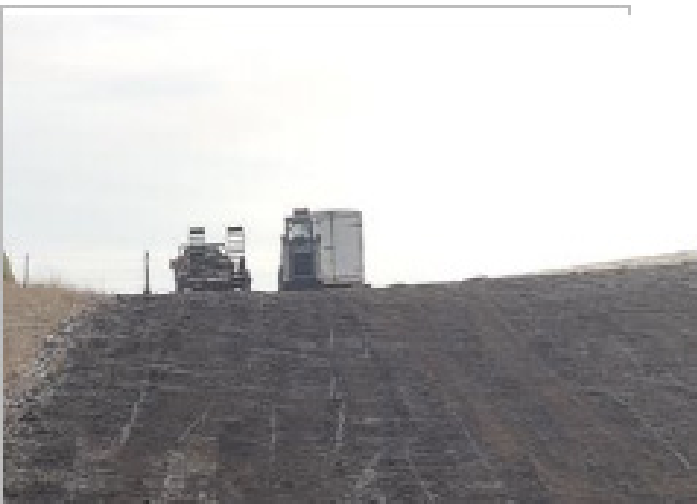
Fencing crew prepping to install fence – SF 59 – Nov 21, 2018

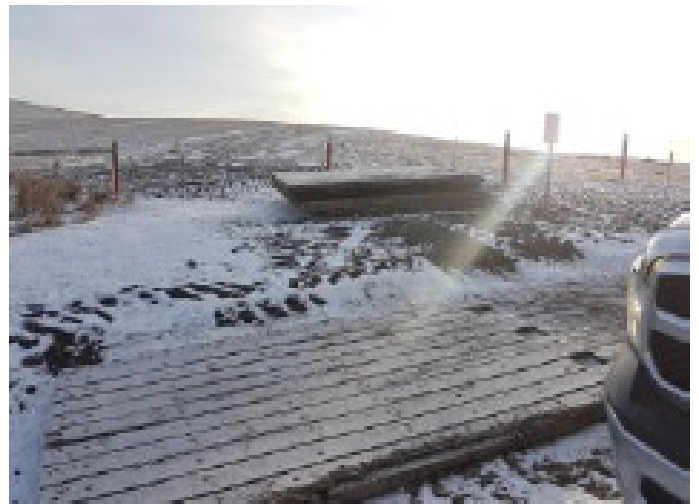
Rig mats at access road ready for removal – SF 61 – Nov 21, 2018

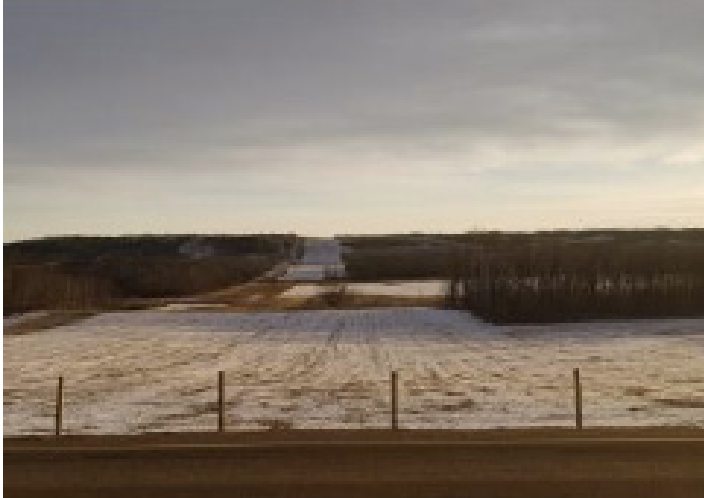
Drive to kickoff – SF 52 - Nov 22, 2018

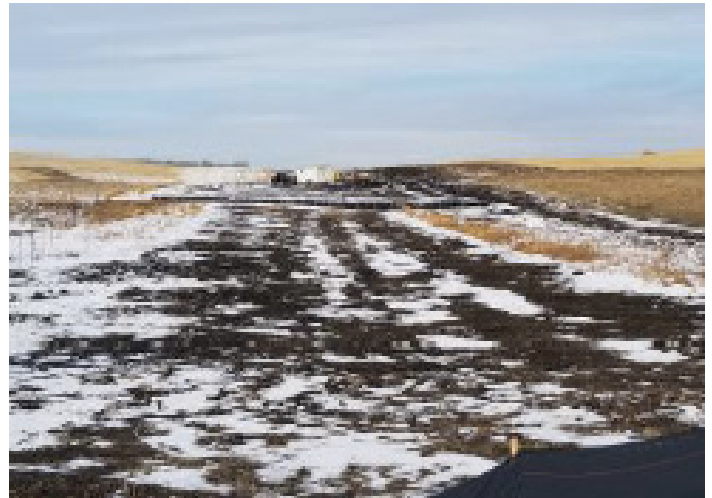
Inspect silt fence – SF 22 – Nov 22, 2018

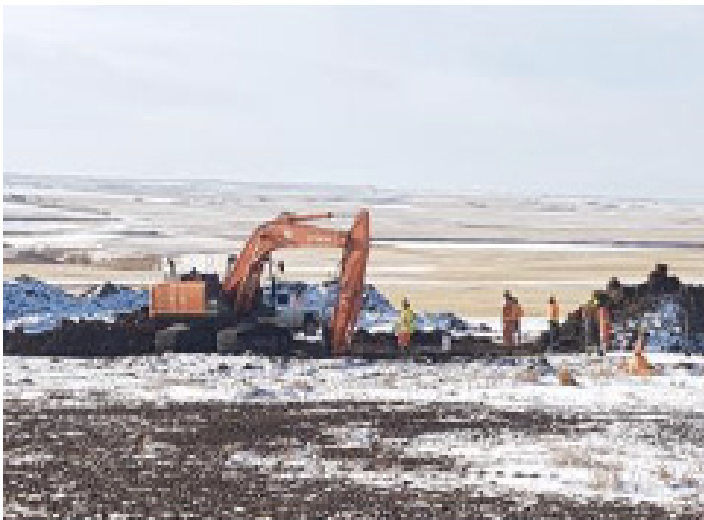
Excavator digging bellhole - SF 71 – Nov 22, 2018

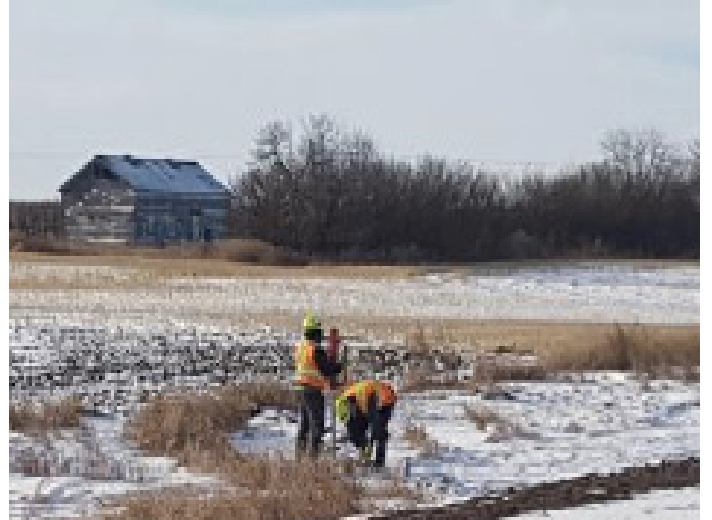
Utility crew putting in pipeline warning signs – SF 79 – Nov 22, 2018

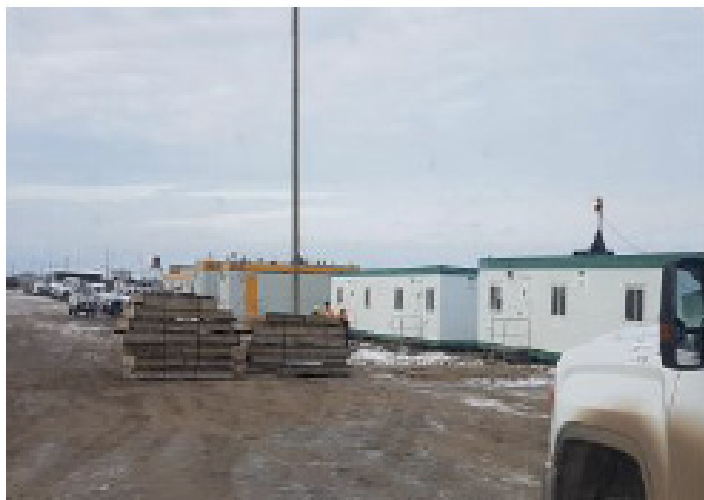
Crews disassembling office trailers - Nov 23, 2018

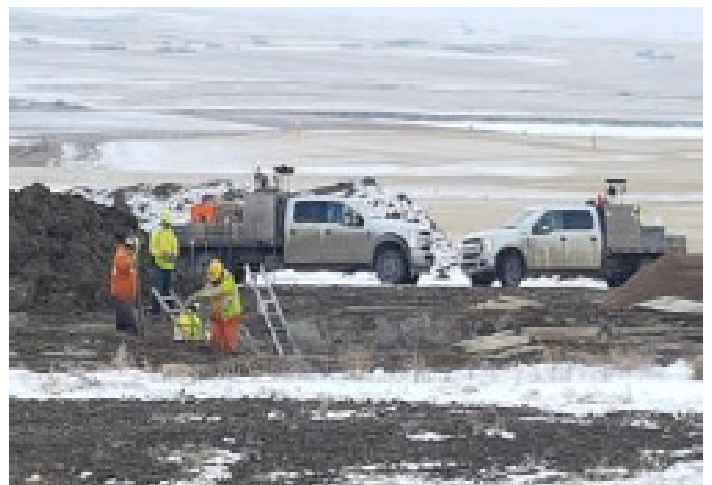
Crew working in bell hole – SF 71 – Nov 23, 2018

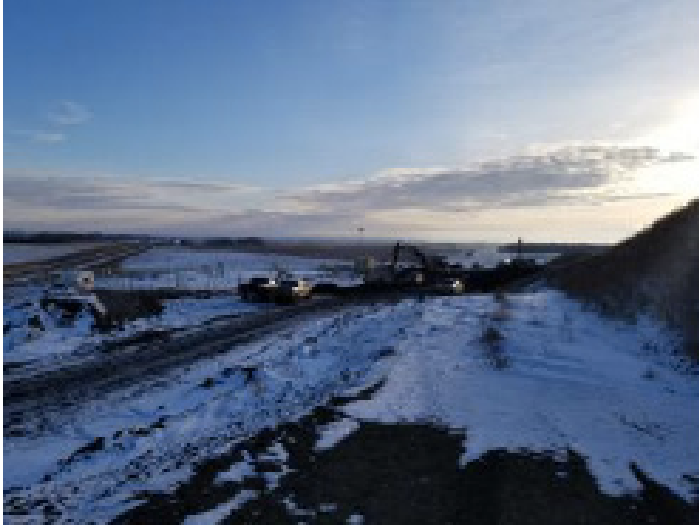
Excavator shading pipe, crew working on valve site– SF 59 – Nov 23, 2018

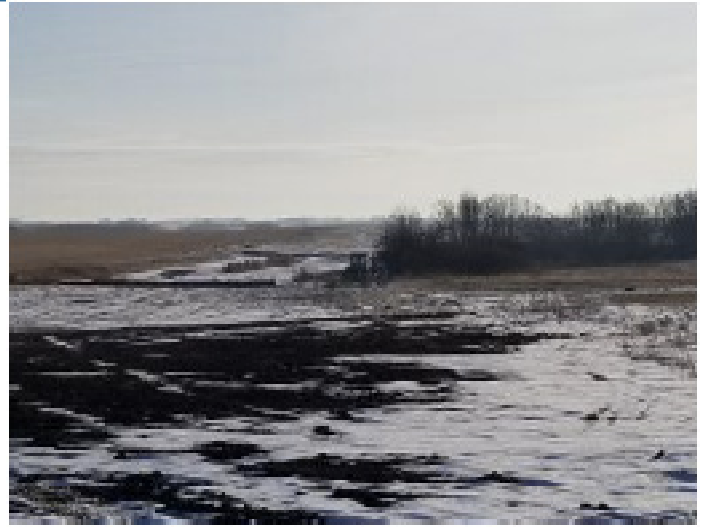
Tractor pulling mower – SF 51– Nov 23, 2018
