**SAMSON CREE NATION – MATRIX SOLUTIONS INC.
PARTNERSHIP**

ABORIGINAL CONSTRUCTION MONITORING

WEEKLY REPORT

NOVEMBER 27TH TO DECEMBER 2ND

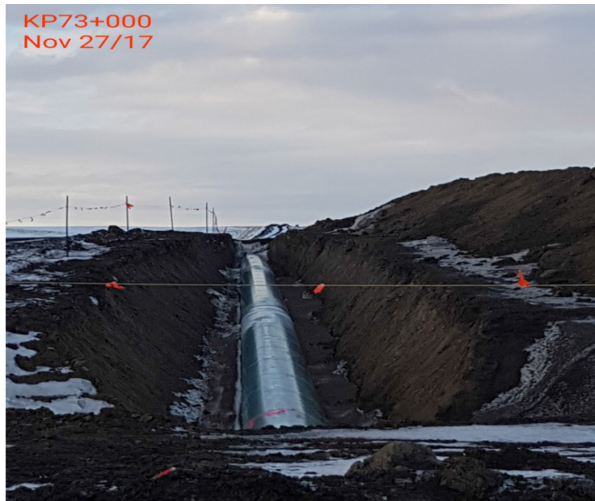
This week's activities started with a drive from km 90+900 to 72+000 on the ROW. At km 72+000, the excavator was active. Tie in work was taking place at km73+000 and the area was mostly backfilled. The backfilled mainline picture taken at km 73+300 and 72+000. At km 89+000 (shoofly 54) the monitors viewed track bore work; then, they headed to km 81+550 to 75+950.

1. Tie-in work – Km73+000 – Nov 27, 2017

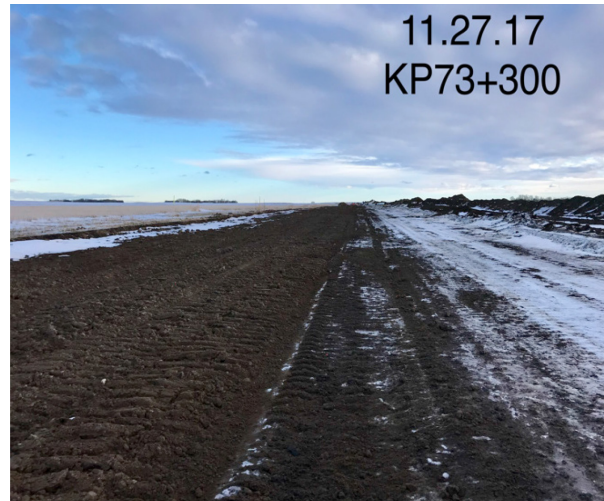
2. Backfilled Mainline – Km 73+300 – Nov 27, 2017

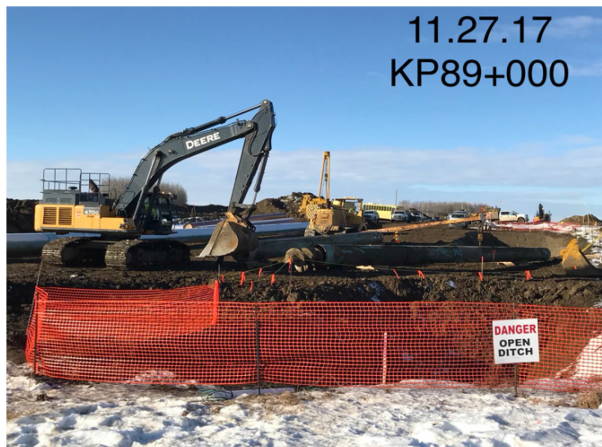
3. Tie-in work – Km 89+000 – Nov 27, 2017

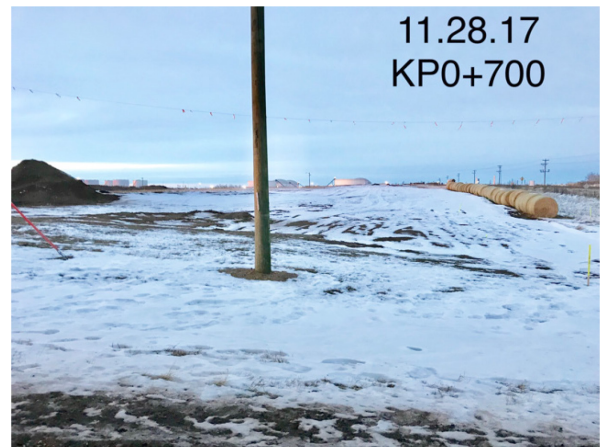
4. Completed work – Km 0+700 – Nov 28, 2017

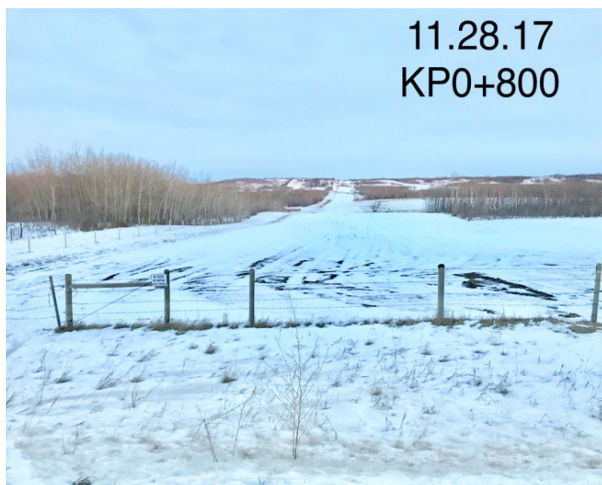
5. Completed Work – km0+800 – Nov 28, 2017

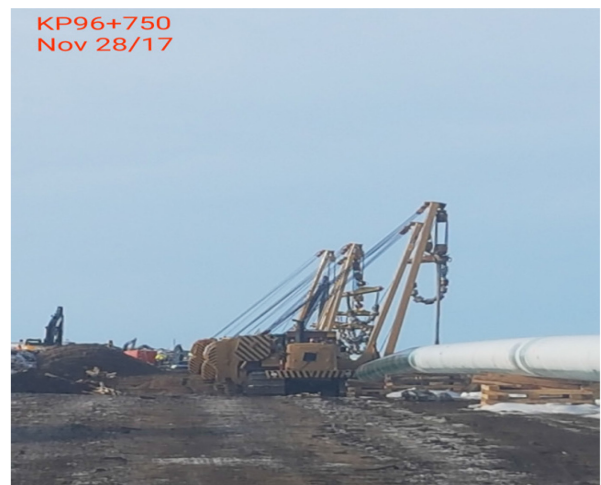
6. Pipe lowering in – Km 96+750 – Nov 28, 2017

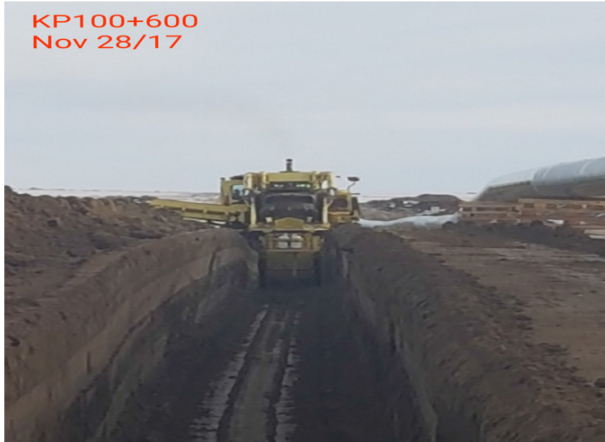
KP100+600
Nov 28/17

7. Lowering in – Km 100+600 – Nov 28, 2017

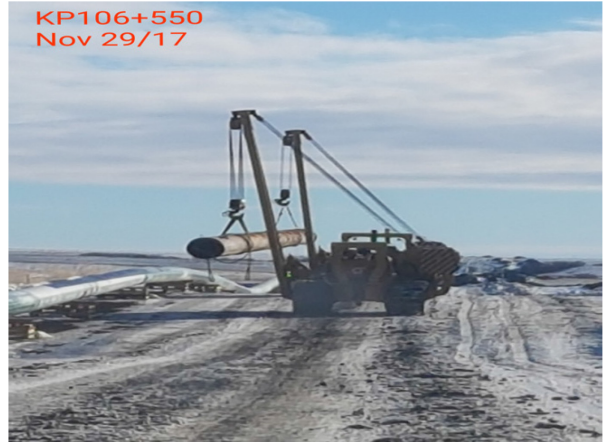
KP106+550
Nov 29/17

8. Side booms moving pipes – km 106+550 – Nov 29, 2017

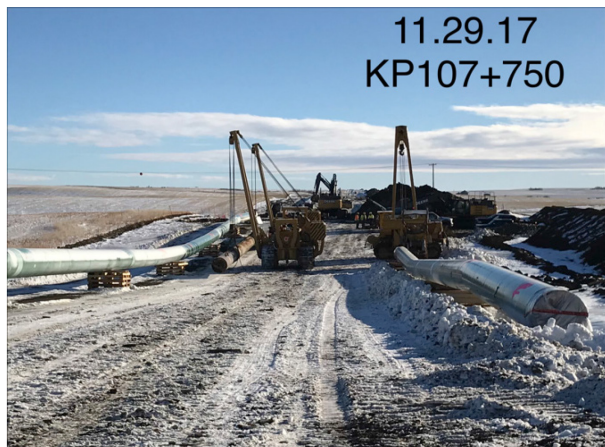
11.29.17
KP107+750

9. Booms and excavators – km107+750 – Nov 29, 2017

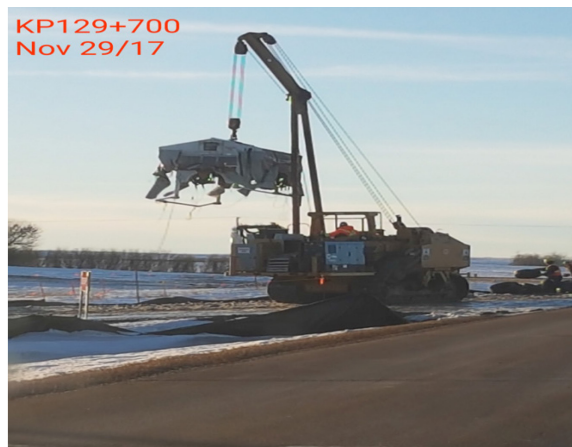
KP129+700
Nov 29/17

10. ROW – km 129+700 – Nov 29, 2017

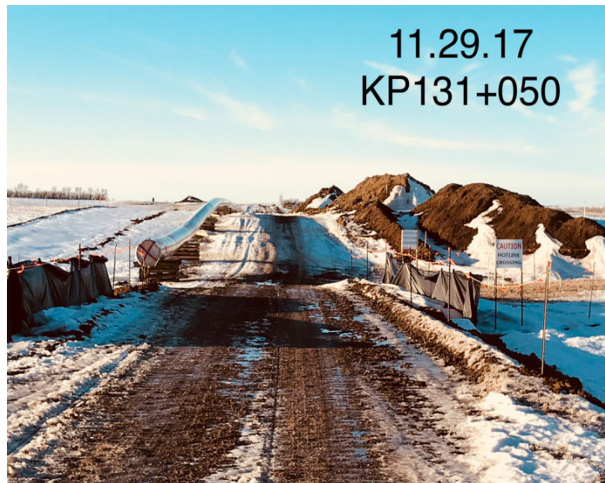
11.29.17
KP131+050

11. ROW - km 131+050 - Nov 29, 2017

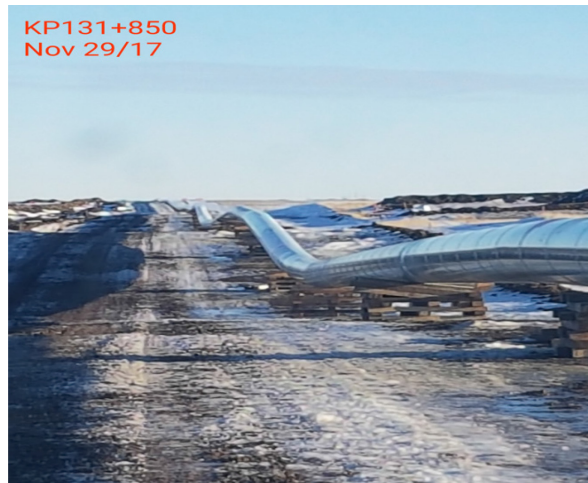
KP131+850
Nov 29/17

12. Pipe on skids - km 131+850 – Nov 29, 2017

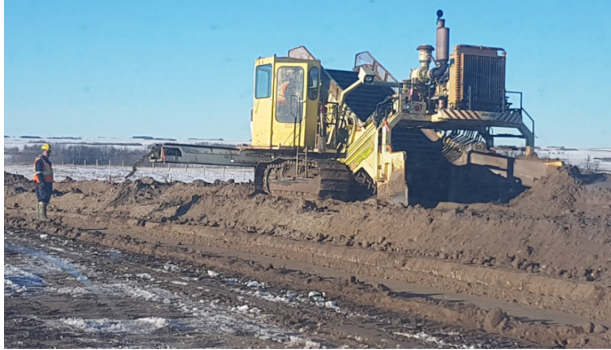
KP99+025
Nov 30/17

13. Soil Sifter – km 99+025 – Nov 30, 2017

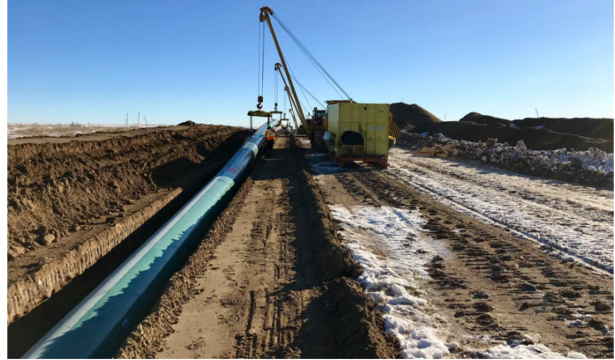
11.30.17
KP99+050

14. Lowering – in – km 99+050 – Nov 30, 2017

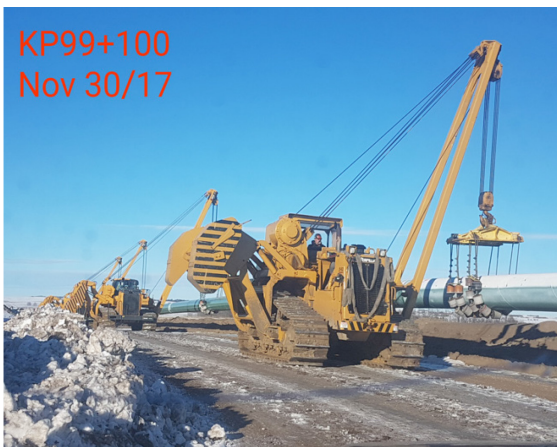
KP99+100
Nov 30/17

15. Excavator clearing ditch – Km 99+100 – Nov 30, 2017

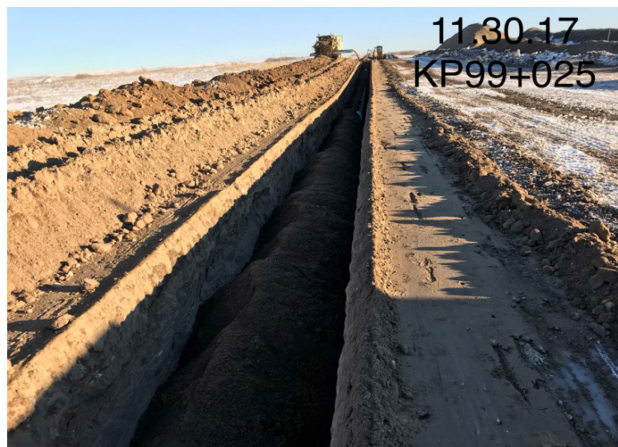
11.30.17
KP99+025

16. Soil Sifter – Km99+025 – Nov 30, 2017

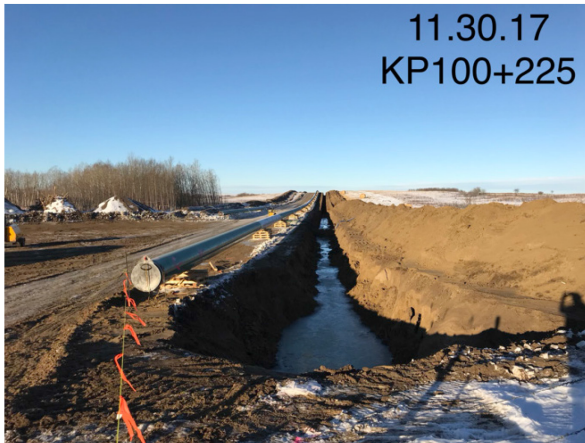
11.30.17
KP100+225

17. Ditch and pipe – km 100+225 – Nov 30, 2017

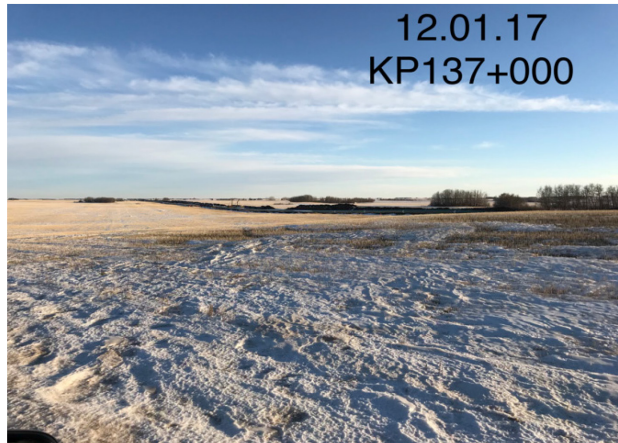
12.01.17
KP137+000

18. ROW (field) – Km 137+000 – Dec 1, 2017

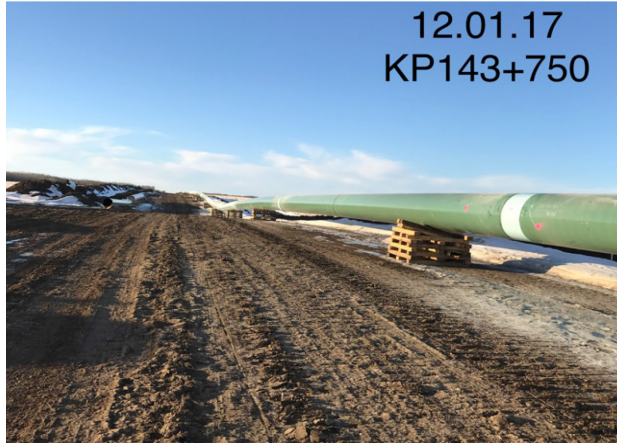
19. Finished pipe on skids – Km143+750 – Dec 2, 2017

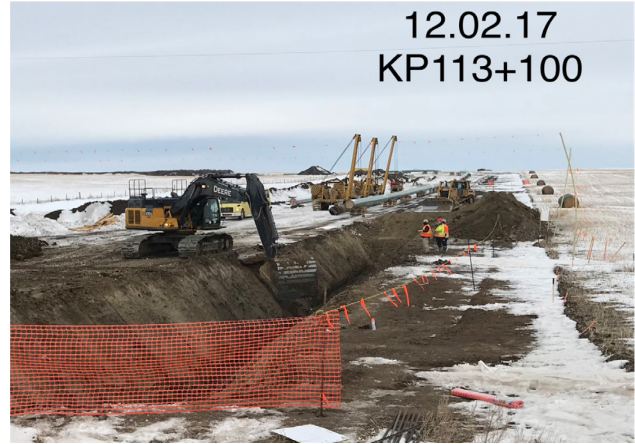
20. Bell hole work – Km113+100 – Dec 2, 2017
