**SAMSON CREE NATION – MATRIX SOLUTIONS INC.
PARTNERSHIP**

ABORIGINAL CONSTRUCTION MONITORING

WEEKLY REPORT

NOVEMBER 6TH TO NOVEMBER 12TH

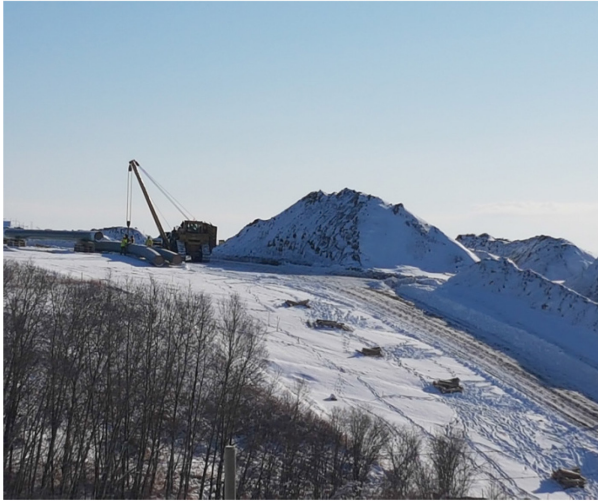
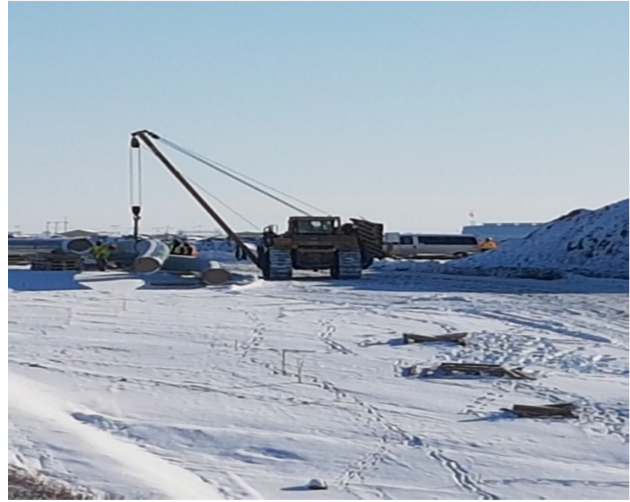
1. & 2. Booms lowering in pipe – km114+ 350 – Nov 6, 2017

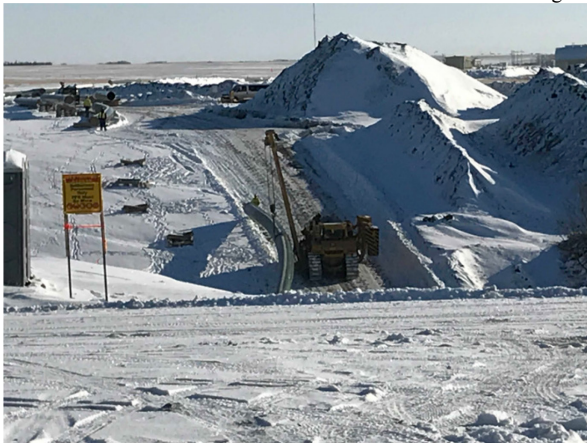
3. Bending Crew – Km114+400 –Nov 6, 2017

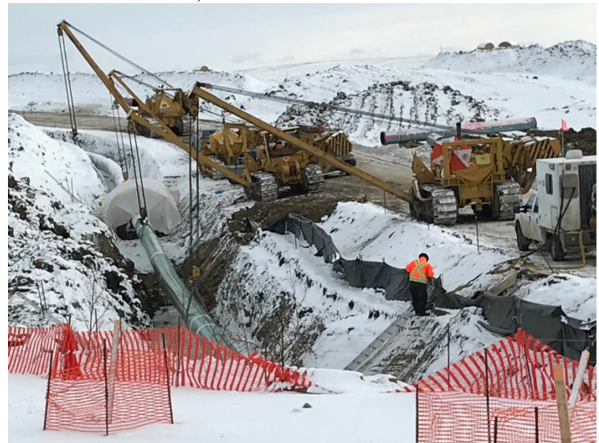
4. Tie in work – Km 33+900 – Nov 7, 2017

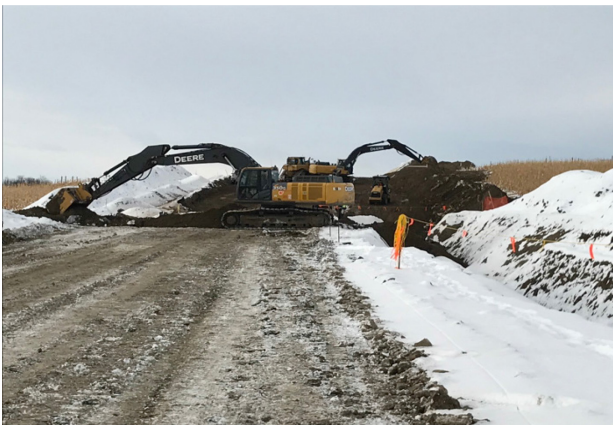
5. Tie-in Backfill – Km 30+750 – Nov 7, 2017

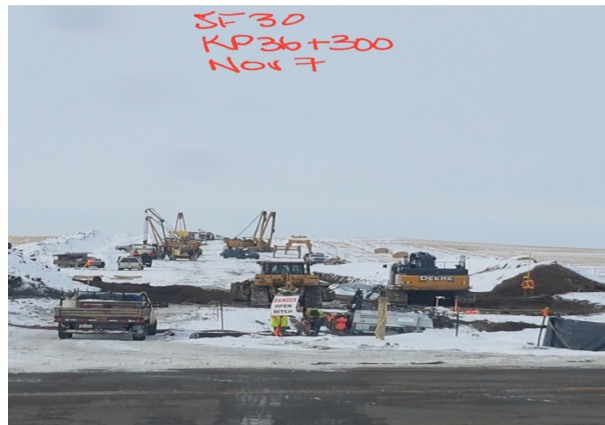
6. Tie in activity – km 36+300(SF 30) – Nov 7, 2017

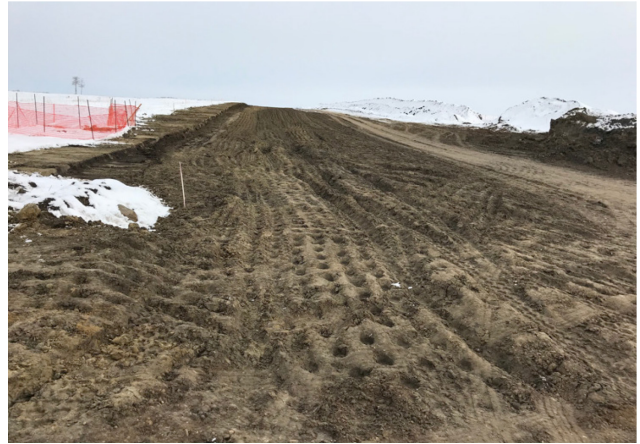
8. Tie in work complete – Km 43+600 – Nov 7, 2017

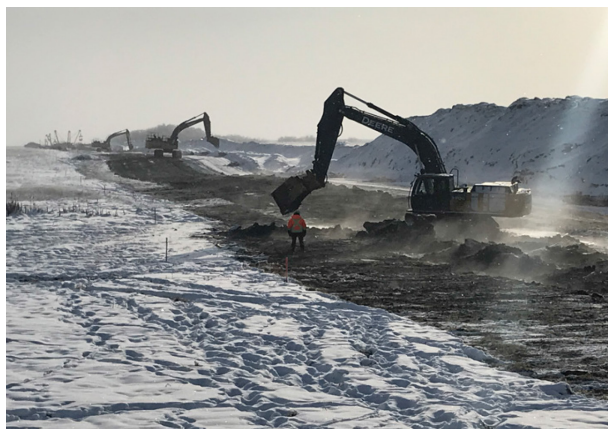
9. Tie-in Backfill – km 58+900 – Nov 8, 2017

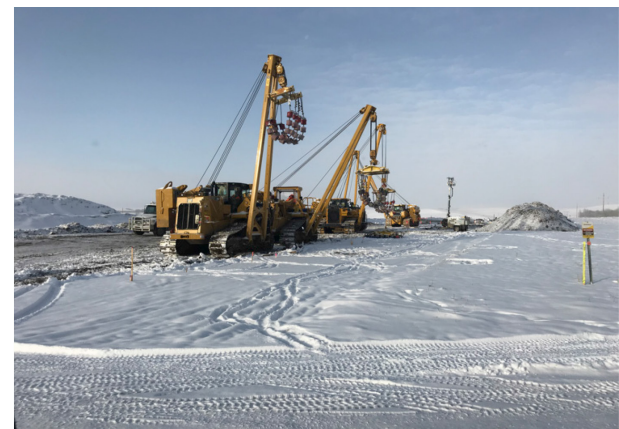
10. Lowering Crew – Km 59+900 – Nov 8, 2017

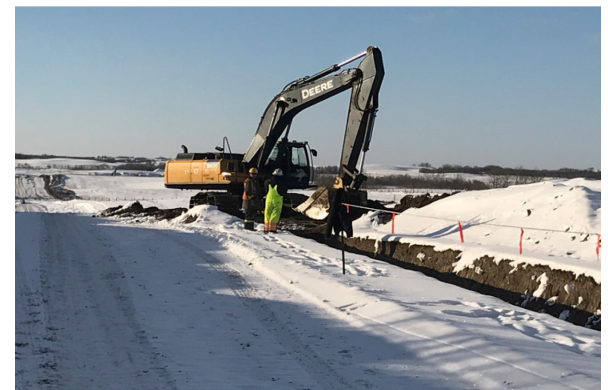
11. Tie in Backfill – Km 28+900 – Nov 8, 2017

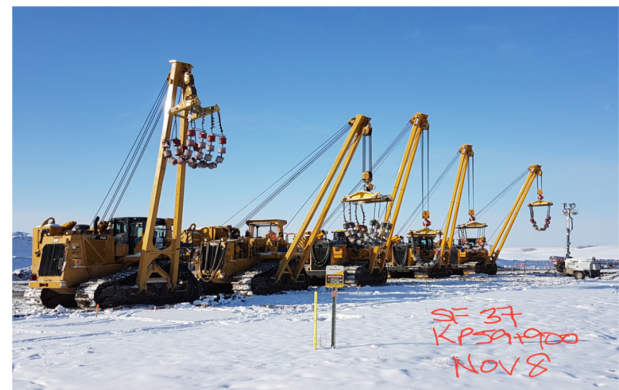
12. Lowering Crew – Km 59+900 – Nov 8, 2017

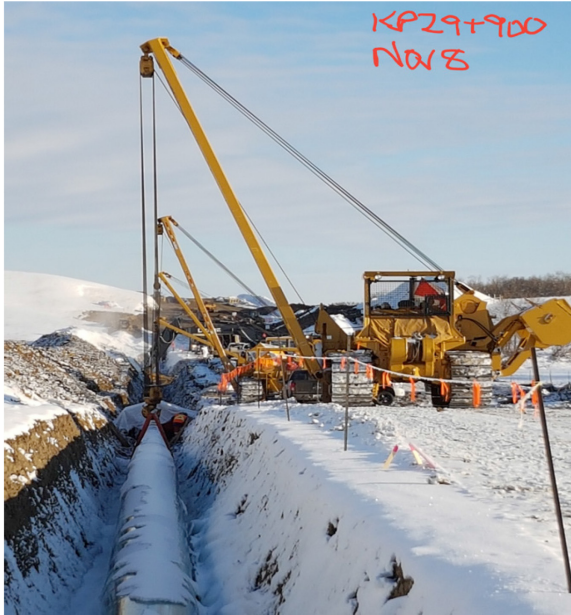
13. Backfill – km 29+900 - Nov 8, 2017

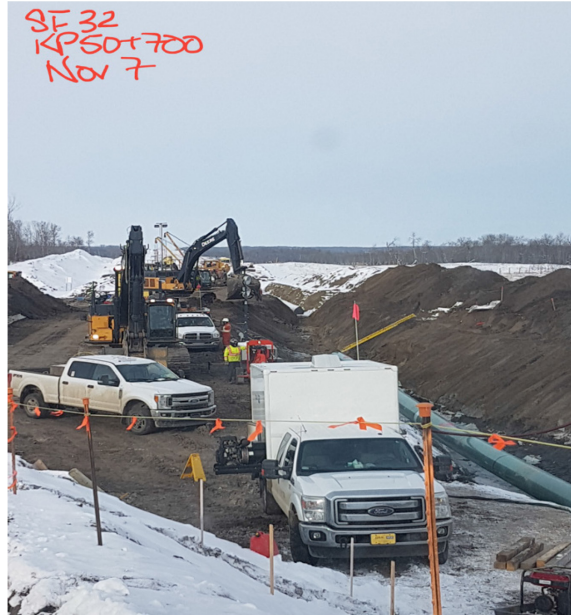
14. Excavating – Km 50+700 – Nov 7, 2017

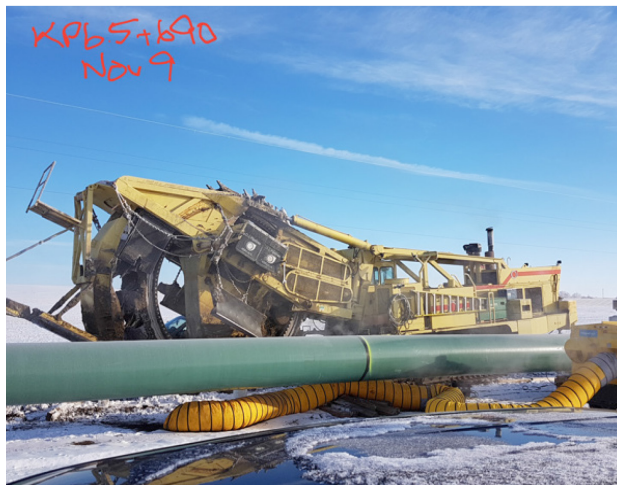
15. Ditcher Maintenance – Km 65+690 – Nov 9, 2017

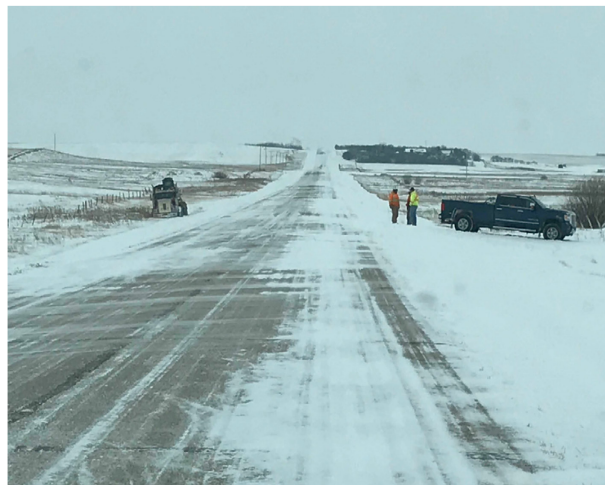
On November 10, the crew proceeded with escorting Spread 2 monitors. The crew headed to km125+550 to view the bending crew. Drove to shoofly 76, snowy conditions and hazardous road conditions were reported in Saskatchewan; they witnessed a truck stuck in the ditch. The crew headed back to Alberta. They drove west to kick-off. At km 63, they observed lowering of pipe and backfilling at shoofly 24. There was no work on November 11, due to a statutory holiday.

16. Truck in ditch (hazardous road conditions) – Nov 10, 2017
