**SAMSON CREE NATION – MATRIX SOLUTIONS INC.
PARTNERSHIP**

ABORIGINAL CONSTRUCTION MONITORING

WEEKLY REPORT

OCTOBER 9TH TO OCTOBER 15TH

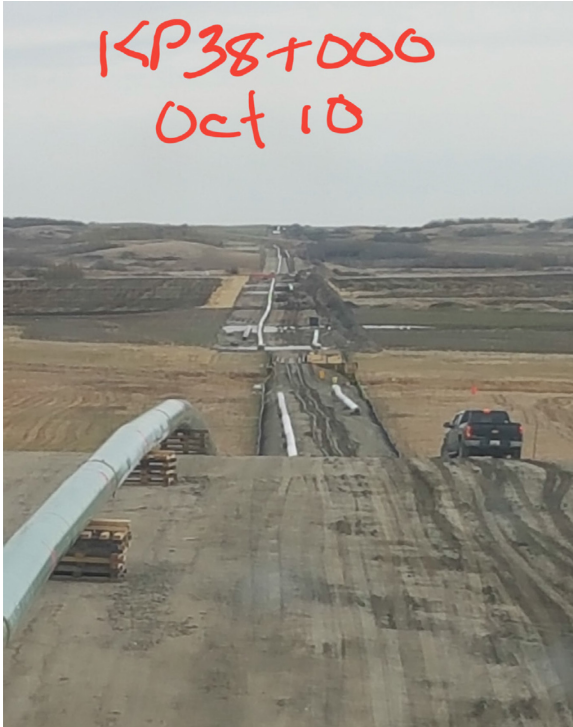
October 9 consisted of viewing bones at location Km122+800; however, no further action is required at site. On October 10, the crew viewed stripping activities (Km113 and 114+275) on the ROW. Virgil identified some bones at Km38+200-300; additionally, the crew identified that there was water in the area and it prevented them from driving to look in further. It was also noted that bridge construction was temporarily stopped at location Km53, as construction crews had to drain water.

1. View of water on ROW at Km38+600 – Oct 10, 2017

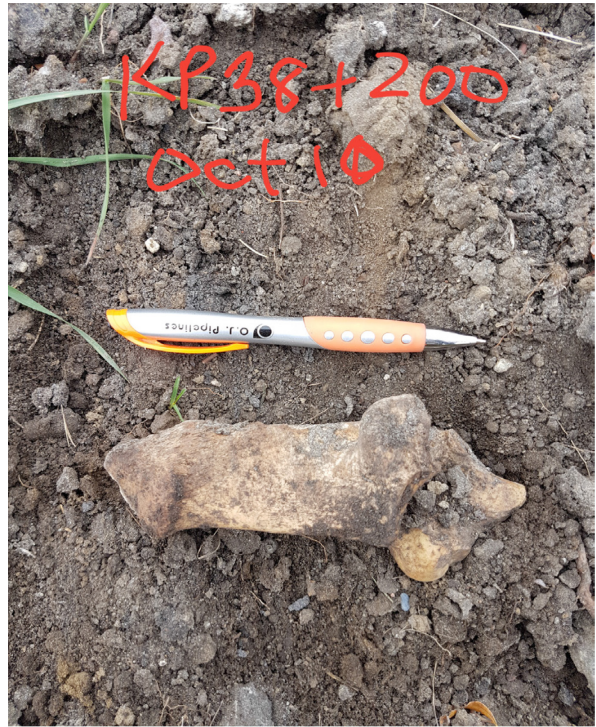
2. Bone at Location Km38+200 – Oct 10, 2017

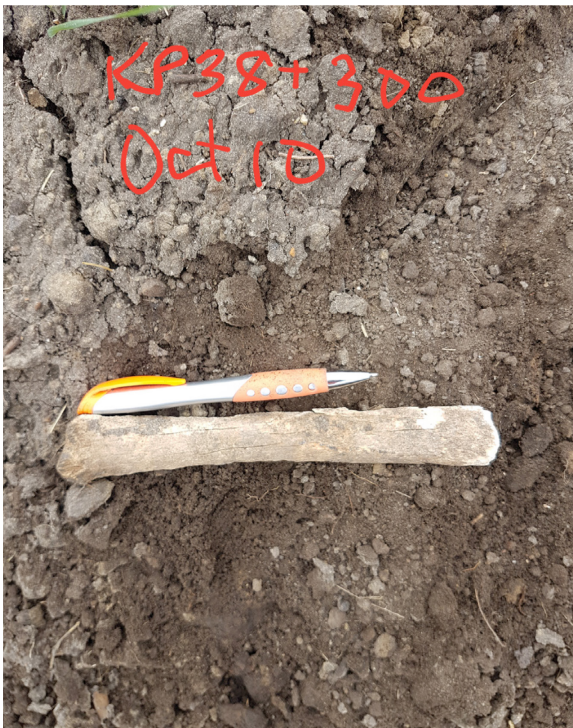
3. Bone identified at location Km38+300 – Oct 10, 2017

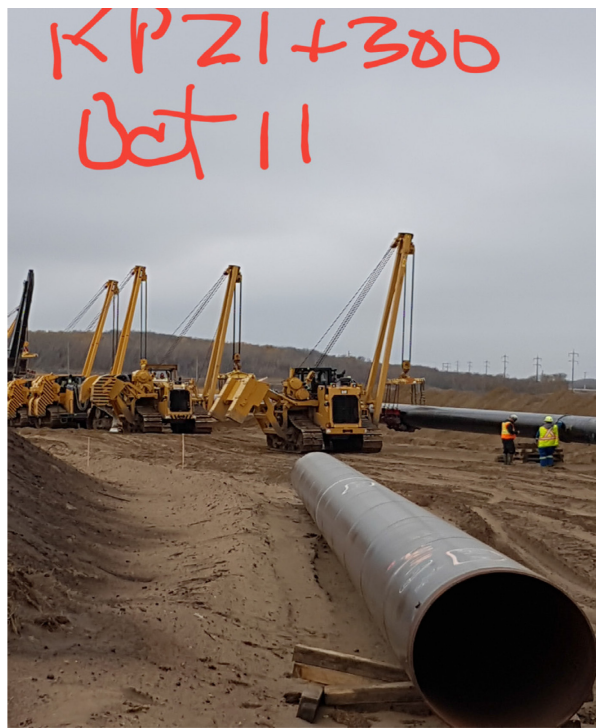
4. Booms at location Km21+300 – Oct 11, 2017

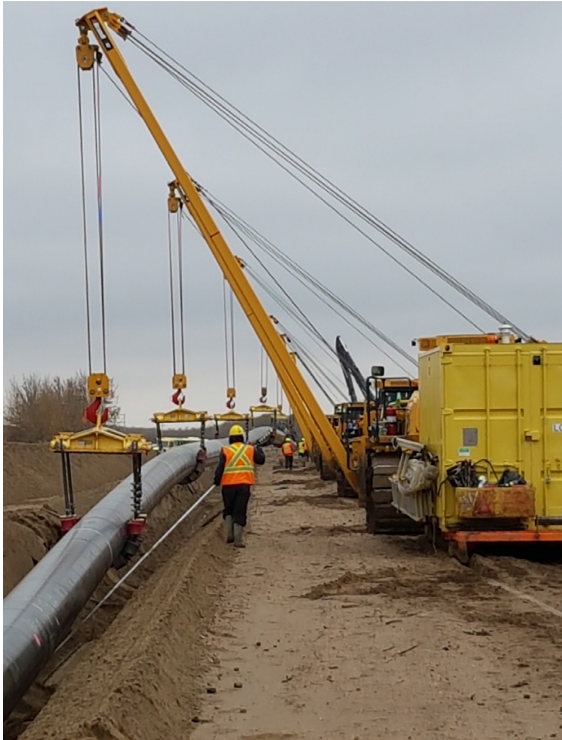
5. Booms at Km 21+300 – Oct 11, 2017

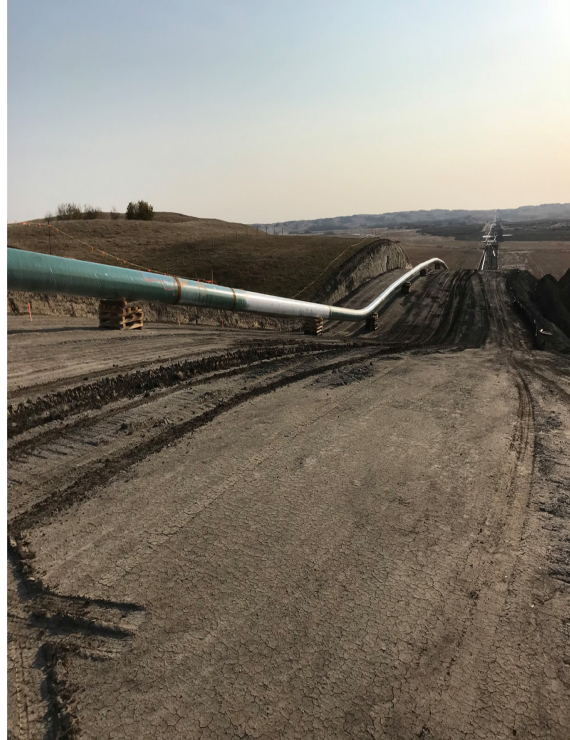
6. East at location 37km+875 – Oct 11, 2017

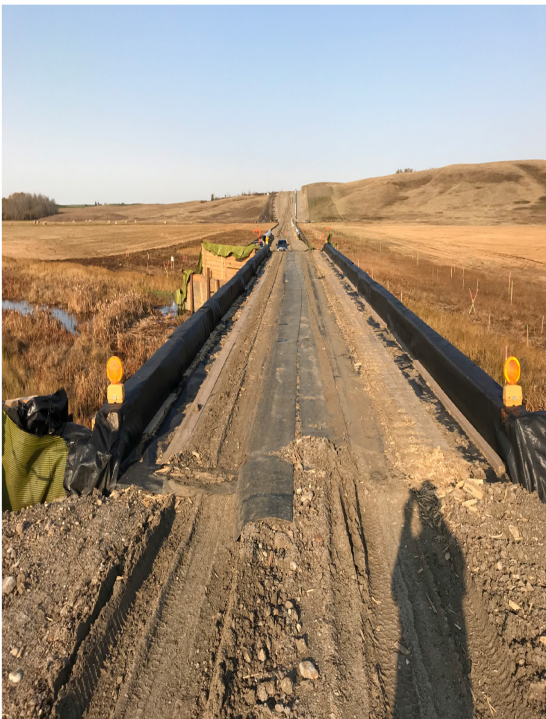
7. Marshlands and Bridge at Km 38+600 – Oct 11, 2017

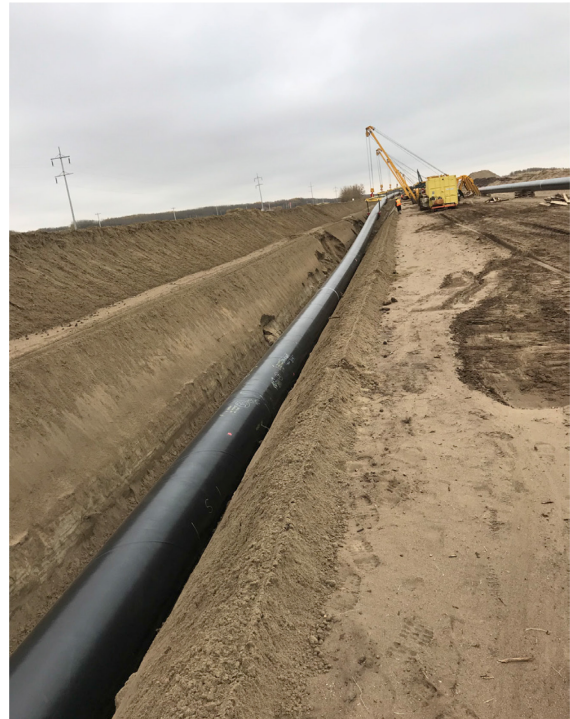
8. Pipe laying at km21+225 – Oct 11, 2017

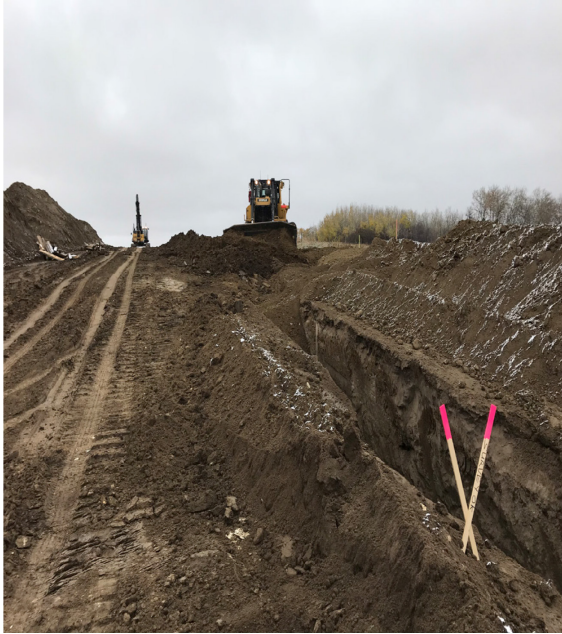
9. Dozer filling in ditch at km20+650 – Oct 12, 2017

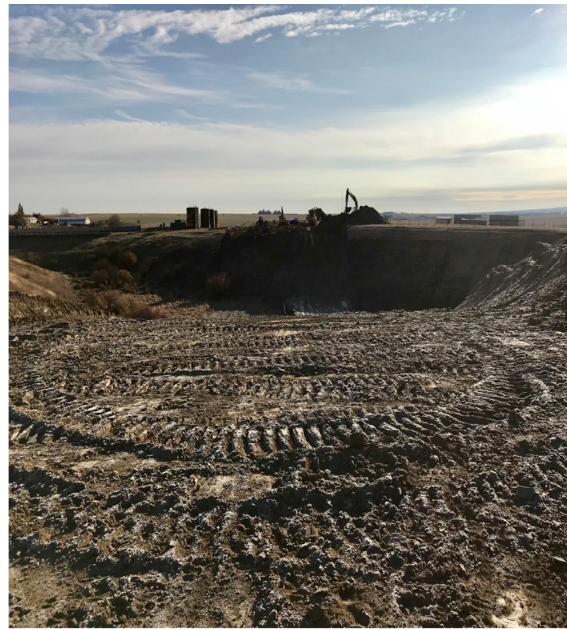
On October 14, wetlands and a ravine were identified at location Km114+100. Virgil found bones on topsoil piles at Km114+200 (photo not available). Ongoing stripping of the ravine was observed, as well as heavy machinery removing dirt. The crew drove to Km36+300 and viewed construction around the bell hole. At Km21+675, the monitors observed a pipe being lowered.

10. Ravine Stripping at 114+100 – Oct 14, 2017

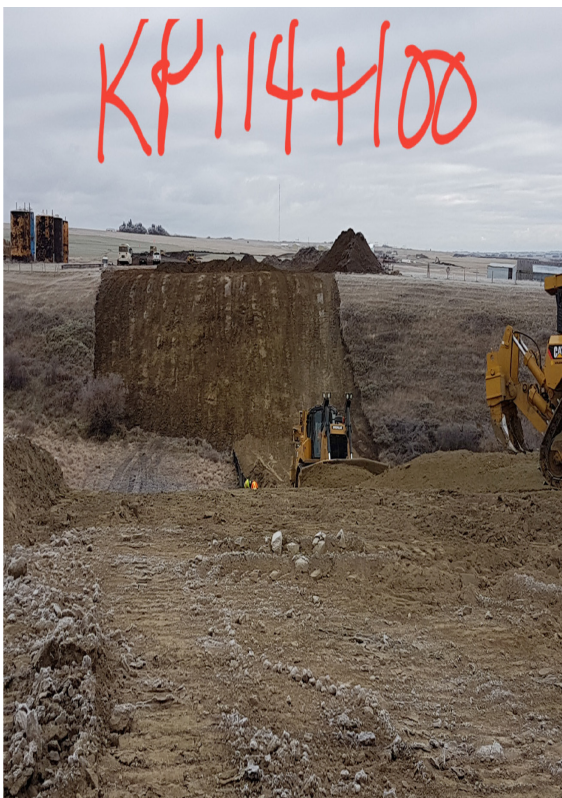
11. Stripping activities at Km 114+100 – Oct 14, 2017
