**SAMSON CREE NATION – MATRIX SOLUTIONS INC.
PARTNERSHIP**

ABORIGINAL CONSTRUCTION MONITORING

WEEKLY REPORT

SEPTEMBER 25TH TO OCTOBER 1ST

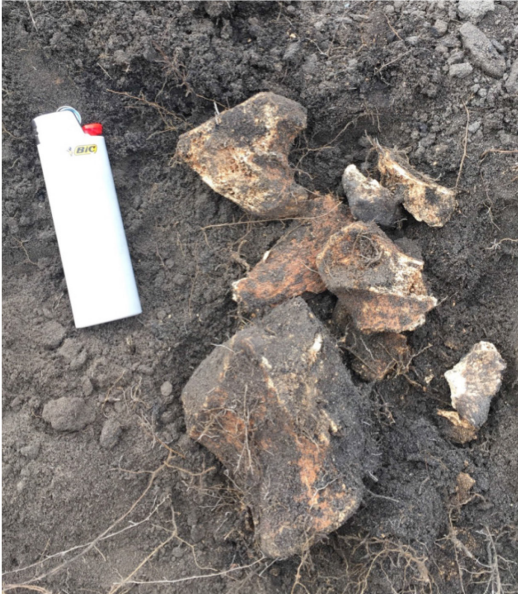
Several bones were discovered on September 25 at location km 69+400 on topsoil. The week consisted of ongoing construction of the water dam installation at location km 68+400; furthermore, it is nearing completion. Boring under-road construction completed at km 66+400 (picture not available). At km 0+800, pipe is in the ground (picture unavailable) and covered. At location km 6+700 (picture unavailable), side booms are ready to lay pipe. Cultural features are present at km 114+100, whereby tepee rings are present, unclear of whether it has been reported previously; pictures are not available. The location of these features was documented and photos were collected (see below). No additional cultural or environmental features were observed within the scanned areas. Spread one complete.

1. Bones found at km 69+400 - Sept 25, 2017

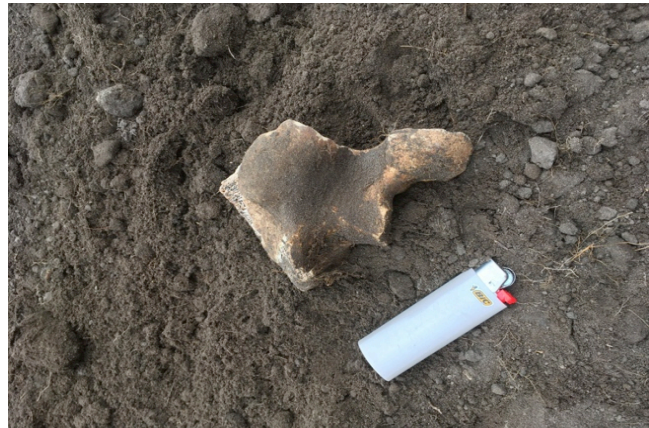
2. Bone found at km 69+400 – Sept 25, 2017

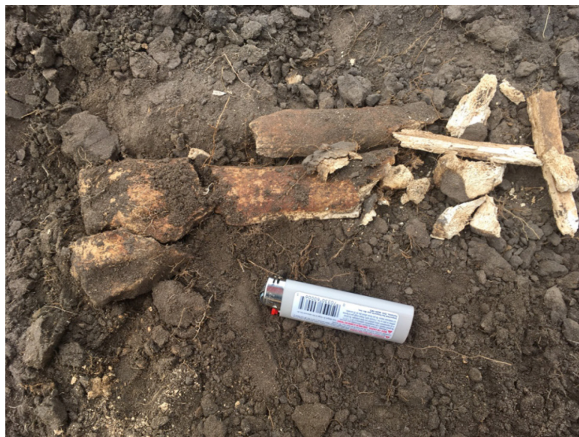
3. Bones found at km 69+400 – Sept 25, 2017

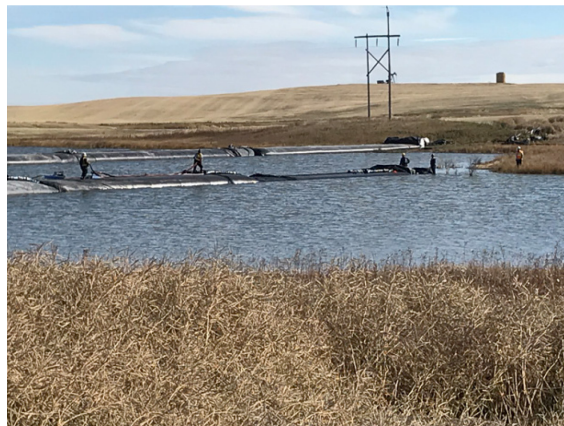
4. Water Dam at km 68 and 200 - Sept 26, 2017

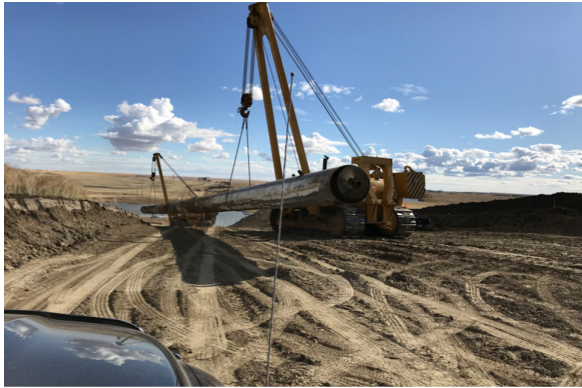
5. Boring crew move located at km68 – Sept 26, 2017

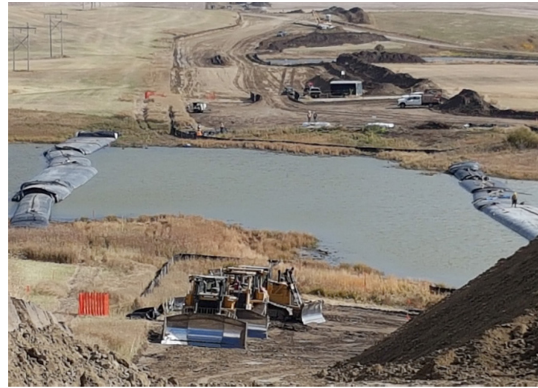
6. Waterway located at km68 and 200 – Sept 26, 2017

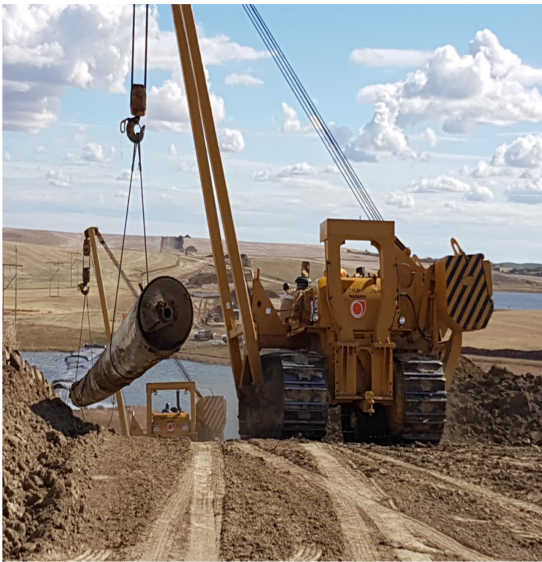
7. Boom located at km 68 and 200 – Sept 26, 2017

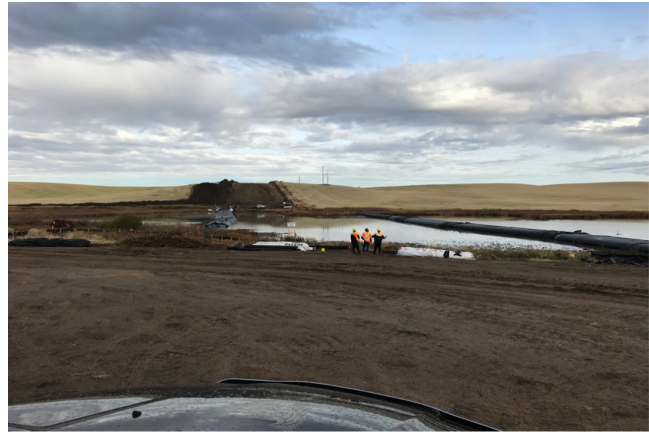
8. Aqua dam located at km68+400 – Sept 27, 2017

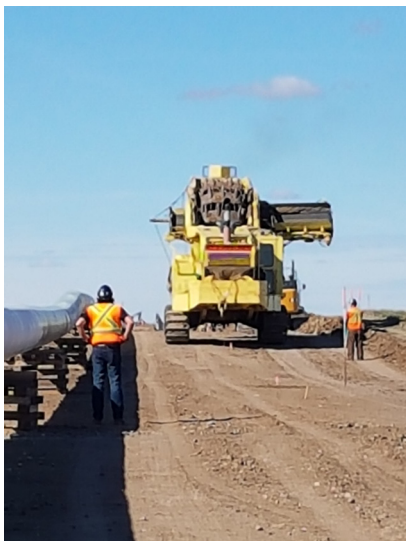
9. Ditcher located at km9+600 – Sept 27, 2017

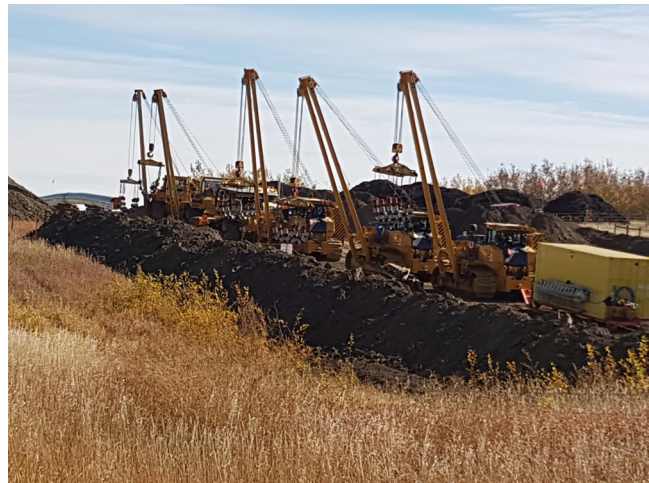
10. Booms located at km6+800 – Sept 27, 2017

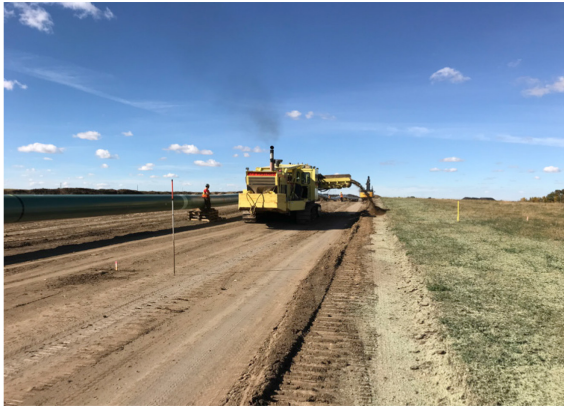
11. Ditcher located at km9+600 – Sept 27, 2017

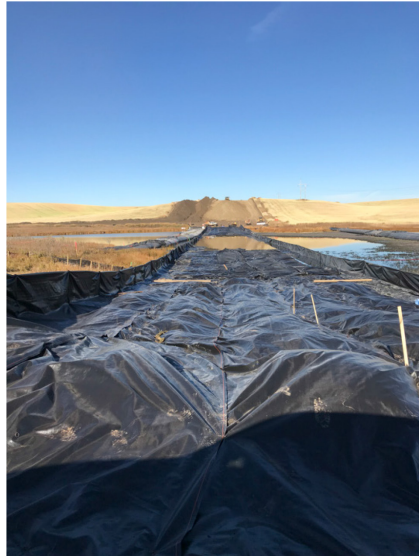
12. Water dam draining and prep for crossing located at 68km and 300 – Sept 28, 2017

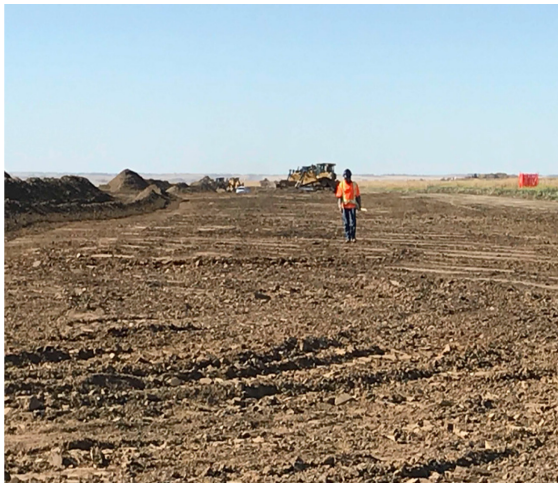
13. Stripping Crew located at 111km and 400 – Sept 28, 2017

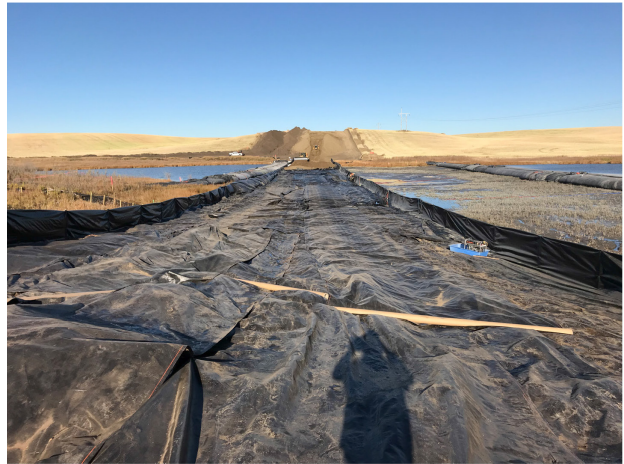
14. Water crossing construction, tarp laid out and proceeding to cover with dirt. Location 68km and 300 – Sept 29, 2017
