# SAMSON CREE NATION – MATRIX SOLUTIONS INC. PARTNERSHIP

## **ABORIGINAL CONSTRUCTION MONITORING**

## WEEKLY REPORT

### **SPREAD 1**

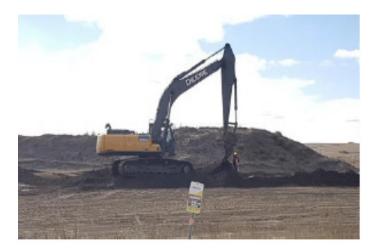
Excavator working topsoil with flat blade – SF 36 - Sept 30, 2018

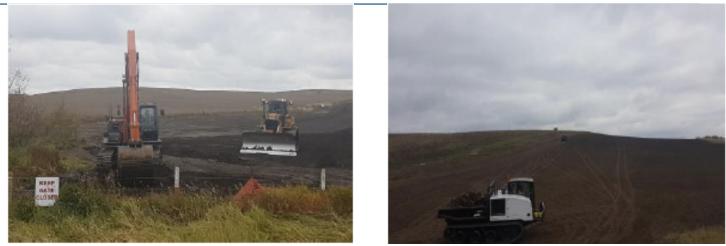
Excavator and dozer touching up final grade - SF 25 – Oct 1, 2018 Marooka loading wood debris for disposal – SF 27 – Oct 1, 2018

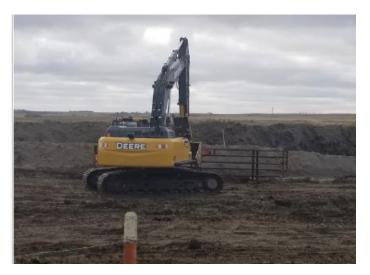
Excavator moving cattle gates - SF 39 - Oct 1, 2018

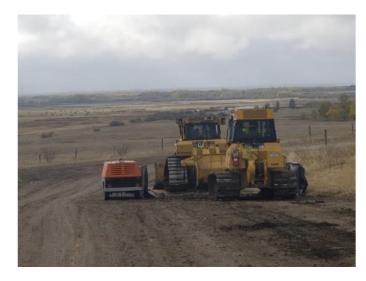
Dozers waiting to be cleaned - SF 27, Oct 1, 2018

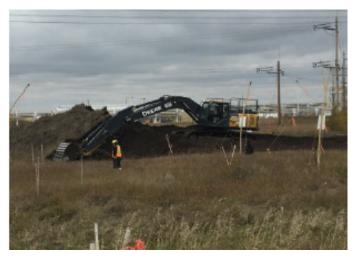
Excavator taking down topsoil - km 54+700 - Oct 1, 2018

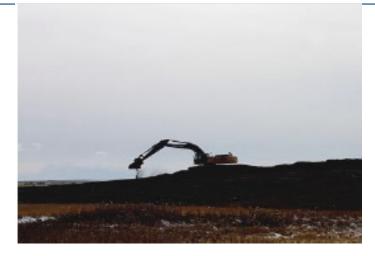
Excavator moving topsoil back onto ROW – SF 36 – Oct 2, 2018

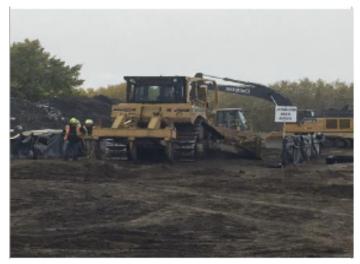
Utility crew cleaning station - SF 37 - Oct 2, 2018

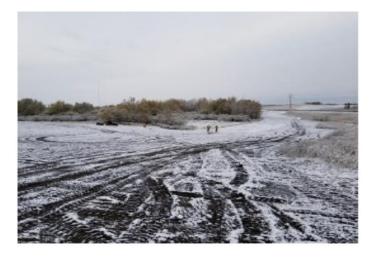
Crew rock picking- SF 25 - Oct 2, 2018

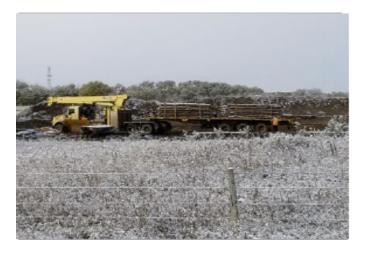
Loader loading mats for transport – SF 35 – Oct 2, 2018

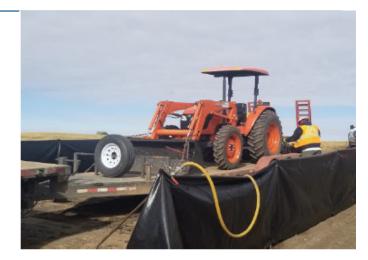
Mechanic working on tractor and ripper - SF 37 - Oct 3, 2018

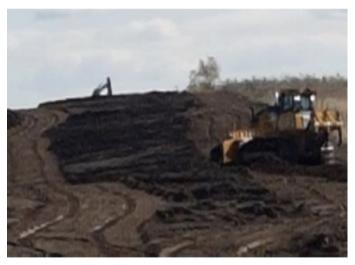
Dozer spreading out topsoil - km 60+900 - Oct 3, 2018

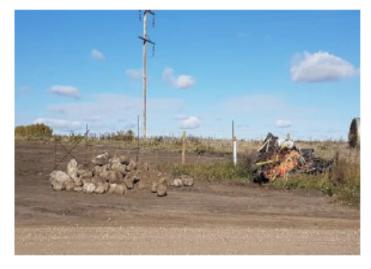
Rocks piled and ready for disposal - SF 38 - Oct 3, 2018

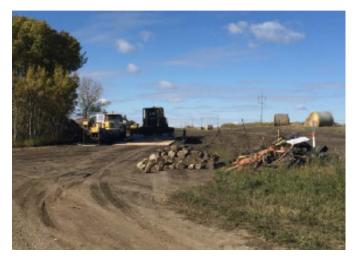
Rock debris at cleaning station - SF 38 -Oct 3, 2018

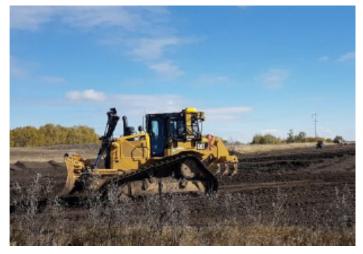
Dozer decompacting subsoil - SF 38 - Oct 3, 2018

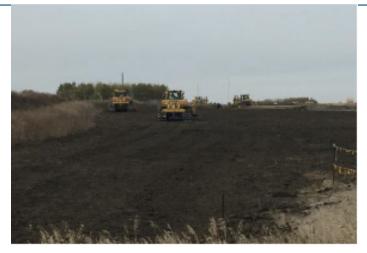
Excavator replacing rig mats - SF 38 - Oct 4, 2018

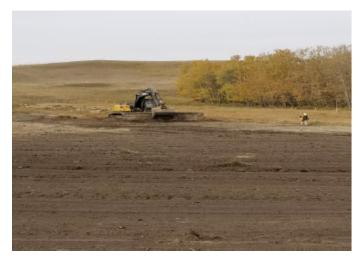
Excavator leveling topsoil with rig mats - SF 29 -Oct 4, 2018

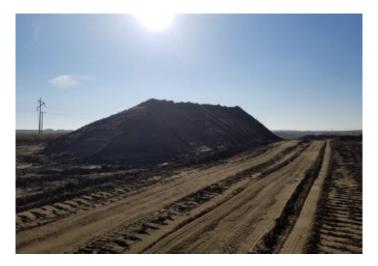
Clay pile from test dig ups - SF 35 -Oct 5, 2018

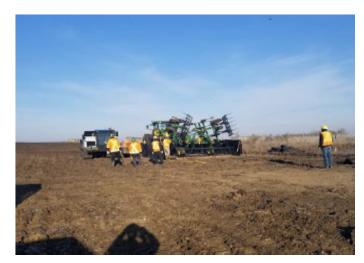
Crews cleaning tractor - SF 25 - Oct 5, 2018

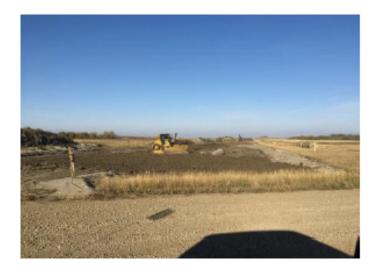
Dozer shaping subsoil - SF 62 -Oct 5, 2018

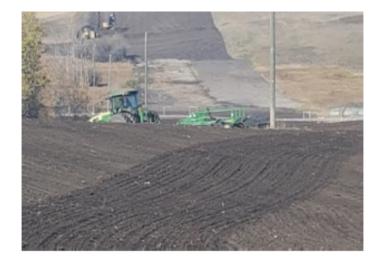
Tractor/harrow - SF 29 - Oct 5, 2018

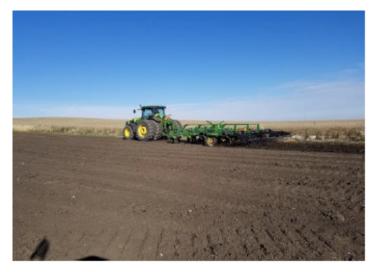
Tractor cultivating ROW - SF 25 & 26 -Oct 6, 2018

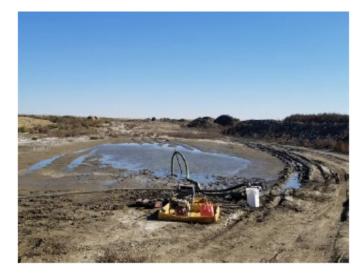
Crews water pumping - SF 44 - Oct 6, 2018

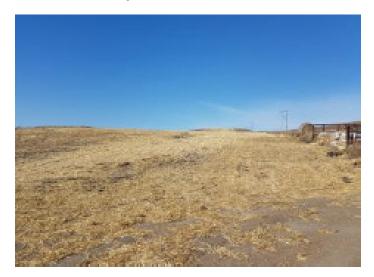
ROW seeded and crimped - km 59+600 - Oct 6, 2018

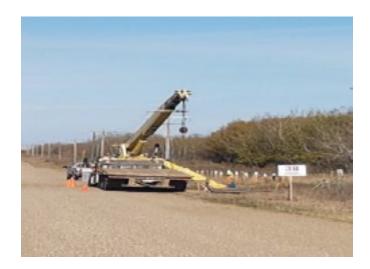
Lowboy with crane loading mats - SF 38 - Oct 6, 2018
