**SAMSON CREE NATION – MATRIX SOLUTIONS INC.
PARTNERSHIP**

ABORIGINAL CONSTRUCTION MONITORING

WEEKLY REPORT

AUGUST 20TH - AUGUST 25TH

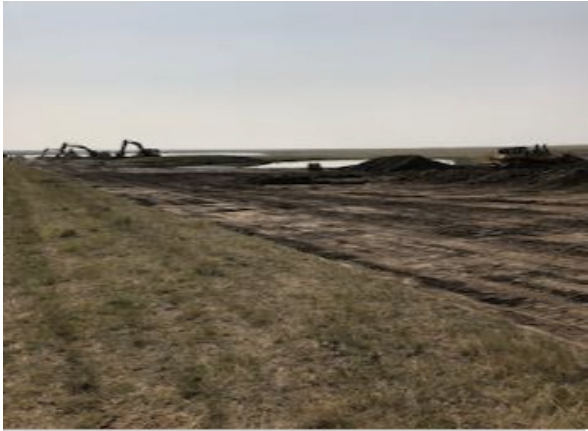
Excavator stripping topsoil – km 152+400 – Aug 20, 2018

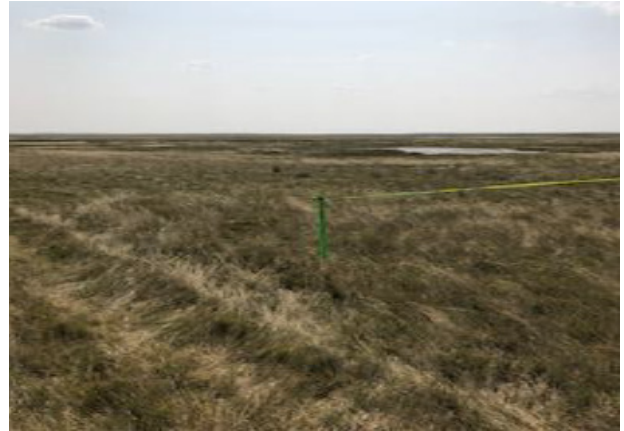
Rare plant, sensitive area – km 153+200 -Aug 20, 2018

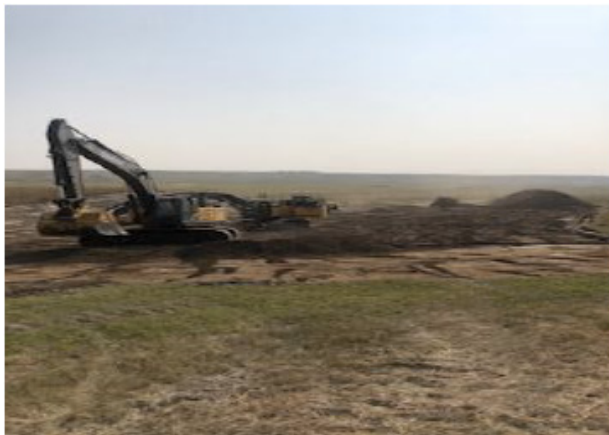
Access crew stripping topsoil - Km 221+ 039 – Aug 20, 2018

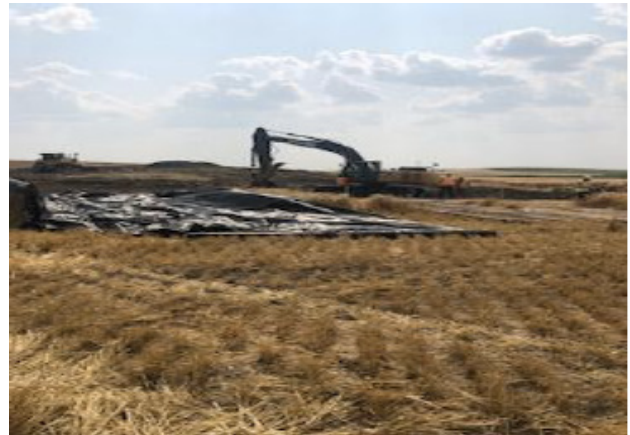
Access ramp built of NAL resource and Sasktel line – Aug 20, 2018

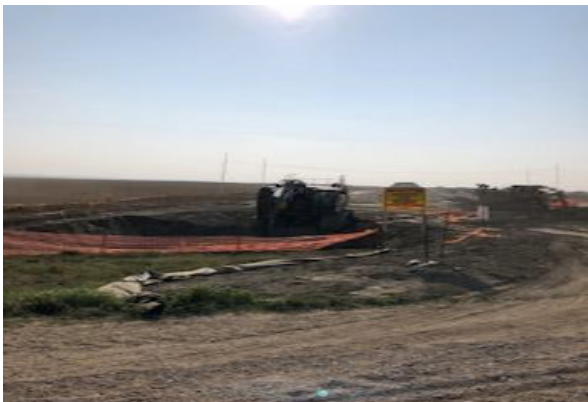
Excavator digging bell hole- Km 218+ 988– Aug 21, 2018

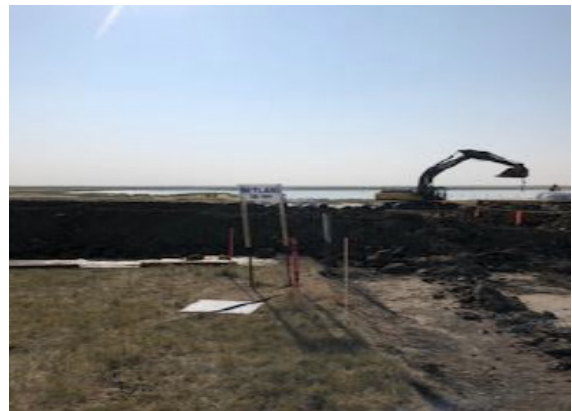
Digging slip bore pit – km 161+000 – Aug 21, 2018

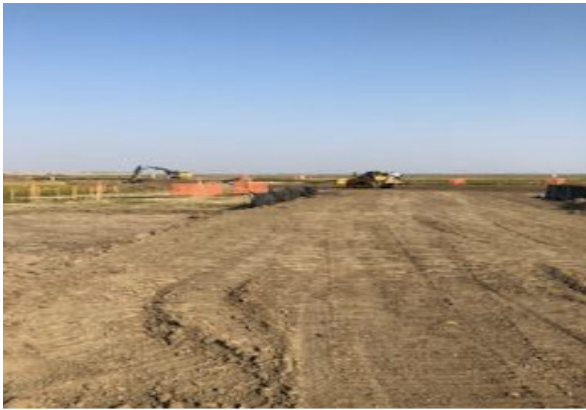
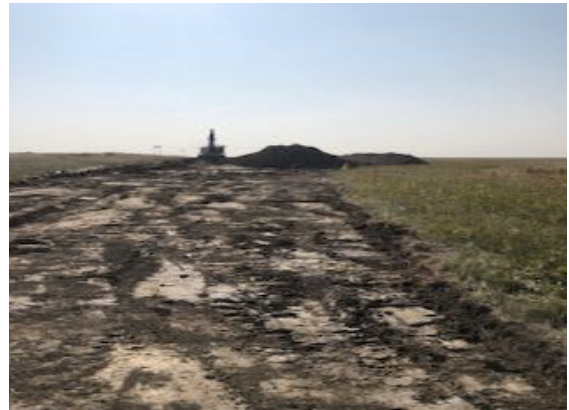
Sasktel line crossing access ramp - Aug 21, 2018 Excavator stripping for drainage to be built– km 171+300, Aug 21, 2018

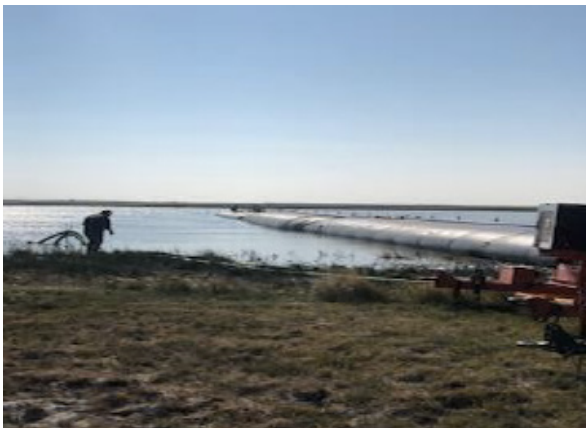
Southside of aquadam – km 152+700 - Aug 22, 2018

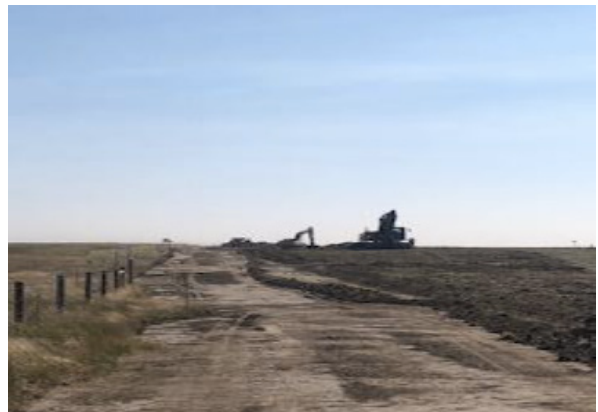
Heritage sensitive area – Km 154+350 – Aug 22, 2018

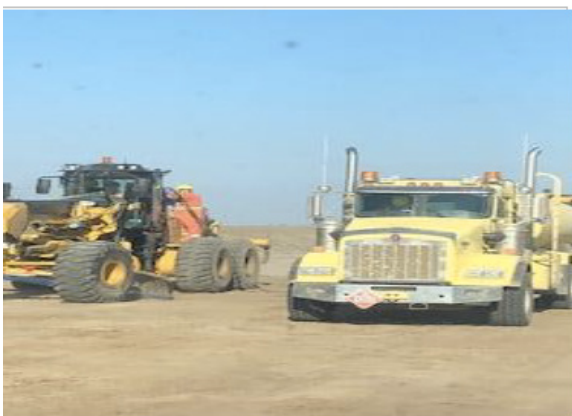
Fueling equipment – SF 124 – Aug 22, 2018

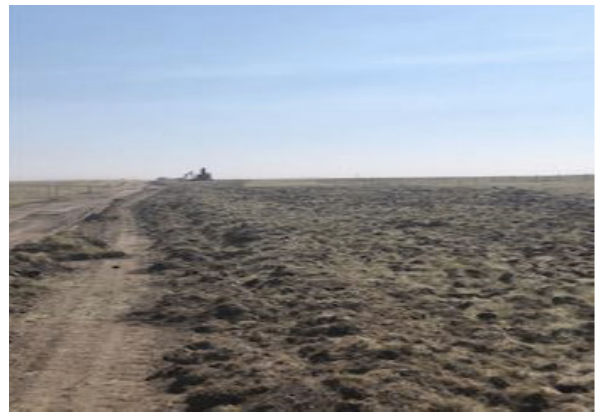
Excavators stripping topsoil – km 154+443 – Aug 22, 2018

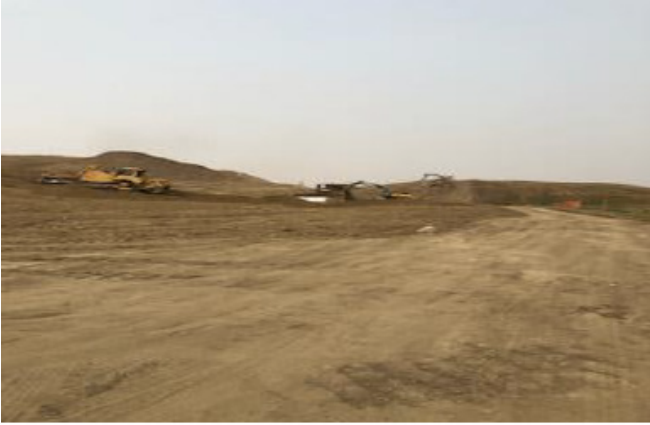
Hill being cut – km 220+900 – Aug 23, 2018

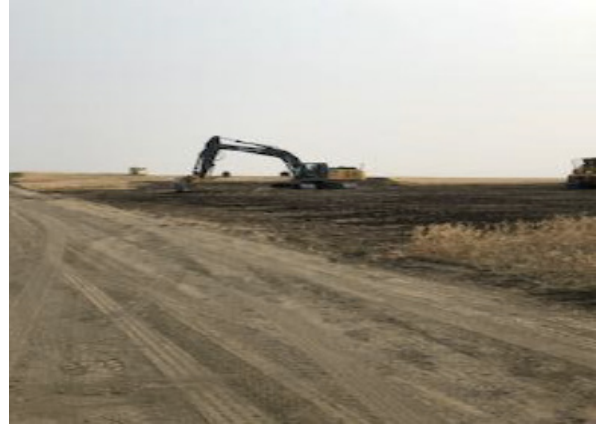
Excavator stripping topsoil – SF 160 – Aug 23, 2018

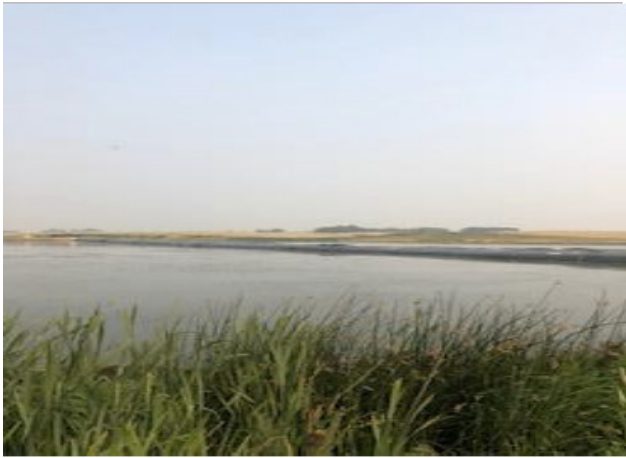
Aqua dam - km 165+265 – Aug 23, 2018

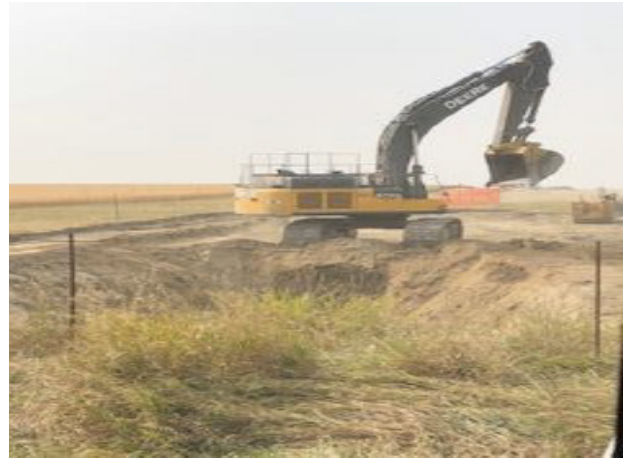
Excavator digging bell hole - km 172+039 – Aug 23, 2018

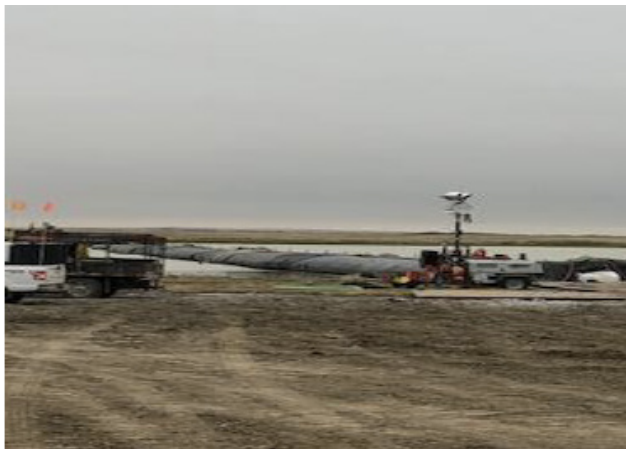
Aqua dam S.E– km 153+000 – Aug 24, 2018

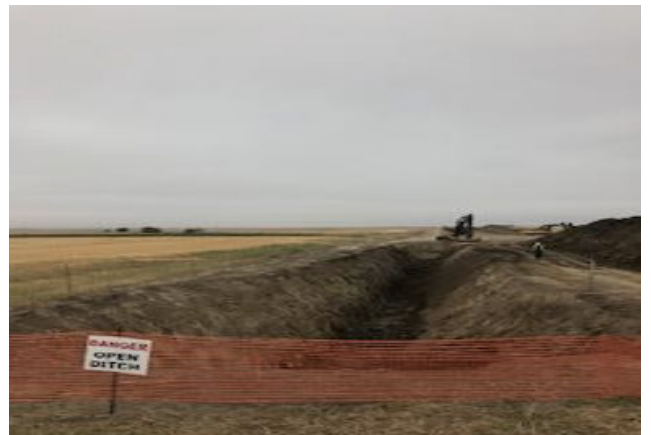
Excavator digging bellhole – km 150+000 – Aug 24, 2018

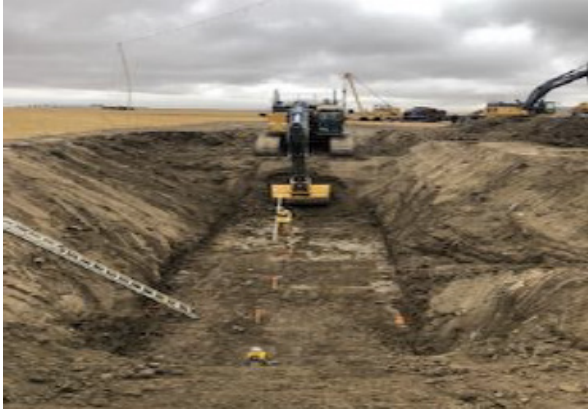
Bore bay digging – SF 115 – Aug 24, 2018

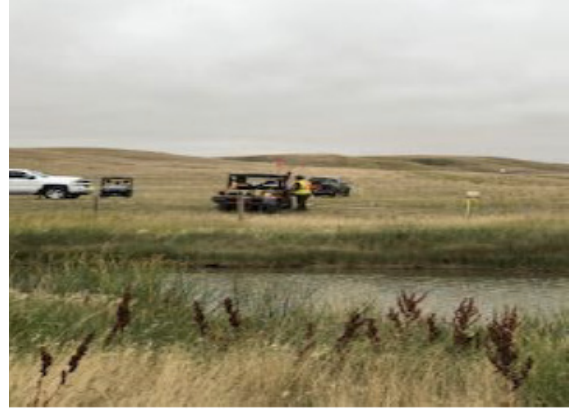
Heritage area being fenced in – km 161 + 000 – Aug 24, 2018

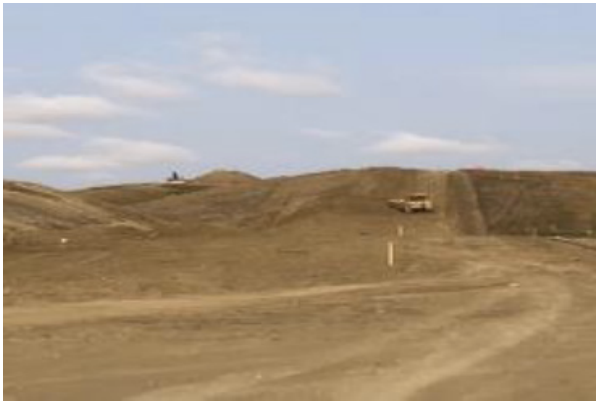
Dozer pushing dirt into valley – km 221+000 – Aug 25,2018

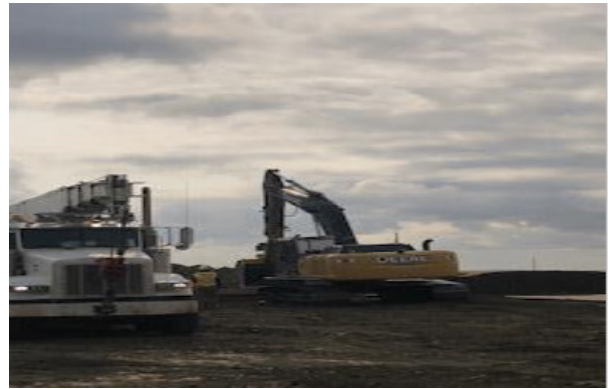
Excavator placing rig mats – km 252+100- Aug 25, 2018

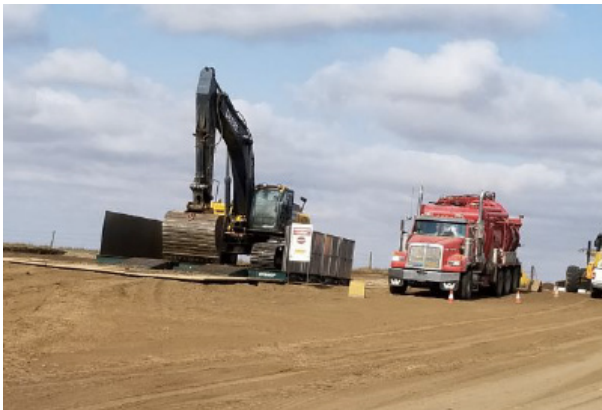
Washing equipment – km 158+600 –Aug 25, 2018

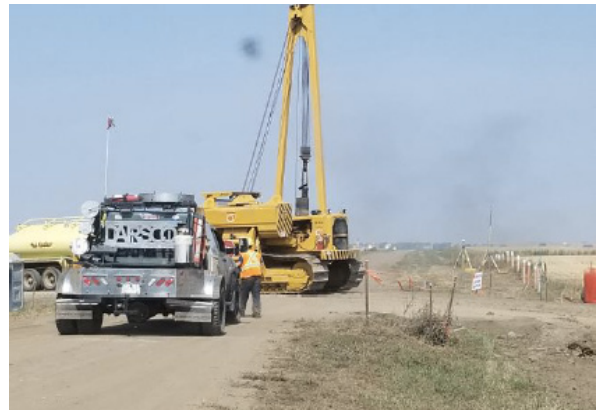
Equipment crossing - 149+950 - Aug 25, 2018

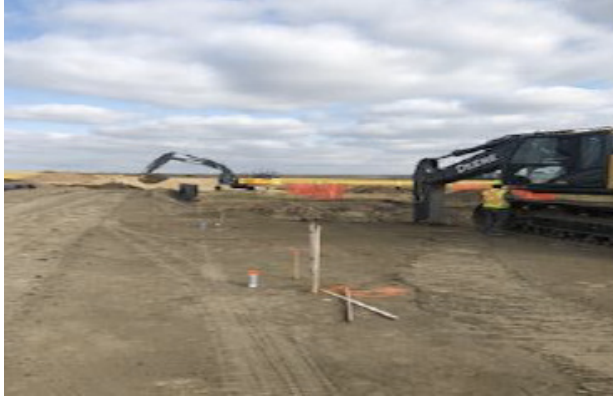
Excavators digging bore bays– Aug 25, 2018

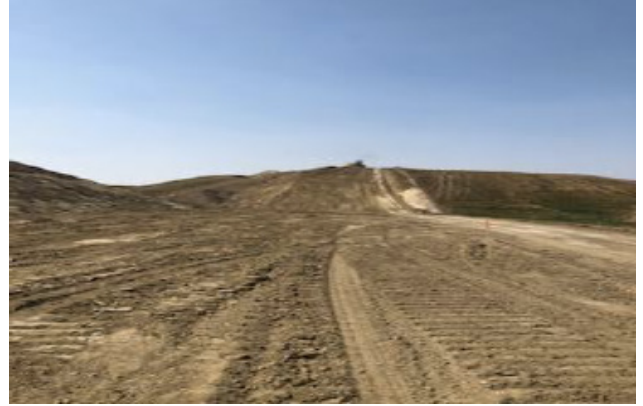
Access crew grading hill – km 222+800- Aug 25, 2018
