**SAMSON CREE NATION – MATRIX SOLUTIONS INC.
PARTNERSHIP**

ABORIGINAL CONSTRUCTION MONITORING

WEEKLY REPORT

FEBRUARY 5TH TO FEBRUARY 10TH

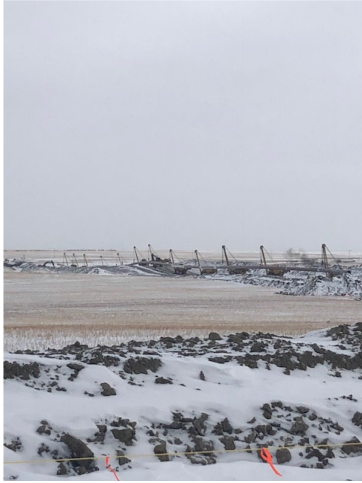
1. Booms at the wetland– km 170+300 – Feb 5, 2018

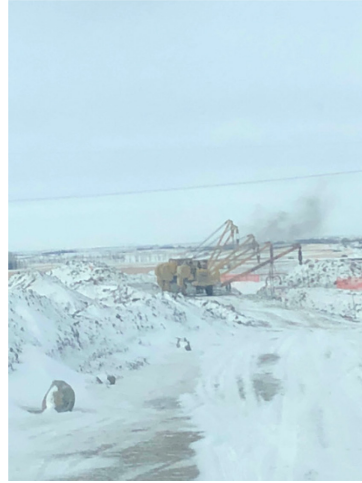
2. Booms going under power line – SF 98 – Feb 5, 2018

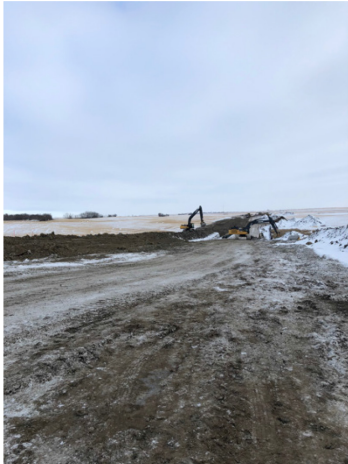
3. Backfill on mainline- km164+473 – Feb 5, 2018

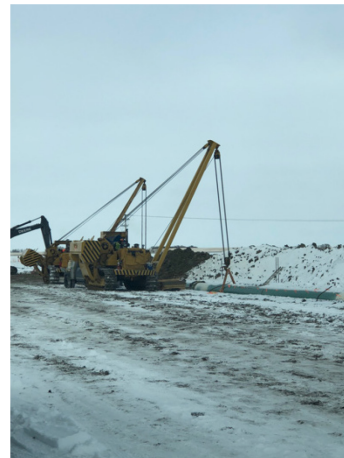
4. Tie-in - Km 166+600 – Feb 5, 2018

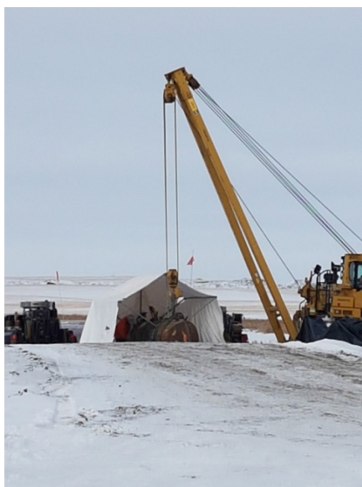
5. Welding pull head – Km 170+750 – Feb 5, 2018

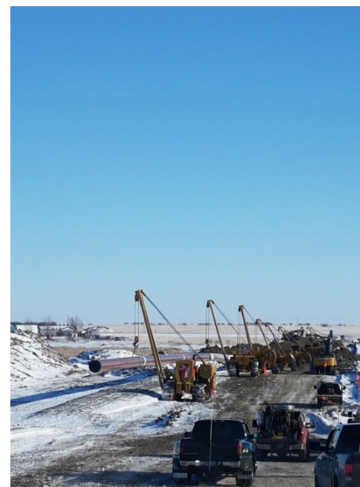
6. Lowering in (Wetlands)– Km 170+000 – Feb 6, 2018

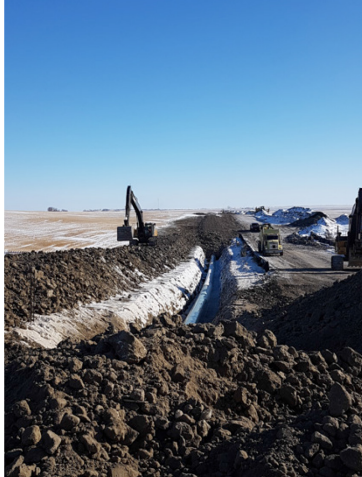
7. Backfill tie-in – Km 164+500 – Feb 6, 2018

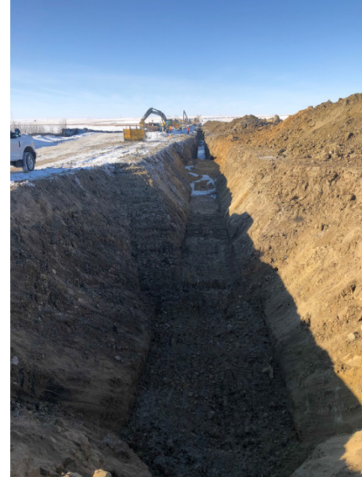
8. Ditch at wetland - Km 170+650 – Feb 6, 2018

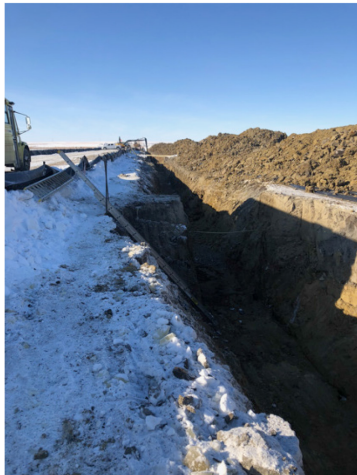
9. Hotline crossing wetland - km 170+500 – Feb 6, 2018

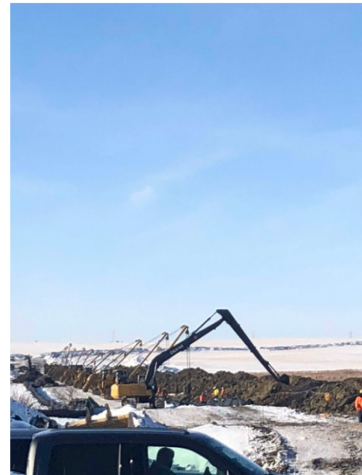
10. Booms lowering in – km 170+300 – Feb 6, 2018

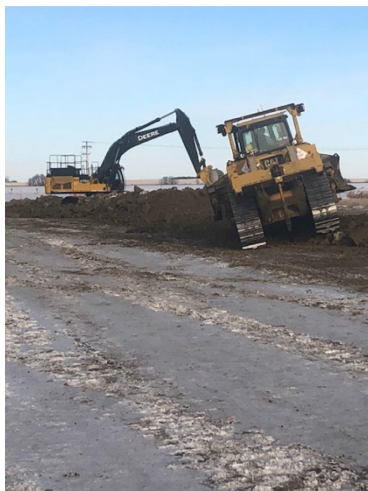
11. Dozer and excavator clean up– Km 166+650 – Feb 7, 2018

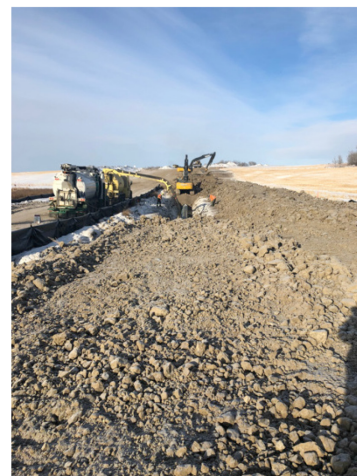
12. Excavator and hydrovac – km 164+600 – Feb 7, 2018

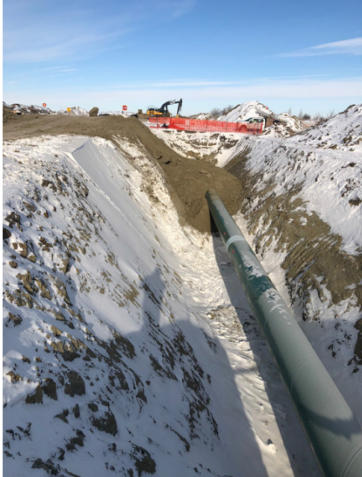
13. Backfill – Km 168+990 – Feb 7, 2018

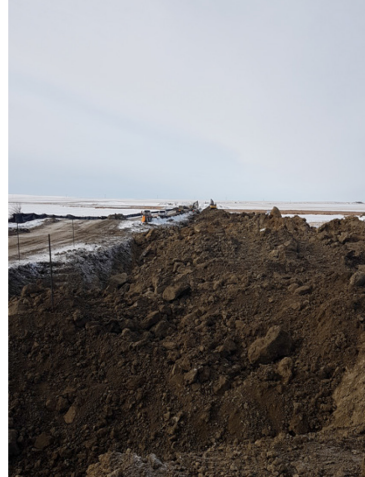
14. Shaded ditch - Km 170+750 – Feb 7, 2018

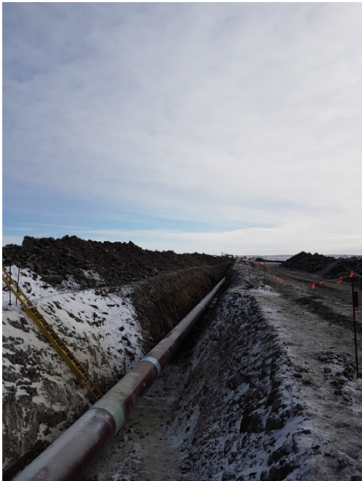
15. Shading pipe - km 170+200 – Feb 7, 2018

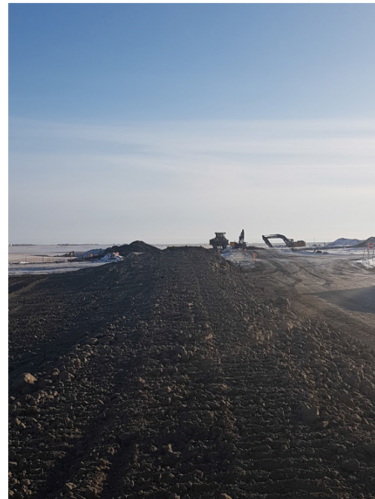
16. Backfill tie-in – km 168+850 – Feb 8, 2018

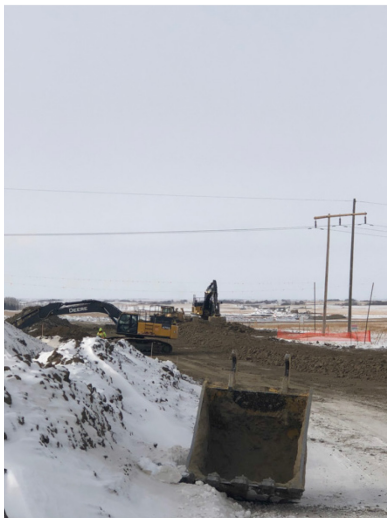
17. Excavator and dozer -167+750 - Feb 8, 2018

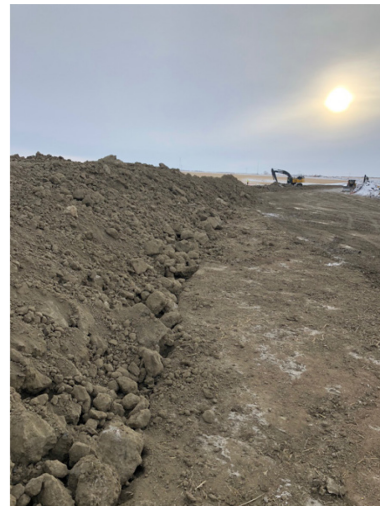
18. Backfilled mainline - km166+700 – Feb 8, 2018

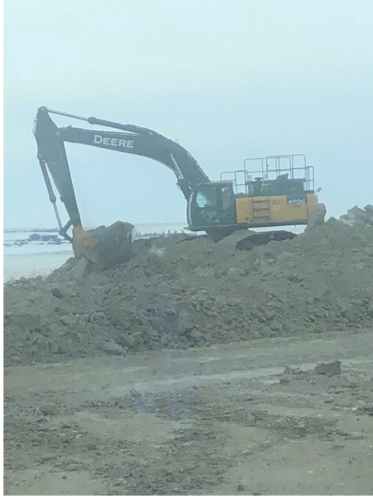
19. Excavator clean up - km168+800 – Feb 8, 2018

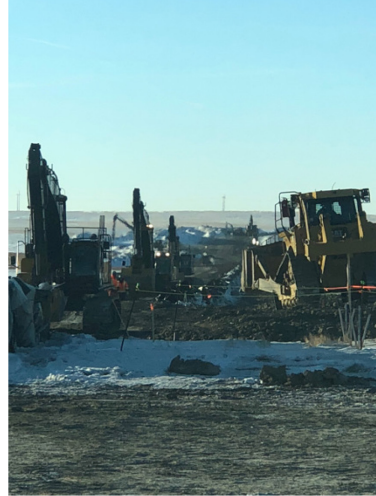
20. Backfill - km170+700 – Feb 9, 2018

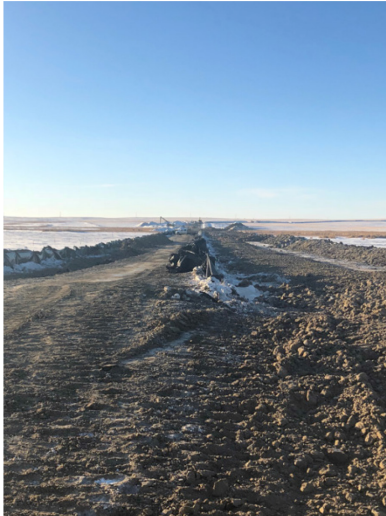
21. Roach – km 170+650 – Feb 9, 2018

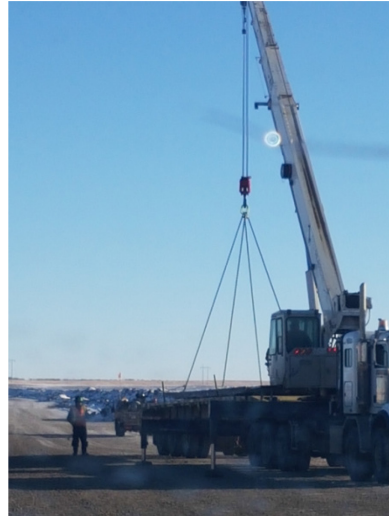
22. Loading mat – Km 166+700 – Feb 9, 2018

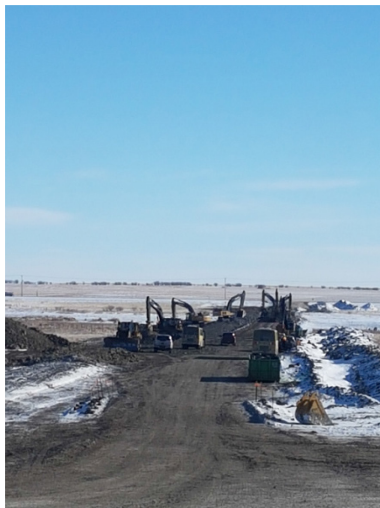
23. Equipment on wetland – km 169+950 – Feb 10, 2018

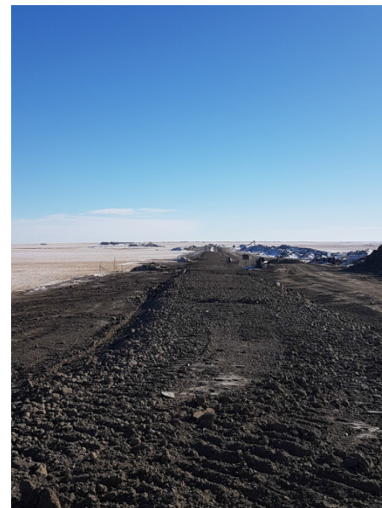
24. Backfilled tie-in – km 169+450 – Feb 10, 2018

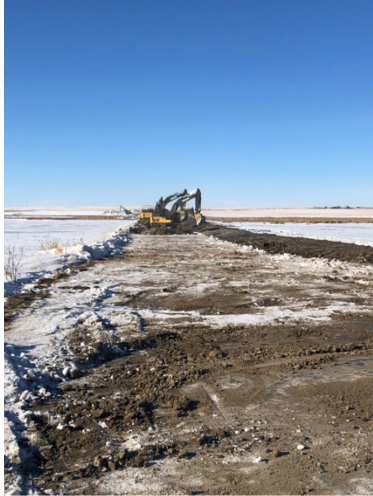
25. Clean up crew at wetland crossing – Feb 10, 2018

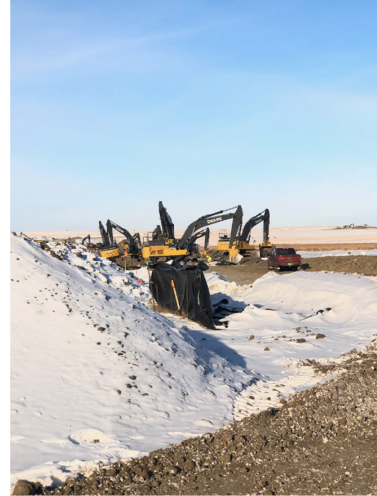
26. Clean up crew – km 170+650 – Feb 10, 2018
