**SAMSON CREE NATION – MATRIX SOLUTIONS INC.  
PARTNERSHIP**

**ABORIGINAL CONSTRUCTION MONITORING**

**WEEKLY REPORT**

**JANUARY 15<sup>TH</sup> TO JANUARY 21<sup>ST</sup>**

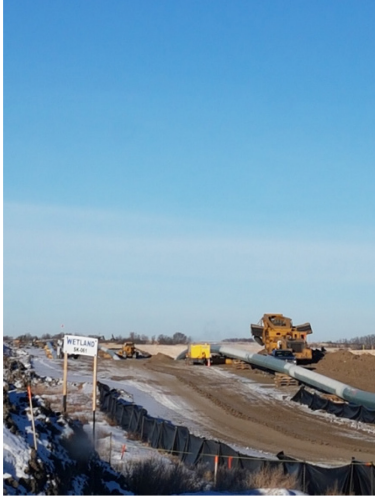
1. Mechanic – km 165+900 – Jan 15, 2018

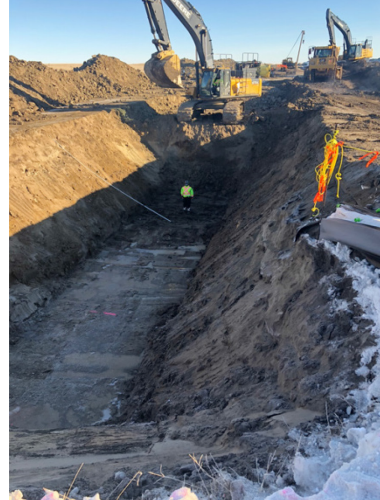
On January 15, the track bore was seen at the bore bay at SF93, and the crew walked the spill pile at this location, nothing significant was found. At km 163+400, x-ray was working at tie-in. Four excavators and two dozers were backfilling at km163+900. The backfill crew cleared a pathway for spring run-off and wildlife (km162+000). At km 165+400, excavator and dozer were pre-ripping, this area was scanned and nothing of significance was found. The crew observed the mechanic servicing equipment at km 165+700; the fuel truck came by to fuel equipment. The ditcher was at work at km 166+250. The boring crew moved from km 161+000 (SF93) to SF 94. The ditching crew was at km 165+300 and the picker was on the ROW.

2. Bore bay – SF 93 – Jan 15, 2018

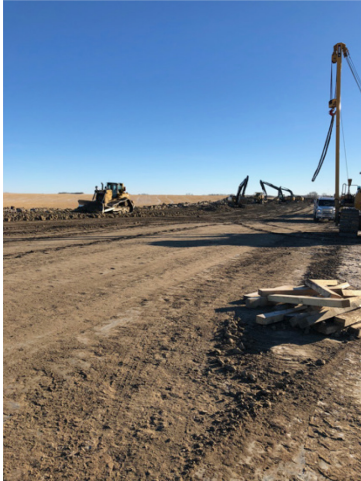
3. Backfill Crew - 164km+050 – Jan 16, 2018

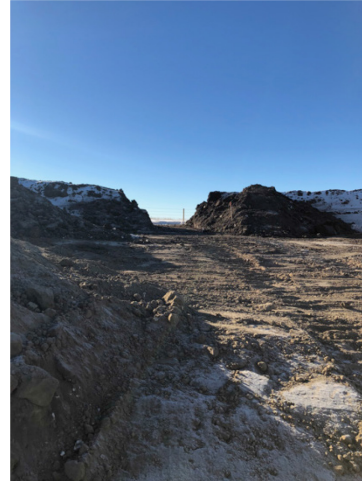
On January 16, the monitors observed backfill crew at km164+100. Medics were at location km163+400. Tie-in was taking place at km 164+310, the backfill crew created a path for wildlife to cross, the area was scanned but nothing was found. The pathways were located at km 162 to km163. Backfill crew was at work at km 164+050. At SF 93, mechanics were servicing equipment; also, the boring crew were pumping water at this location, Hydrovac was on site. At km 161+350, there is an access route for wildlife, as well as for the spring thaw.

4. Wildlife and run-off pathway - Km 162+010 – Jan 16, 2018

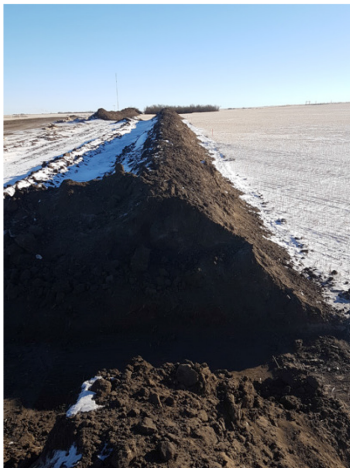
5. Access route (wildlife and run-off) – Km 161+350 – Jan 16, 2018

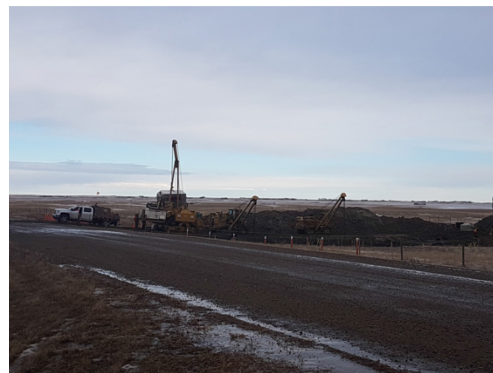
6. Median Survey – SF 93 (N.E) – Jan 18, 2018

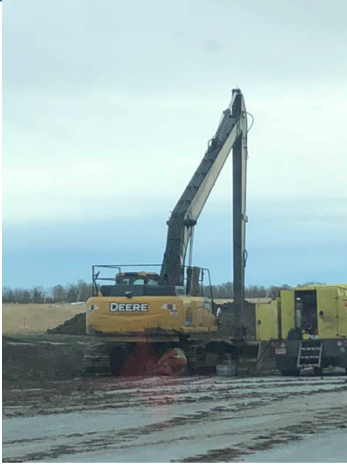
On January 18, at km 164+580 and km 166+500, the mechanic was at work. Excavator and dozer were being serviced at km 164+125. Medics were located at km 163+400. Backfilling was observed at km 164+280 and sandblasting at tie-in was taking place at km 164+325. Backfilling crew were shading mainline at km 164+260. Median surveys were on site at SF93, and offloading of equipment was taking place at this location. At SF98, the mechanic was servicing the trackhoe. At km 166+368.7 two excavators were digging the ditch. Boring work was taking place at km 163+400, ditching work was observed at km 166+400 and lowering in at km 166+200.

7. Mechanic servicing excavator – Km 164+125 – Jan 18, 2018

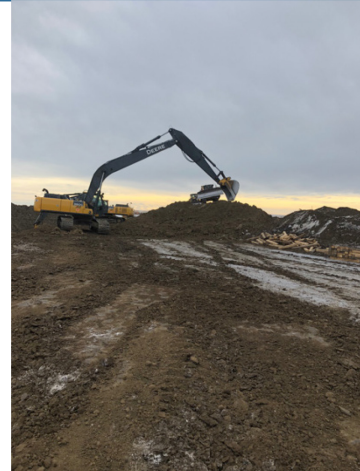
8. Backfill - Km 164+244 – Jan 18, 2018

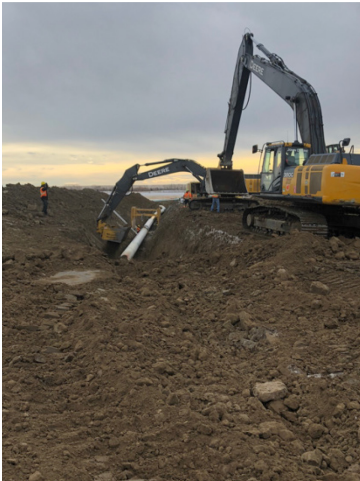
9. Backfill shading mainline - km 162+260 – Jan 18, 2018

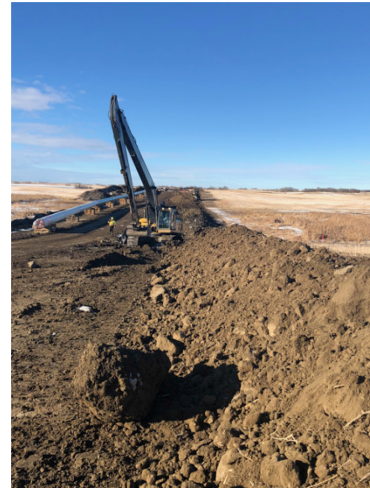
10. Long stick excavator clearing wetland - Km 165+190 – Jan 19, 2018

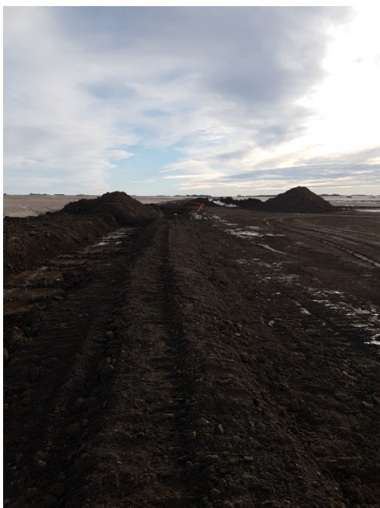
11. Ditch – Km 144+300 – Jan 19, 2018

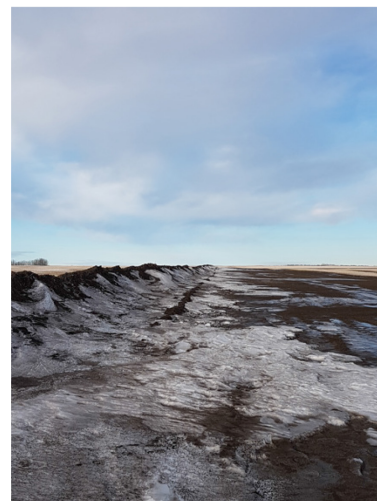
12. Topsoil where monitors walked – km 150+800 – Jan 19, 2018

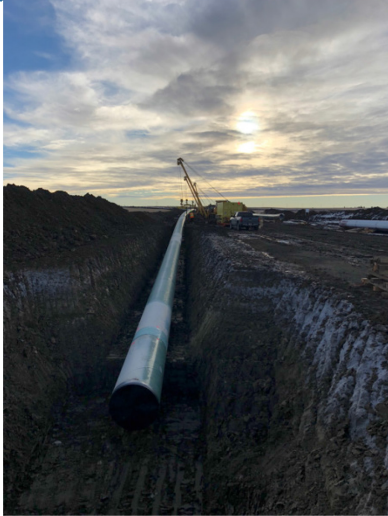
13. Lowering in – Km 166+650 – Jan 19, 2018

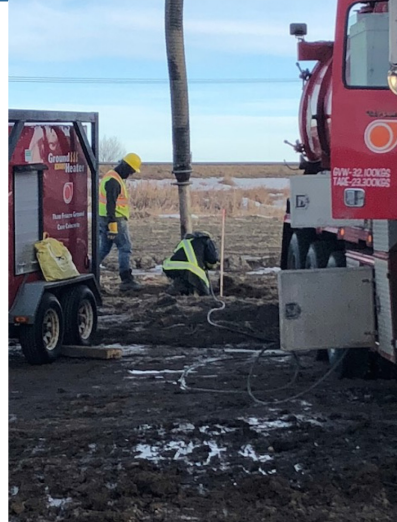
14. Hydrovac - Km 166+610 – Jan 19, 2018

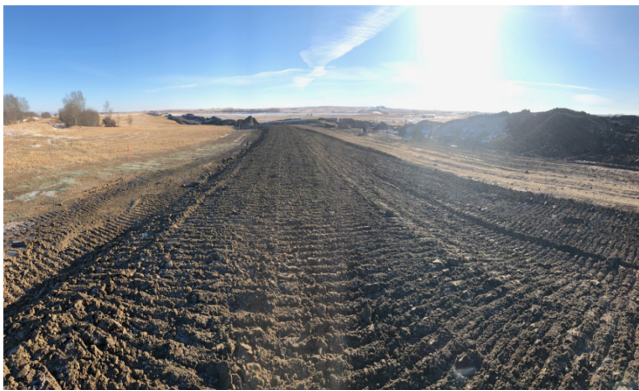
15. Tie-in backfill - km 164+325 – Jan 20, 2018

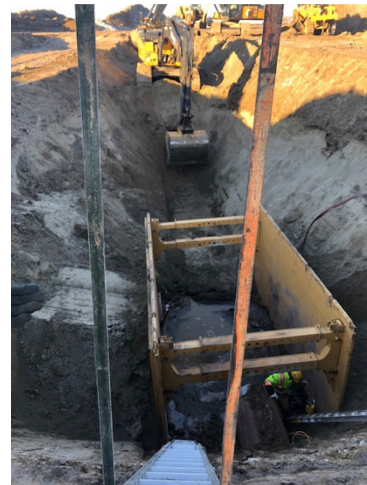
On January 20, the monitors observed the excavator and dozers widen the catch pit at km 159+400 (SF93). Hydrovac day-lighting lines were noted at km 166+610. The monitors walked the area after equipment left at km 164+325, nothing was found. Lowering in was taking place at km 167+675 to km168+850 (SF99). Backfill shading was observed at km 167+790, and backfilling at km 168+296. The ditcher was observed at km 167+296.

16. Excavator dig – km 159+428 – Jan 20, 2018

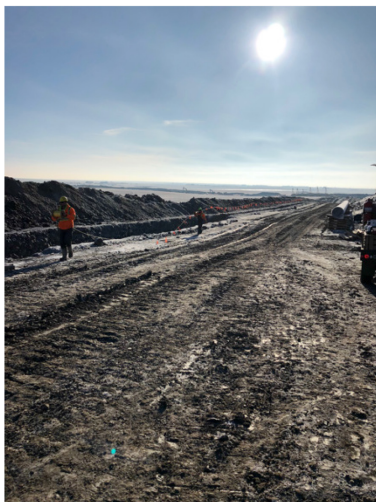
On January 21, the crew observed the excavator pre-ripping frost on the ditch line at km 170+200. The mechanic was observed at km 170+100. The ditcher was seen working towards East at km 169+900 and lowering in was noted at km 169+000 to km169+420. At km 169+000, the bell hole was flagged, as there was an open ditch. Backfill crew was at km 168+530, it was noted that the ditch was prepared for the tie in crew to hook up side booms.

17. Flagging bell hole -169+000 - Jan 21, 2018

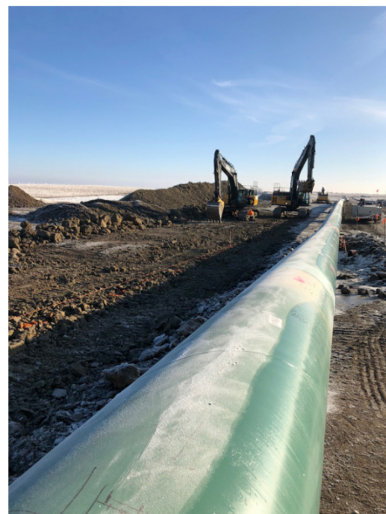
18. Pre-ripped ditch line - km170+200 – Jan 21, 2018

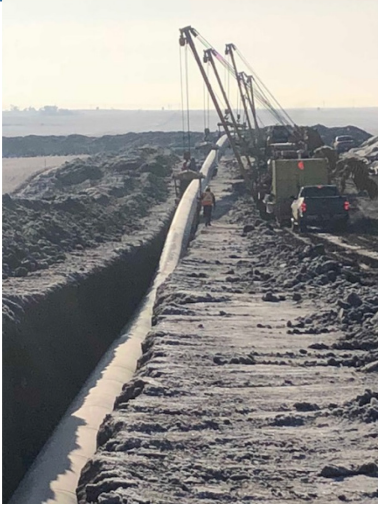
19. Side booms lowering in- km169+200 – Jan 21, 2018

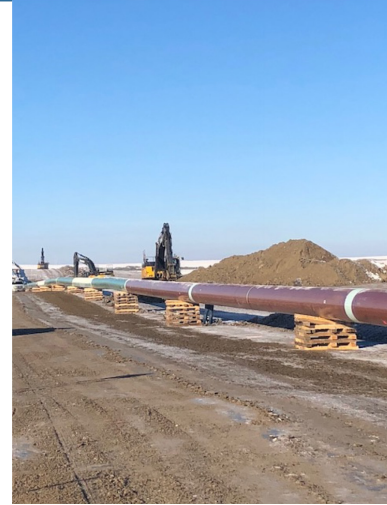
20. Excavators - km170+300 – Jan 21, 2018
