**SAMSON CREE NATION – MATRIX SOLUTIONS INC.
PARTNERSHIP**

ABORIGINAL CONSTRUCTION MONITORING

WEEKLY REPORT

JANUARY 8TH TO JANUARY 13TH

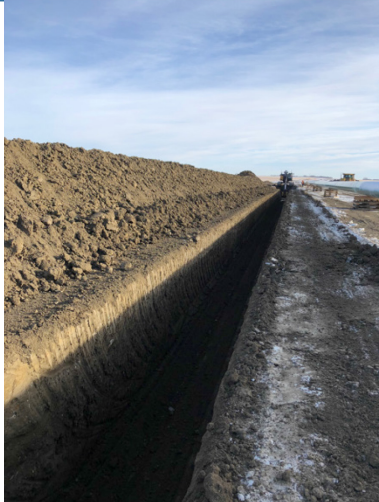
1. Ditch – km 144+250 (S.E) – Jan 8, 2018

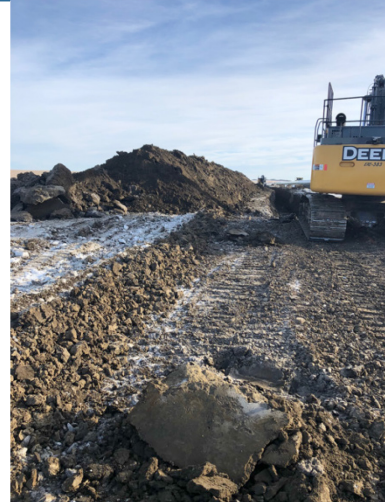
2. Excavator and spill pile – Km 144+200 – Jan 8, 2018

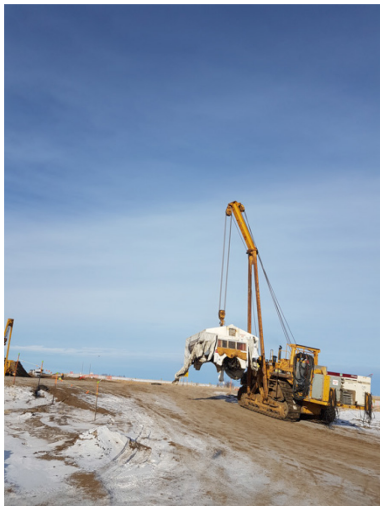
3. Equipment crossing - SF 96 – Jan 8, 2018

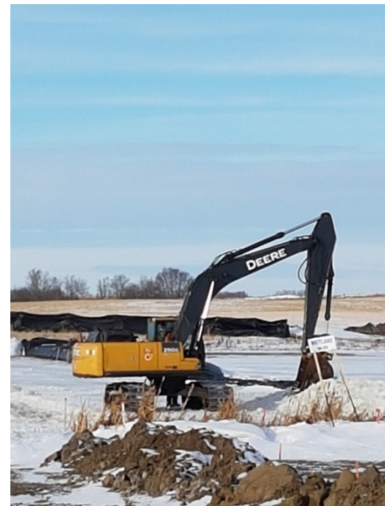
4. Track hoe working on wetland - Km 165+300 – Jan 8, 2018

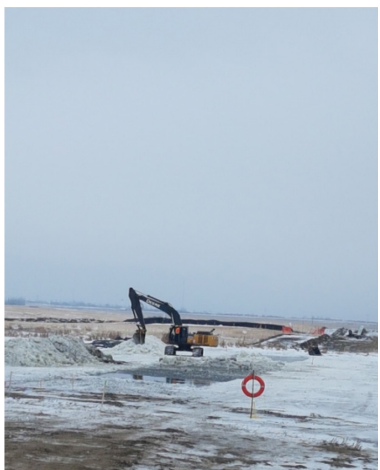
5. Track hoe (wetland) – Km 165+050 – Jan 9, 2018

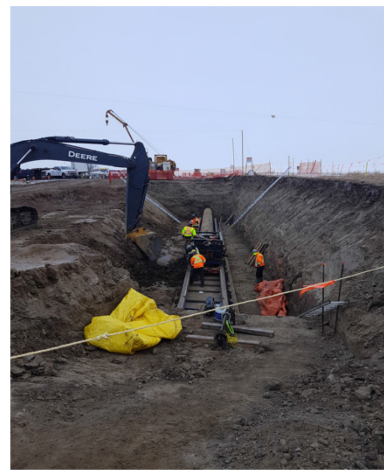
6. Spill Piles - Km 163+500 – Jan 9, 2018

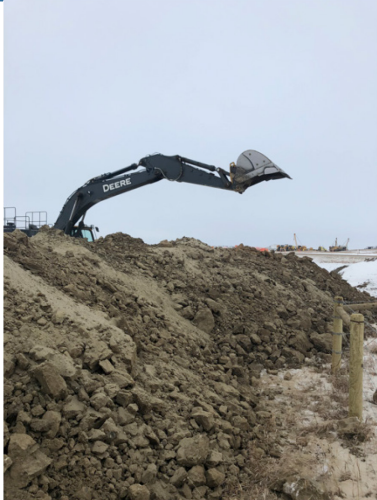
7. Spill pile (N) – Km 159+620 – Jan 9, 2018

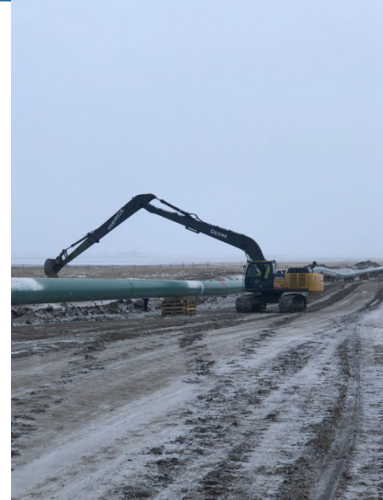
8. Long stick excavator - Km 160+100 – Jan 10, 2018

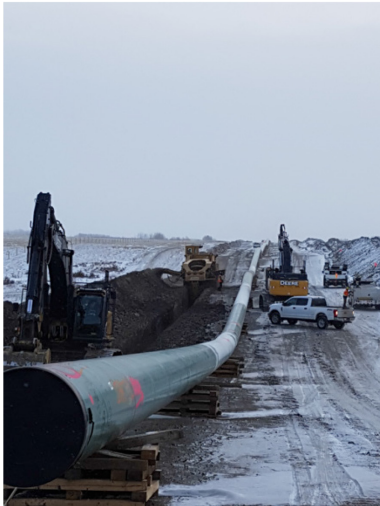
9. Ditcher Machine - km 161+850 – Jan 10, 2018

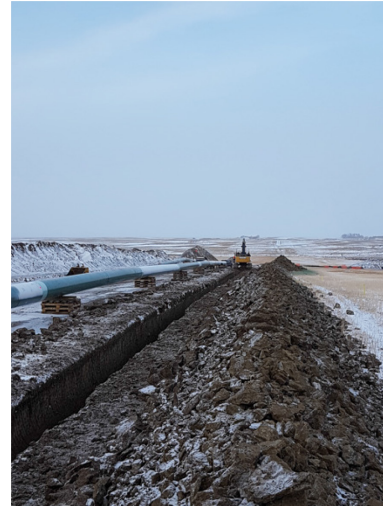
10. Mechanic - Km 161+300 – Jan 10, 2018

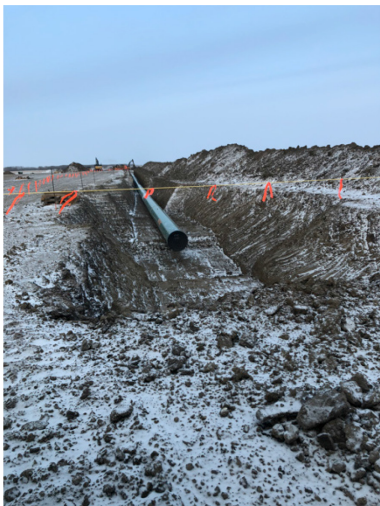
11. Mainline – Km 144+393 – Jan 10, 2018

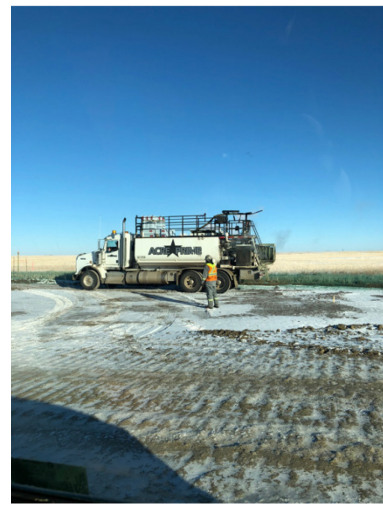
12. HydroVac Spraying Mulch – km 166+400 – Jan 11, 2018

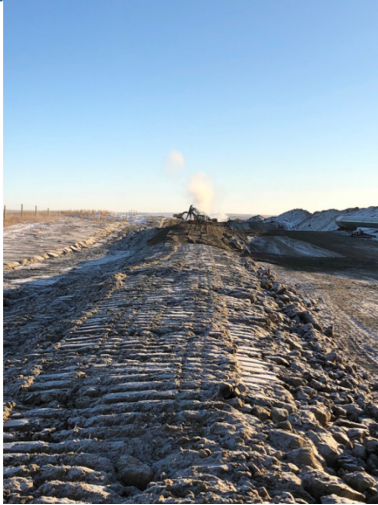
13. Backfill – Km 159+700 – Jan 11, 2018

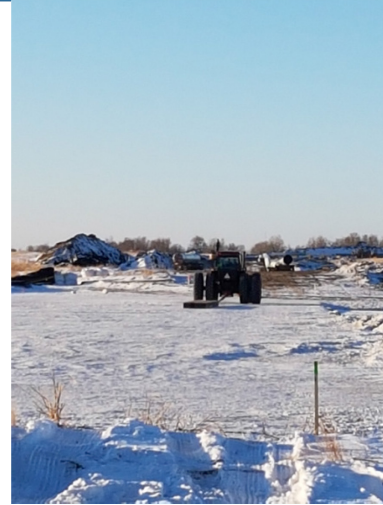
14. Tractor dragging mat - Km 165+250 – Jan 11, 2018

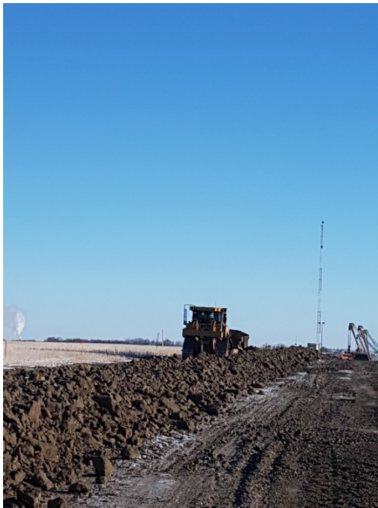
15. Mechanic - km 161+400 – Jan 11, 2018

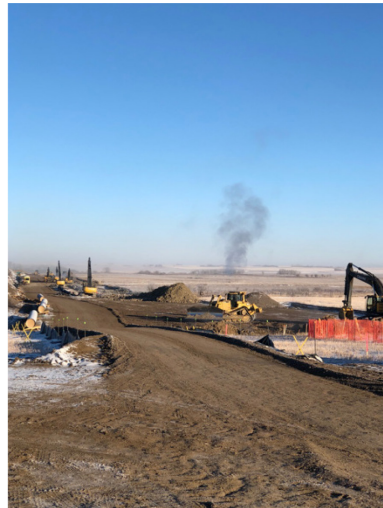
16. Bore crew and dozer at bore pit – km 161+000 – Jan 12, 2018

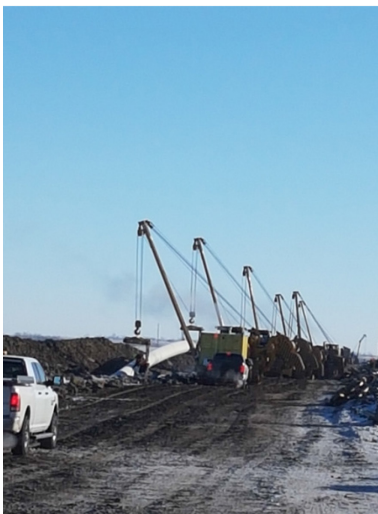
17. Track hoe cleaning clumps in ditch-162+600 - Jan 12, 2018

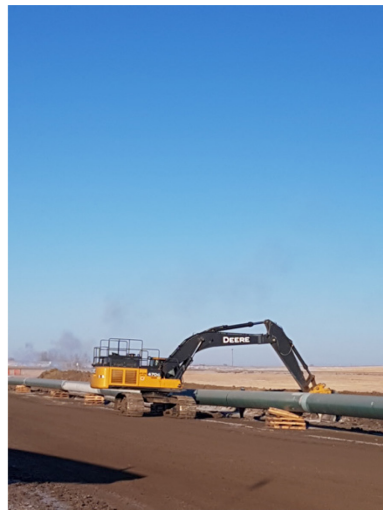
18. Mechanic - km163+800 – Jan 12, 2018

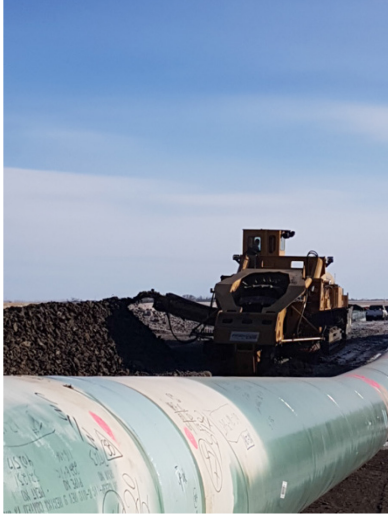
19. Excavators digging out plug - km164+850 – Jan 13, 2018

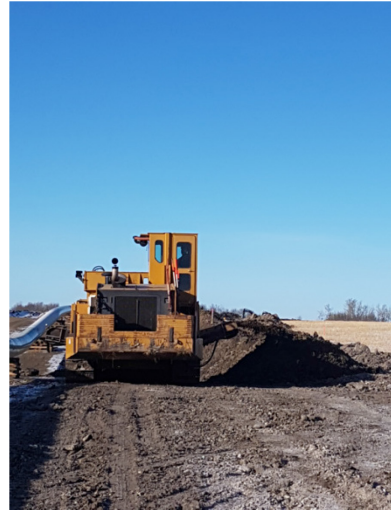
20. Excavator - km164+900 – Jan 13, 2018

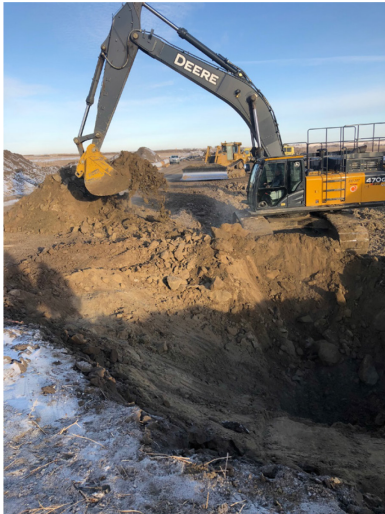
21. Excavator digging in bore bay – Km 161+000 – Jan 13, 2018
