**SAMSON CREE NATION – MATRIX SOLUTIONS INC.
PARTNERSHIP**

ABORIGINAL CONSTRUCTION MONITORING

WEEKLY REPORT

NOVEMBER 13TH - NOVEMBER 17TH

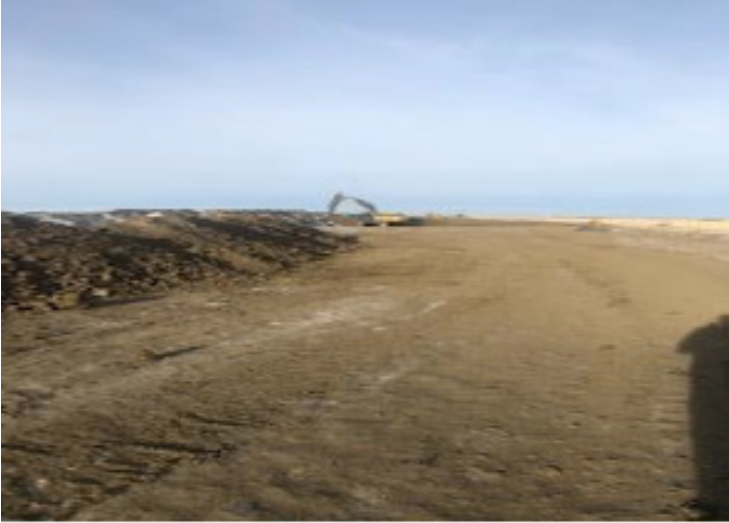
Excavator and dozer spreading clay - km 174+740 – Nov 13, 2018

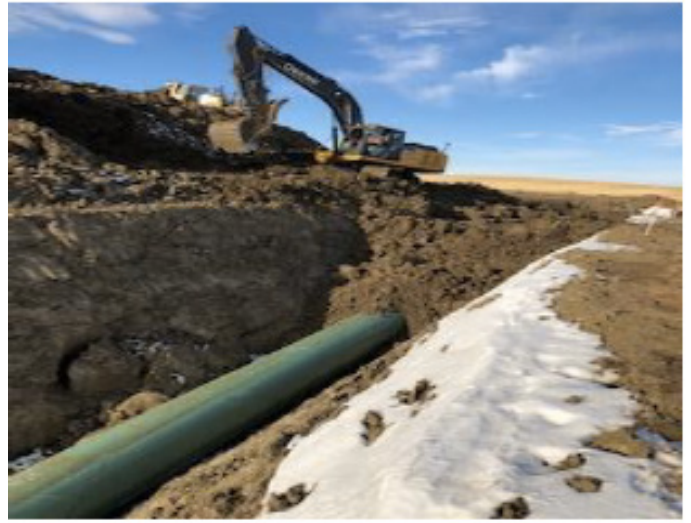
Excavator shading mainline - km 192+740 – Nov 13, 2018

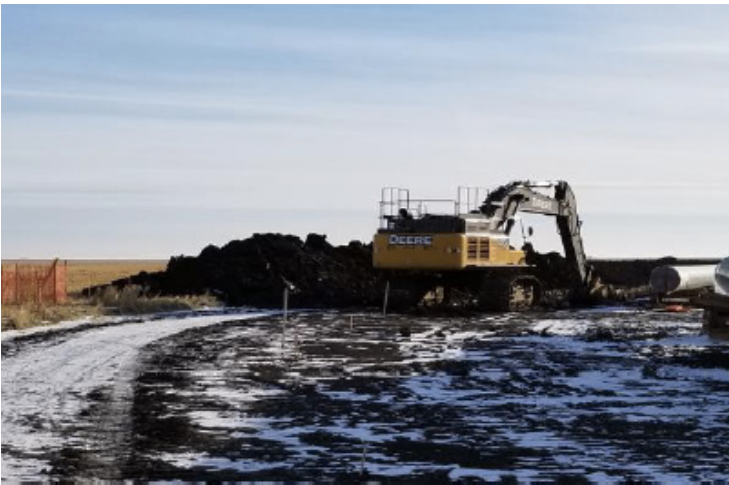
Digging ditch – km 245+720 – Nov 13, 2018

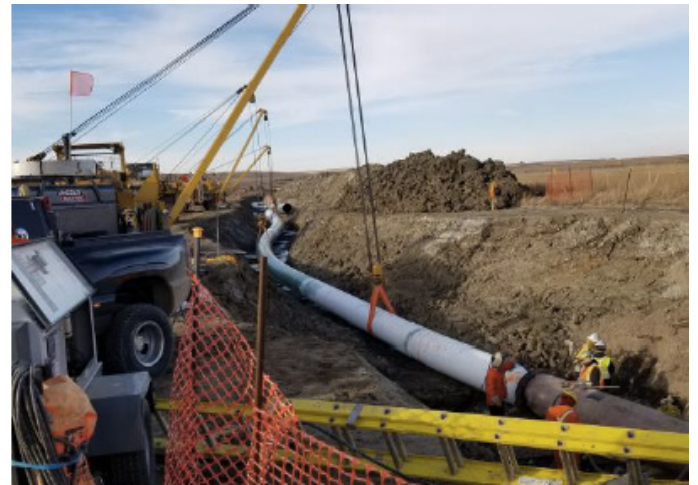
Welding tie-in– km 221+890 – Nov 13, 2018

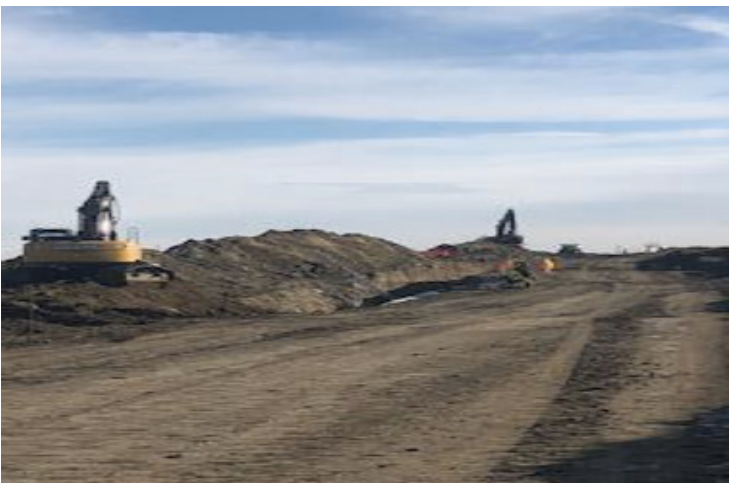
Excavator shading pipe for backfill – km 190+100 – Nov 13, 2018

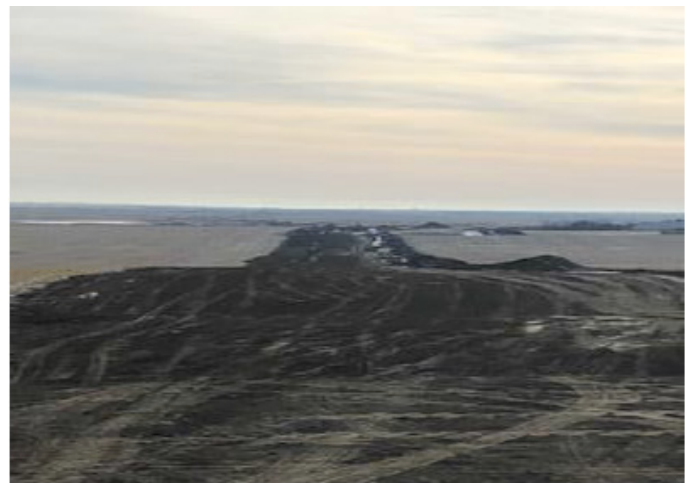
Clean up crew– km 172+525 – Nov 13, 2018

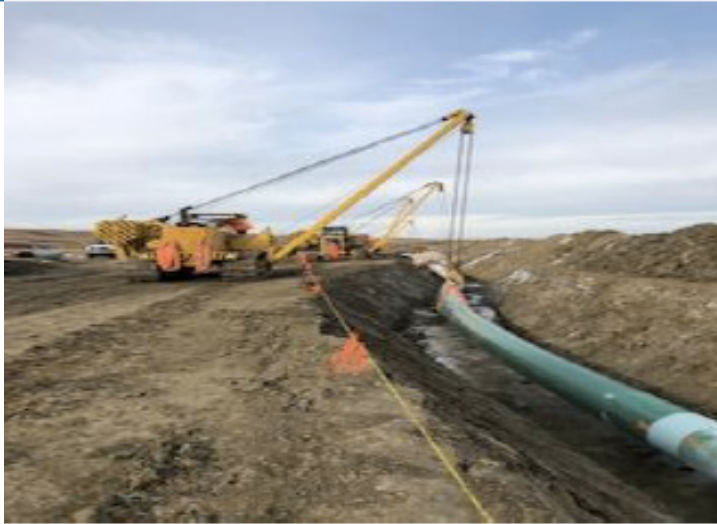
Final tie-in – SF 140 – Nov 14, 2018

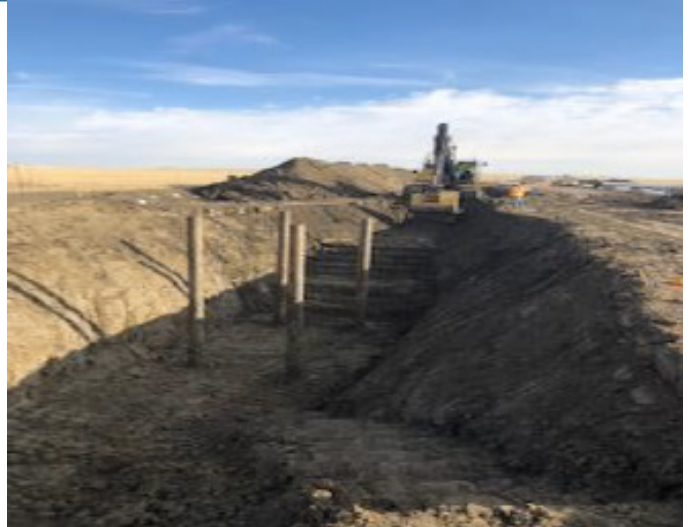
Excavator digging tie-in ditch – SF 132 – Nov 14, 2018

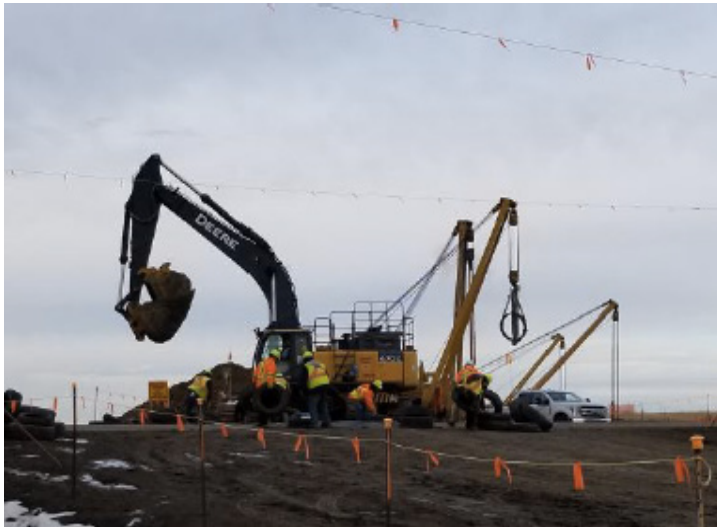
Crossing equipment under power lines – Km209+800 – Nov 14, 2018

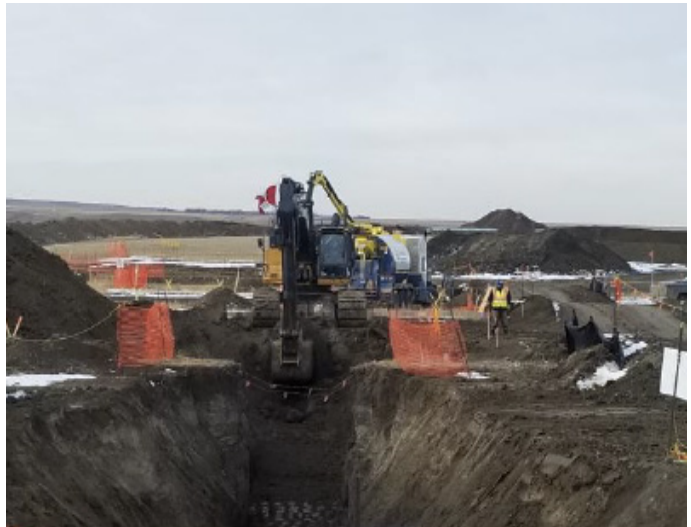
Digging tie-in section – km 223+675 – Nov 14, 2018

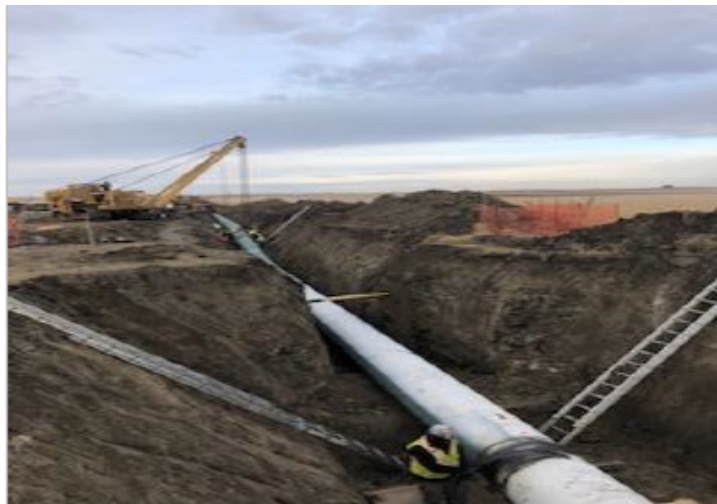
Tie-in under mainline – km 200+900 – Nov 14, 2018

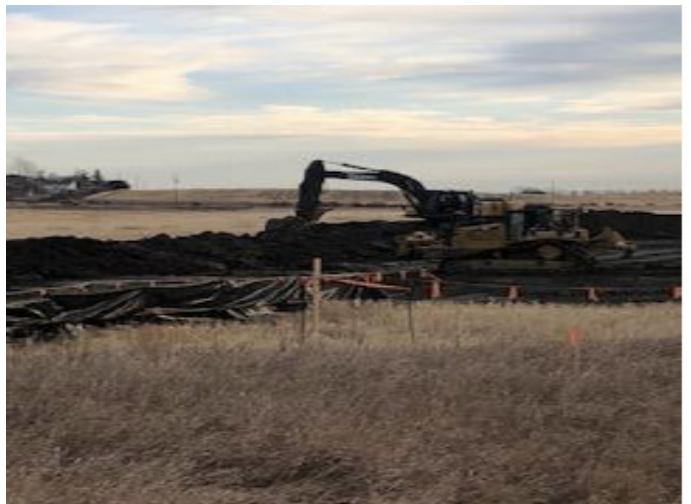
Dozer and excavator pushing dirt –SF 121– Nov 14, 2018

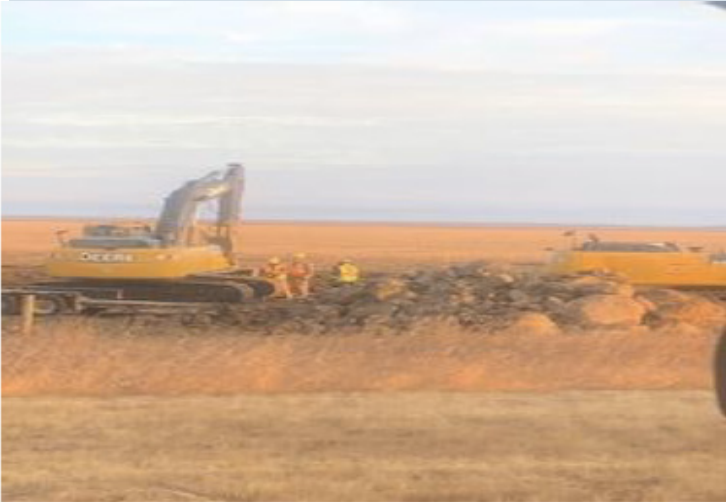
Mechanical clean up crew – km 176+350 – Nov 15, 2018

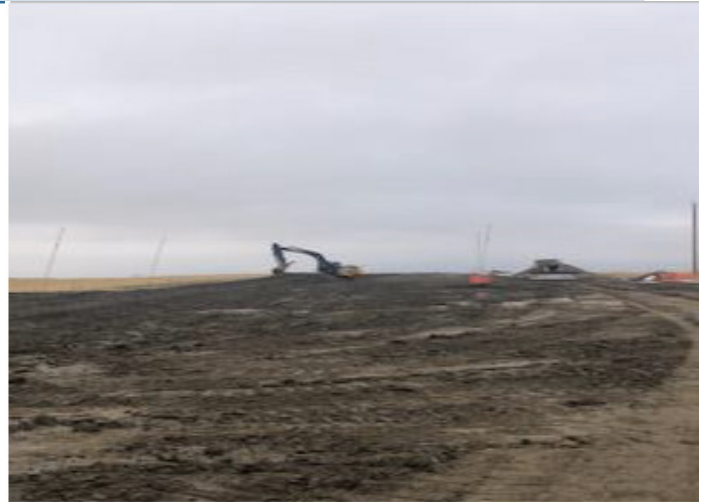
Dozer levelling – 197+450 – Nov 15, 2018

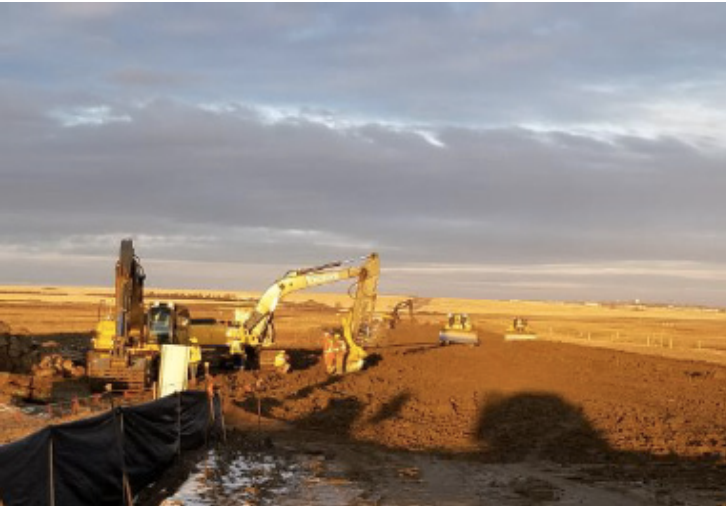
Cleaning equipment and moving dirt – km 176+400 – Nov 15, 2018

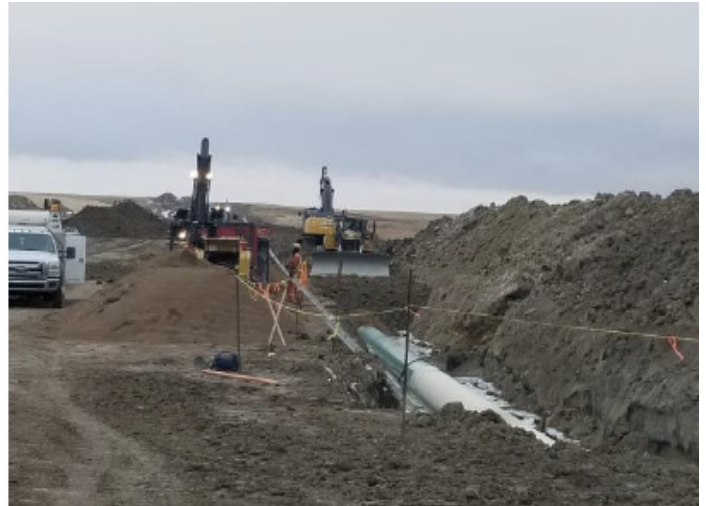
Shading pipe – km 187+700 – Nov 15, 2018

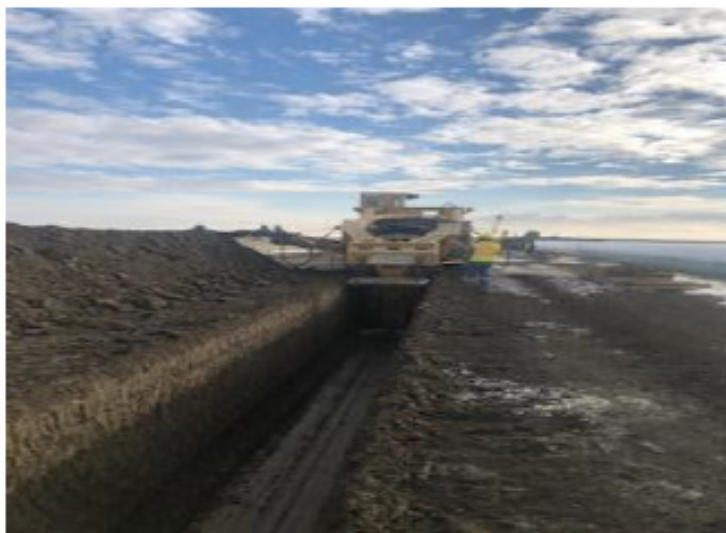
Wheel ditcher digging mainline ditch– km 251+700– Nov 15, 2018

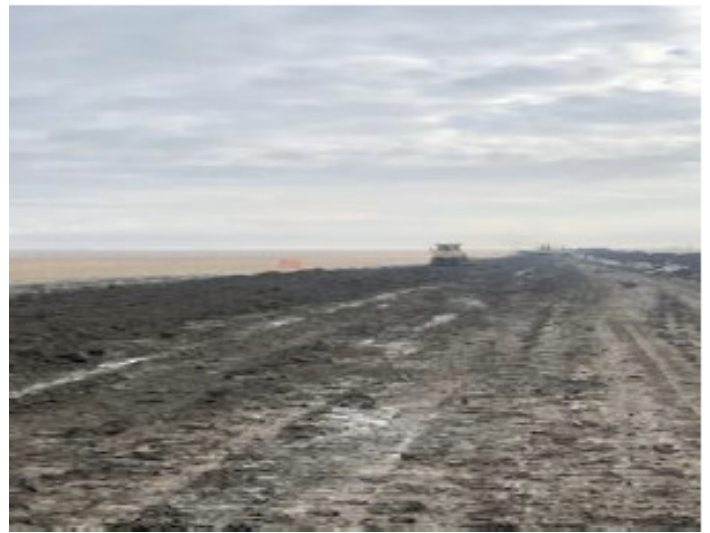
Dozer track packing mainline – km 248+200 – Nov 15, 2018

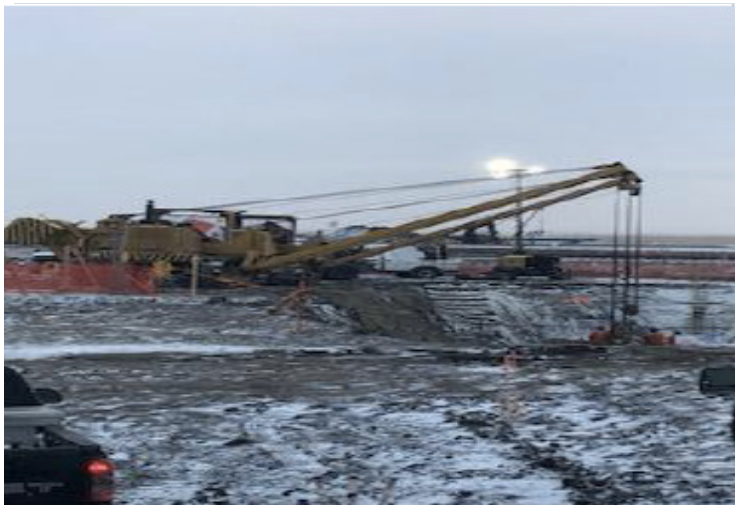
Bore crew – SF 170 – Nov 16, 2018

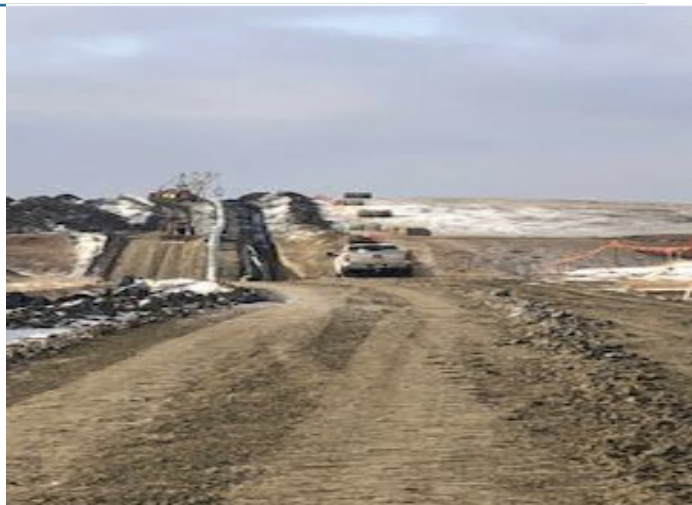
Lowering in at Heritage area – km 252+500 – Nov 16, 2018

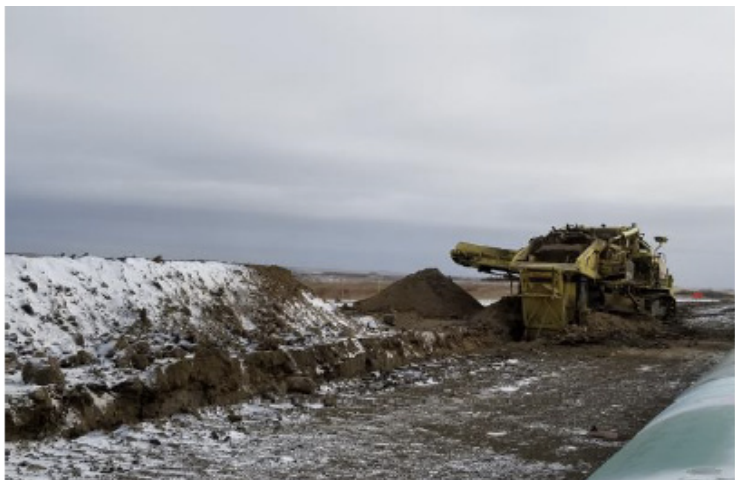
Servicing ditching wheel – km 254+100 – Nov 16, 2018

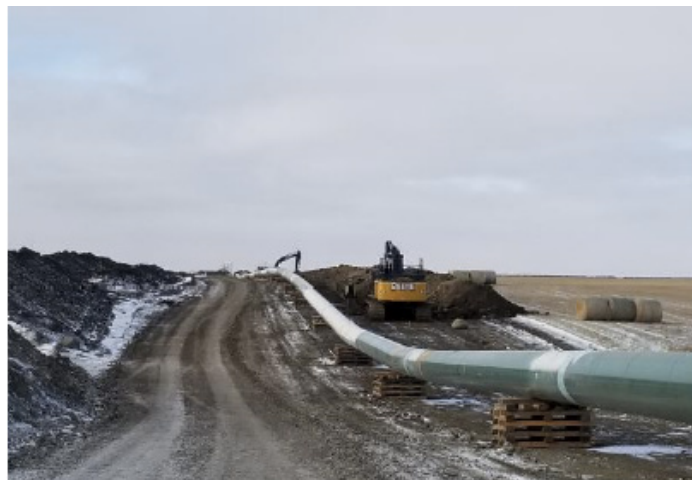
Digging ditch – km 254+700 – Nov 16, 2018

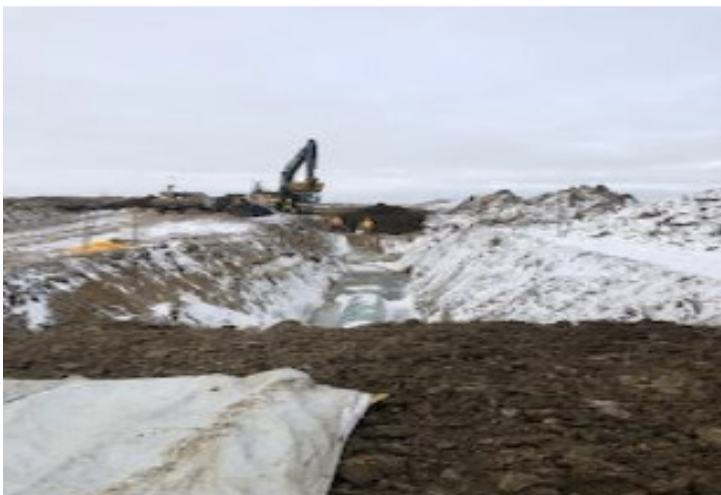
Backfilling around TIENE line crossing – km 187+612 – Nov 16, 2018

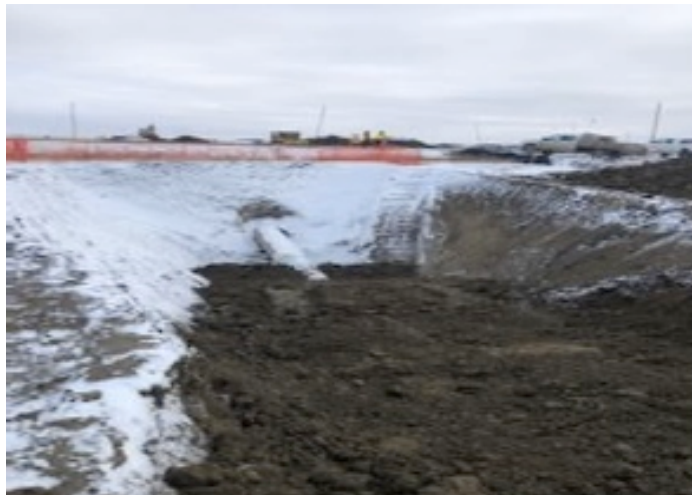
Tie-in backfill crew shading – SF 168 – Nov 16, 2018

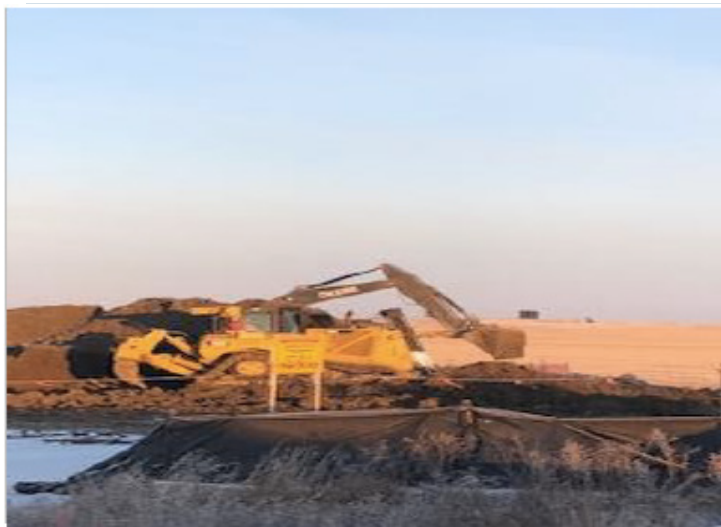
Filling tie-in open ditch – km 201+099 – Nov 17, 2018

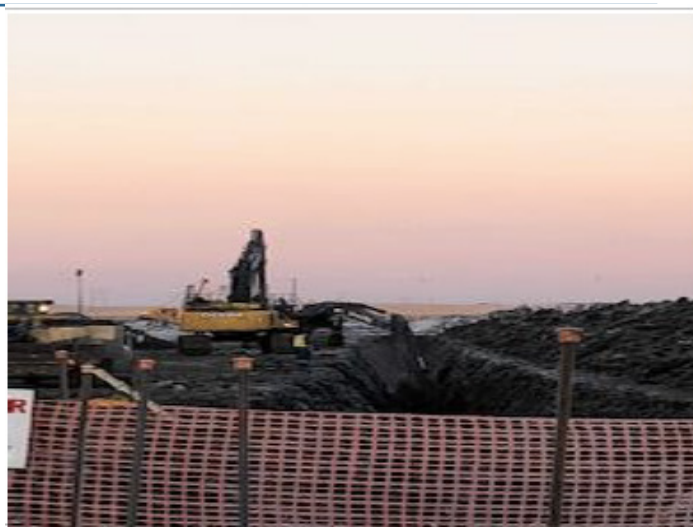
Excavator cleaning sluff in for tie-in – km 196+000– Nov 17, 2018

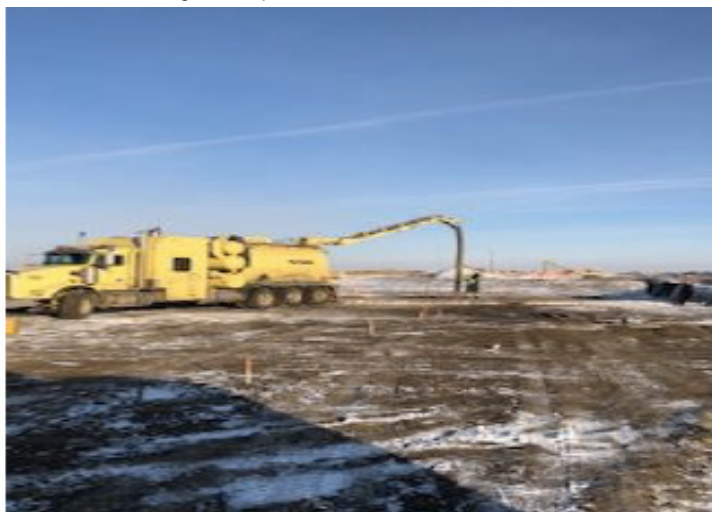
Hydro vac slot digging the line crossing - km 224+914 – Nov 17, 2018

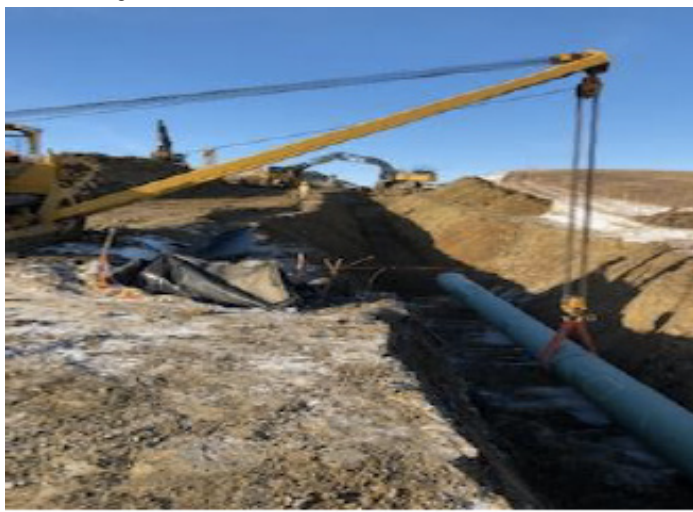
Excavator digging tie-in – km 221+133 – Nov 17, 2018

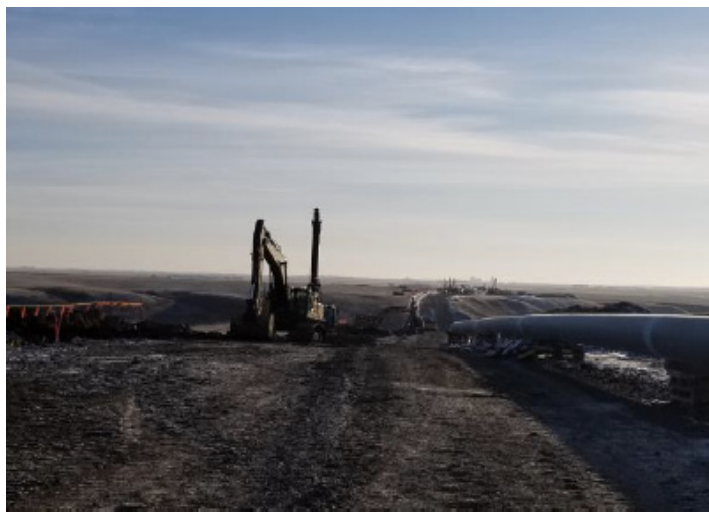
Backfill – km 252+270 – Nov 17, 2018

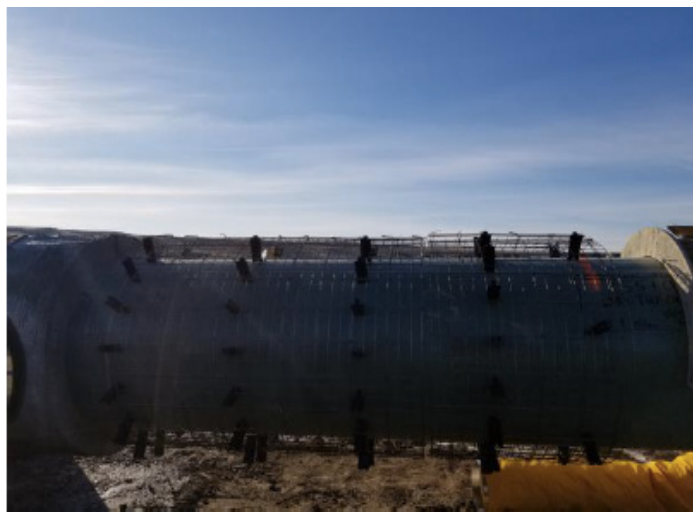
Prepping concrete coding – km 254+700 – Nov 17, 2018
