**SAMSON CREE NATION – MATRIX SOLUTIONS INC.  
PARTNERSHIP**

**ABORIGINAL CONSTRUCTION MONITORING**

**WEEKLY REPORT**

**NOVEMBER 19<sup>TH</sup> - NOVEMBER 24<sup>TH</sup>**

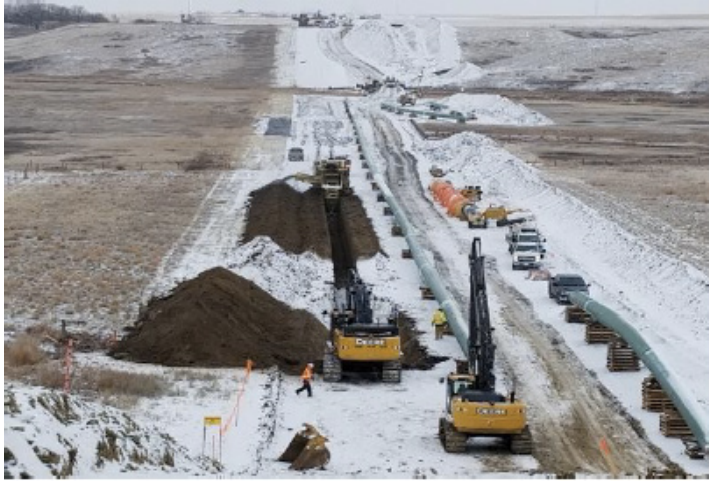
Digging ditch at heritage site - km 254+400 – Nov 19, 2018

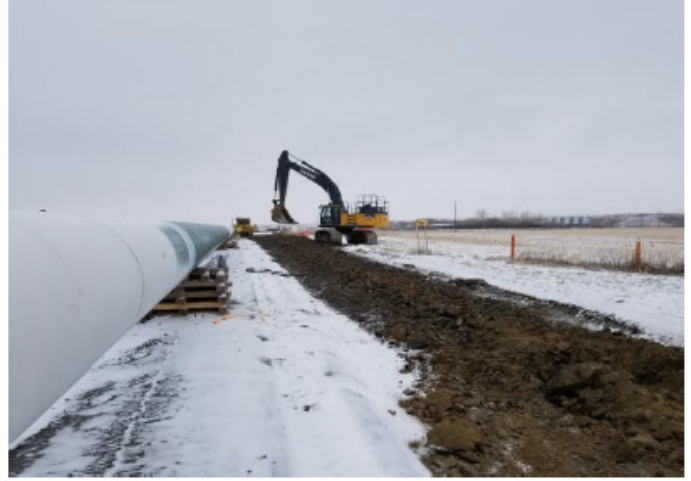
Dozer ripping frost - km 255+850 – Nov 19, 2018

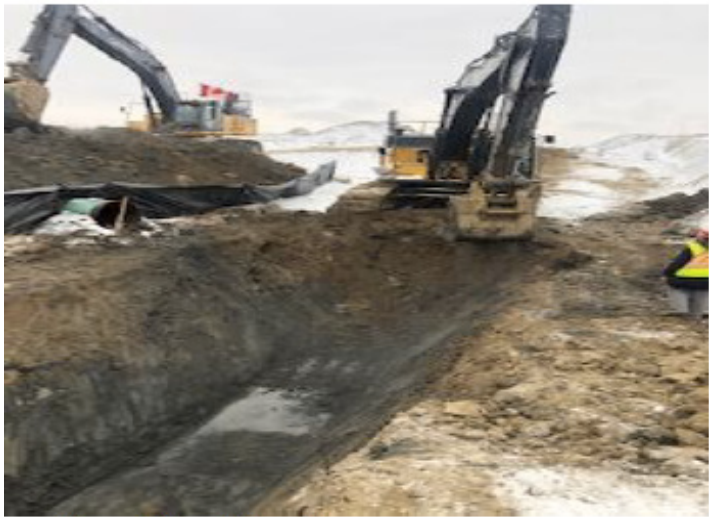
Digging tie-in ditch – km 222+670 – Nov 19, 2018

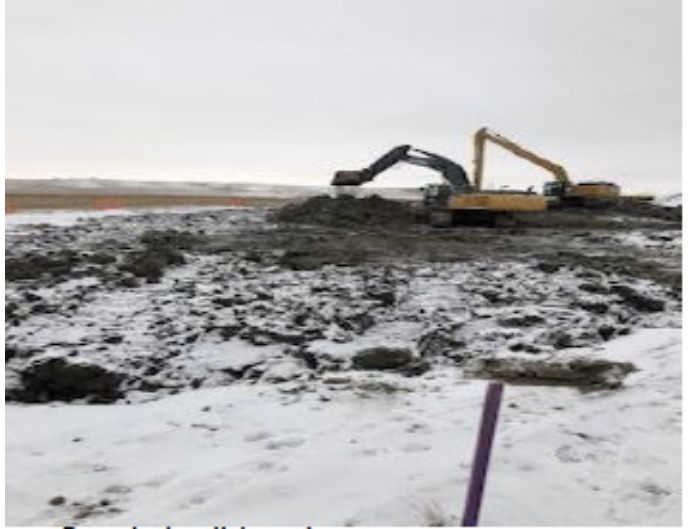
Tie-in backfill excavator in Stranraer Valley– Nov 19, 2018

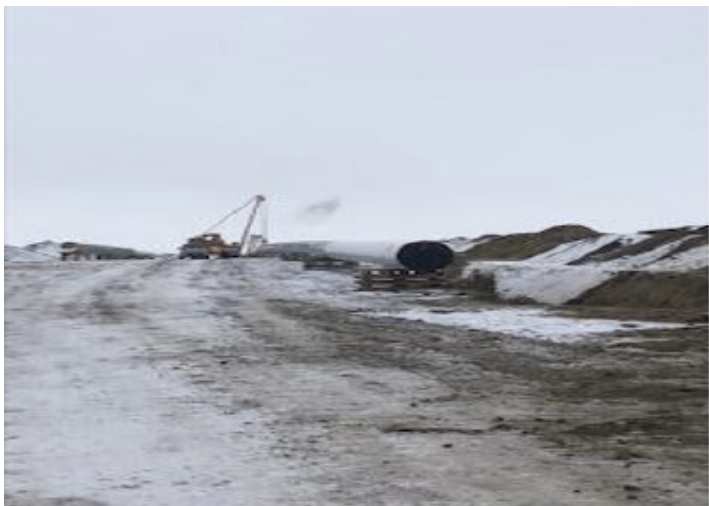
Lowering-in crew waiting on ditch – km 253+900 – Nov 19, 2018

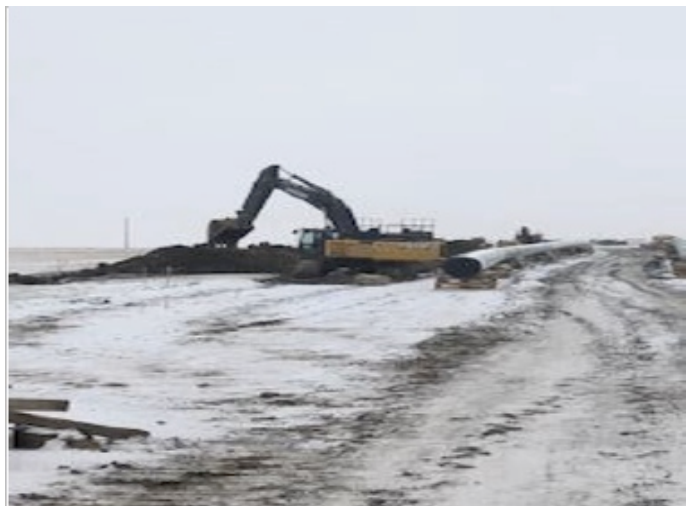
Excavator plugging out mainline– km 255+900 – Nov 19, 2018

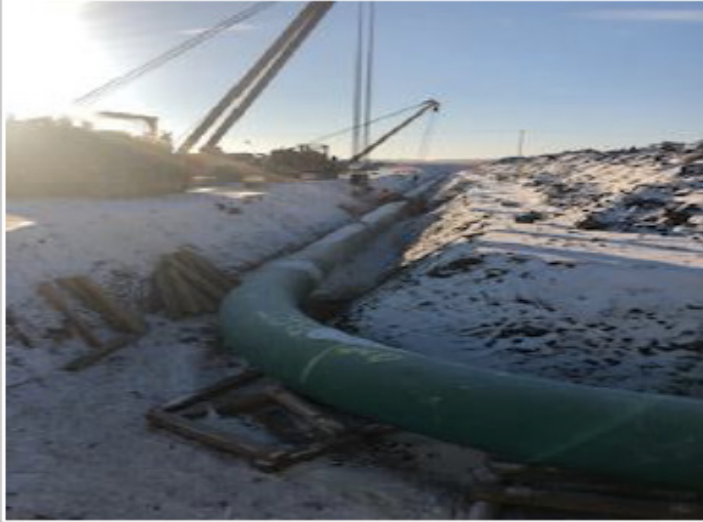
Tie-in crew weld – km 224+590 – Nov 20, 2018

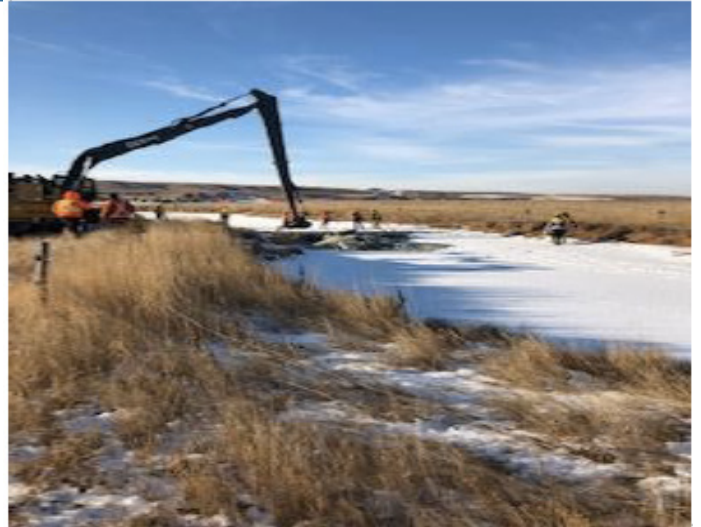
Excavator taking out ice at Eagle Creek – Nov 20, 2018

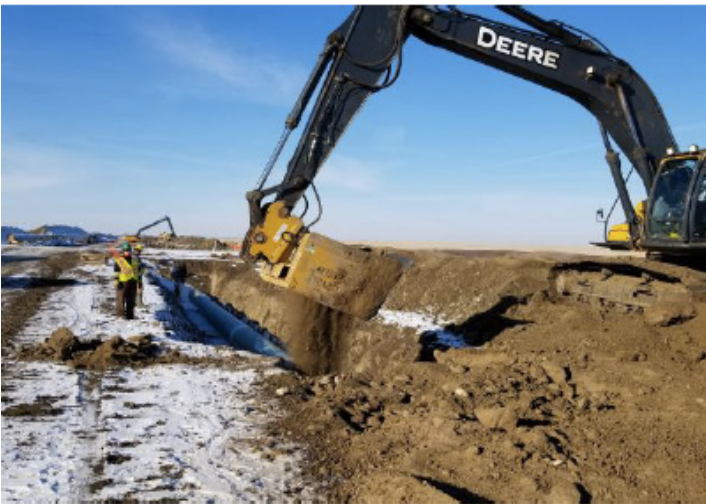
Shading pipe – km 254+000 – Nov 20, 2018

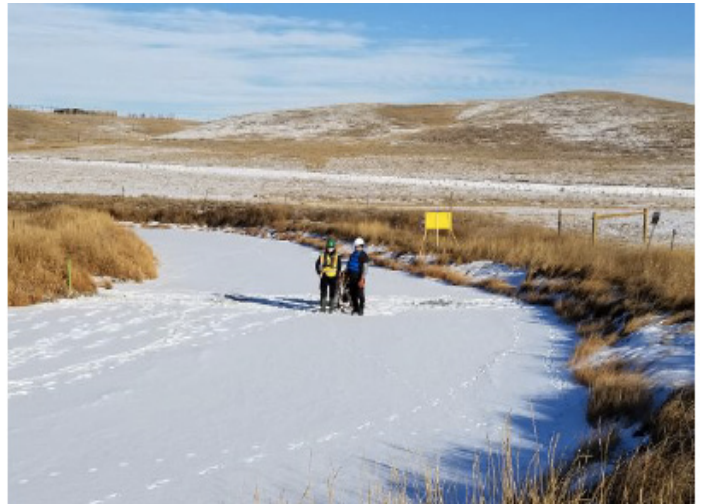
Checking water flow – km 222+100 – Nov 20, 2018

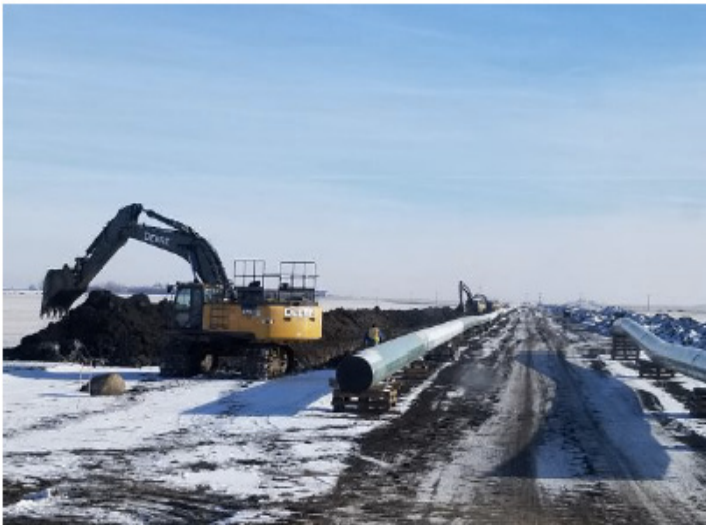
Digging ditch – km 259+300 – Nov 21, 2018

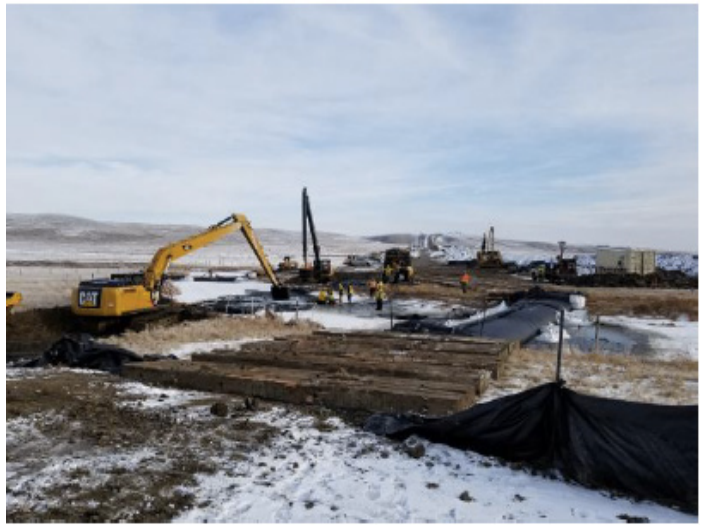
Removing ice – km 221+975 – Nov 21, 2018

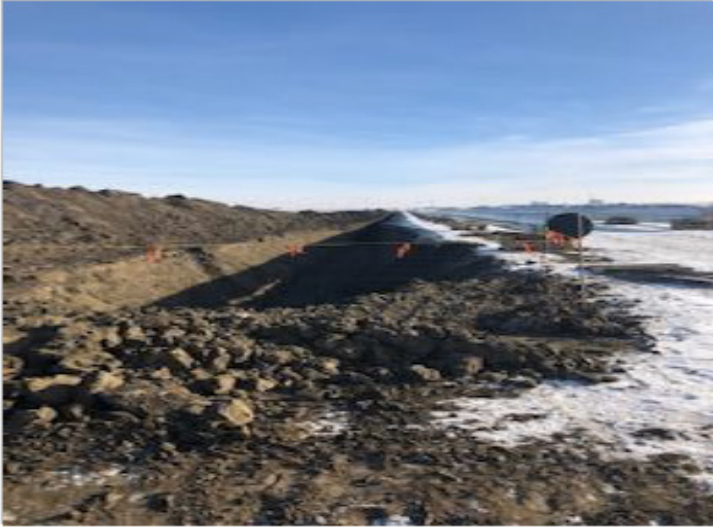
Mainline section ready for lowering in – km 260+300 – Nov 21, 2018

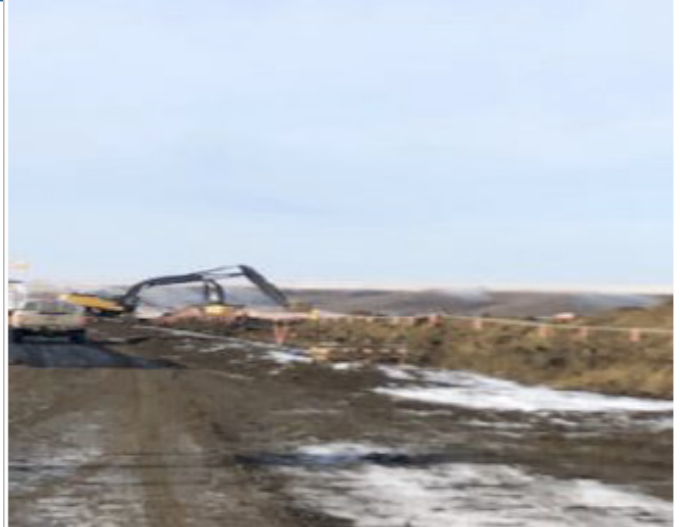
Excavator shading pipe – 255+625 – Nov 21, 2018

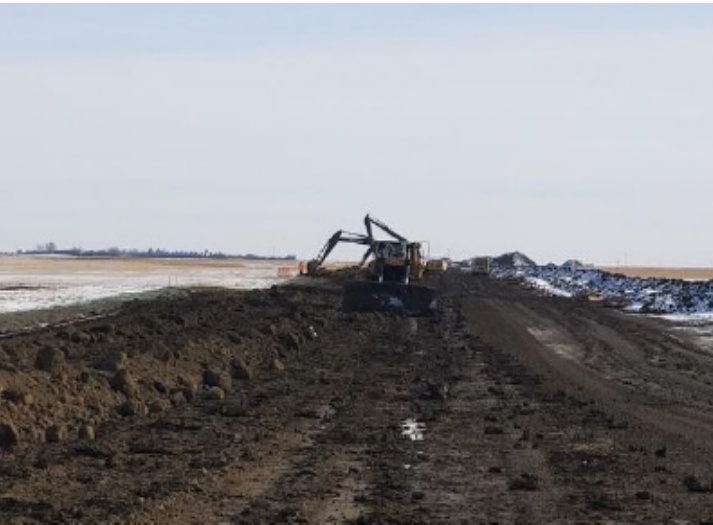
Backfill ditch – km 258+000 – Nov 22, 2018

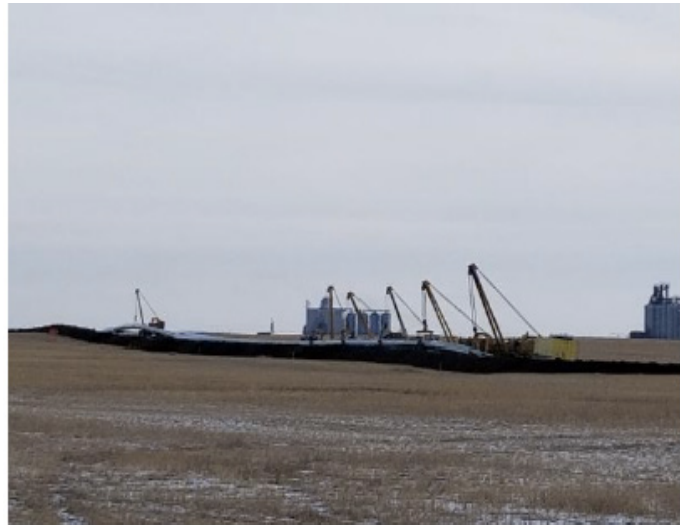
Lowering in pipe – km 262+631 – Nov 22, 2018

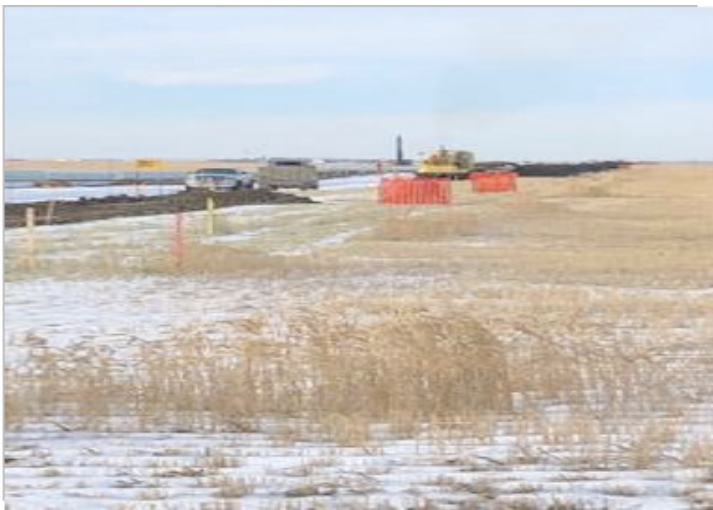
Ditching wheel working – km 262+800 – Nov 22, 2018

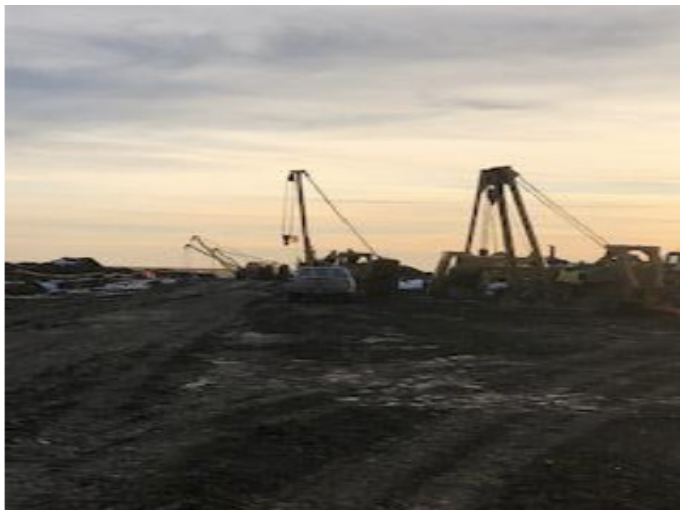
Tie-in weld in the ditch – km 216+800 – Nov 22, 2018

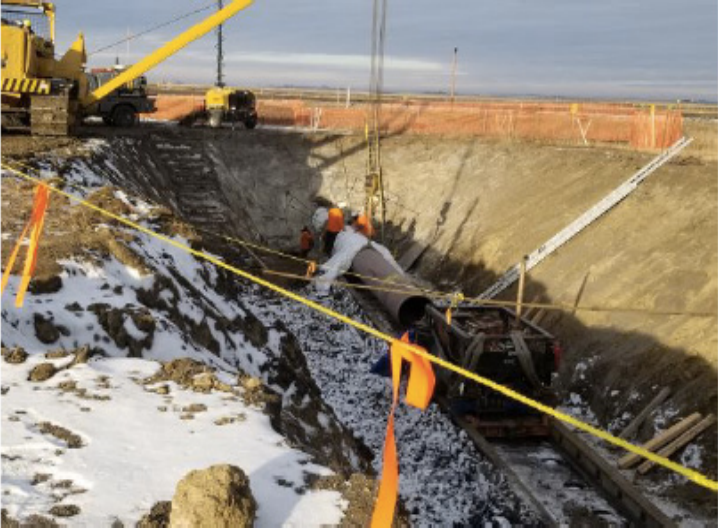
Track bore – km 266+700 – Nov 23, 2018

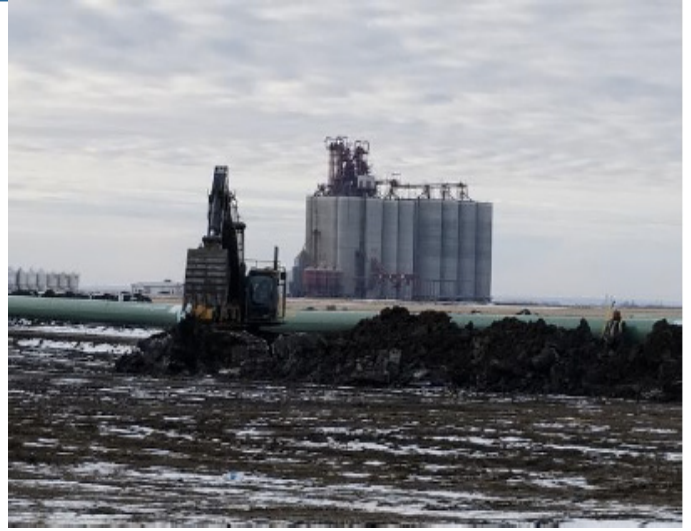
Digging ditch – km 264+350 – Nov 23, 2018

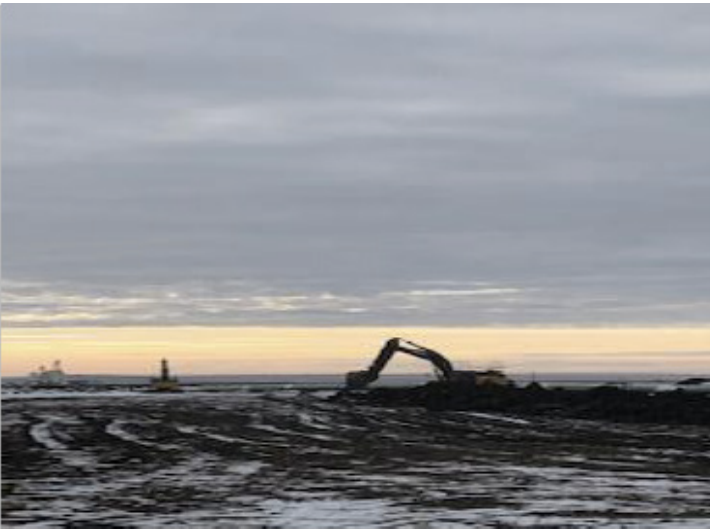
Excavators digging ditch – km 264+500 – Nov 23, 2018

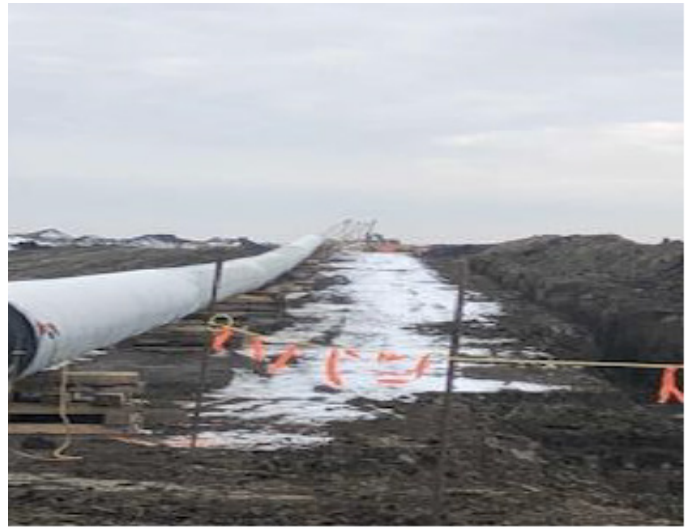
Lowering-in crew waiting on ditch – km 263+800 – Nov 23, 2018

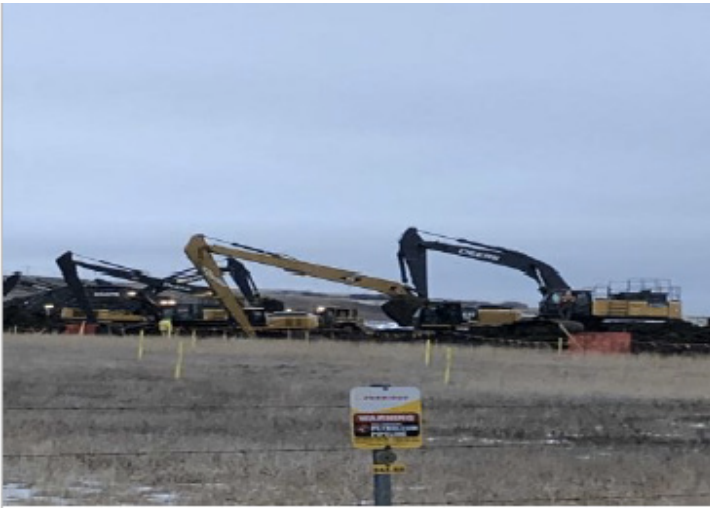
Cleaning up and backfilling – SF 141 – Nov 24, 2018

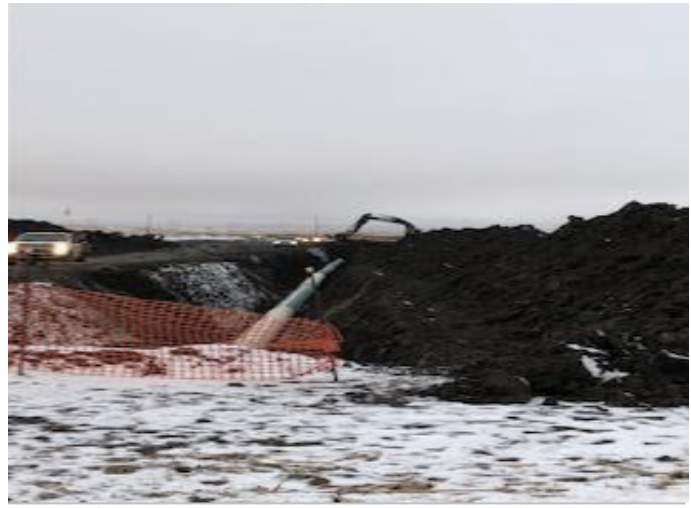
Excavator shading backfill – km 195+500 – Nov 24, 2018

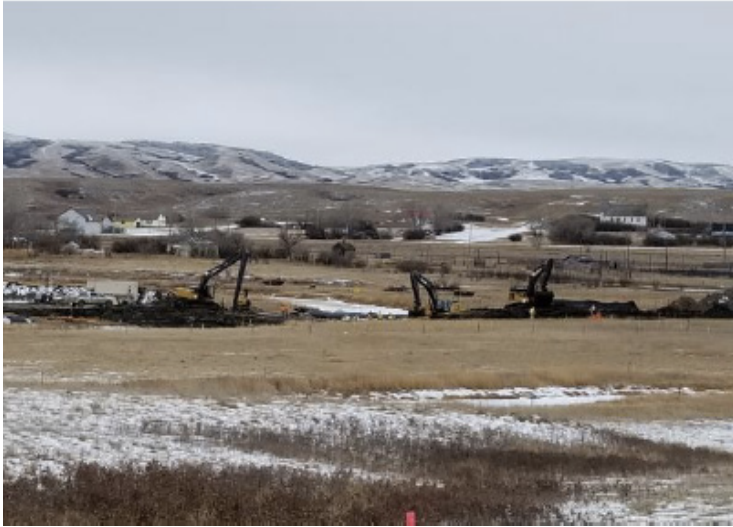
Backfilling creek section – km 222+300 – Nov 24, 2018

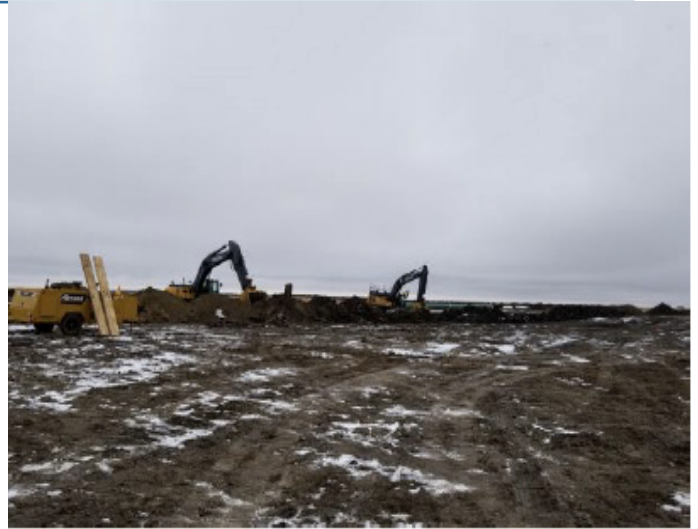
Backfill– km 264+550– Nov 24, 2018
