**SAMSON CREE NATION – MATRIX SOLUTIONS INC.
PARTNERSHIP**

ABORIGINAL CONSTRUCTION MONITORING

WEEKLY REPORT

NOVEMBER 26TH - DECEMBER 1ST

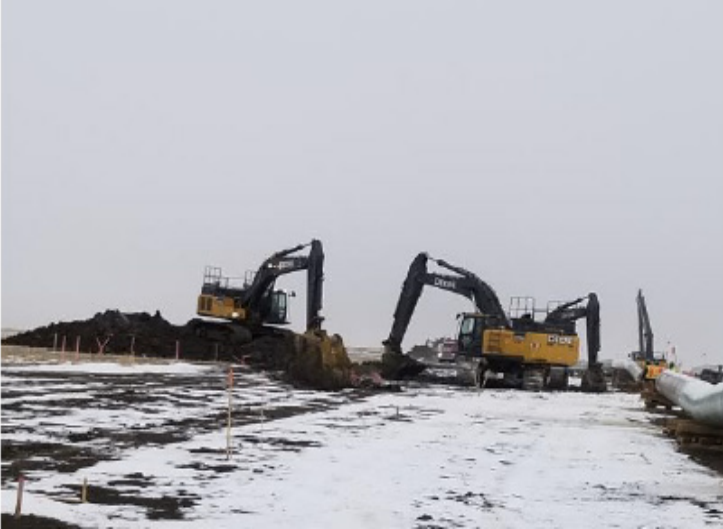
Digging tie-in section - km 221+185 – Nov 26, 2018

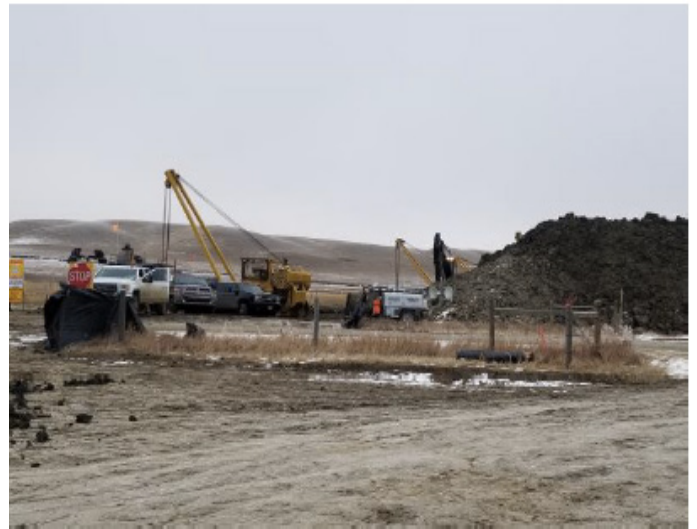
Tie-in at heritage site - km 221+890 – Nov 26, 2018

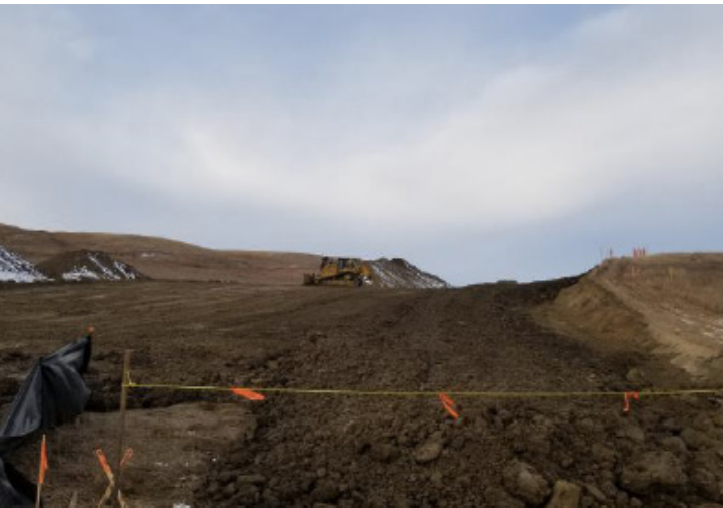
Levelling the ROW – km 222+670 – Nov 27, 2018

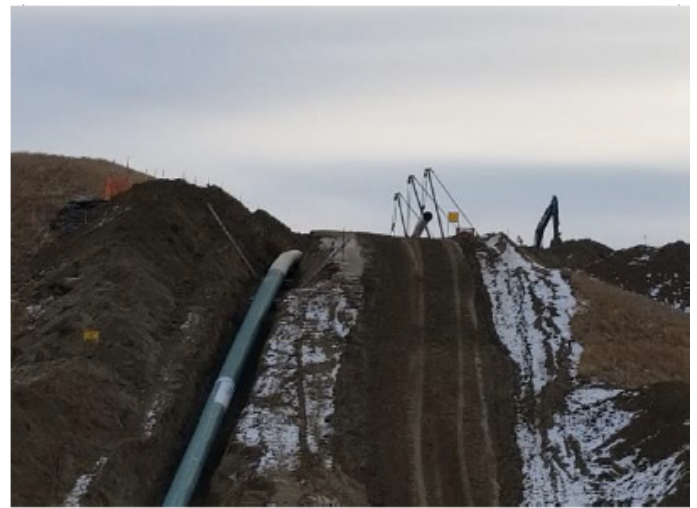
Lower in tie-in section – km 222+600 - Nov 27, 2018

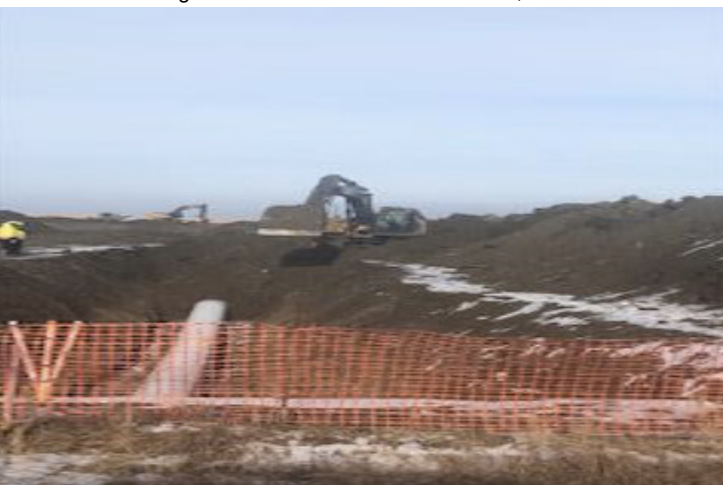
Excavator shading tie-in – km 232+800 – Nov 27, 2018

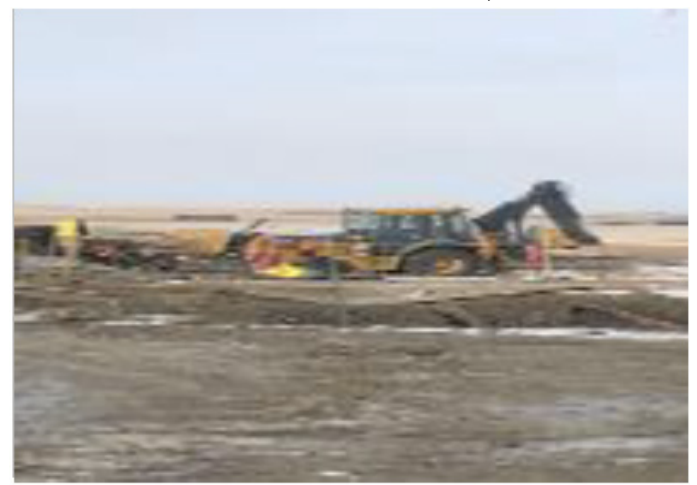
Rubber tire hoe working – km 195+500 – Nov 27, 2018

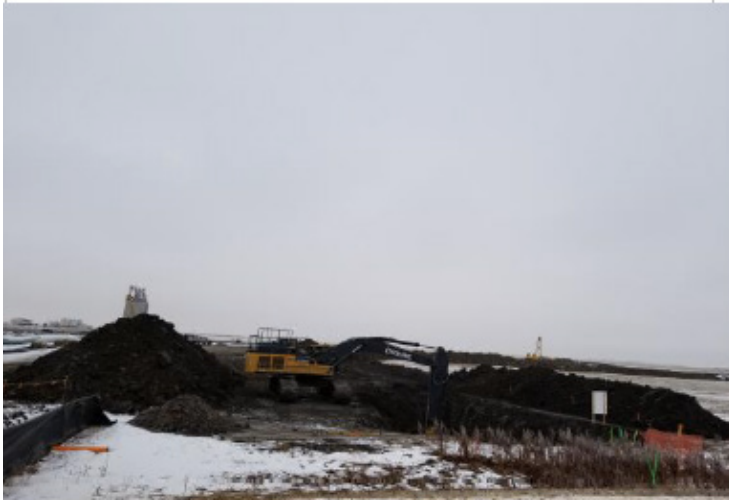
Digging bore pit – km 265+060 – Nov 28, 2018

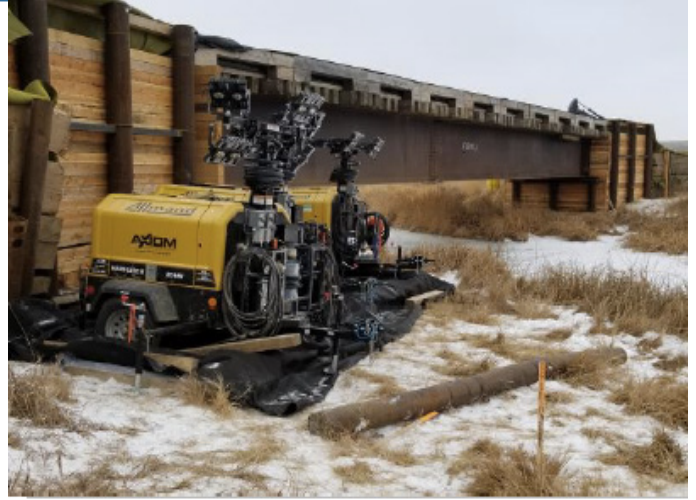
Containment for plants – km 255+150 - Nov 28, 2018

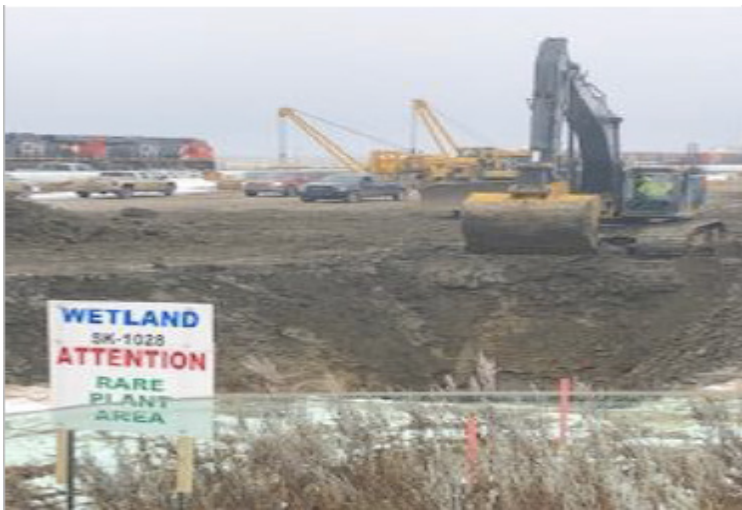
Excavator digging bell hole through rare plant area – SF 169 – Nov 28, 2018

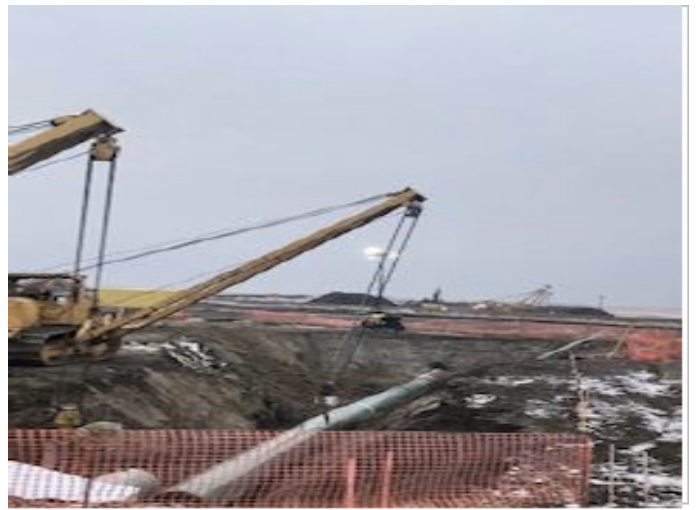
Lining up the cut – SF 170 – Nov 28, 2018

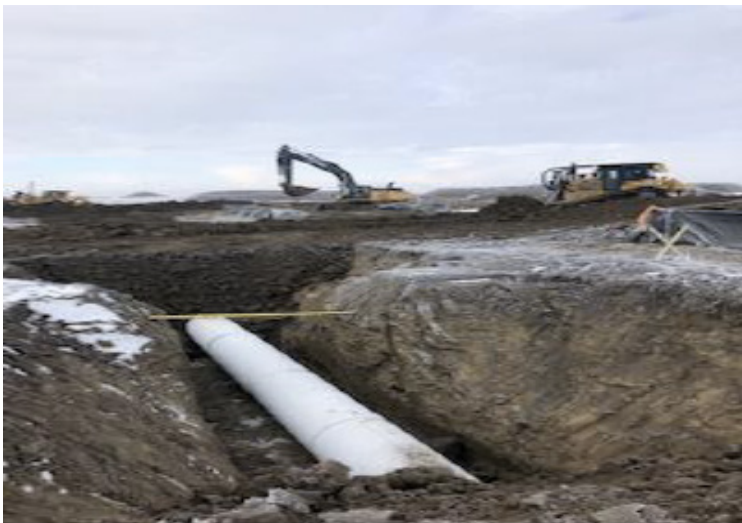
Dozer and excavator levelling ROW – km 223+600 – Nov 29, 2018

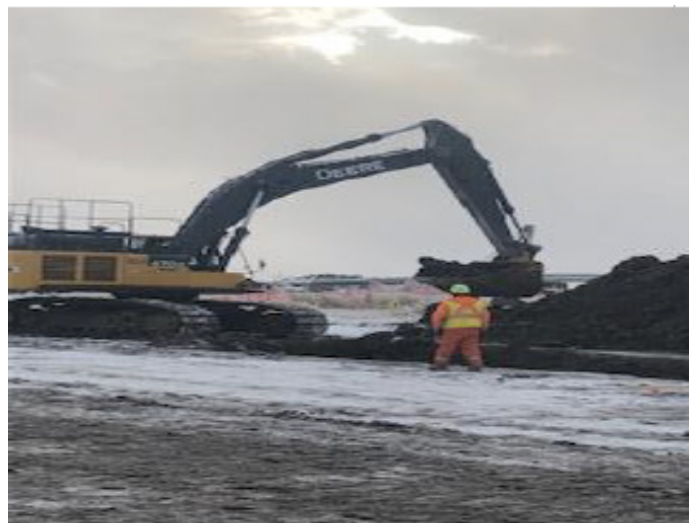
Digging ditch for tie-in – km 227+900– Nov 29, 2018

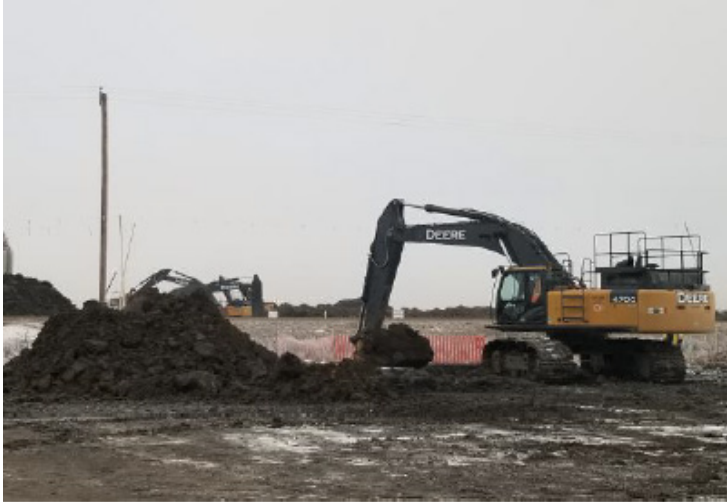
Digging bore pit – km 265+160 – Nov 29, 2018

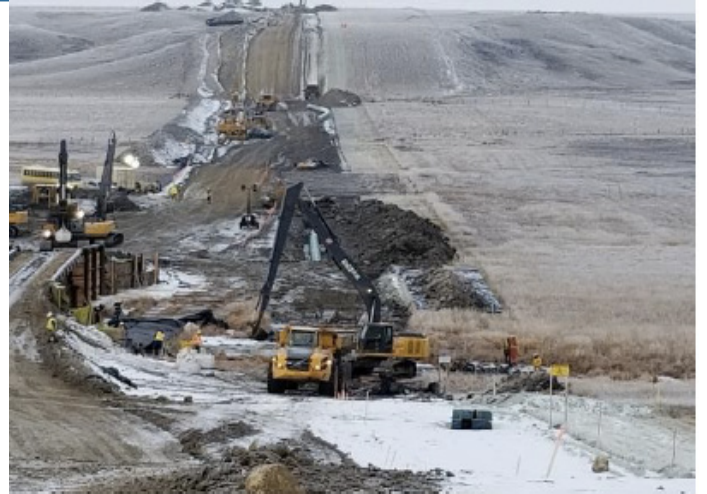
Loading ice and installing aqua dam –km 255+300– Nov 29, 2018

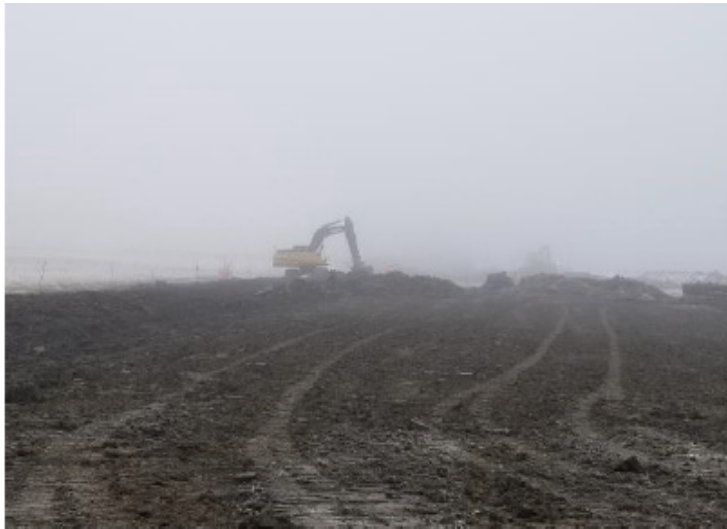
Levelling off ROW and clean up – km 221+920 – Nov 30, 2018

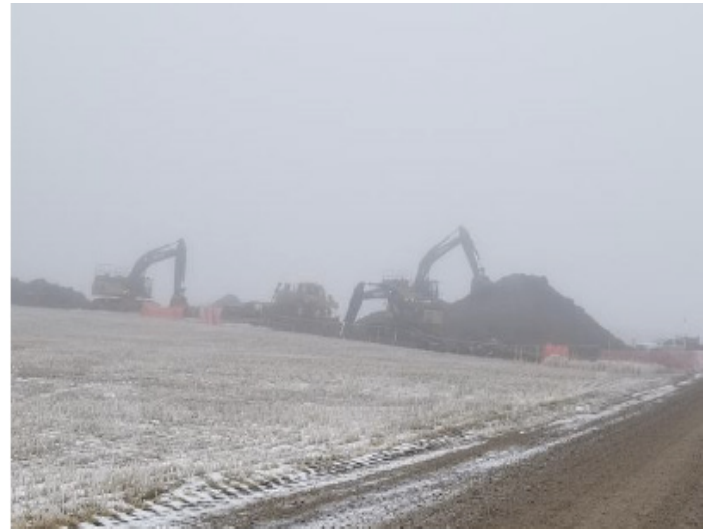
Digging tie-in section – km 262+631 – Nov 30, 2018

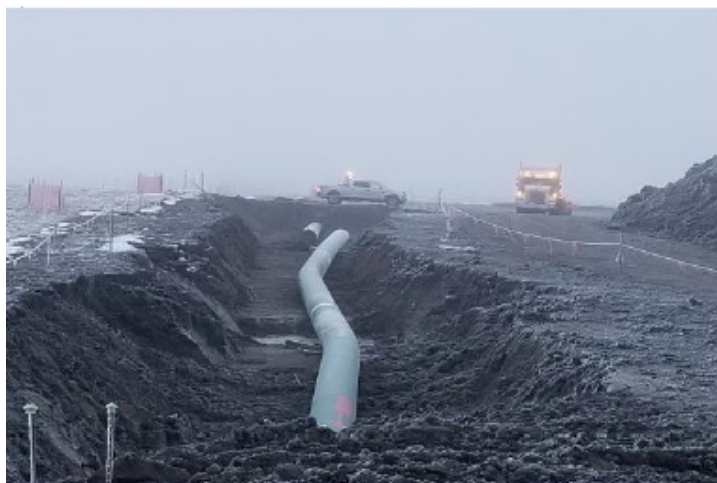
End tie-in – km 266+760 – Dec 1, 2018

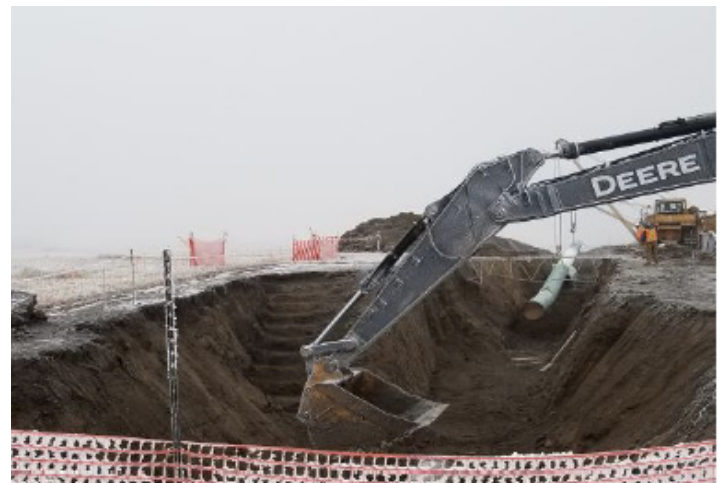
Lower in tie-in section under hotline – km 262+640– Dec 1, 2018

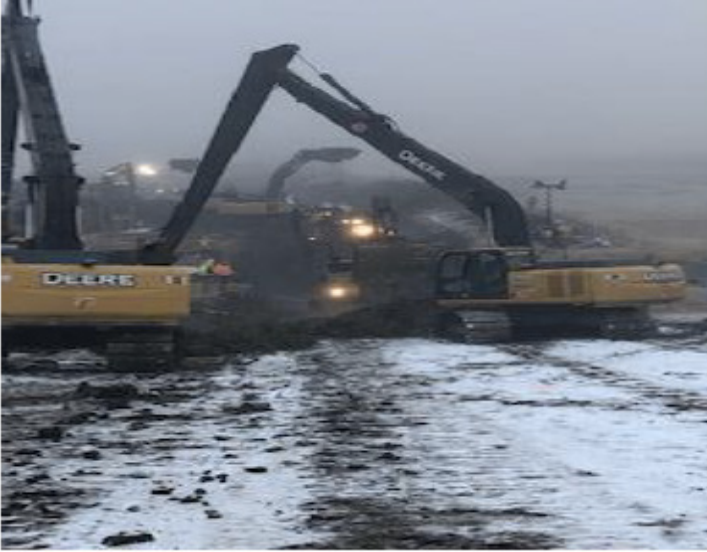
Heritage area and Creek crossing – SF 162 – Dec 1, 2018

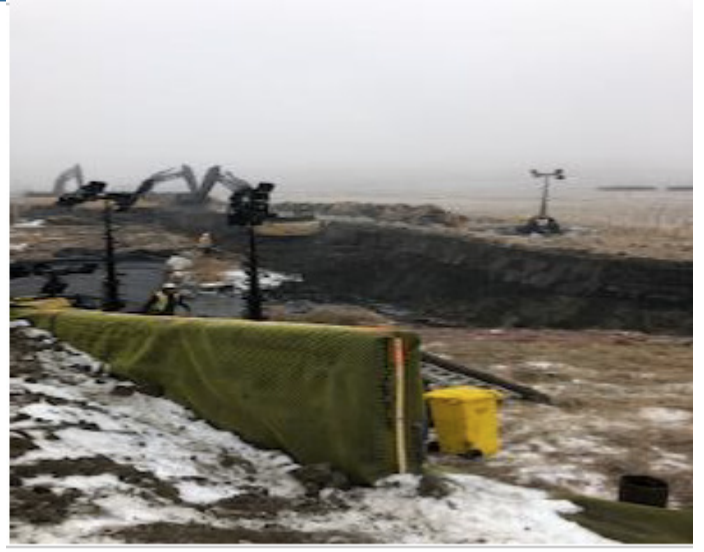
Excavator digging mainline ditch – SF 162 – Dec 1, 2018
