**SAMSON CREE NATION – MATRIX SOLUTIONS INC.  
PARTNERSHIP**

**ABORIGINAL CONSTRUCTION MONITORING**

**WEEKLY REPORT**

**OCTOBER 15<sup>TH</sup> - OCTOBER 20<sup>TH</sup>**

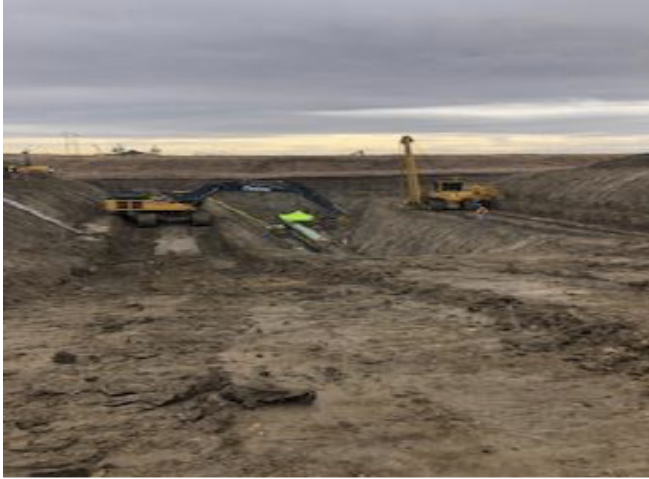
Track bore crew – km 193+300 – Oct 15, 2018

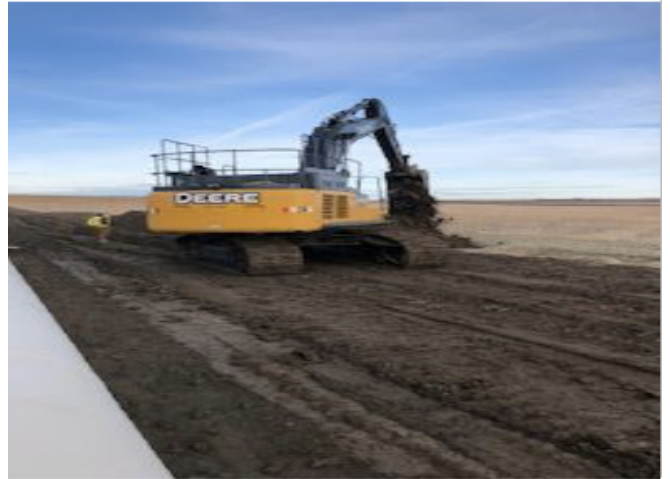
Excavator digging ditch for mainline crew – SF 103 – Oct 15, 2018

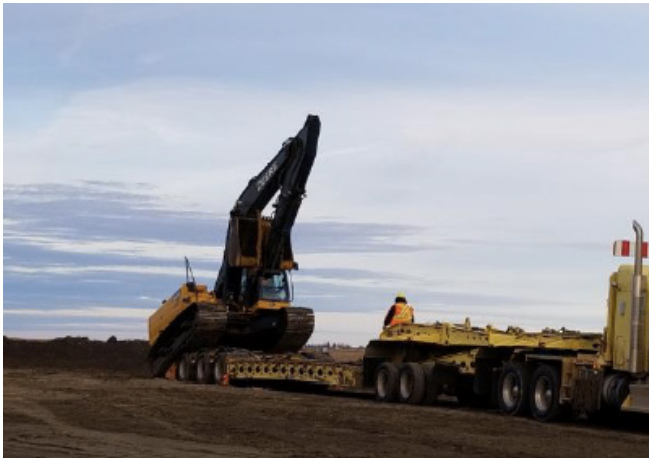
Loading equipment – km 266+700 – Oct 15, 2018

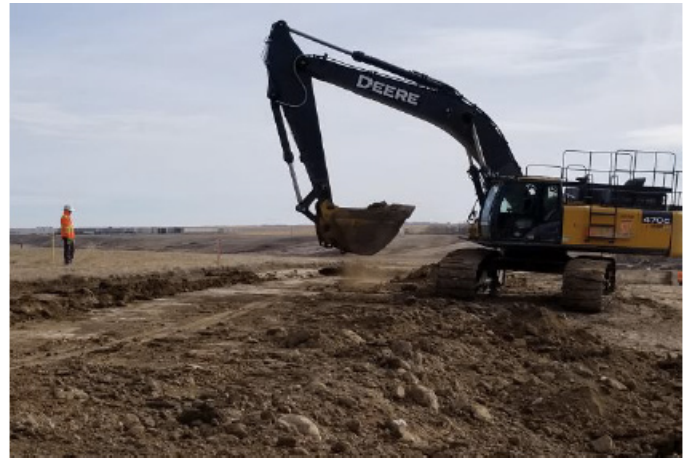
Grading sensitive area with Archaeologist onsite – km 254+300 – Oct 15, 2018

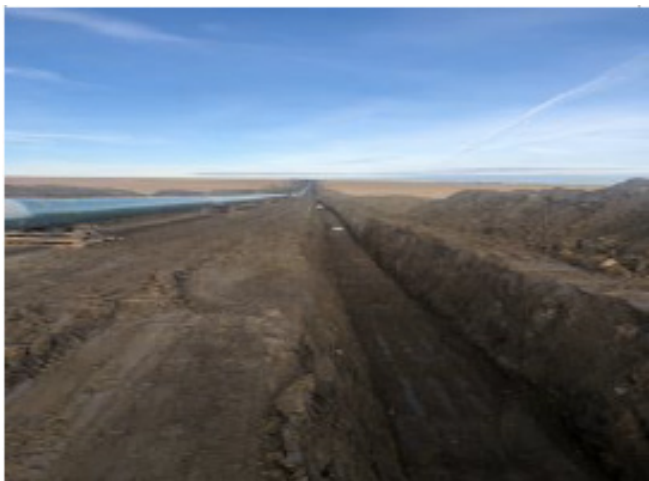
Ditched mainline – km 172 to 173 – Oct 15, 2018

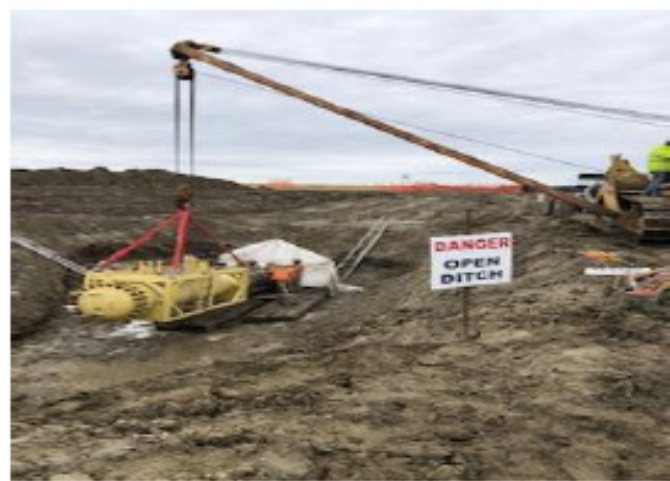
Welding on pig catcher – km 178+300 – Oct 15, 2018

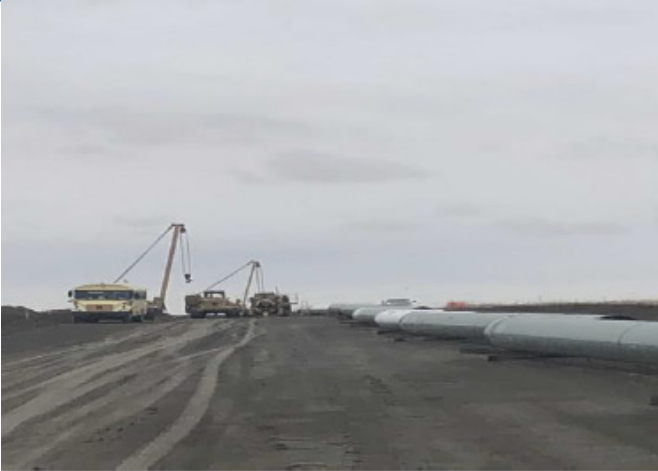
Bending crew working at the Native Prairie – km 220+300 – Oct 16, 2018

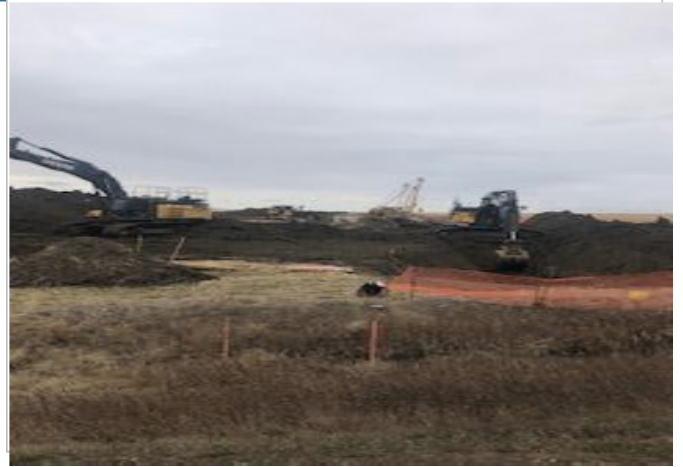
Bore pit dig– km 241+819 – Oct 16, 2018

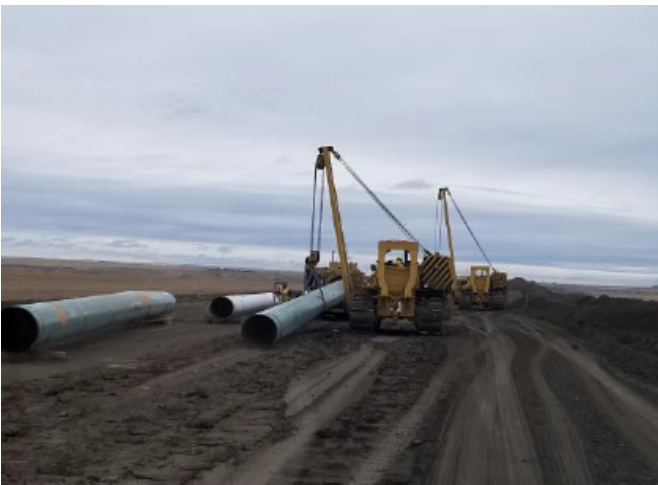
Bending Crew – km 220+200 – Oct 16, 2018

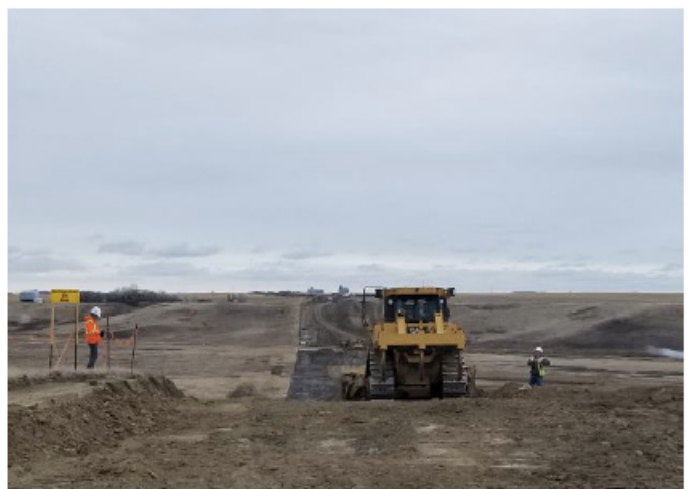
Grading– km 254+300 – Oct 16, 2018

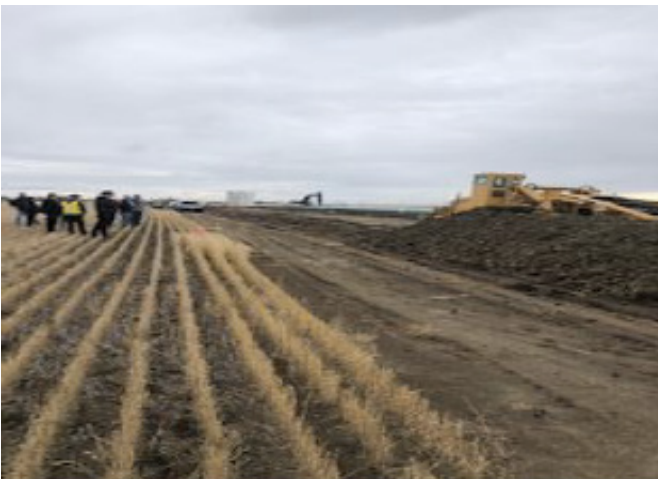
First Nation visitors on ROW– Km177+700 – Oct 16, 2018

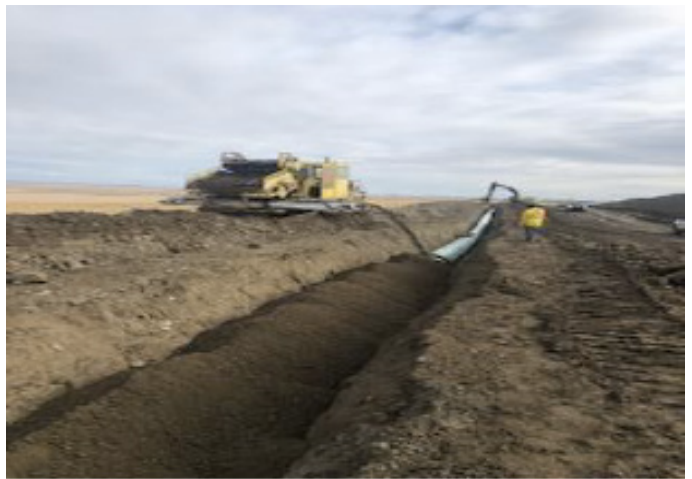
Shading mainline – km 172+670 – Oct 16, 2018

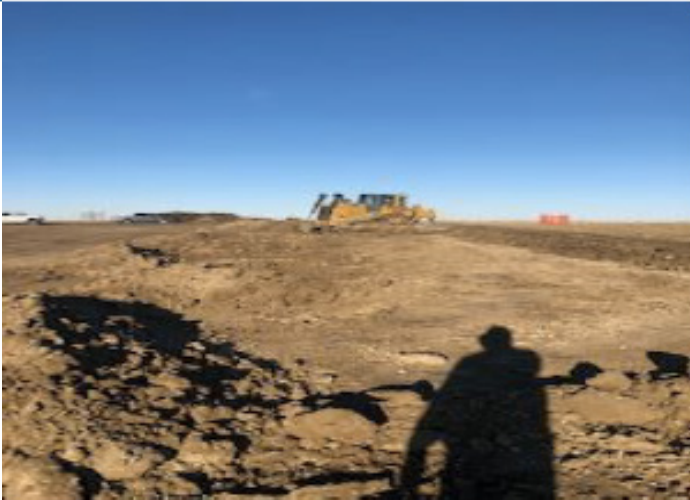
Dozer grading on Native Prairie – km 254+178 – Oct 17, 2018

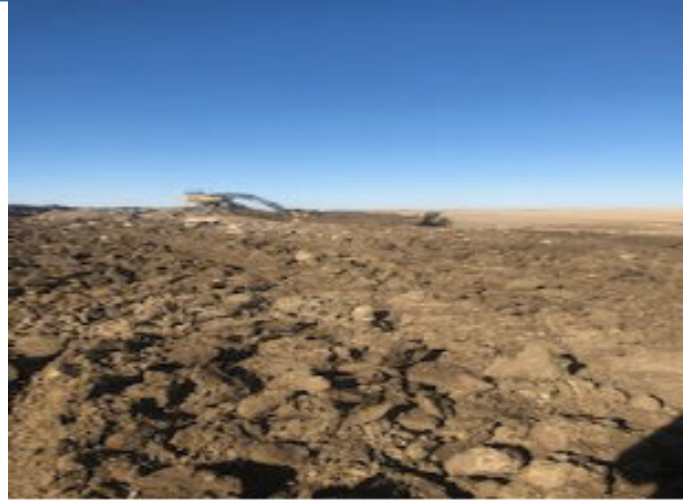
Grading and stock piling clay – km 253 – Oct 17, 2018

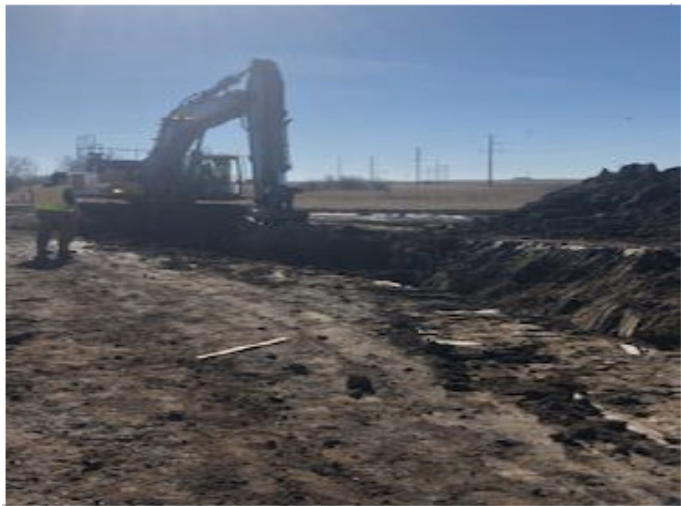
Excavator digging hot bend – SF 110 - Oct 17, 2018

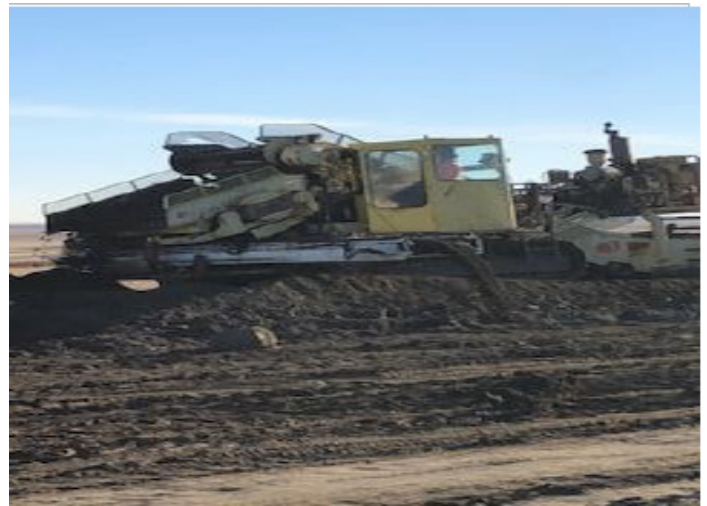
Ditcher working east – km 174+100– Oct 17, 2018

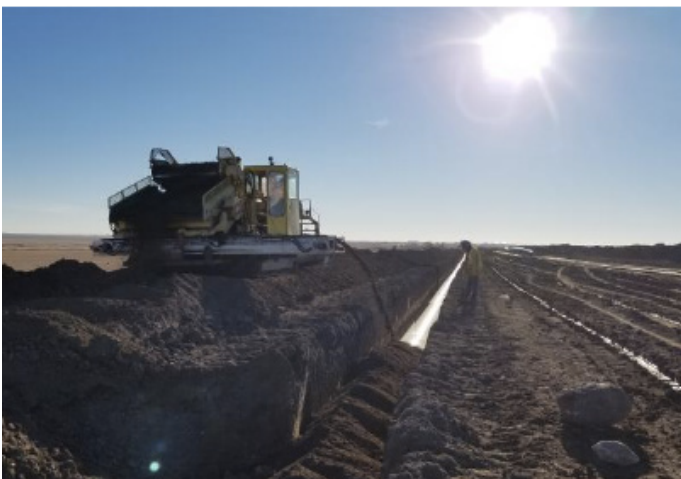
Shading pipe - km 173+900 – Oct 17, 2018

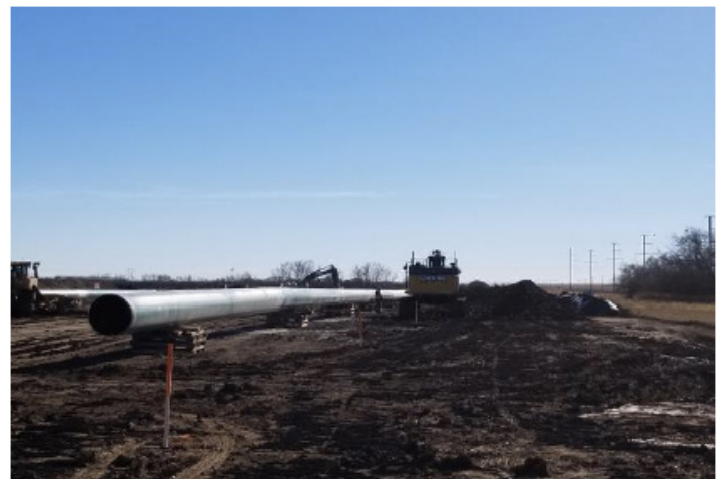
Digging ditch – km 179+830 – Oct 17, 2018

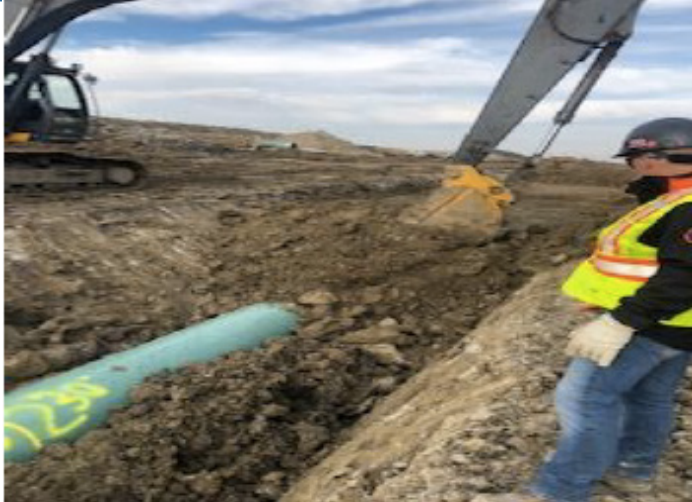
Excavator backfilling tie-in– km 152+640– Oct 18, 2018

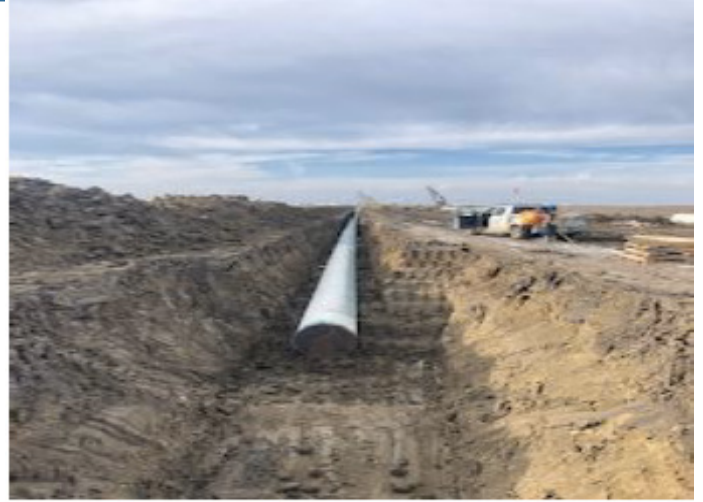
Mainline lowered into ditch– km 181+900 – Oct 18, 2018

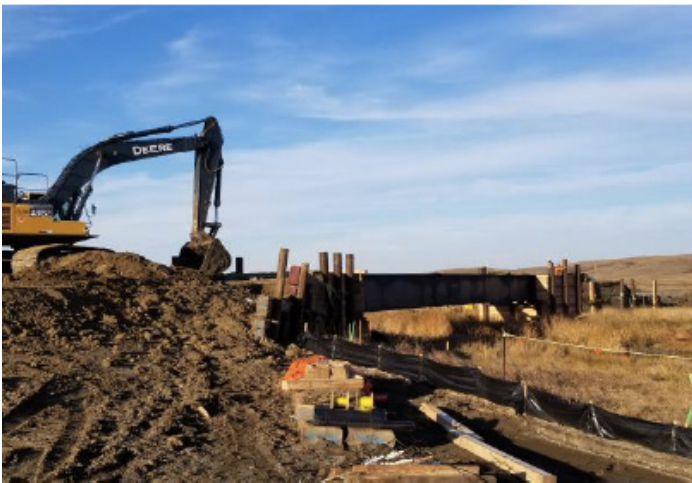
Working on bridge– km 255+150 – Oct 18, 2018

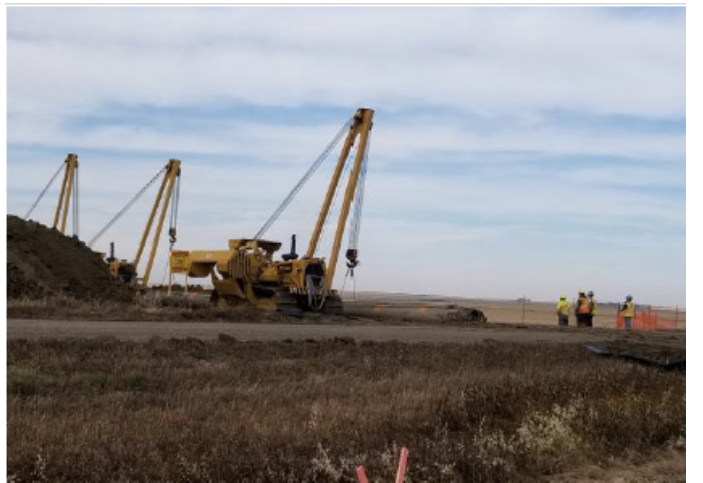
Prepping bore – km 249+105 - Oct 18, 2018

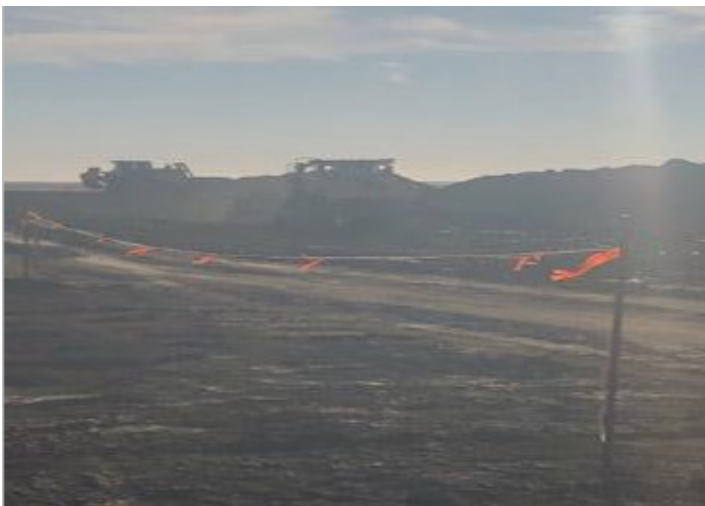
Dozers cutting soil – SF 162 – Oct 18, 2018

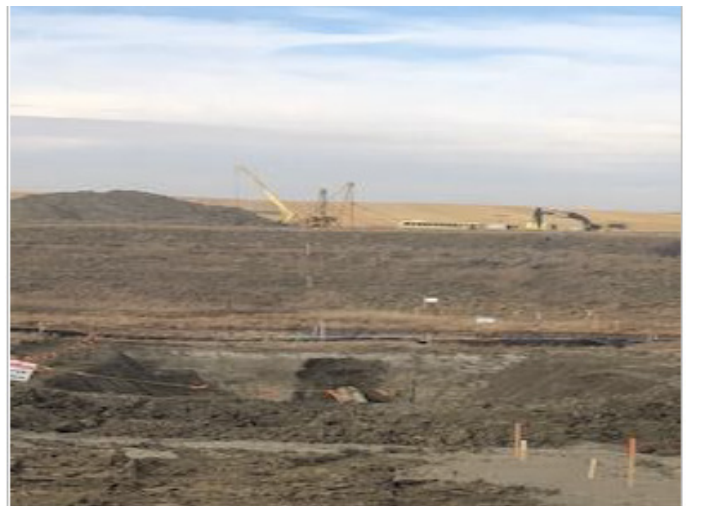
Track bore at railway crossing– km 193+200 – Oct 18, 2018

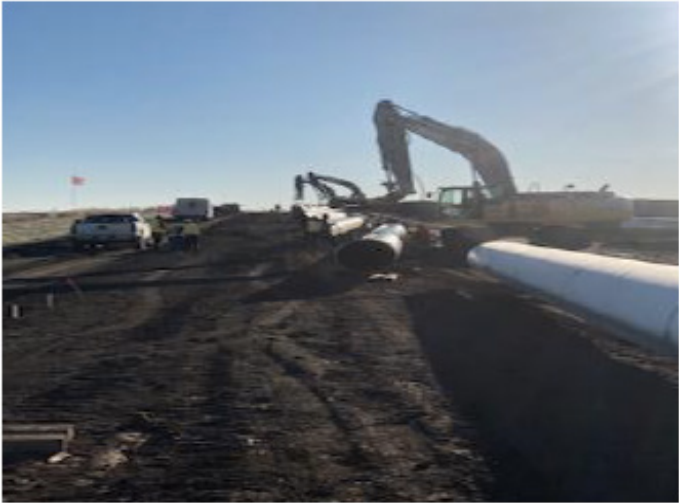
End prep crew - km 214+700 – Oct 19, 2018

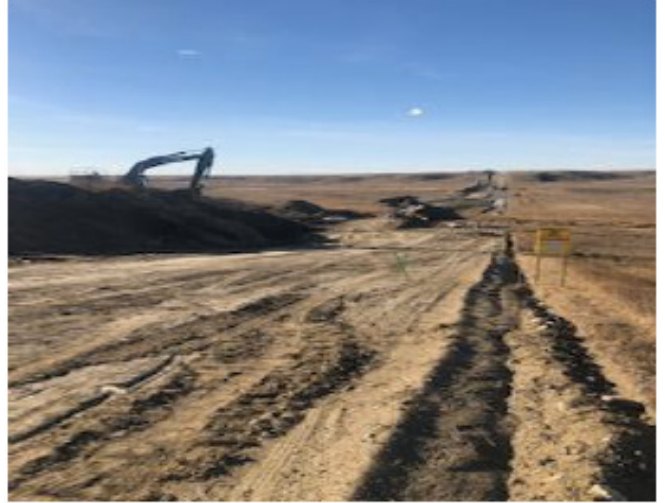
Excavator moving spill pile – km 255+180 – Oct 19, 2018

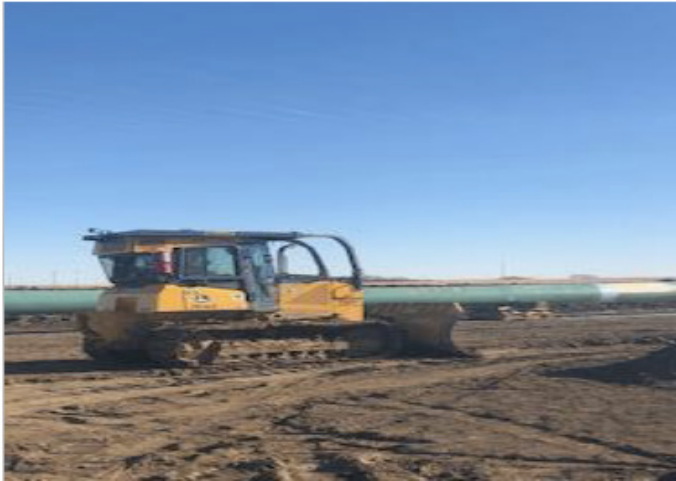
Dozer clearing work space – SF 111 – Oct 19, 2018

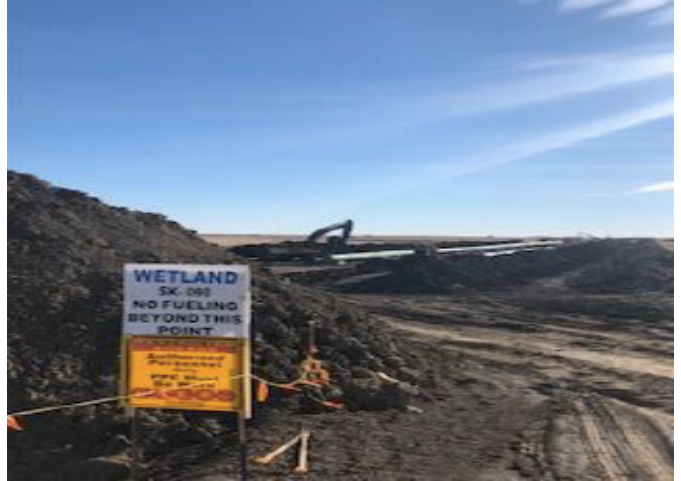
Digging mainline ditch – km 184+050– Oct 19, 2018

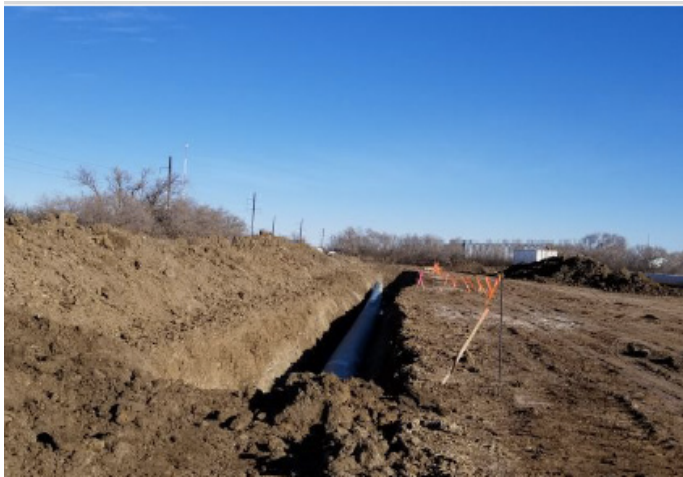
Lowered in pipe - km 179+850 – Oct 19, 2018

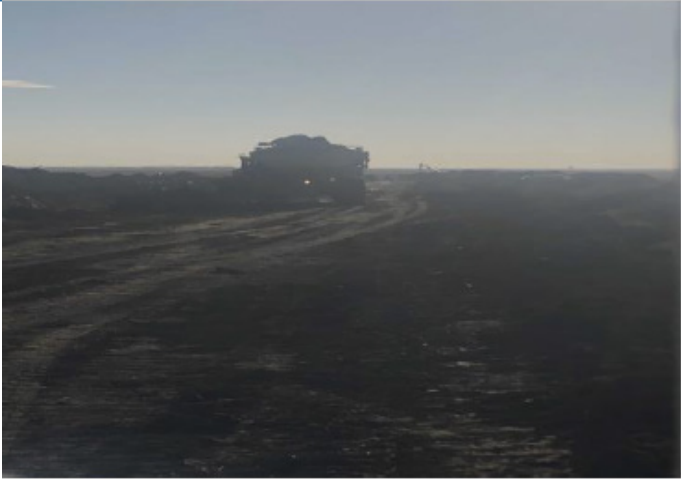
Load of clay for tie-in - km 153+800 – Oct 20, 2018

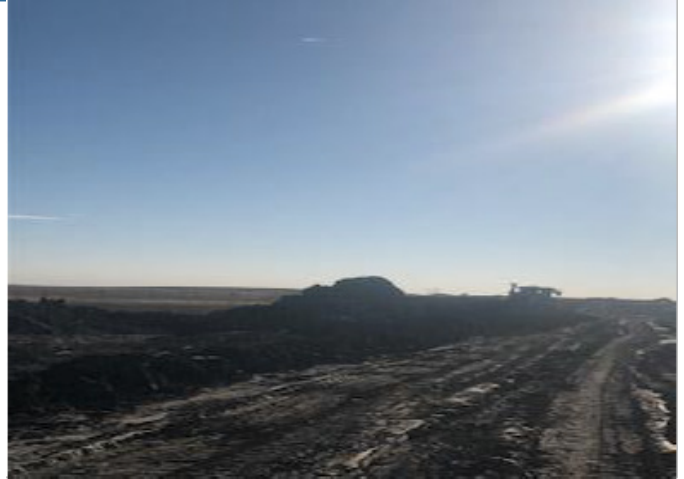
Dozer pushing clay into tie-in backfill – km 151+800 – Oct 20, 2018

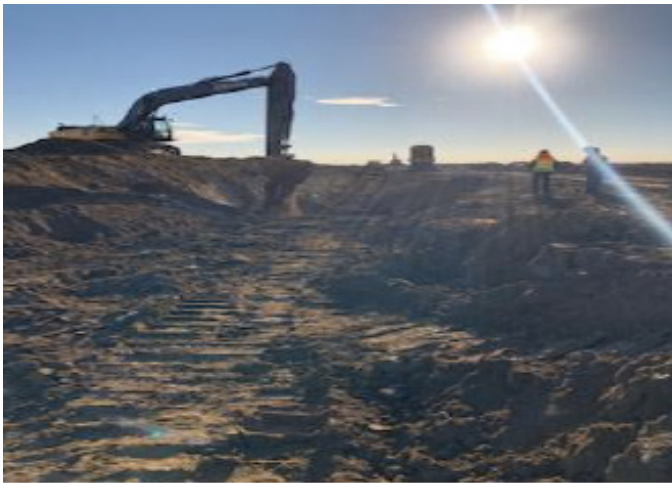
Backfill and shading bell holle - km 151+840 – Oct 20, 2018

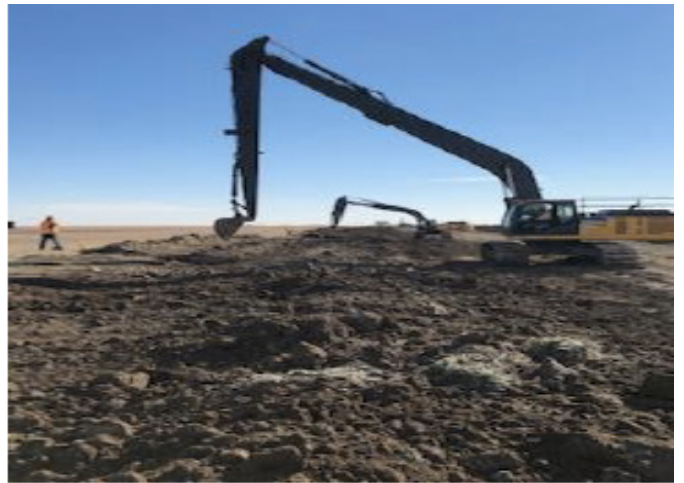
Main line backfill crew pulling soil – km 185+100 – Oct 20, 2018
