**SAMSON CREE NATION – MATRIX SOLUTIONS INC.  
PARTNERSHIP**

**ABORIGINAL CONSTRUCTION MONITORING**

**WEEKLY REPORT**

**OCTOBER 22<sup>ND</sup> - OCTOBER 27<sup>TH</sup>**

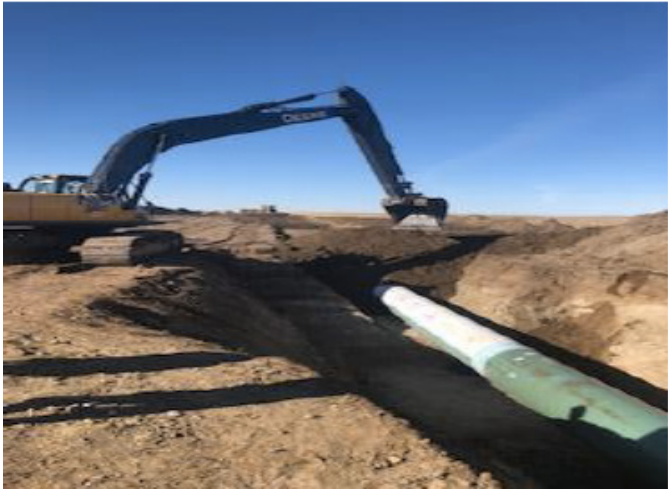
Excavator shading final tie-in backfill – km 155+700 – Oct 22, 2018

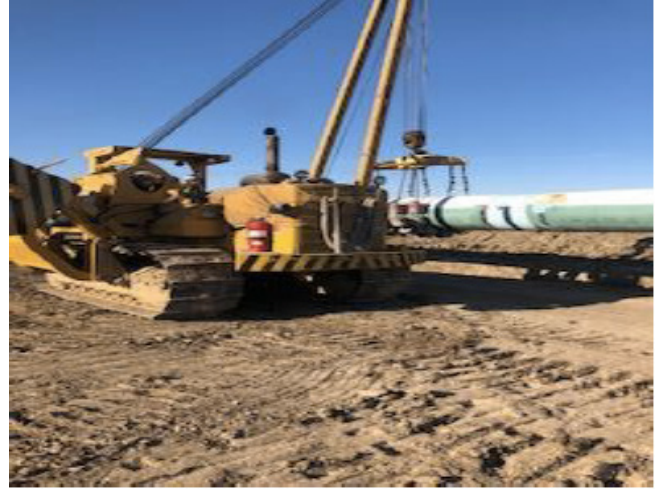
Lower-in crew – km 189+300 – Oct 22, 2018

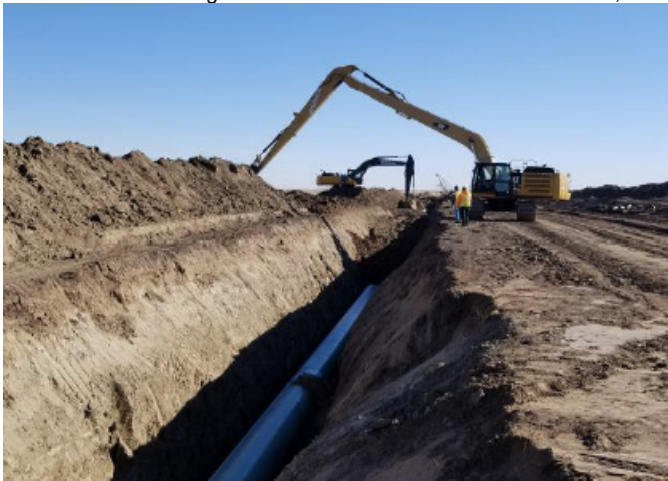
Backfill pipe – km 155+600 – Oct 22, 2018

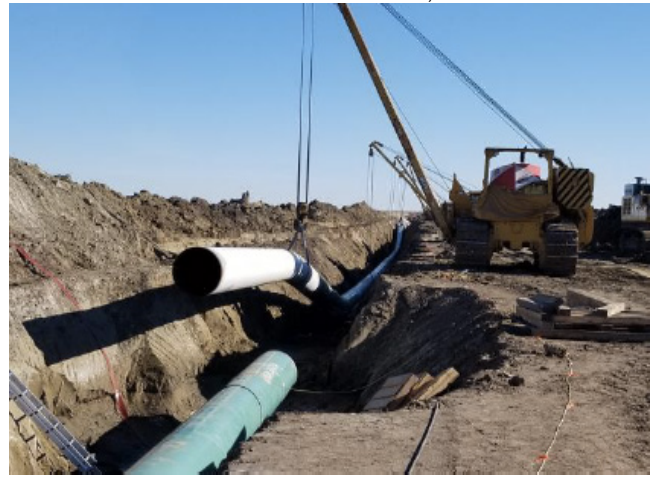
Welding tie-in section – km 155+800 – Oct 22, 2018

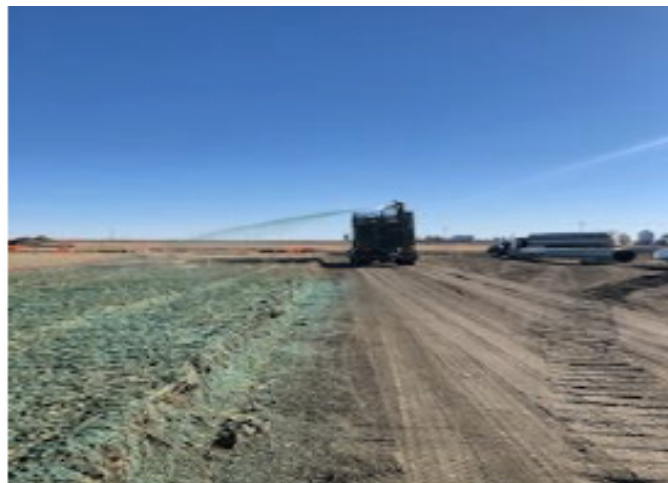
Hydro mulch being sprayed – km 223+400 – Oct 22, 2018

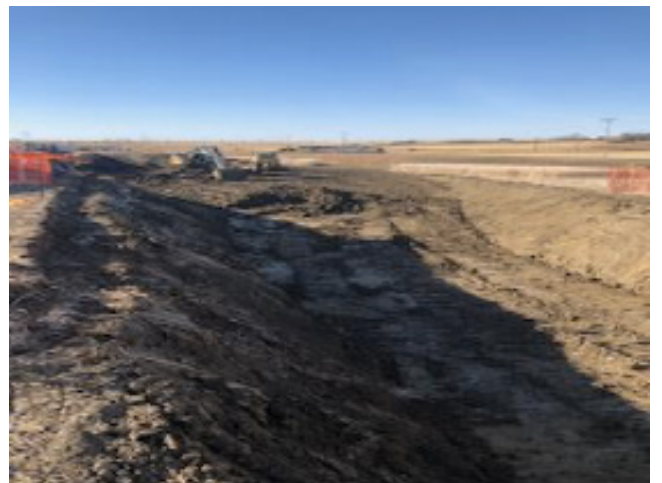
Cutting on ROW for bore crew – km 196+370 – Oct 22, 2018

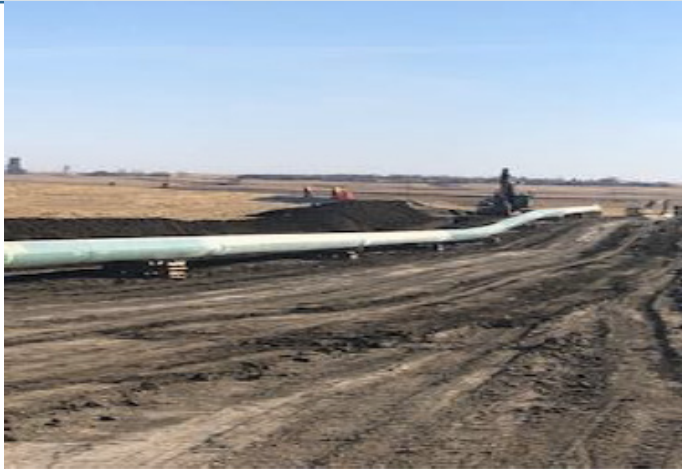
Laying geotec for ditch – km 192+700 – Oct 23, 2018

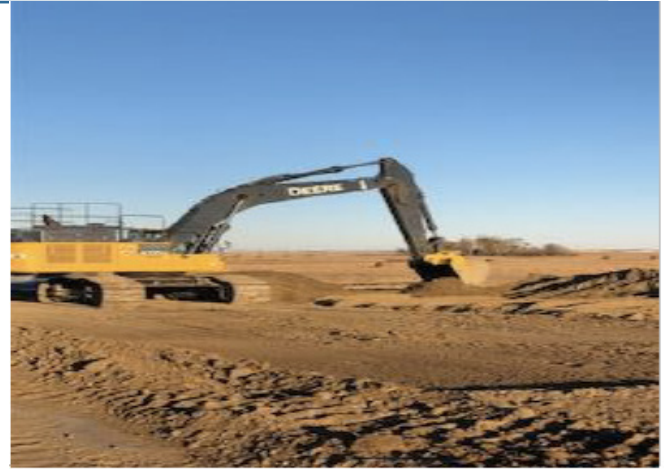
Excavator cleaning spill pile– km 159+250 – Oct 23, 2018

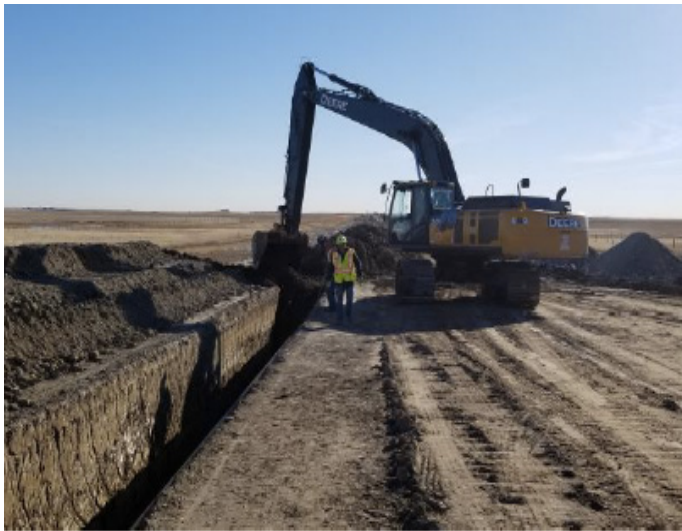
Shading pipe – km 156+250 – Oct 23, 2018

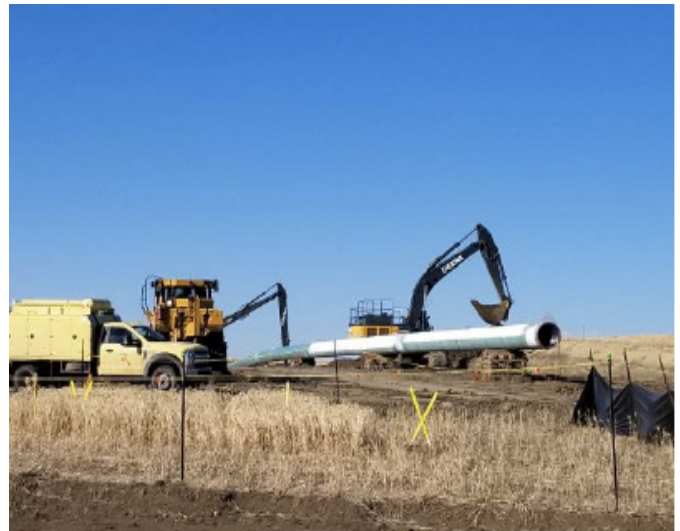
Digging ditch and crumbling ditch– km 192+800 – Oct 23, 2018

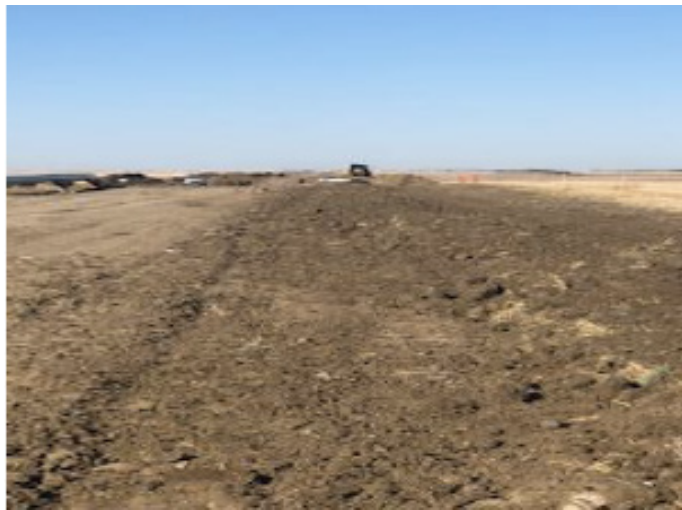
Dozer shaping mainline ditch– Km188+950 – Oct 23, 2018

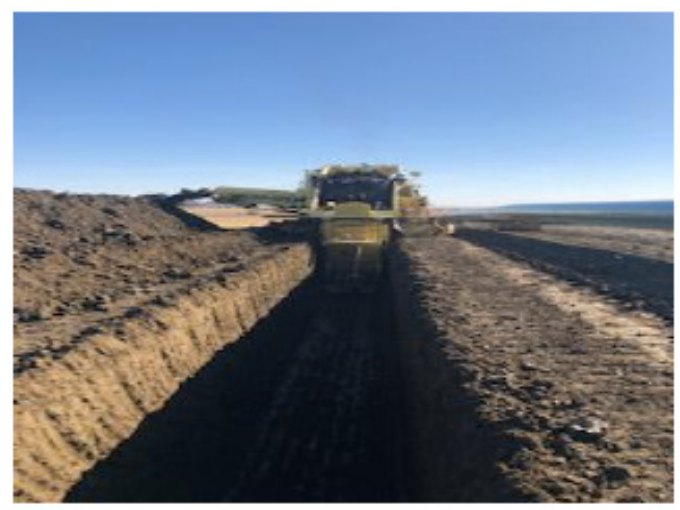
Wheel ditcher digging mainline – km 194+600 – Oct 23, 2018

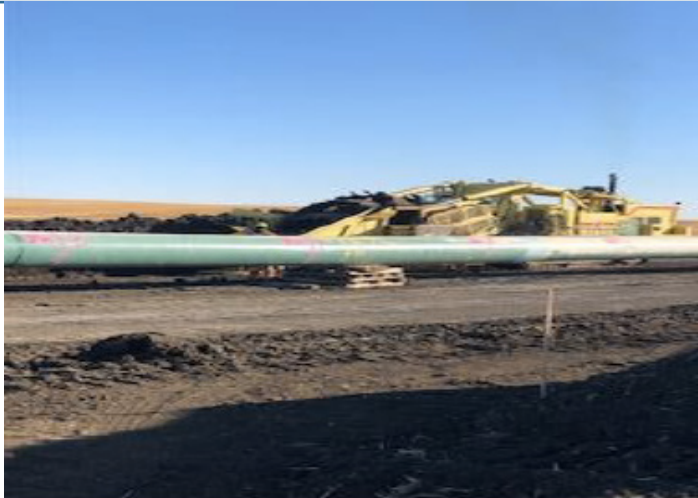
Ditching wheel working through wetland – km 197+850 – Oct 24, 2018

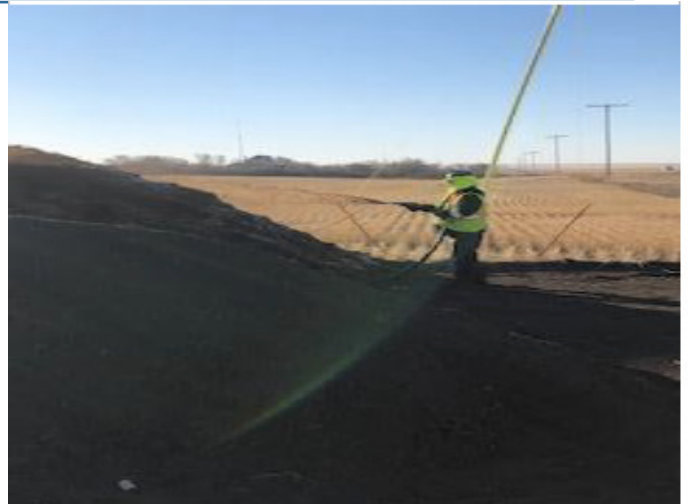
Crew tactifying – km 209+900 – Oct 24, 2018

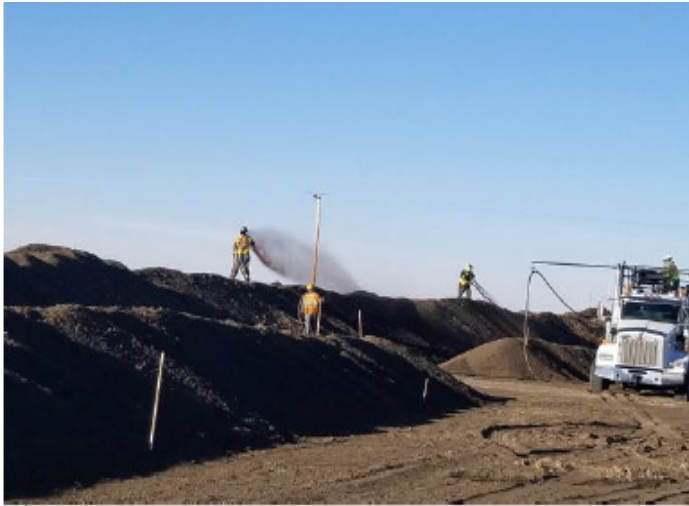
Crew tactifying topsoil – km 209+950 - Oct 24, 2018

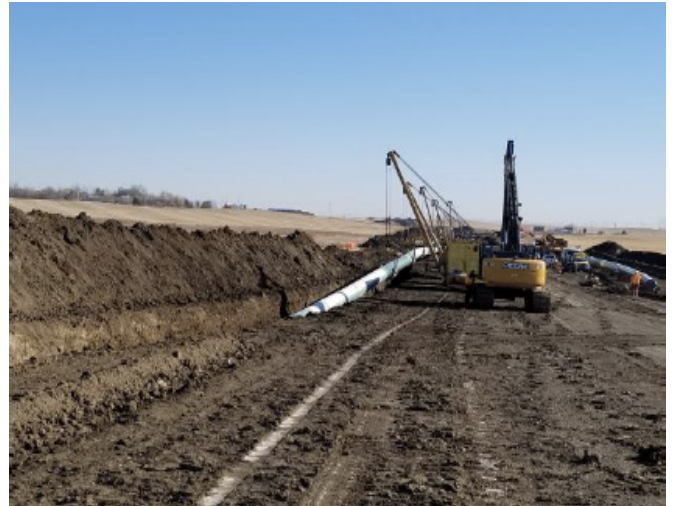
Lowering in pipe – km 194+850– Oct 24, 2018

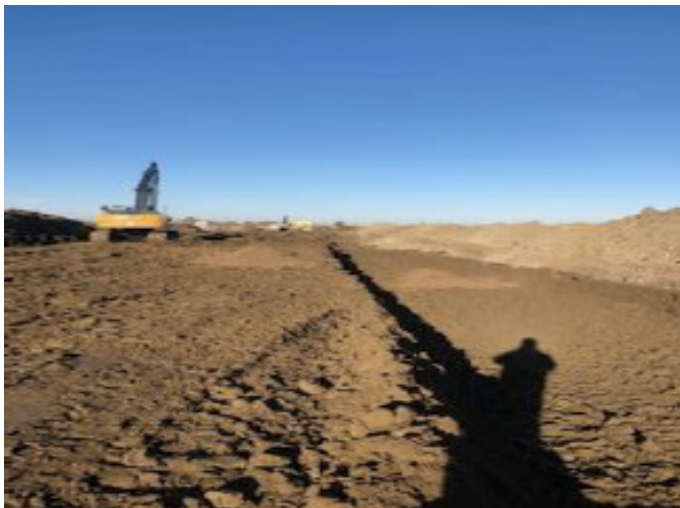
Backfilling tie in ditch - km 156+270 – Oct 24, 2018

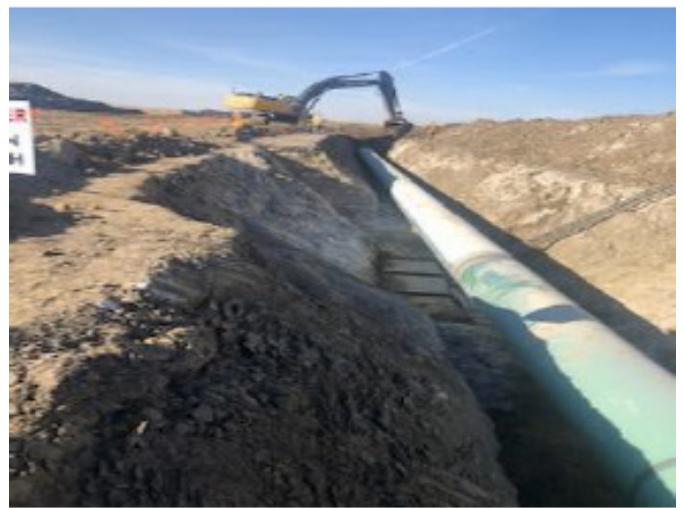
Shading tie-in ditch – km 157+430 – Oct 24, 2018

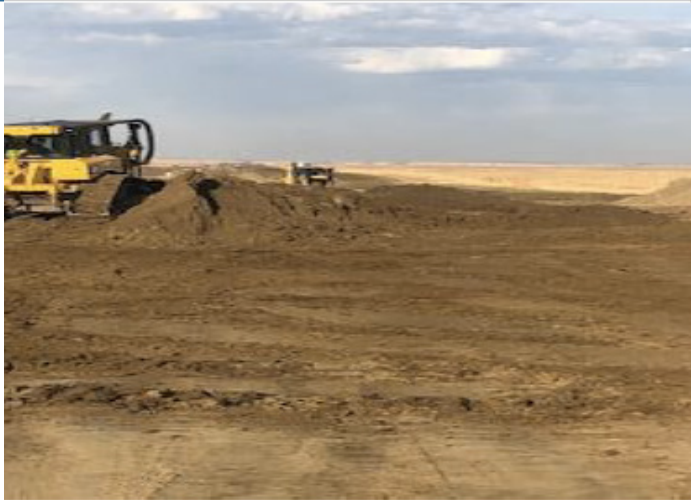
Final tie-in backfill– km 157+700– Oct 25, 2018

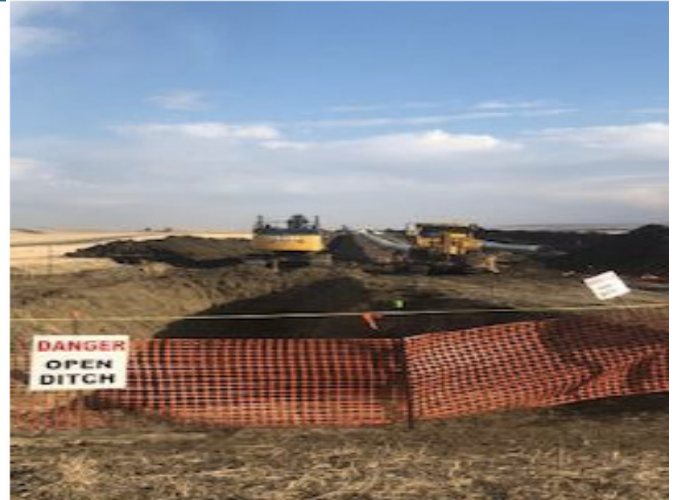
Excavator digging ditch– km 201+000 – Oct 25, 2018

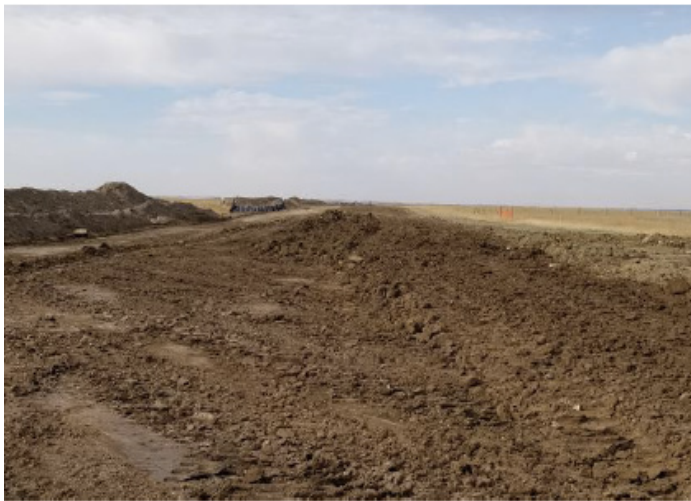
Tie-in backfilled area– km 157+600 – Oct 25, 2018

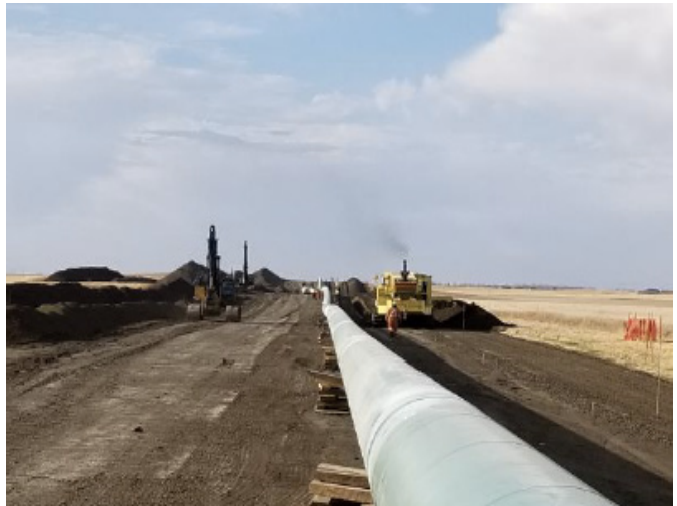
Ditching wheel – km 200+650 - Oct 25, 2018

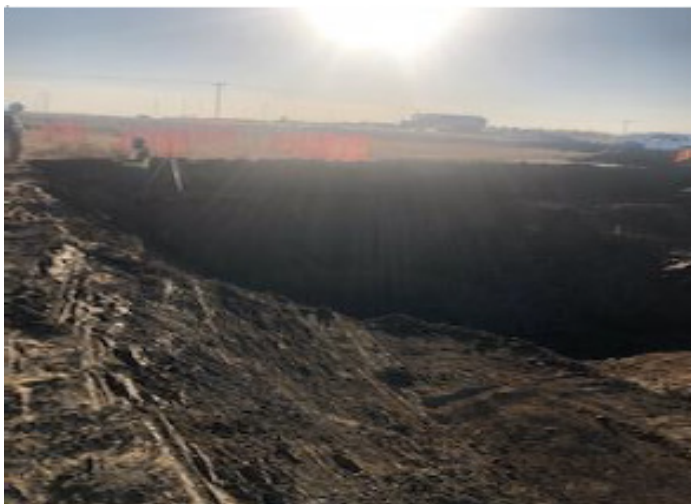
Bore bay being dug – km 259+100 – Oct 25, 2018

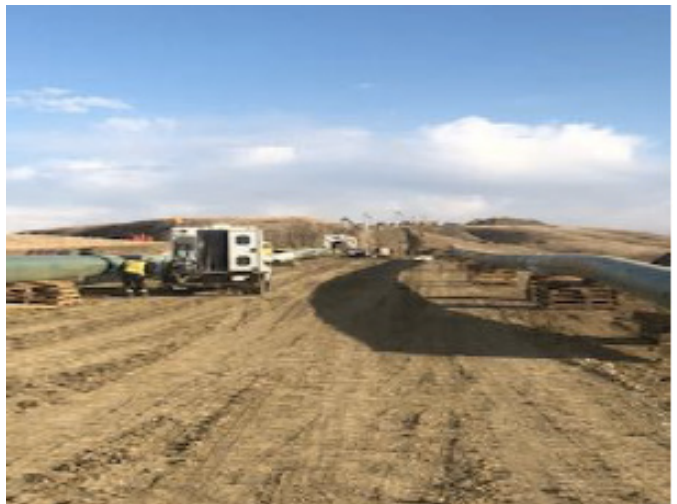
Last weld – km 222+600 – Oct 25, 2018

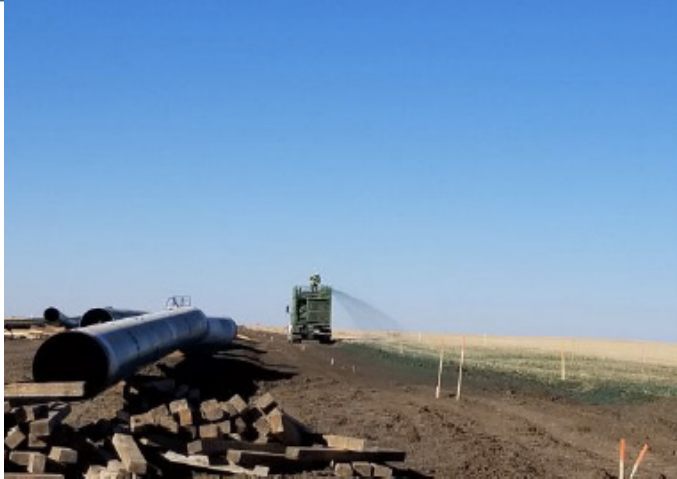
Hydro mulch - km 238+170 – Oct 26, 2018

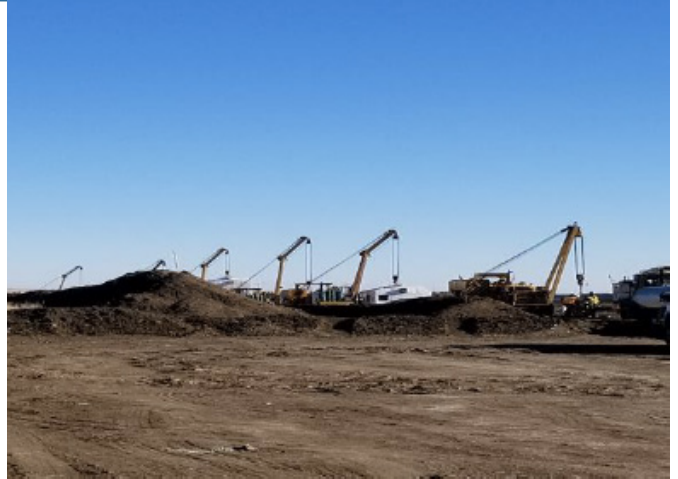
Excavator moving spill pile – km 255+180 – Oct 26, 2018

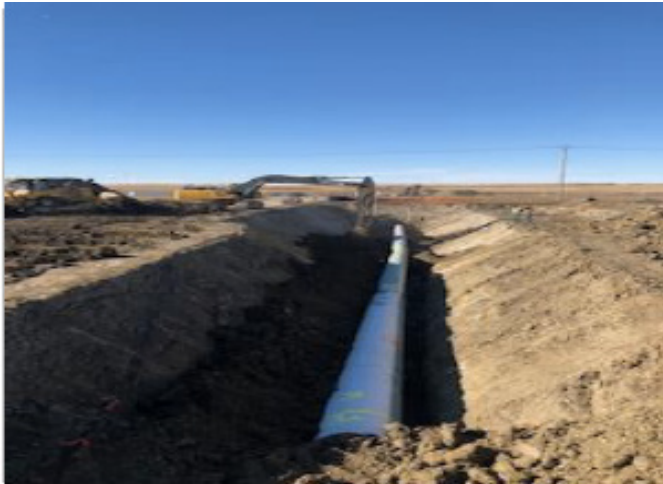
Tie-in backfill – km 170+880 – Oct 26, 2018

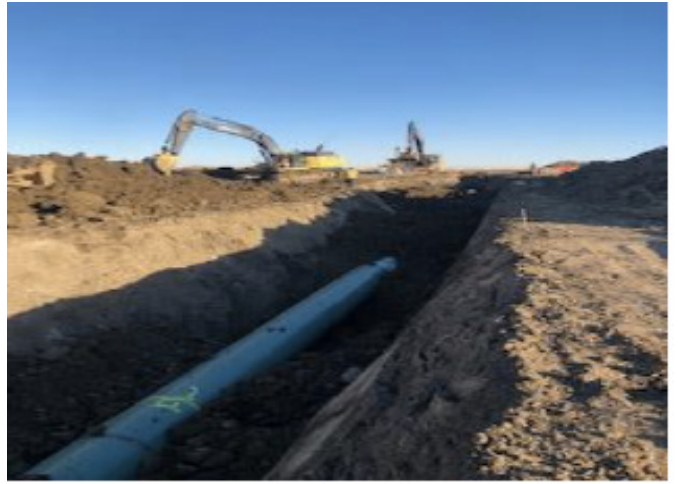
Backfill tie-in (south) – SF 111– Oct 26, 2018

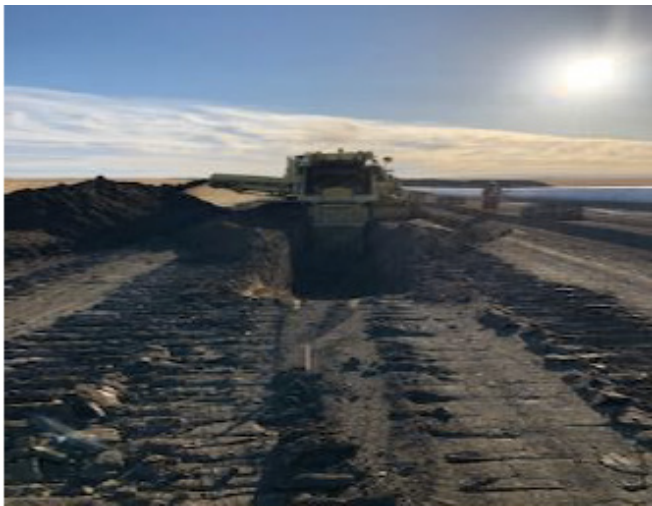
Ditcher wheel - km 207+052 – Oct 27, 2018

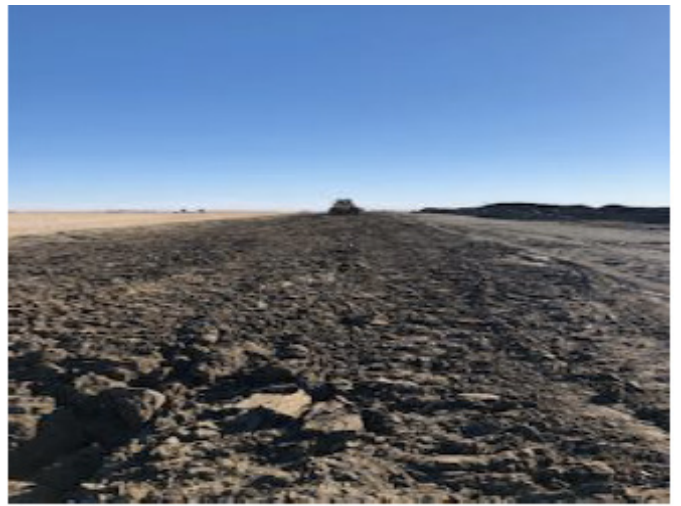
D6T following backfill excavators – km 201+112 – Oct 27, 2018

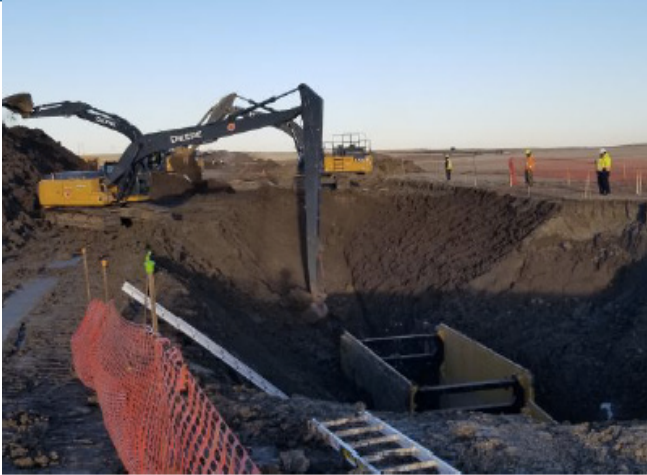
Digging ditch - km 195+580 – Oct 27, 2018

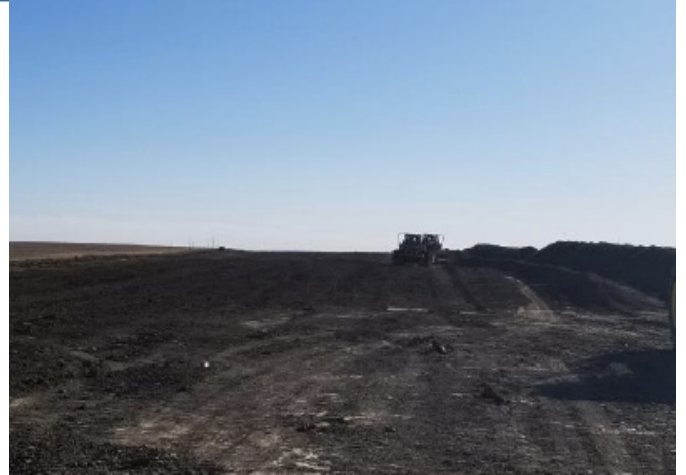
Clean up – km 148+100 – Oct 27, 2018

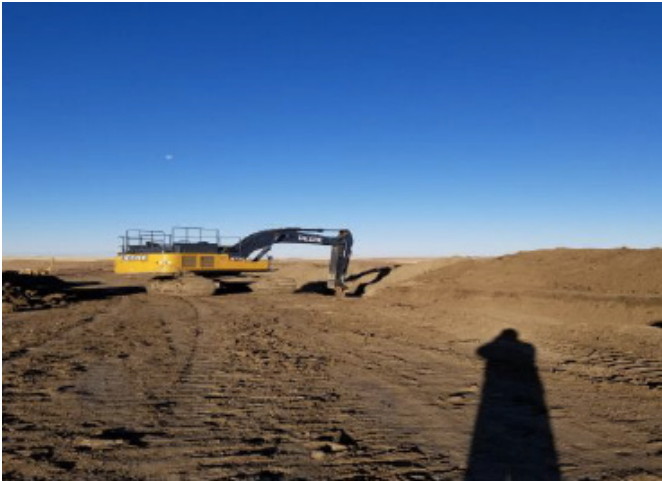
Excavator digging ditch - km 193+050 – Oct 27, 2018

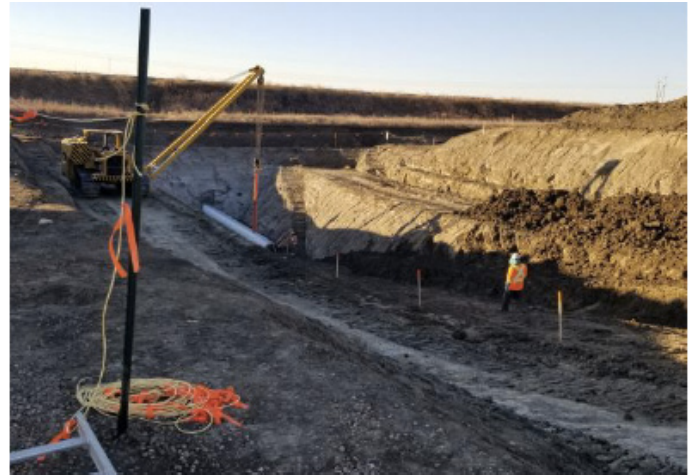
Bore bay – km 196+283 – Oct 27, 2018
