**SAMSON CREE NATION – MATRIX SOLUTIONS INC.  
PARTNERSHIP**

**ABORIGINAL CONSTRUCTION MONITORING**

**WEEKLY REPORT**

**OCTOBER 29<sup>TH</sup> - NOVEMBER 3<sup>RD</sup>**

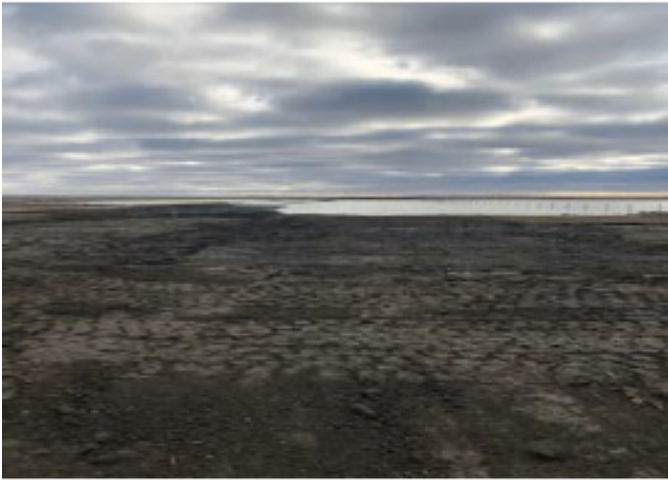
Reclaimed wetland after mainline was installed - km 152+700 - Oct 29, 2018

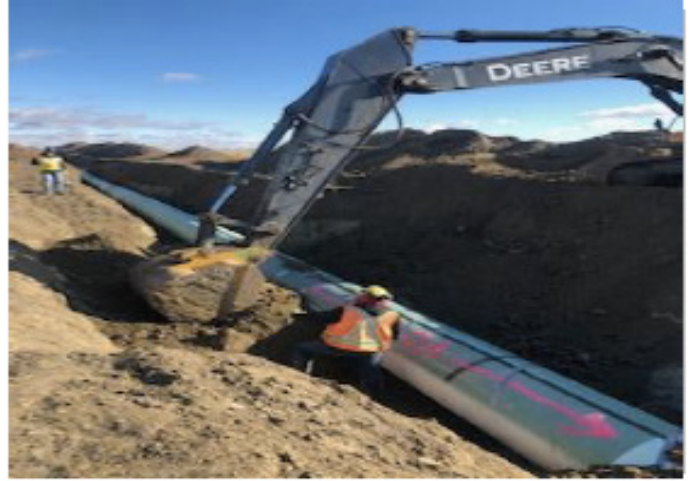
Excavator packing clay into bell hole - km 171+064 - Oct 29, 2018

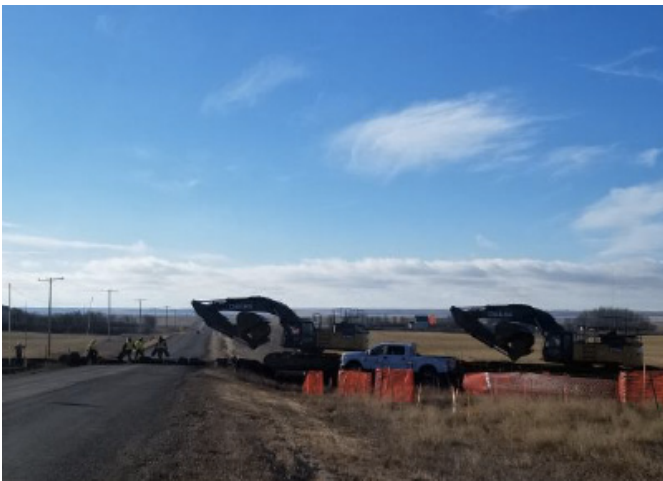
Crossing equipment – km 209+789 – Oct 29, 2018

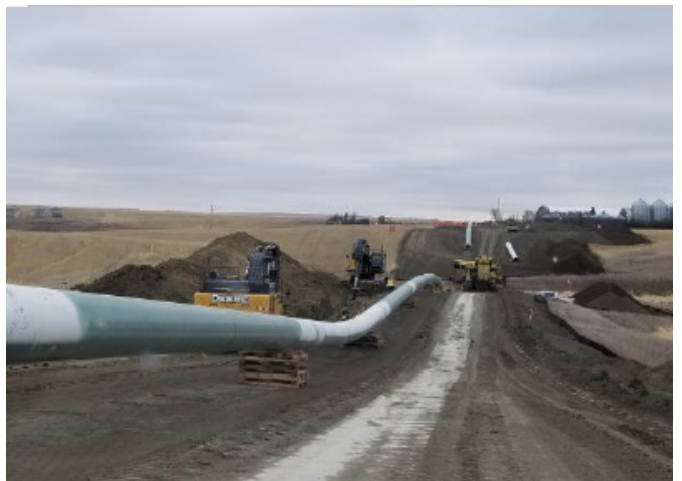
Digging ditch– km 211+100 – Oct 29, 2018

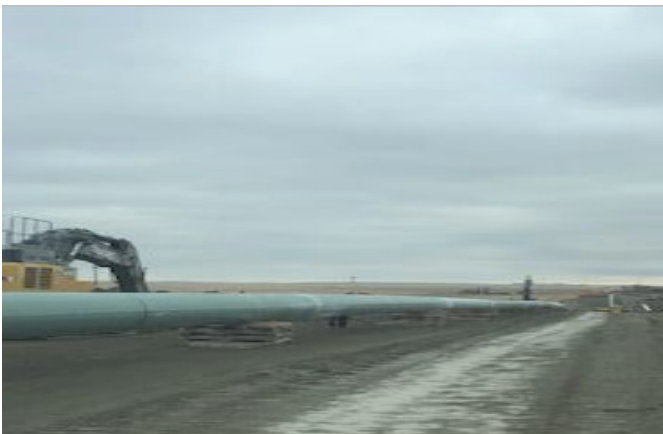
Excavators digging mainline ditch – km 210+900 – Oct 29, 2018

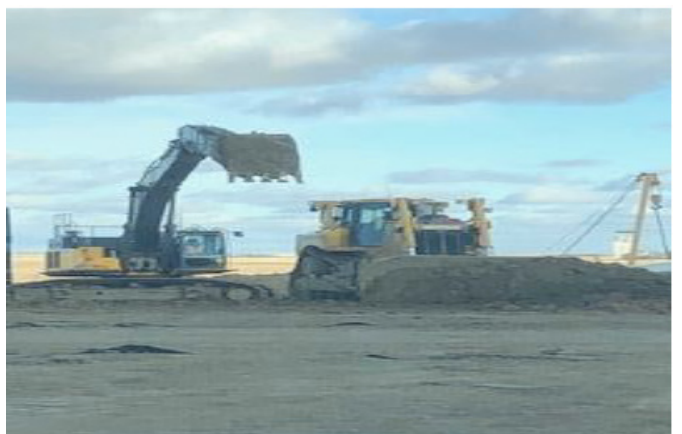
Excavator digging ditch – SF 120 – Oct 29, 2018

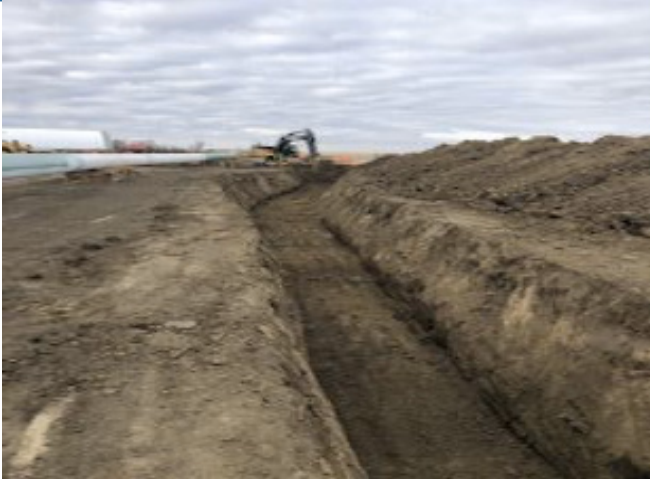
Excavator digging out bends in mainline ditch– km 211 – Oct 30, 2018

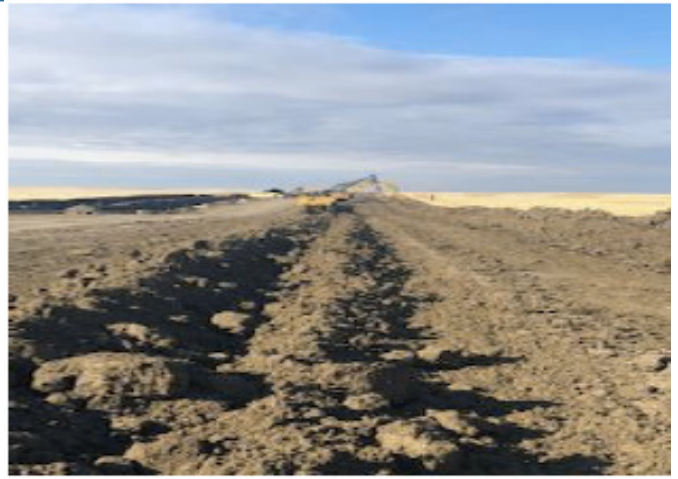
Shading crew pulling soil– km 209+200 – Oct 30, 2018

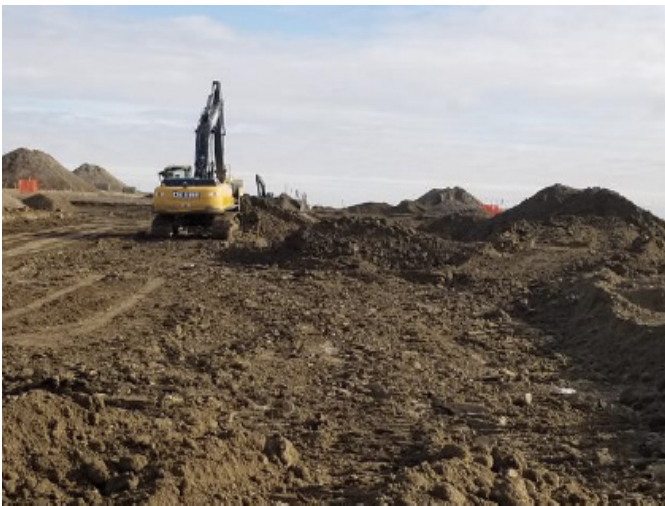
Backfill tie-in – km 171+600 – Oct 30, 2018

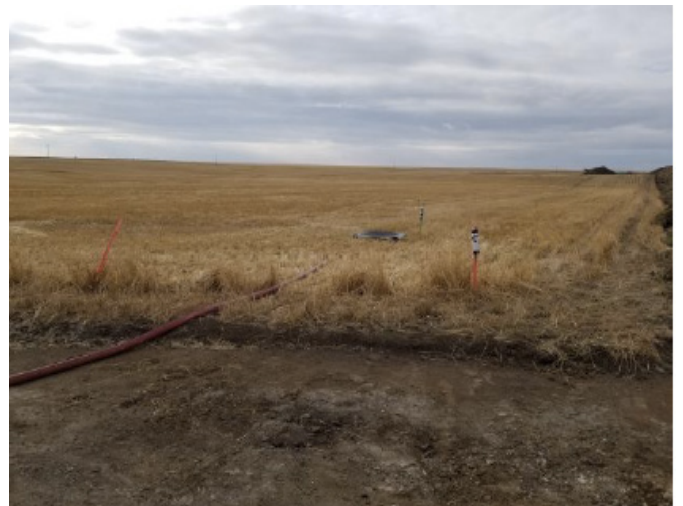
Discharge hose for pumping water– km 175+250 – Oct 30, 2018

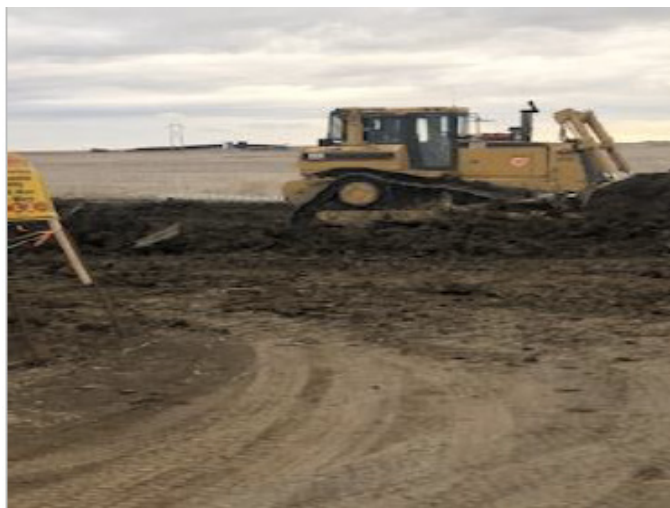
Dozer pushing clay– Km183+007 – Oct 30, 2018

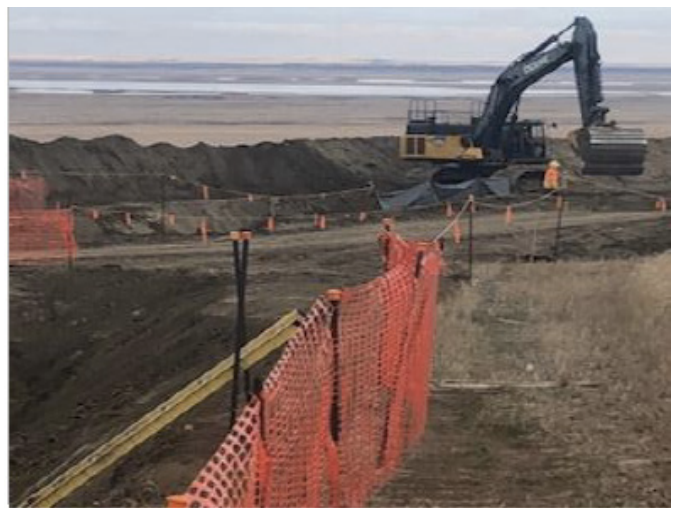
Excavator digging bend for tie-in– km 172+140 – Oct 30, 2018

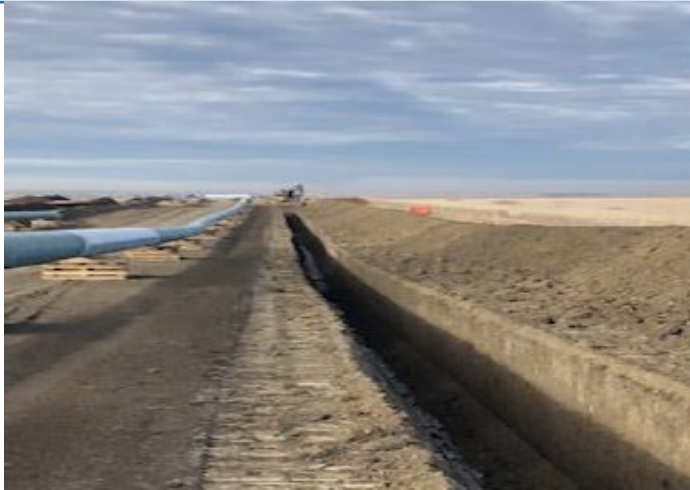
Ditch before lowering in – km 218+900 – Oct 31, 2018

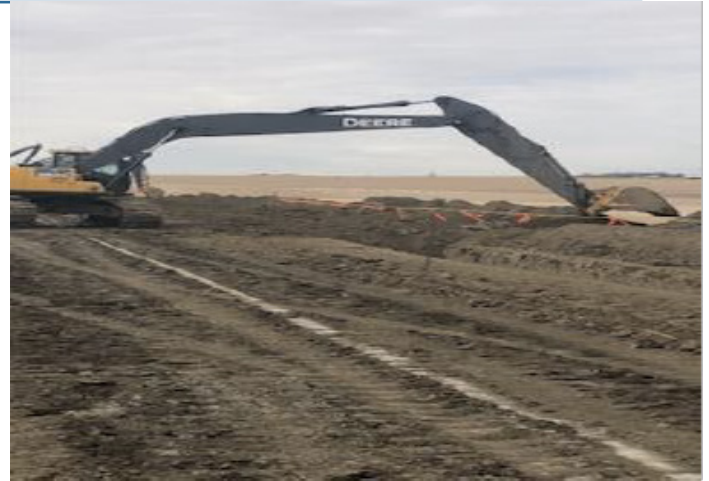
Excavator shading pipe – km 213+300 – Oct 31, 2018

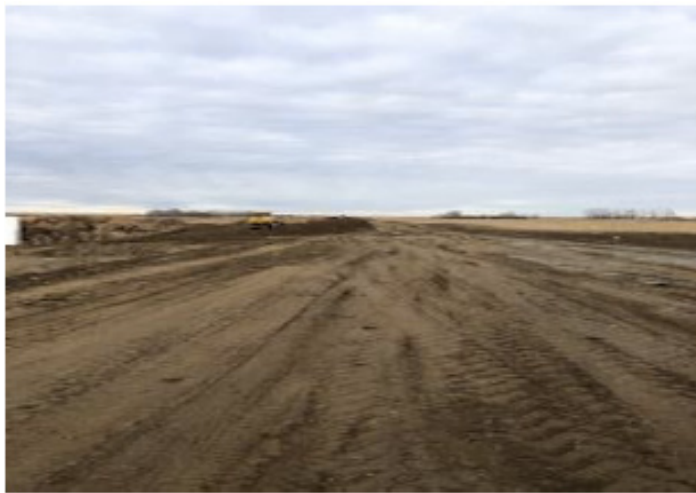
Dozer reclaiming natural grade – km 162+900 - Oct 31, 2018

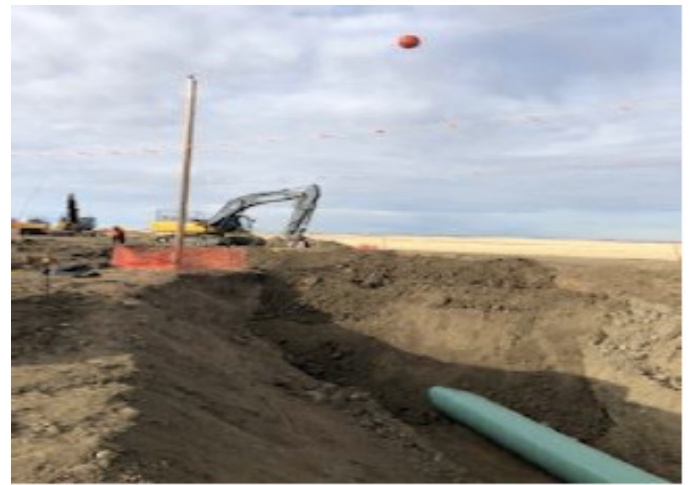
Open cut on access road – SF 115– Oct 31, 2018

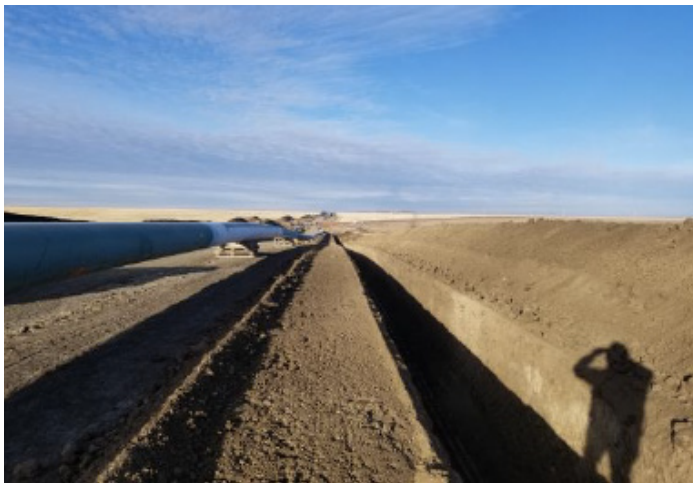
Ditch - km 218+900 – Oct 31, 2018

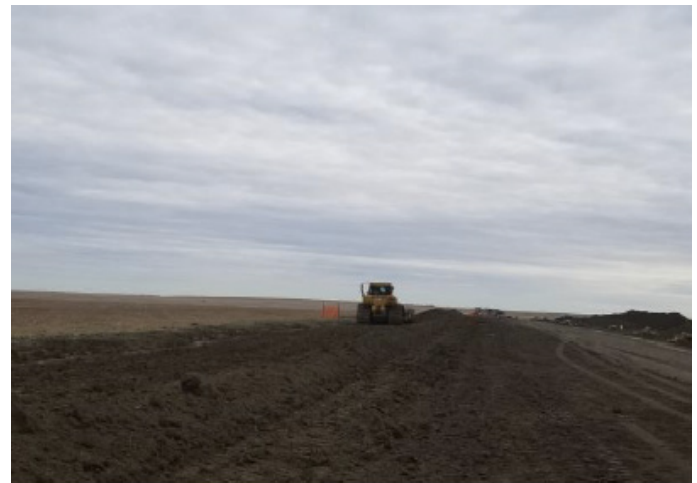
Dozer moving dirt – km 212+200 – Oct 31, 2018

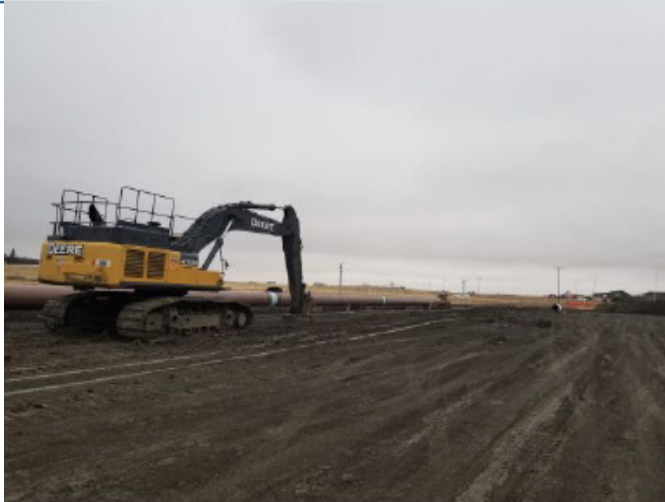
Pulling bore– km 196+000– Nov 1, 2018

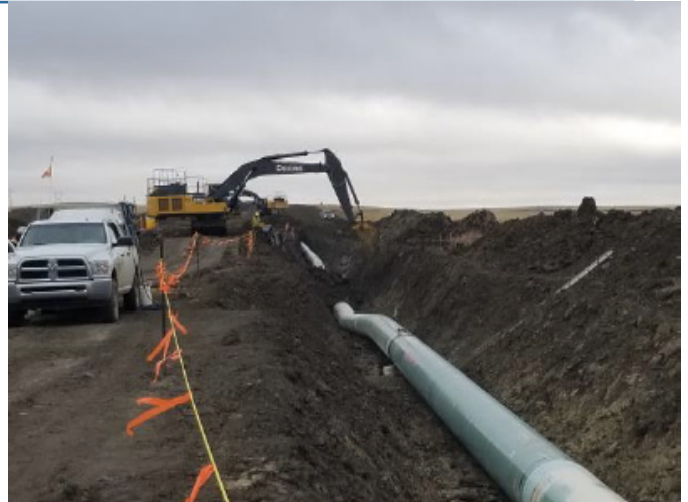
Shading and backfill tie-in– km 195+200 – Nov 1, 2018

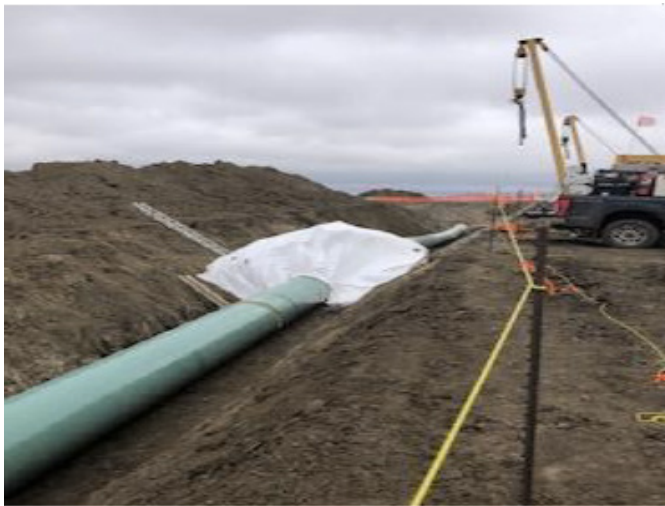
Final tie-in weld – SF 113 – Nov 1, 2018

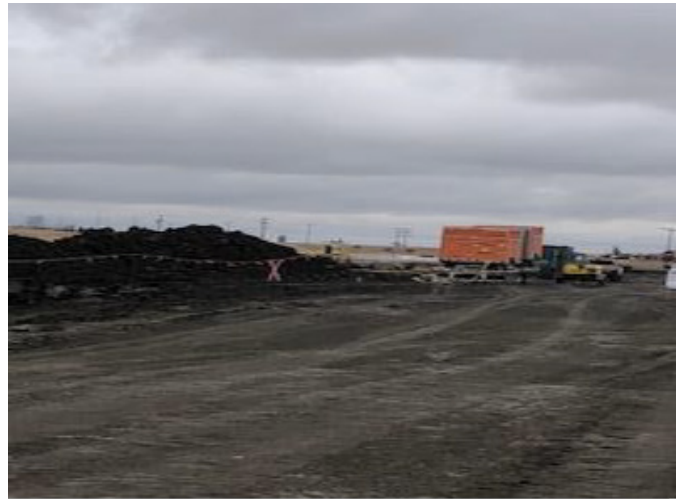
Testing crew – km 195+700 – Nov 1, 2018

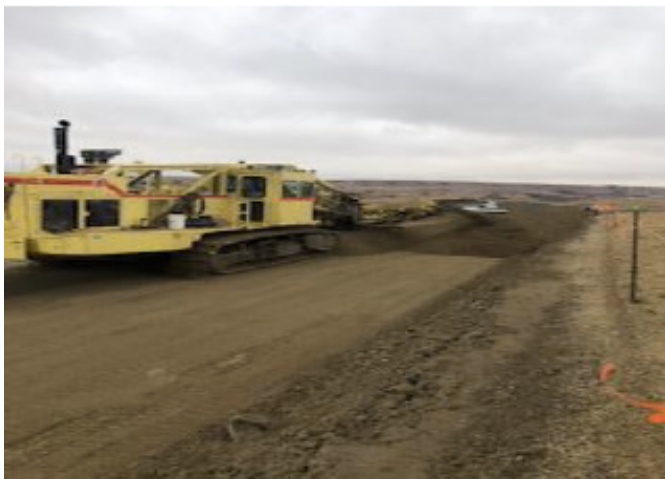
Ditcher digging in Heritage area – km 259+100 – Nov 1, 2018

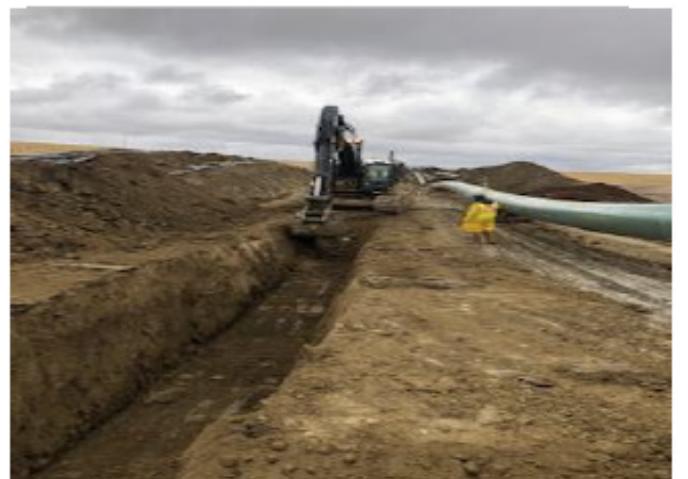
Excavator digging on the west side – km 219+415 – Nov 1, 2018

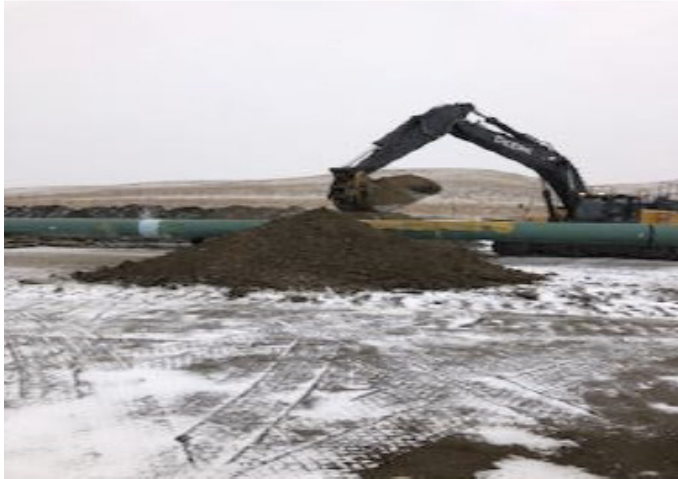
Excavator digging ditch in Heritage area - km 222+300 – Nov 2, 2018

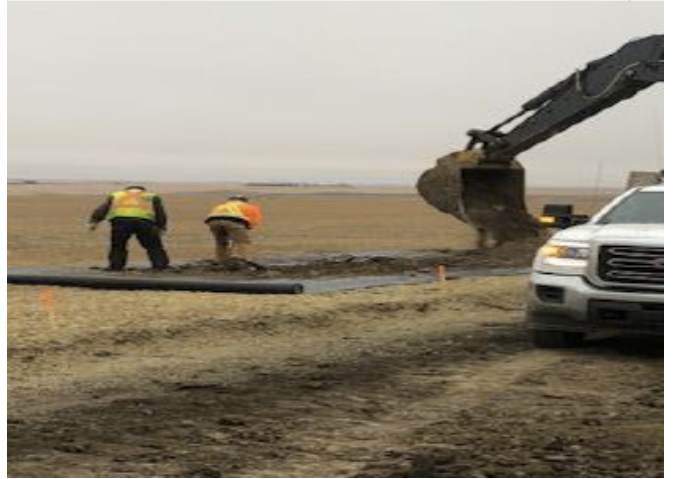
Excavator digging ditch – km 220+198 – Nov 2, 2018

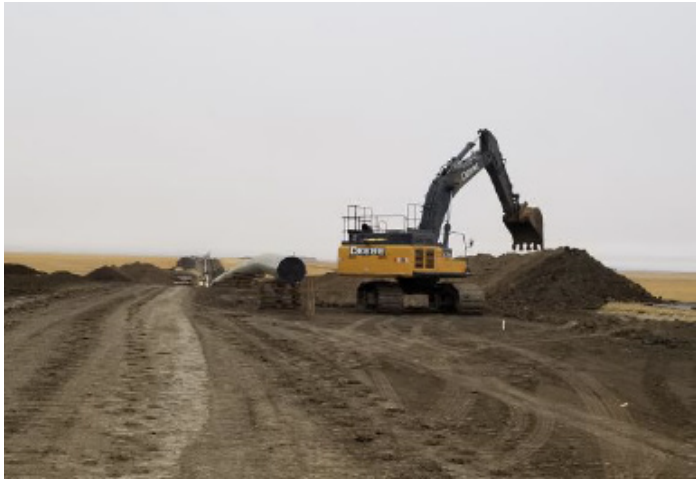
Excavator digging ditch – km 220+050 – Nov 2, 2018

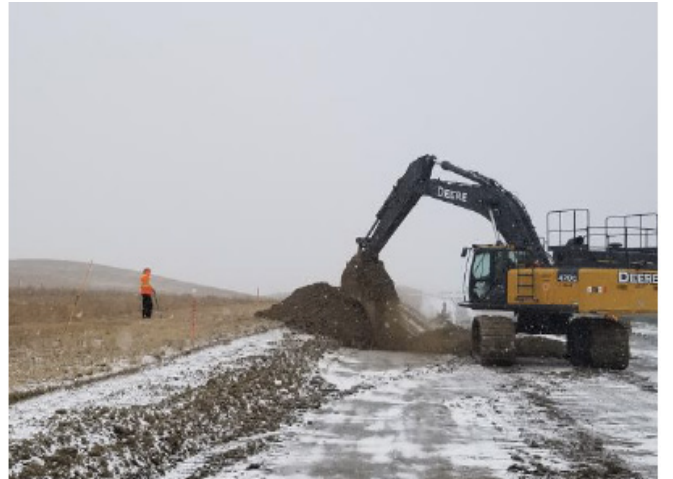
Digging in Heritage area – km220+300– Nov 2, 2018

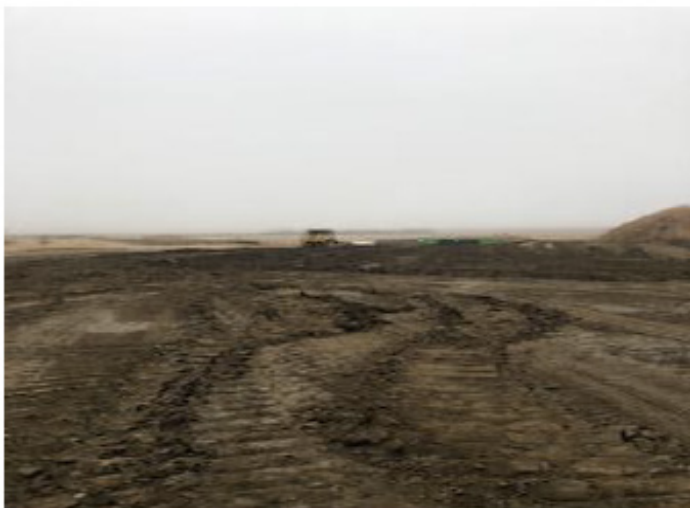
Dozer reclaiming natural grade - km 164+360 – Nov 2, 2018

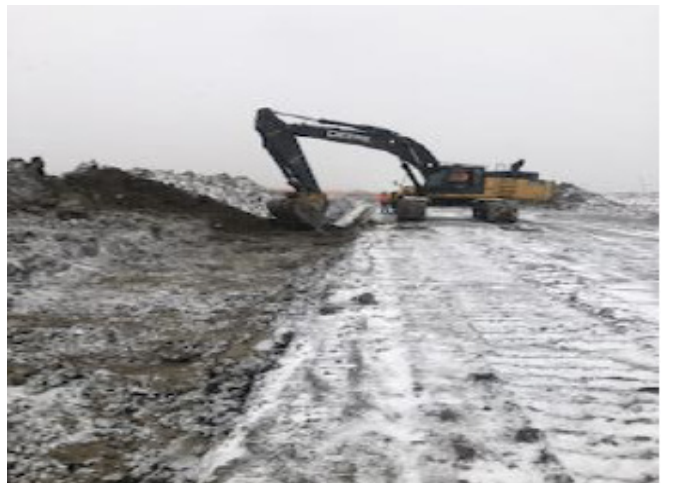
Backfill crew shading – km 182+172 – Nov 2, 2018

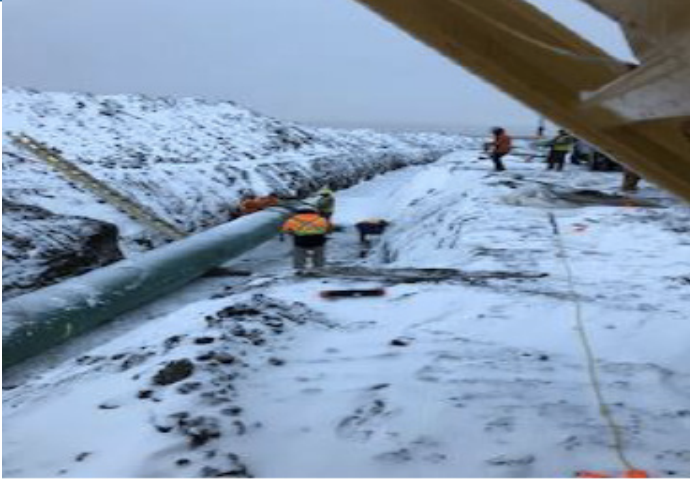
Tie-in weld - km 175+073 – Nov 3, 2018

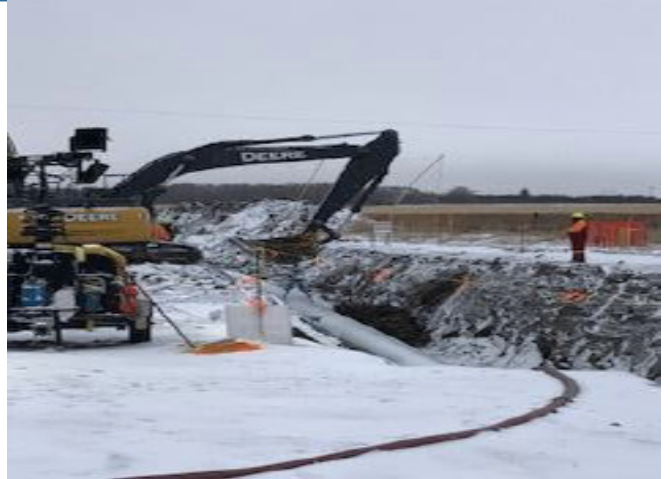
Excavator shading pipe in wetland – SF 110 – Nov 3, 2018

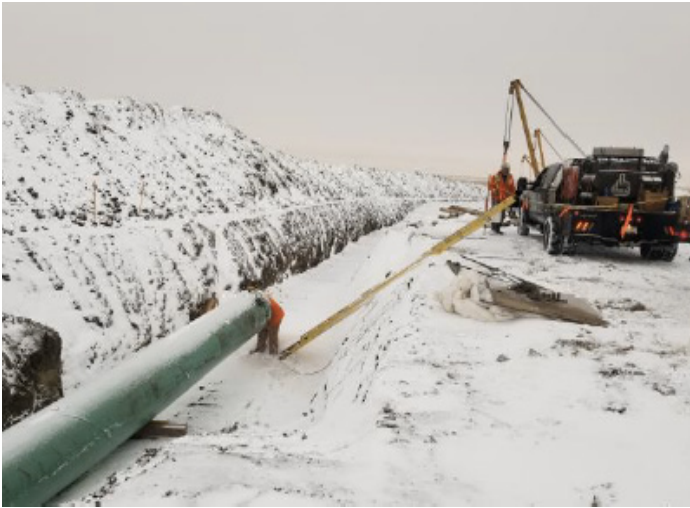
Prepping pipe for tie-in - km 193+050 – Nov 3, 2018

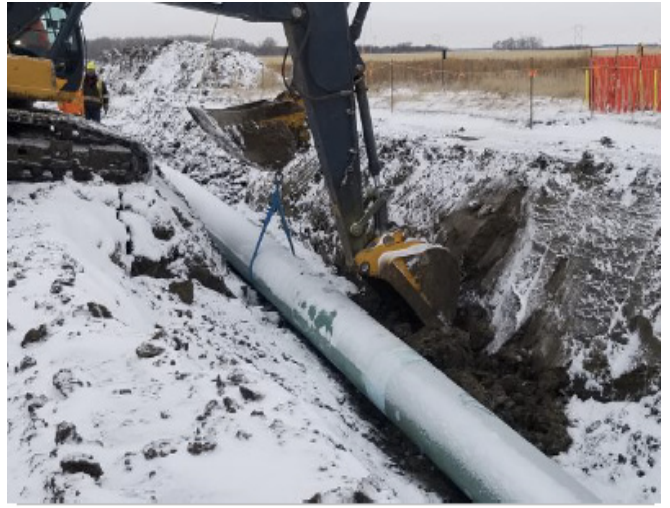
Shading tie-in section – km 182+100 – Nov 3, 2018

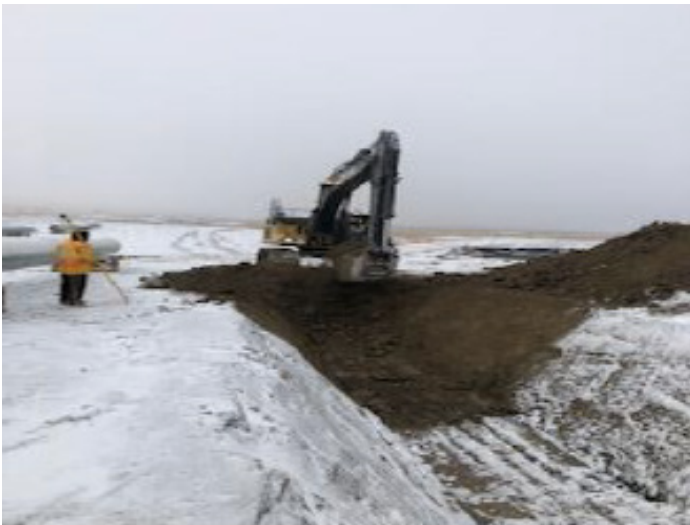
Digging bell hole in Heritage area- km 222+275 – Nov 3, 2018

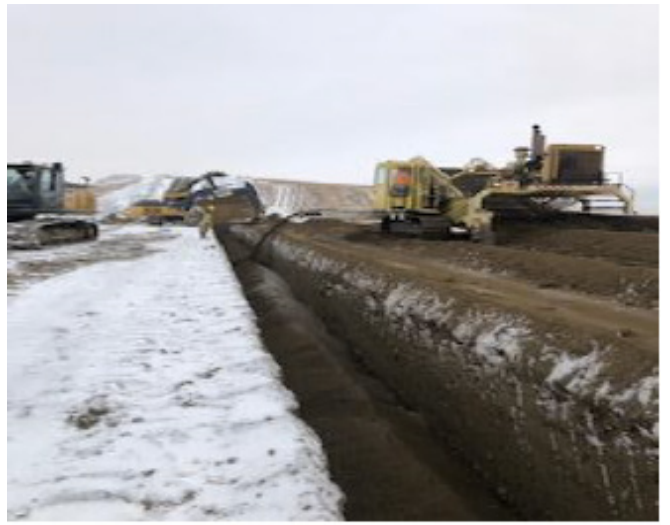
Shading mainline – km 220+980 – Nov 3, 2018
