SAMSON CREE NATION – MATRIX SOLUTIONS INC. PARTNERSHIP

ABORIGINAL CONSTRUCTION MONITORING

WEEKLY REPORT

OCTOBER 9TH - OCTOBER 13TH

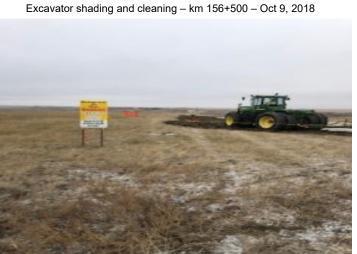
Tractor discing on Native Prairie - km 254+180 - Oct 9, 2018

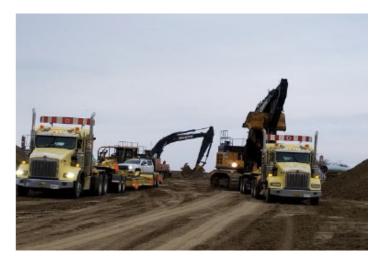
Loading equipment - Km159+300 - Oct 9, 2018

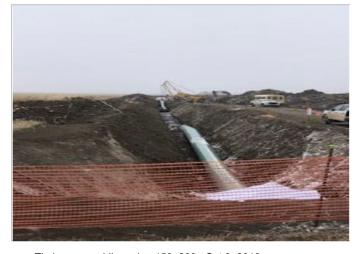
Tie in crew welding - km 150+200 -Oct 9, 2018

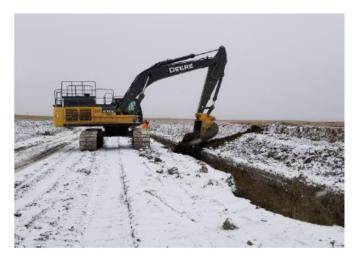
Shading pipe - km 156+550 - Oct 9, 2018

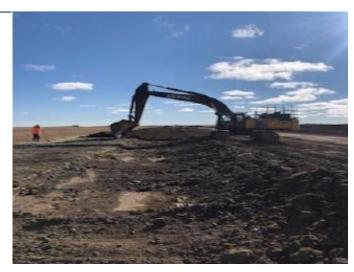
Backfill crew cleaning up spill pile - km 157+200 - Oct 10, 2018

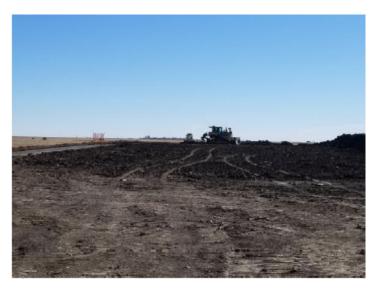
Equipment moving dirt - km 257+525 - Oct 10, 2018

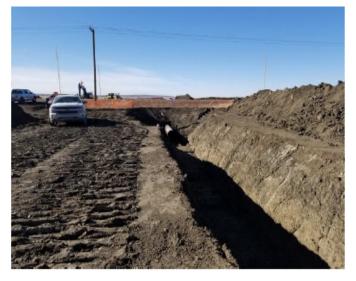
Pulled bore -km 233+247- Oct 10, 2018

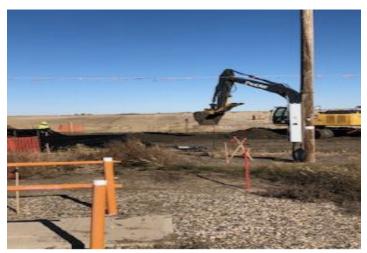
Excavator stripping ROW near power line- km 262+362- Oct 10, 2018 Bridge being moved to watercourse- SF 162 - Oct 10, 2018

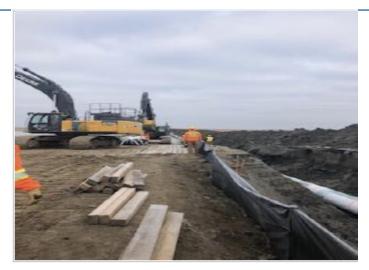
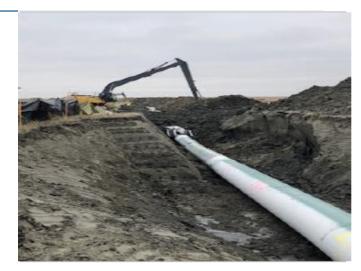
Excavators hoisting pipe weights through wetlands—SF 92 – Oct 11, 2018 Excavator shading wetland – km 152+900 - Oct 11, 2018

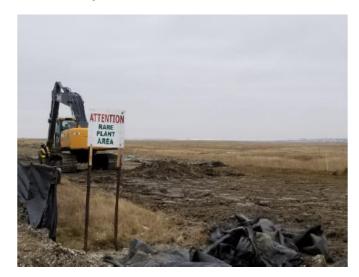
Moving topsoil back - km 153+400 - Oct 11, 2018

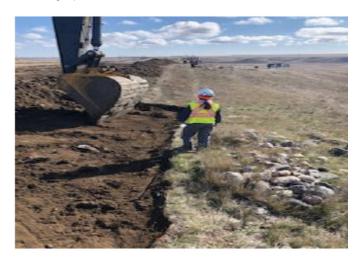
Native Prairie being stripped – km 254+180 – Oct 11, 2018 Possible rock formations stripped by excavator – km254+306 – Oct 11, 2018

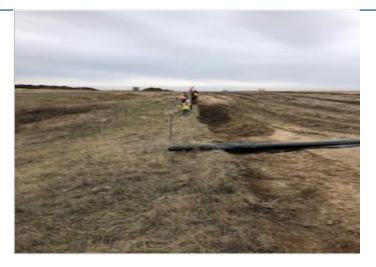
Archaelogist on Native Prairie - km 254+300 - Oct 12, 2018

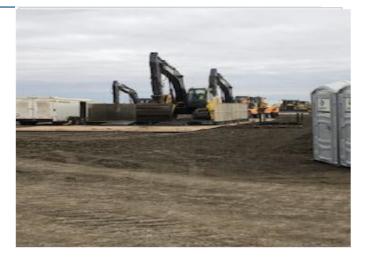
Wash bay - SF 168 - Oct 12, 2018

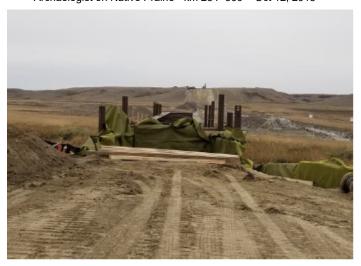
Bridge construction - km 255+250 - Oct 12, 2018

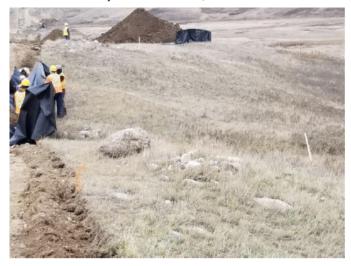
Possible sensitive area - km 254+300 - Oct 12, 2018

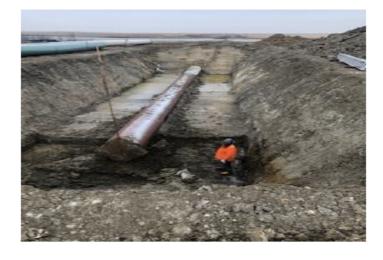
Crew digging pre-existing mainline – SF 101 – Oct 12, 2018

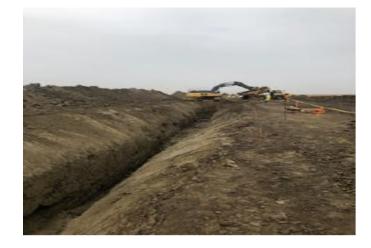
Digging ditch on mainline for lowering in – km 151– Oct 12, 2018
