**SAMSON CREE NATION – MATRIX SOLUTIONS INC.  
PARTNERSHIP**

**ABORIGINAL CONSTRUCTION MONITORING**

**WEEKLY REPORT**

**SEPTEMBER 10<sup>TH</sup> - SEPTEMBER 15<sup>TH</sup>**

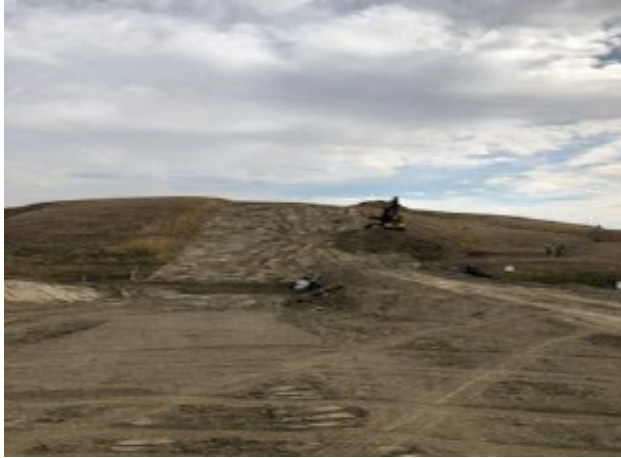
Excavator stripping topsoil – km 222+781 – Sept 10, 2018

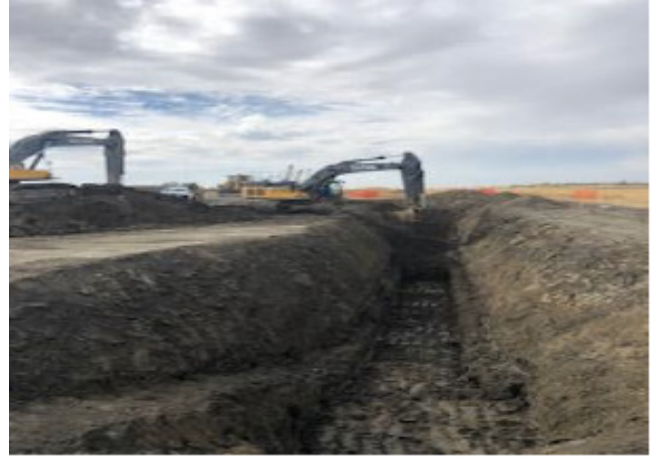
Digging bore bay – SF 124 –Sept 10, 2018

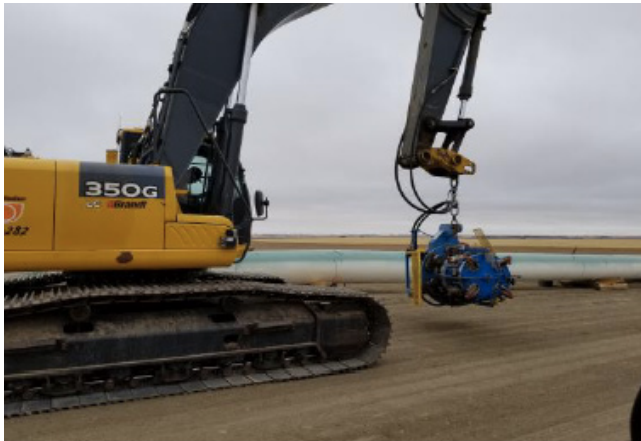
Prep crew - Km 148+ 700 – Sept 10, 2018

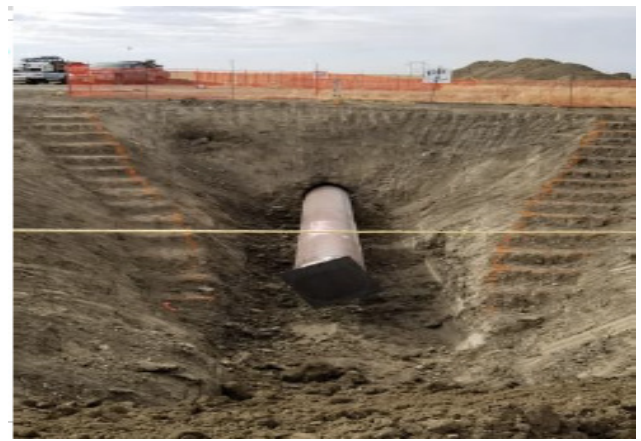
Bore – km 193+ 810 – Sept 10, 2018

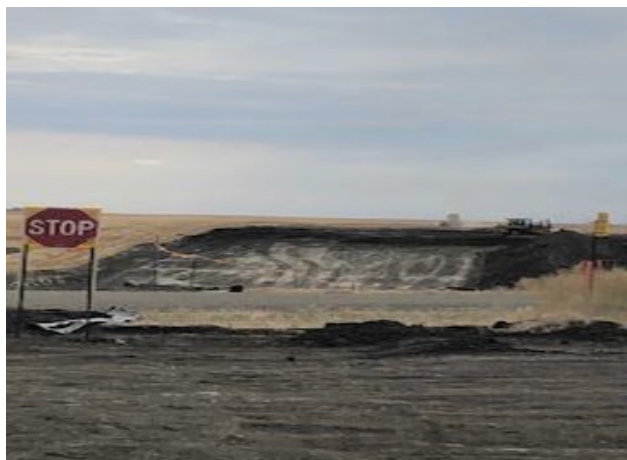
Dozer stripping (S.E) – Sf 151 – Sept 10, 2018

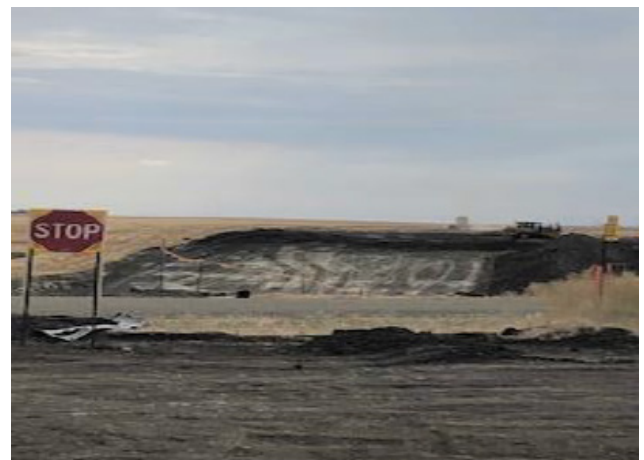
Contaminated spill pile (N.E) – km 236+400 – Sept 10, 2018

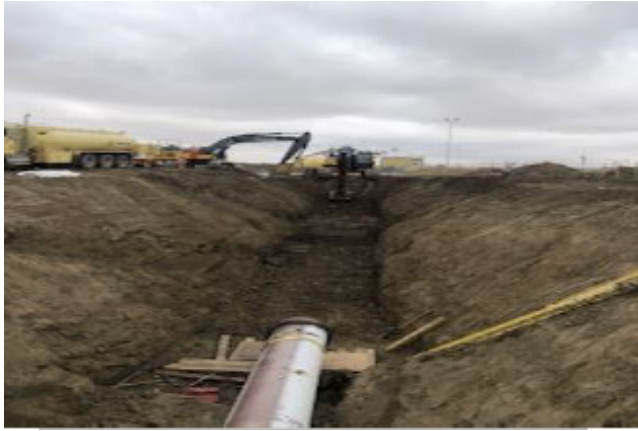
Tie in crew digging - Km 147+970- Sept 11, 2018

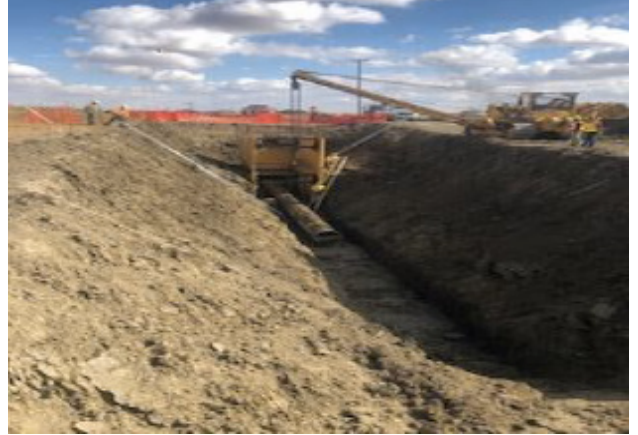
Trench box installed – SF 121 – Sept 11, 2018

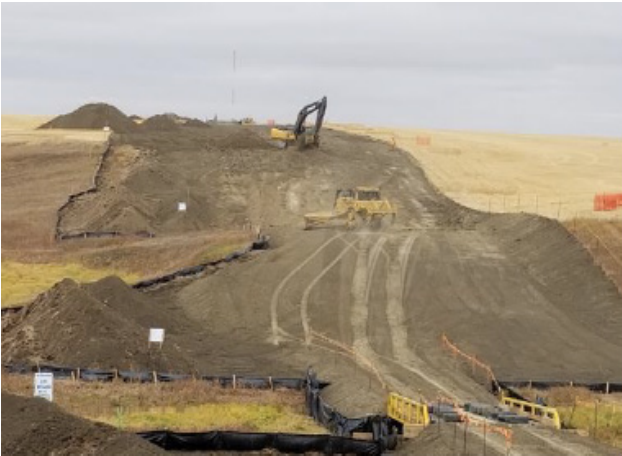
Equipment moving dirt – km 211+360 – Sept 11, 2018

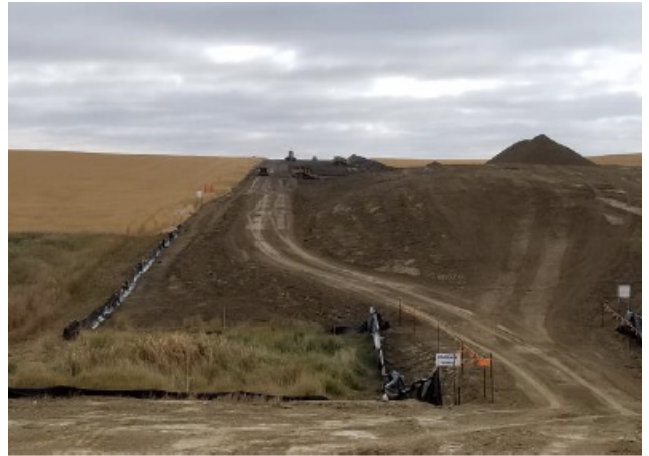
Equipment moving dirt – km 219+450 – Sept 11, 2018

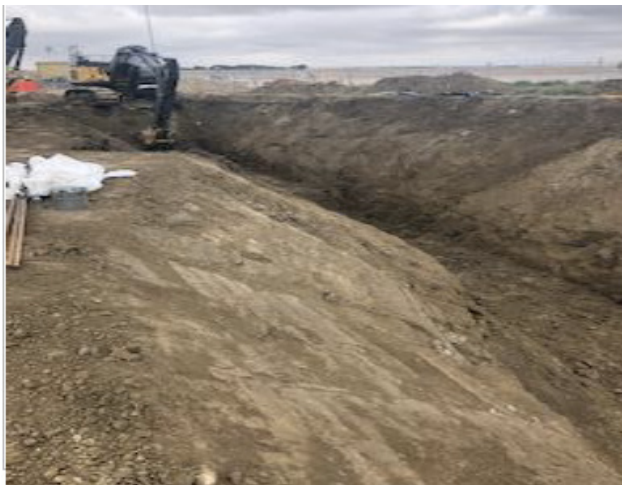
Excavator digging in bore pit for tie in – km 147+950 - Sep 11, 2018

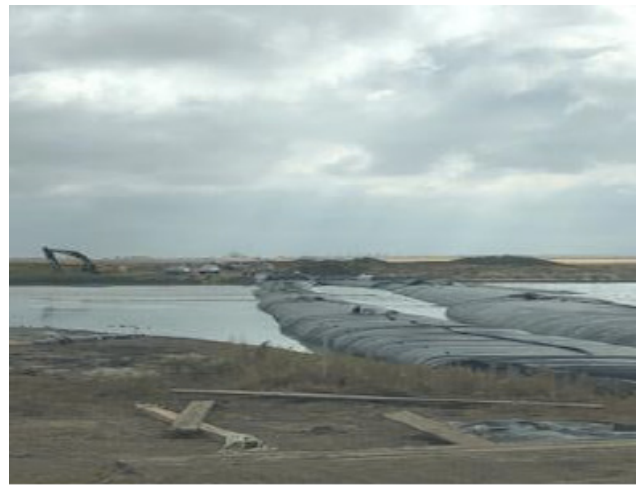
De-watering the aqua dam – km 165+100 – Sept 11, 2018

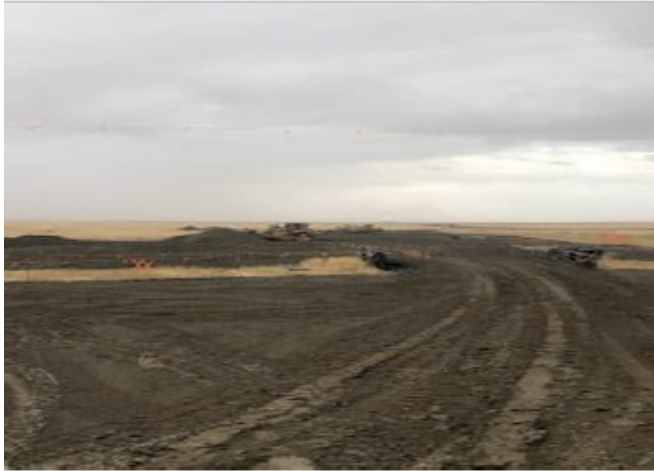
Stripping topsoil – SF 145 – Sept 12, 2018

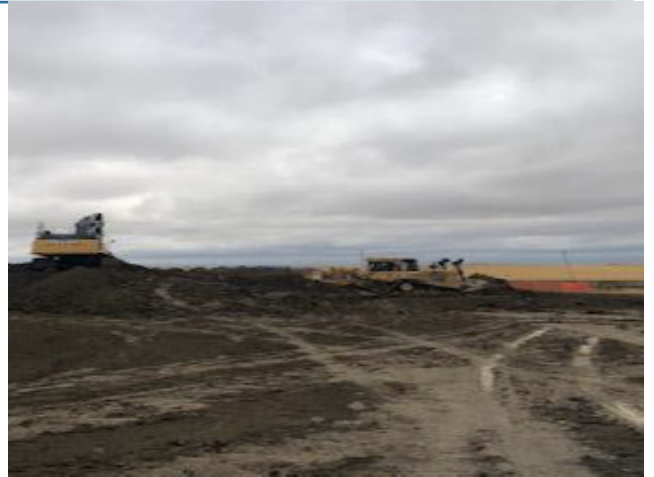
Crew tightening up bore bay – SF 125 – Sept 12, 2018

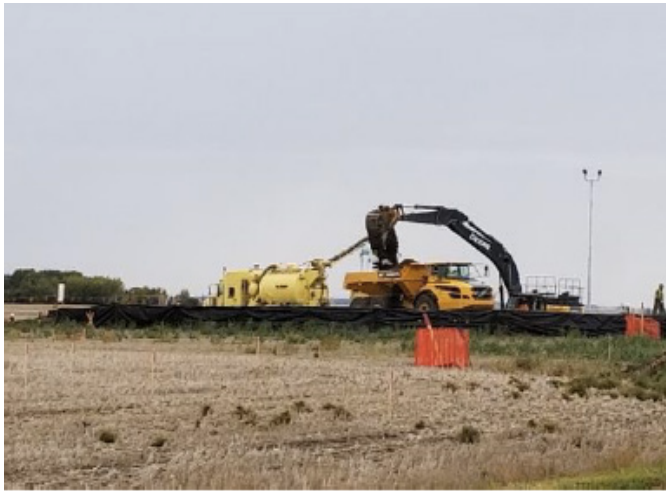
Loading rock truck - km 148+006 – Sept 12, 2018

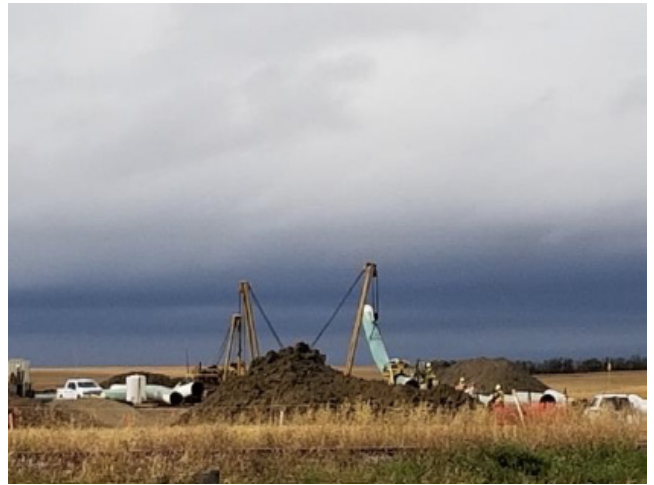
Bending pipe – km 175+300 – Sept 12, 2018

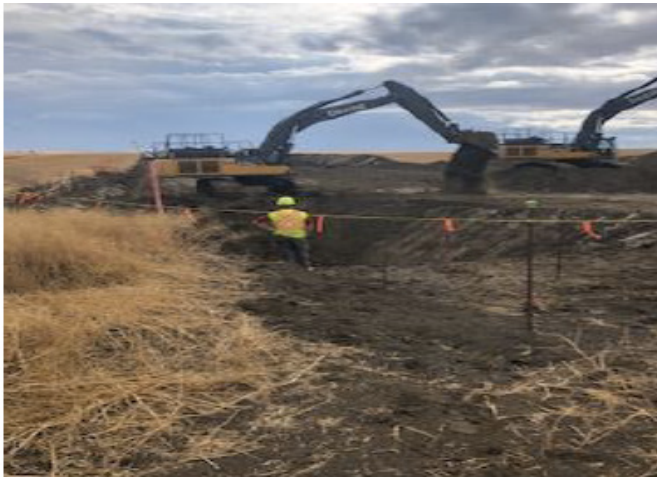
Excavator digging bore pit – SF 126 – Sept 12, 2018

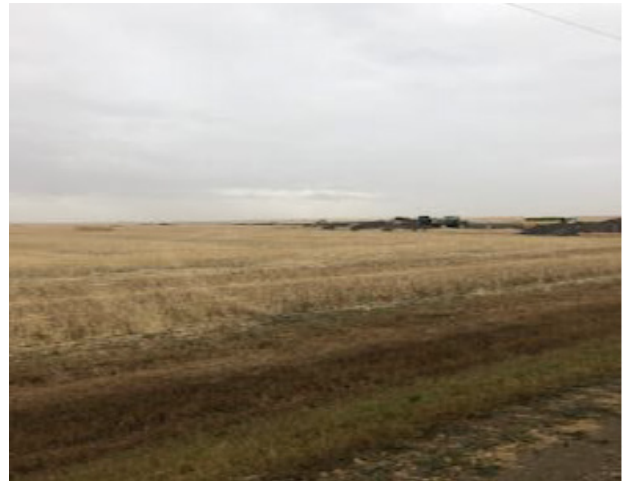
Shutting down due to conditions on ROW – SF 145 – Sept 12, 2018

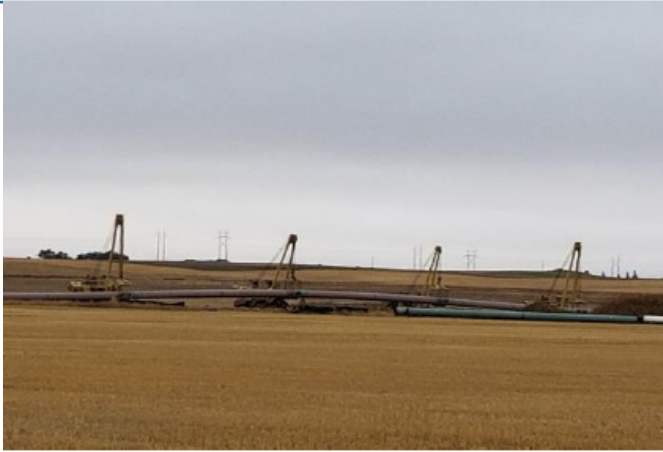
Booms prepping pipe – km 178+023 – Sept 13, 2018

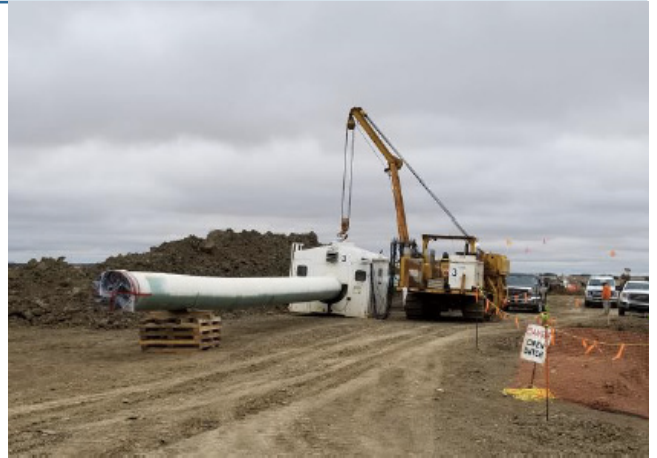
Welding Shack - km 146+076 – Sept 13, 2018

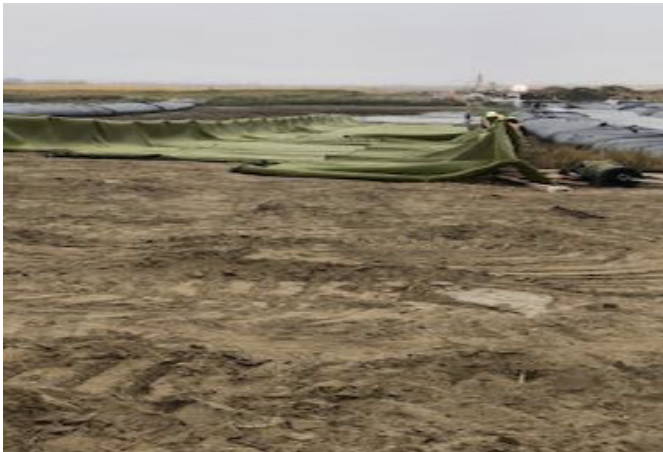
Geo tec for ramp access (aquadam) - km 165+100 – Sept 13, 2018

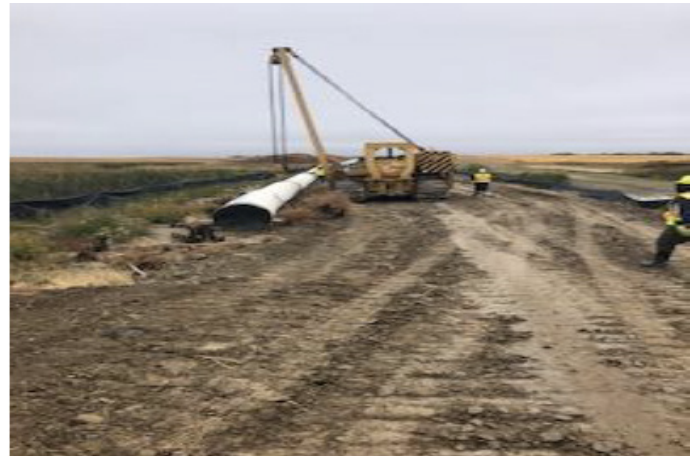
Prep – km 165+300 – Sept 13, 2018

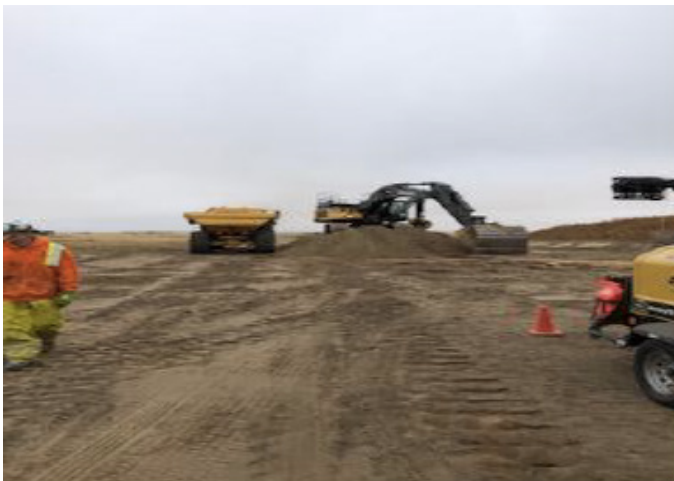
Stripping on ROW – km 164+800 – Sept 13, 2018

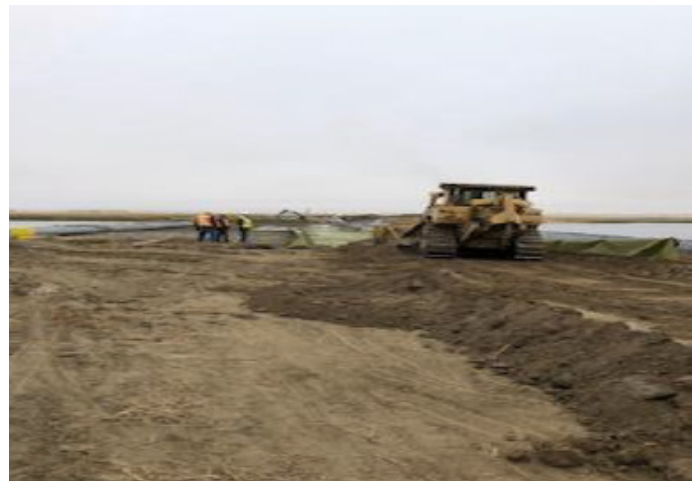
Crew building ramp across the wetland – km 165+200 – Sept 13, 2018

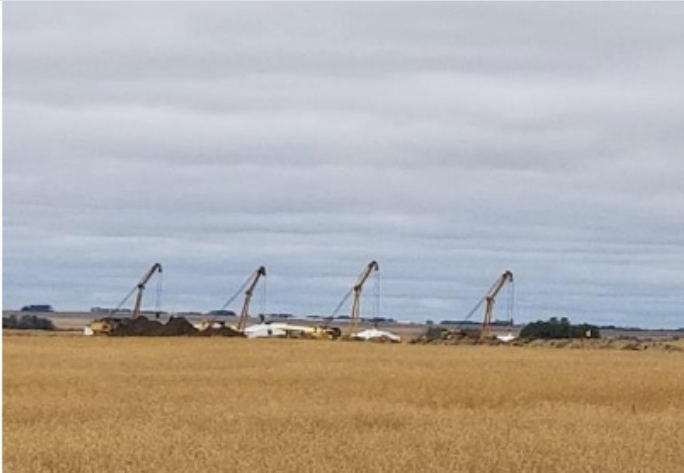
Mainline welding – km 146+076 - Sept 14, 2018

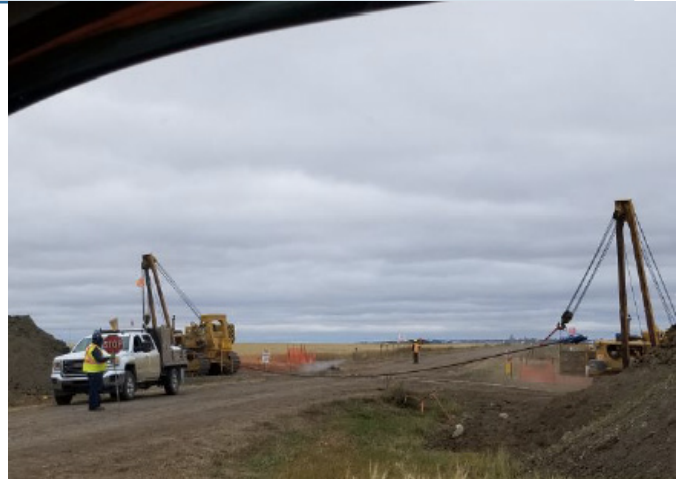
Equipment crossing with reach rod – km 149+936 – Sept 14, 2018

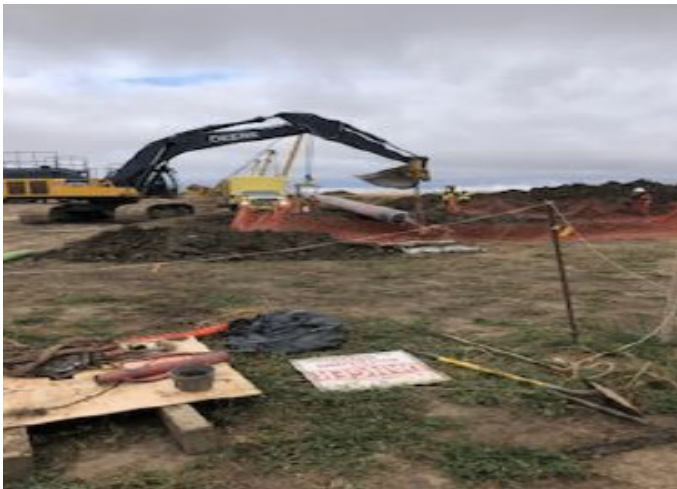
Bore being pulled – km 178+000 - Sept 14, 2018

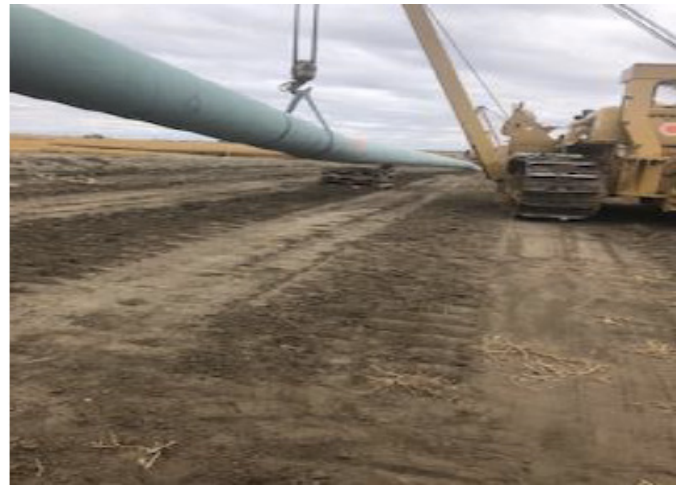
Aquadam about to be lifted and put into ditch – km 165+100 – Sept 14, 2018

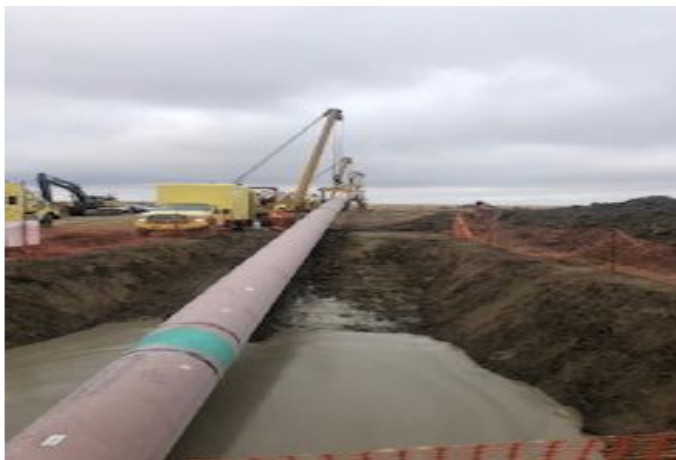
Bore section being pulled on west side of SF 107 – Sept 14, 2018

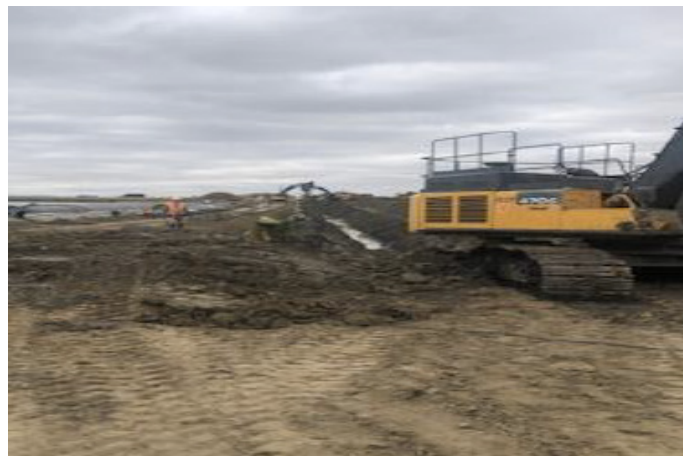
Digging ditch on east side of aqua dam – km 165+200 – Sept 14, 2018

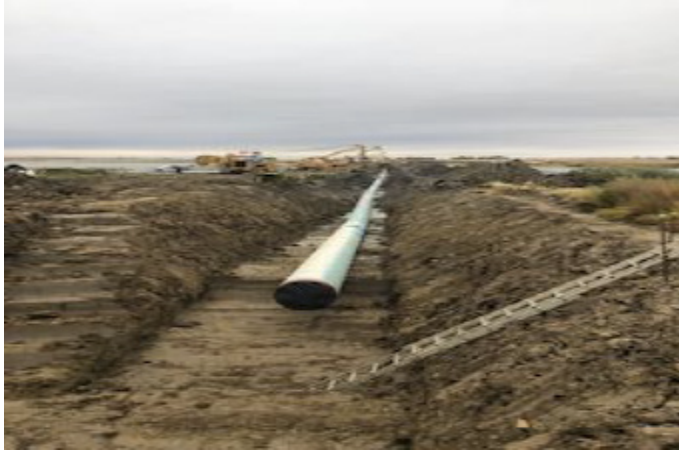
Mainline section lowered into ditch - km 165+200 – Sept 15, 2018

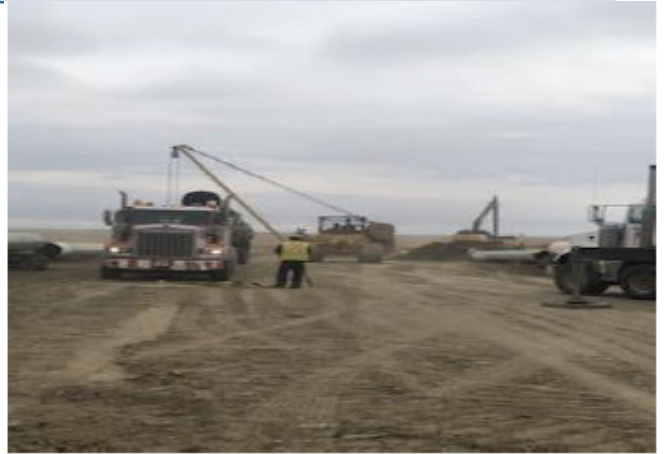
Unloading of bore casing and auger – km 222+300  
Sept 15, 2018

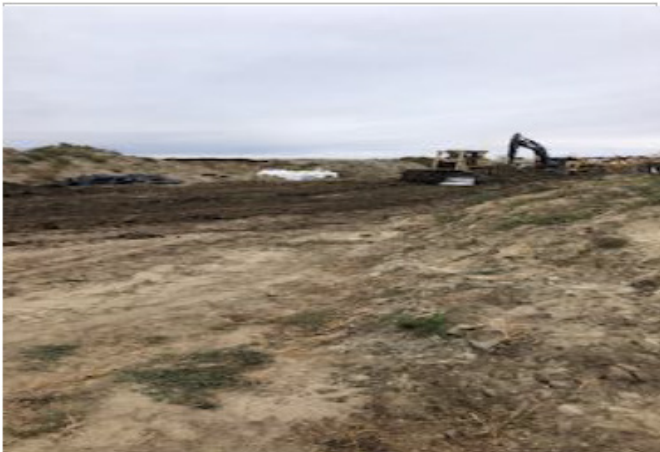
Dozer and backhoe moving dirt – km 165+300 – Sept 15, 2018

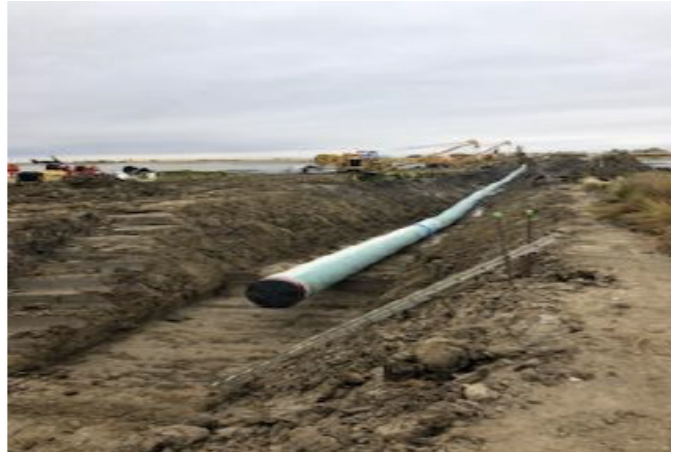
Side boom ready for tie in– km 165+200 – Sept 15, 2018

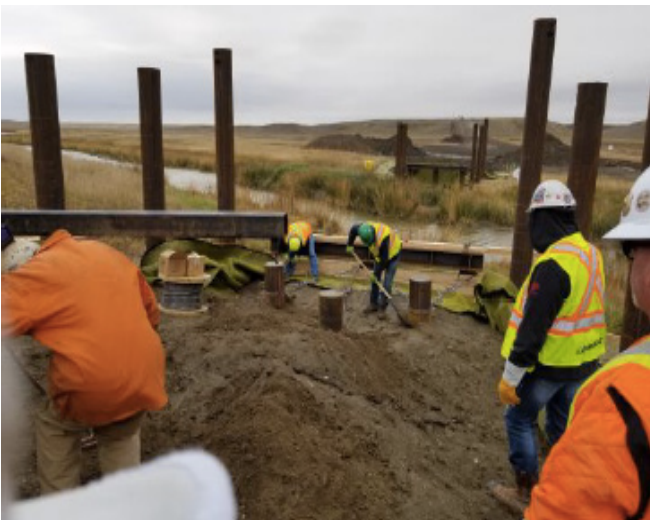
Crews working on bridge – km 255+200 – Sept 15, 2018

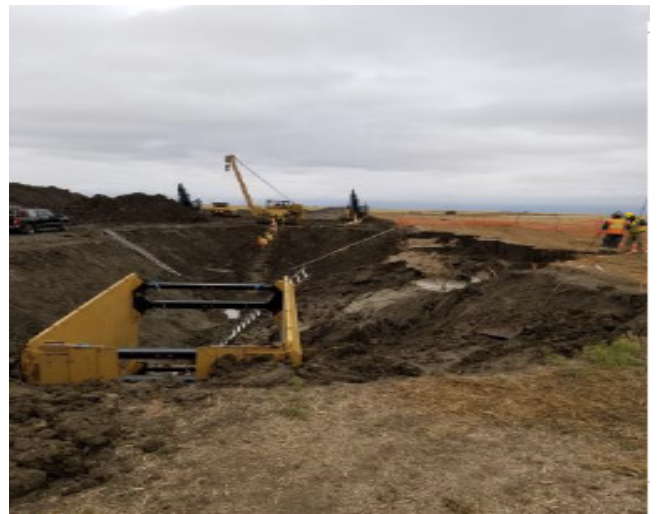
Bore is getting ready to be pulled– km 195+590 – Sept 15, 2018
