**SAMSON CREE NATION – MATRIX SOLUTIONS INC.
PARTNERSHIP**

ABORIGINAL CONSTRUCTION MONITORING

WEEKLY REPORT

SEPTEMBER 19TH - SEPTEMBER 21ST

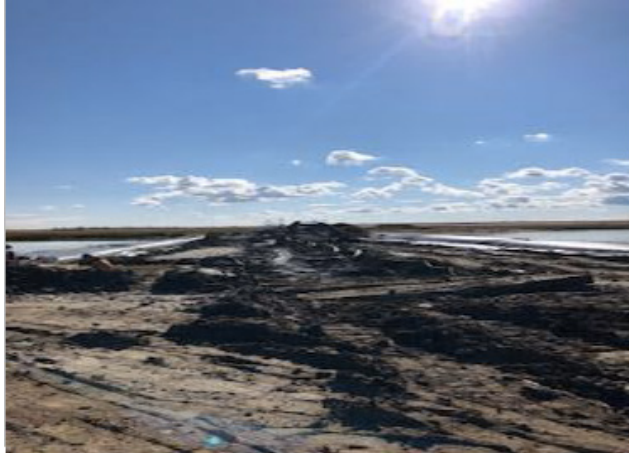
Backfill at aquadam – SF 97 – Sept 19, 2018

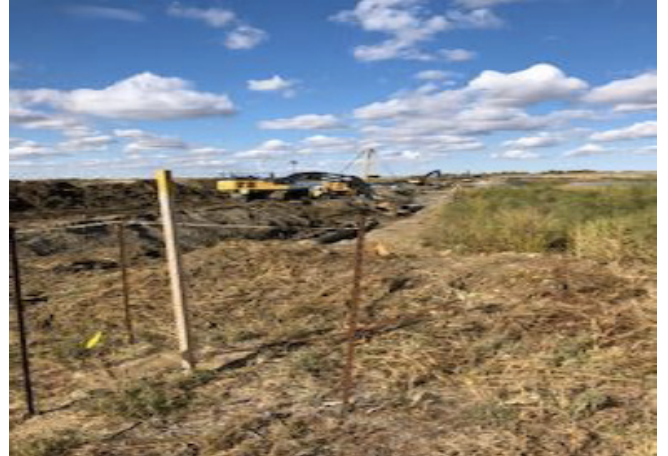
Crew prepping for tie in – SF 97 –Sept 19, 2018

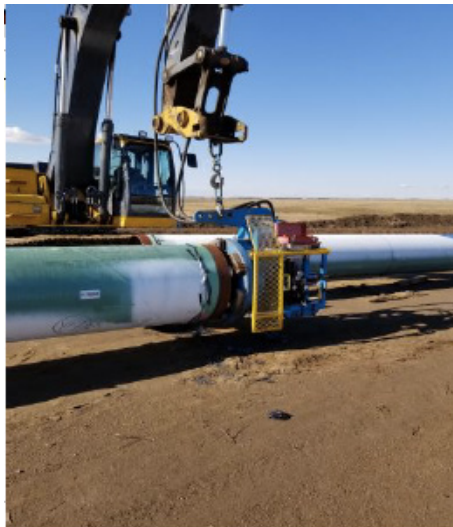
Prepping pipe - Km 158+ 400 – Sept 19, 2018

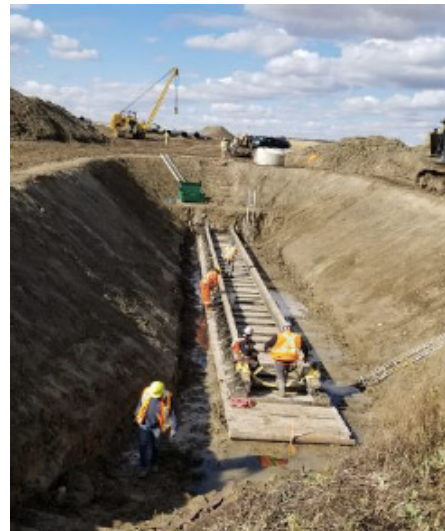
Prepping bore – km 175+ 245 – Sept 19, 2018

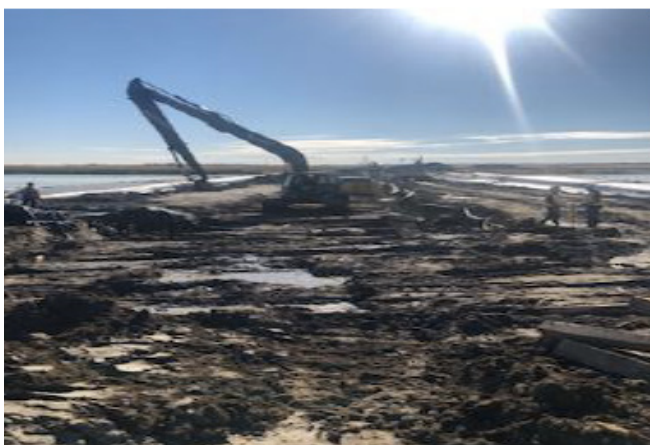
Equipment cleaning – Km165+140 – Sept 19, 2018

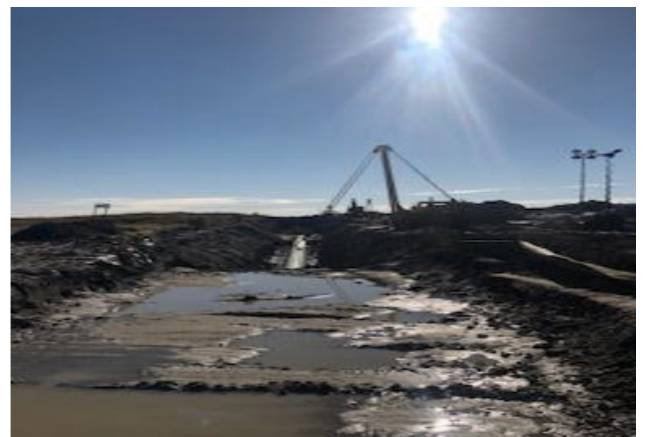
Bellhole for tie in at wetland – km 165+230 – Sept 19, 2018

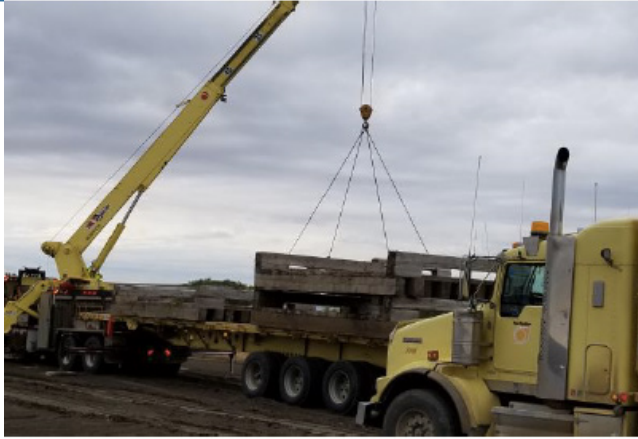
Offloading bridge - Km 255+680– Sept 20, 2018

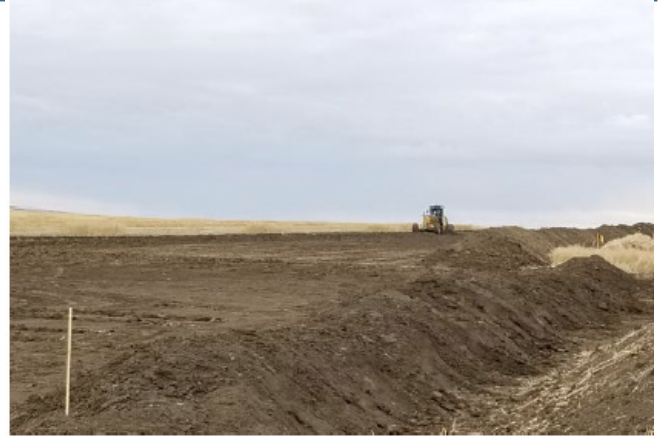
Moving dirt – km 227+543 – Sept 20, 2018

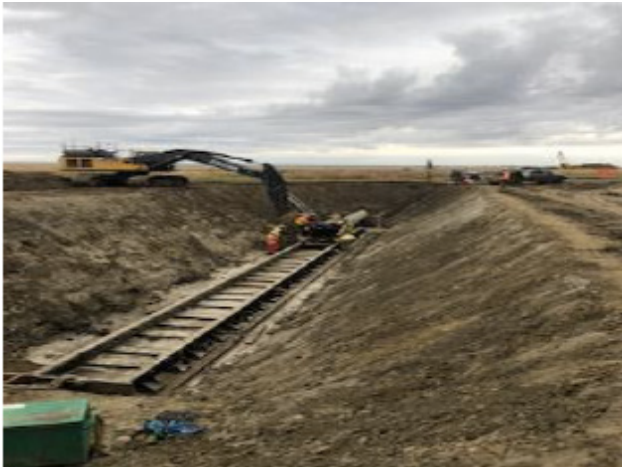
Track bore crew working beneath train tracks – km 175+200 – Sept 20, 2018

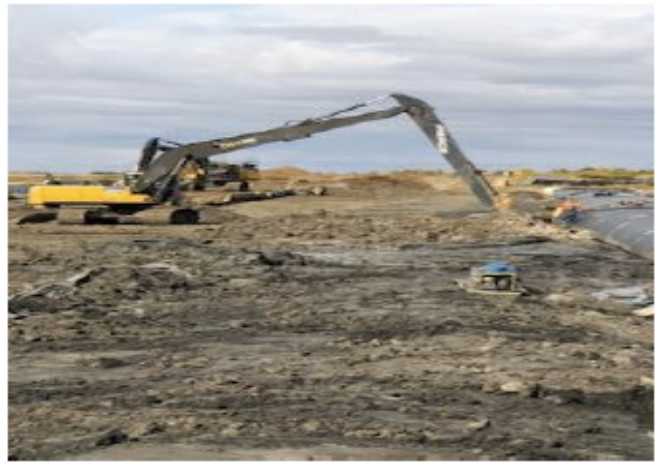
Backfill crew cleaning up geo tech – Sept 20, 2018

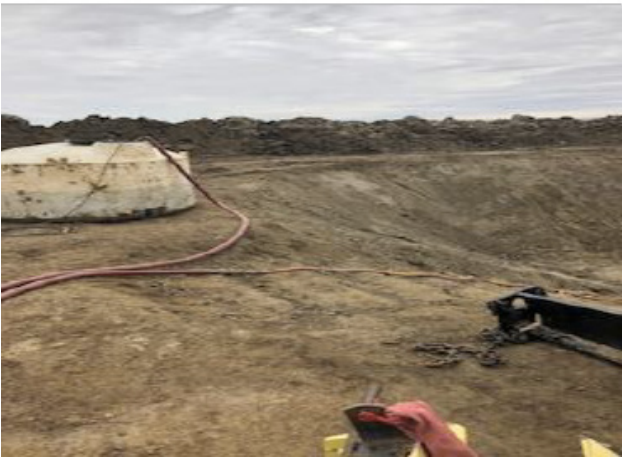
Water storage to soften soil for track bore – km 175+200 - Sep 20, 2018

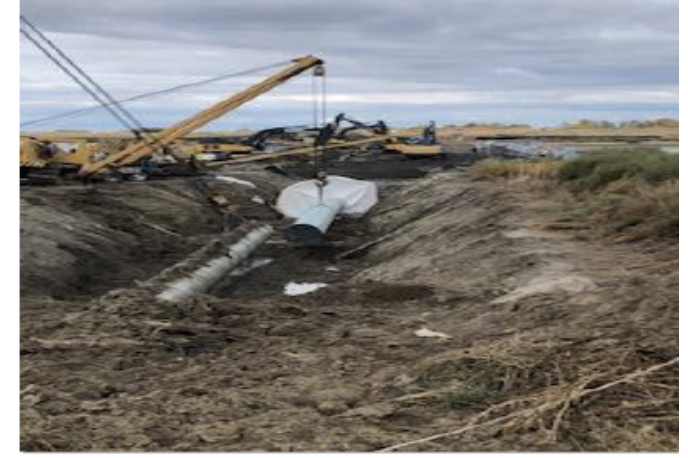
Welding tie - in – SF 97 – Sept 20, 2018

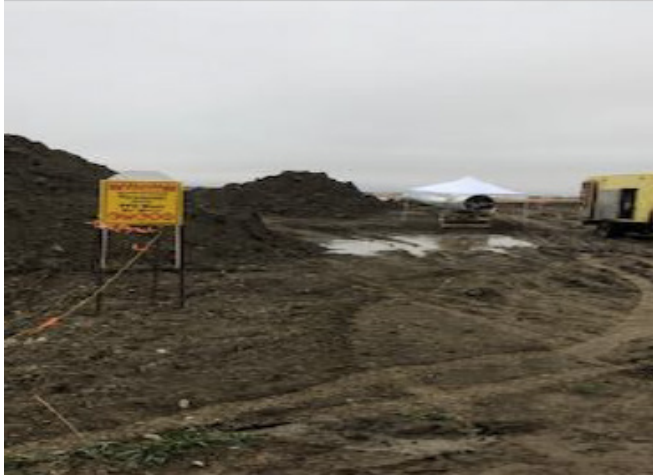
Coating Crew – km 146+076 – Sept 21, 2018

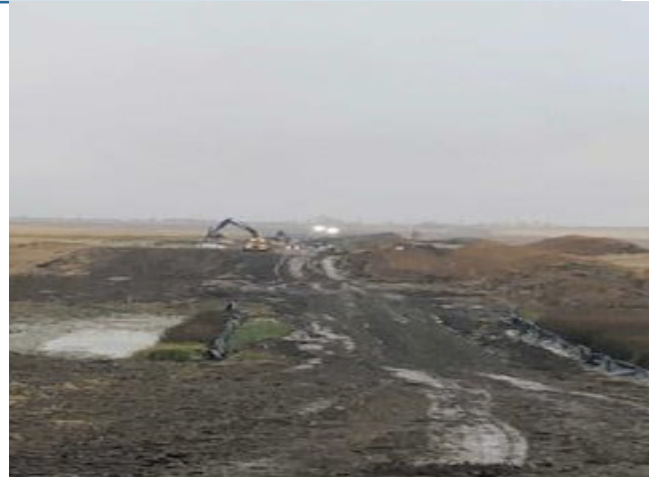
Excavators loading rock trucks – km 164+400 – Sept 21, 2018

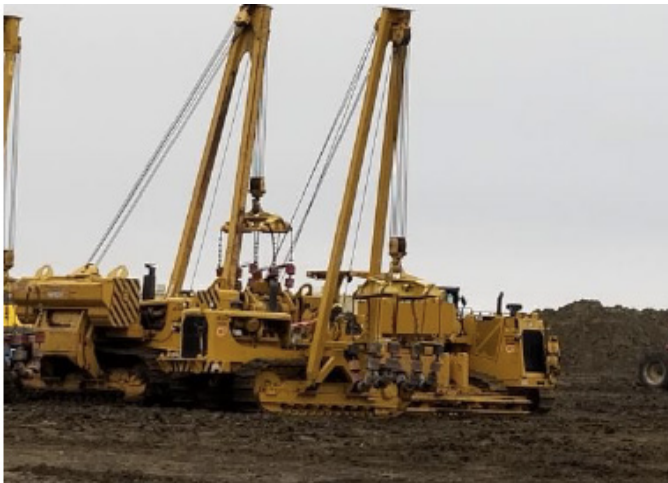
Putting on cradles - km 144+169 – Sept 21, 2018

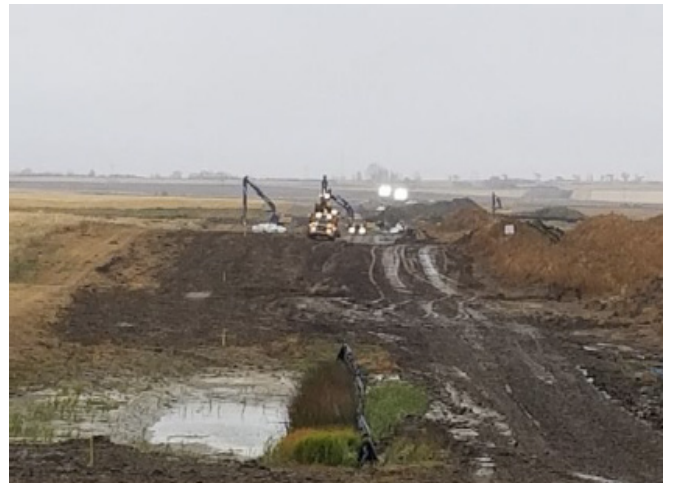
Working on aquadam – km 164+500 – Sept 21, 2018

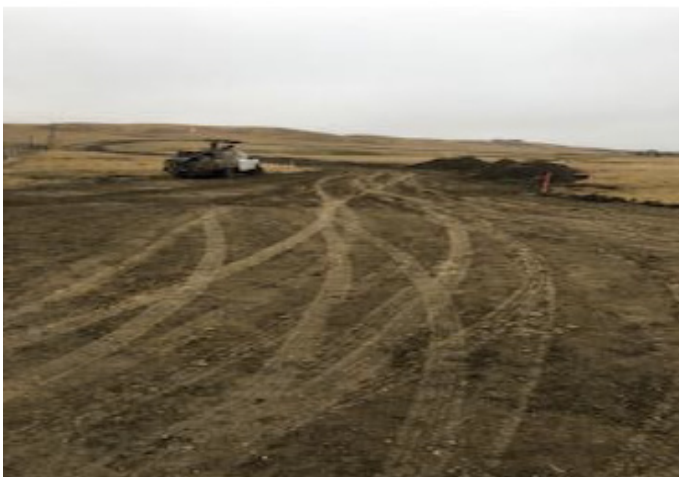
Approach and access approach– SF 141 – Sept 21, 2018

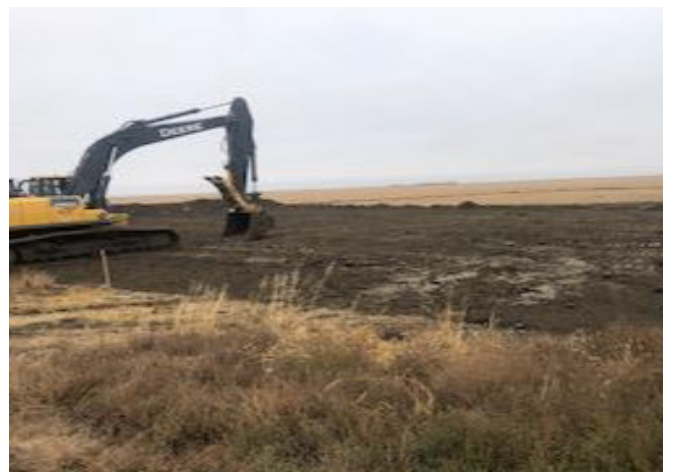
mechanic was onsite. Crews were unloading equipment at kick off at km 144+395. The coating crew were prepping welds at km 146+076. The coding crew were at km 146+076 At SF 91, welding and x-ray were noted, as well as, mainline welding. At SF 92, crews were on standby, due to weather conditions. Track bore for the railway was monitored at km 175+200. Excavators were filling rock trucks at km 164+400. At SF 96, crews were working on the aqua dam. At SF 141, geo ec was laid at the approach. The crew was working on stiffening up the approach and the road for the stinging crew and heavy trucks to use, so they do not get stuck. An excavator and rock truck were used to complete the job. At SF 142, excavator was being cleaned at the cleaning station. At SF 146, topsoil and transitions were being stripped. At SF 151, crews were digging the contaminated soil, so that soil levels can be monitored. At SF 153, access approach was completed at the north access. The crew was trying to finish the access over the Sasktel line crossing at km 242+907. At SF 158, dozer and excavator were stripping the topsoil but were later shut down due to rain.

Topsoil being stripped – SF 158 – Sept 21, 2018
