**SAMSON CREE NATION – MATRIX SOLUTIONS INC.
PARTNERSHIP**

ABORIGINAL CONSTRUCTION MONITORING

WEEKLY REPORT

SEPTEMBER 26TH - SEPTEMBER 29TH

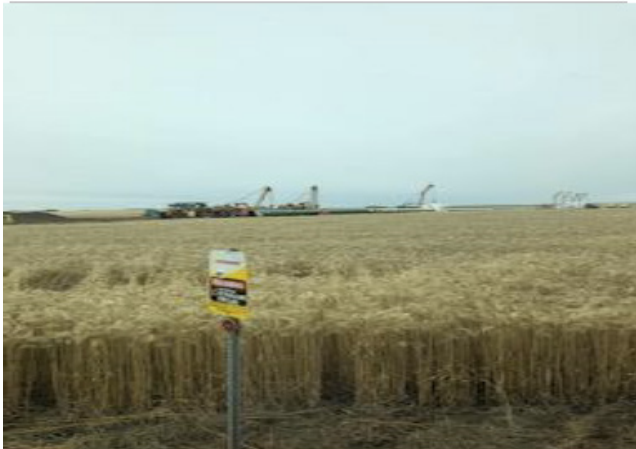
Mainline welding – SF 92 – Sept 26, 2018

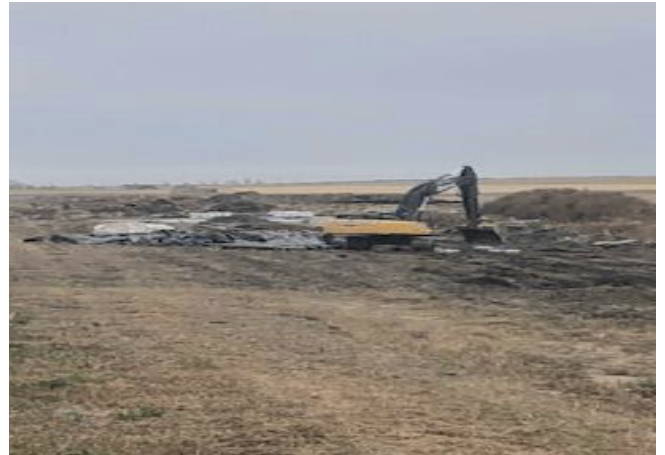
Excavator pulling dams out of watercourse – SF 97 –Sept 26, 2018

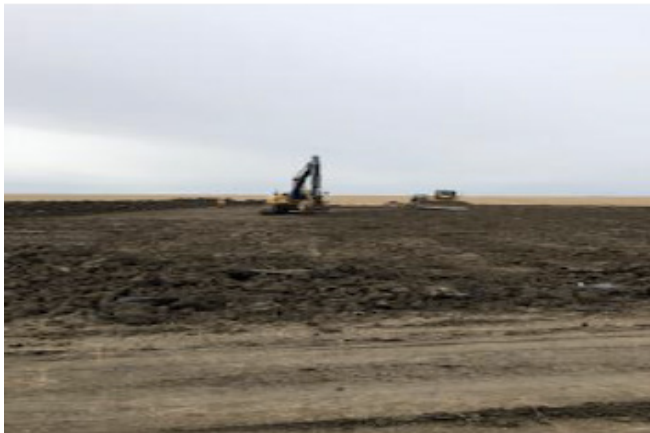
Access approach being constructed – SF 158 – Sept 26, 2018

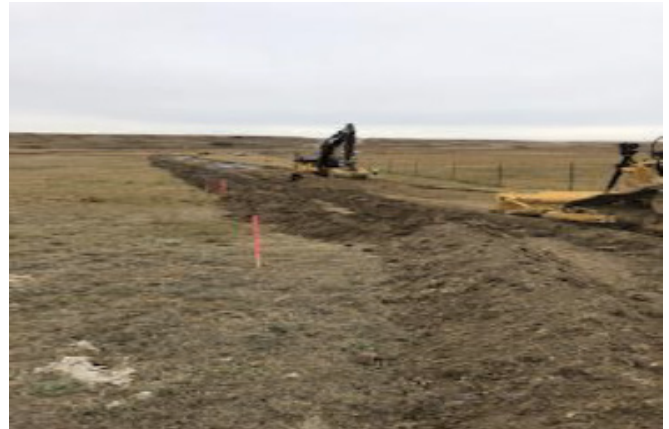
Building access road for stinging trucks– SF 141 – Sept 26, 2018

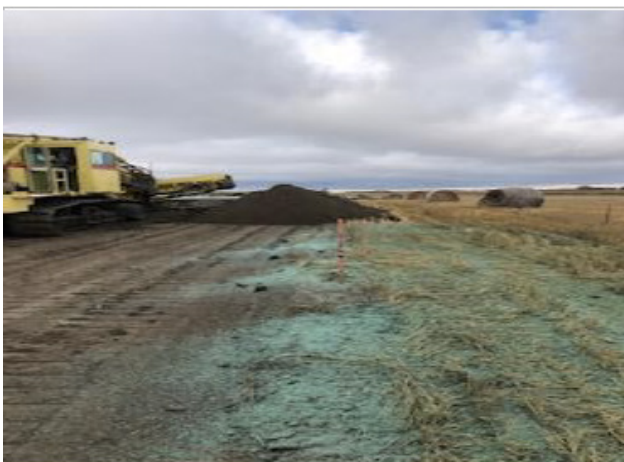
Terra wood sprayed at spill pile – Km144+900 – Sept 27, 2018

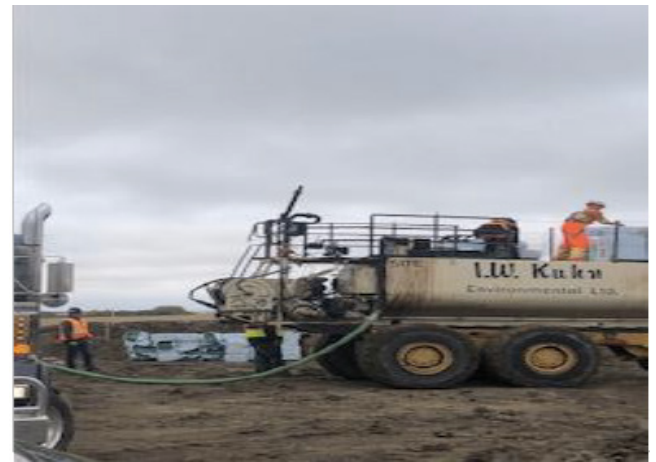
Crews unloading terra wood – km 145+950 – Sept 27, 2018

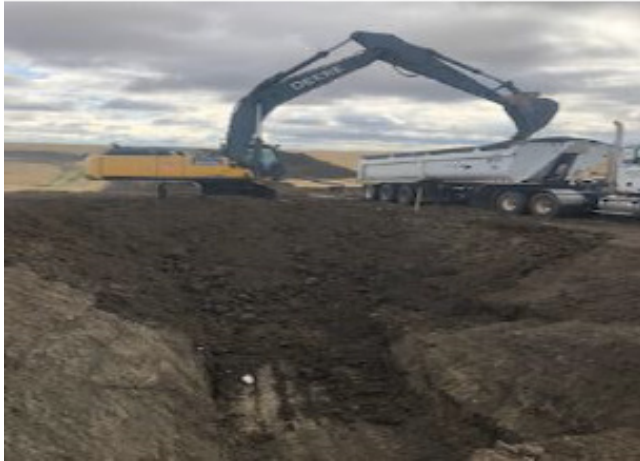
Loading trailer with contaminated soil – Sept 27, 2018

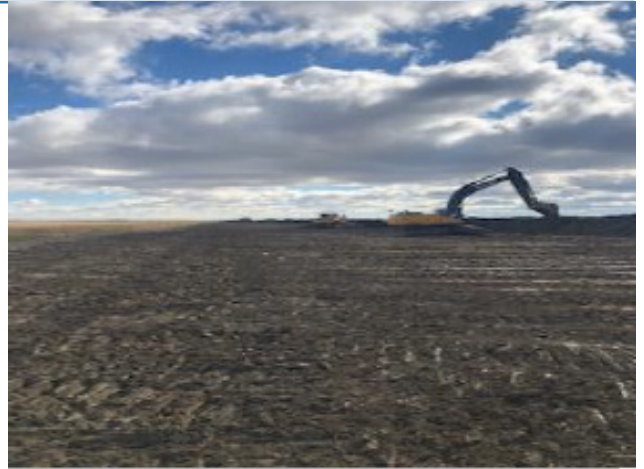
Topsoil being stripped – km 234+100 – Sept 27, 2018

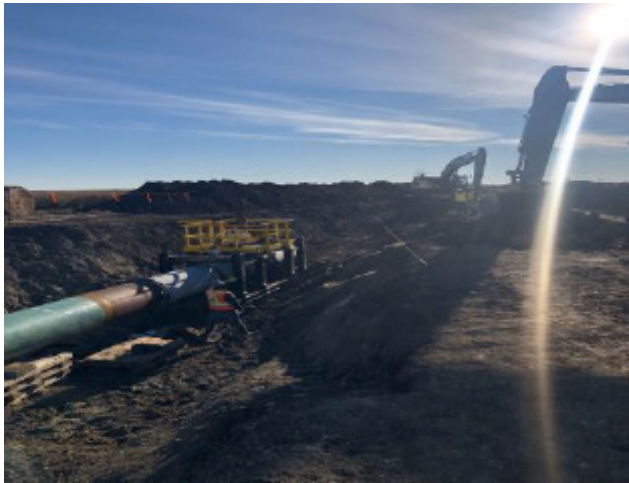
Tie-in plug being dug out – Sept 27, 2018

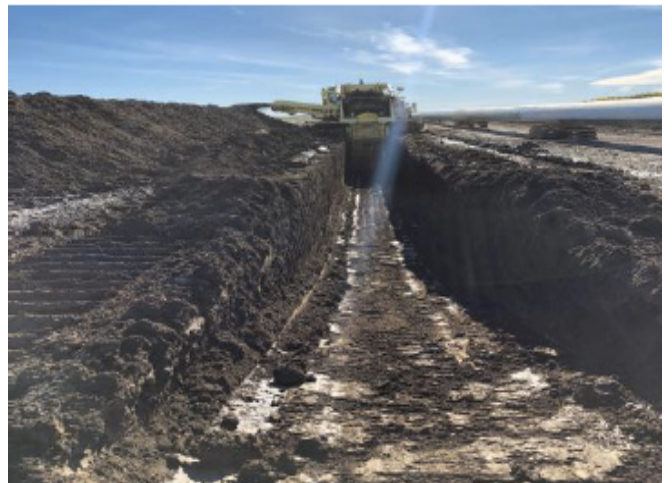
Wheel ditcher spudded and ditching on ROW –km 146+700– Sept 27, 2018

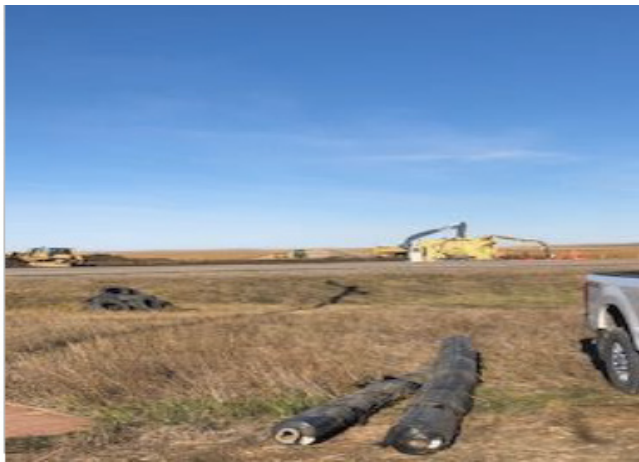
Excavator and dozer stripping topsoil – km 253+300 - Sep 28, 2018

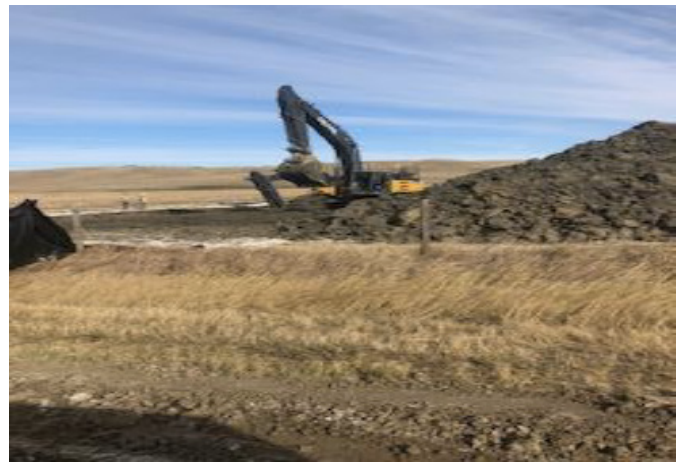
Excavators digging bore pit (Native Prairie) – SF 141 – Sept 28, 2018

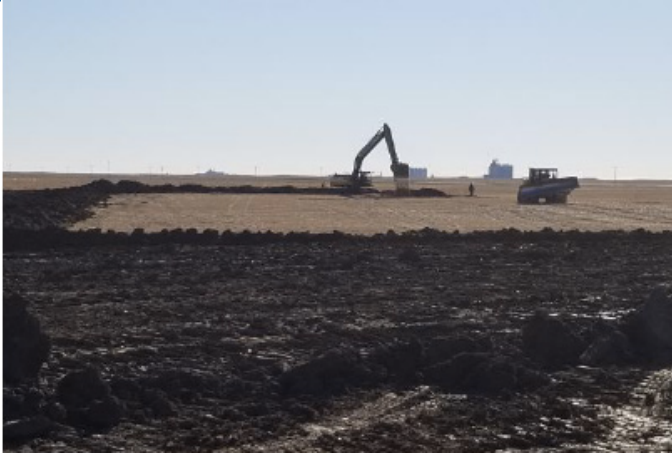
Equipment moving dirt – km 259+150 – Sept 28, 2018

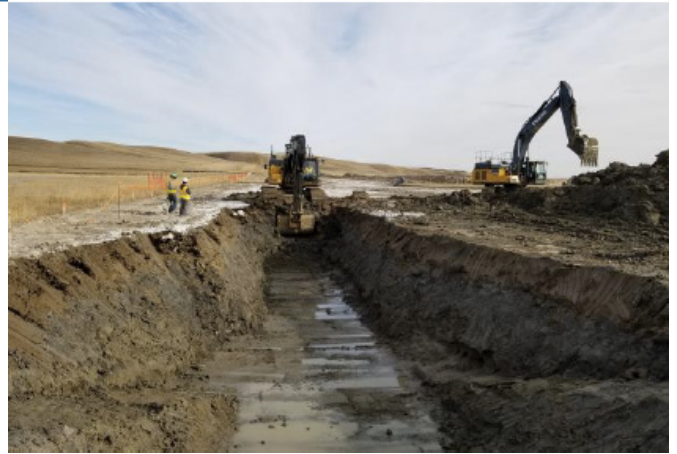
Digging bore pit on Heritage site – km 221+910 – Sept 28, 2018

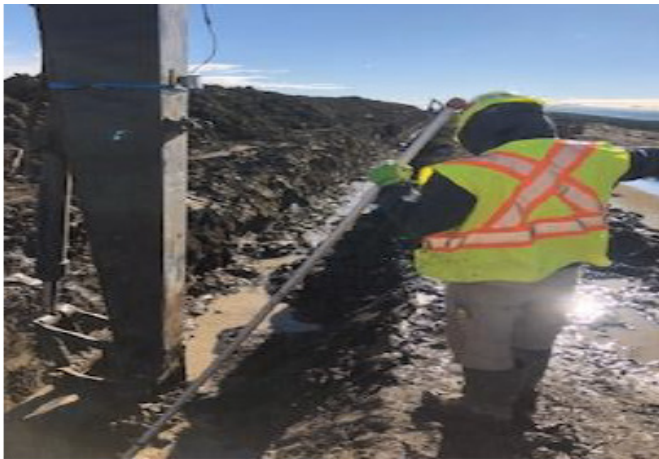
Excavator and swamper shading pipe - km 145+150 – Sept 28, 2018

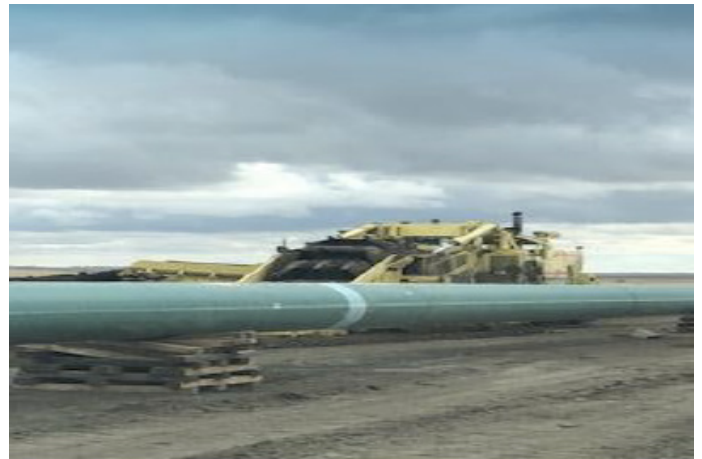
Ditching wheel working east – km 149+000 – Sept 28, 2018
