# SAMSON CREE NATION – MATRIX SOLUTIONS INC. PARTNERSHIP

## **ABORIGINAL CONSTRUCTION MONITORING**

## WEEKLY REPORT

## **SPREAD 2**

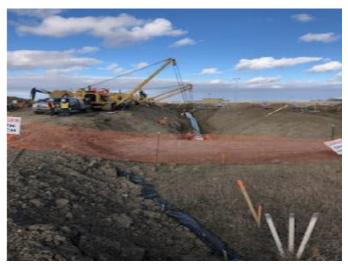
Tie in at bore - SF 91 - Sept 30, 2018

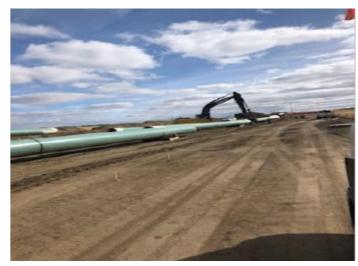
Excavator transitioning welds - km 182+900 - Sept 30, 2018

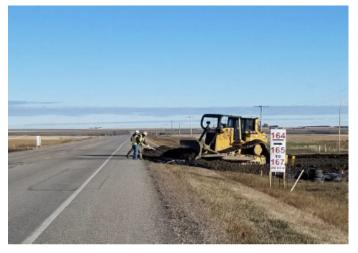
Building ramp - km 259+141 - Sept 30, 2018

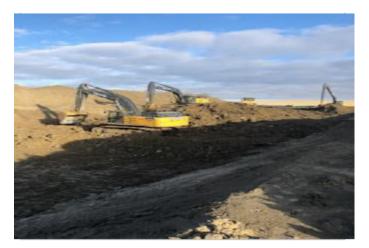
Digging bore bay - Km193+075 - Sept 30, 2018

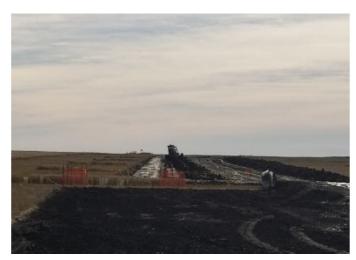
Grader moving dirt- km 247+355 - Sept 30, 2018

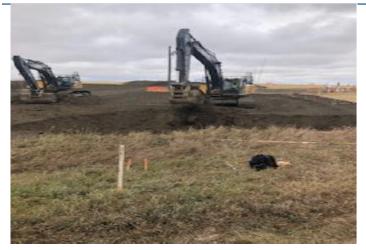
Digging bore bay - SF 144 - Oct 1, 2018

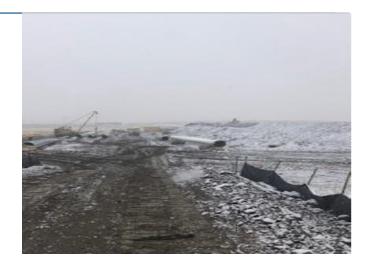
Set up crew - km 192+200 - Oct 1, 2018

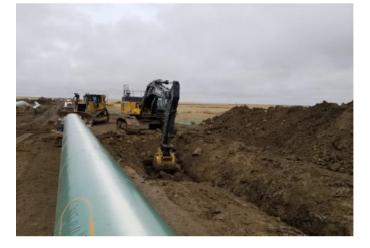
Digging bell hole -km 150+200- Oct 1, 2018

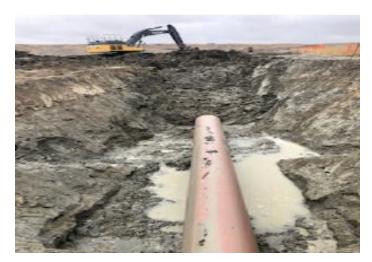
Backfilling bore bay - SF 140 - Oct 1, 2018

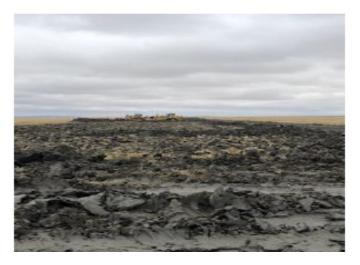
Top soil crew stripping ROW- km 245+200 - Oct 1, 2018

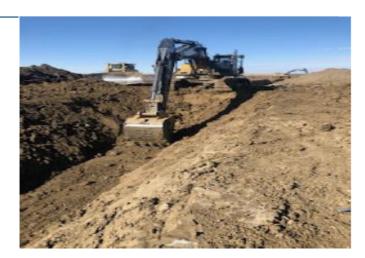
Excavator digging out tie in plug - SF 92 - Oct 3, 2018

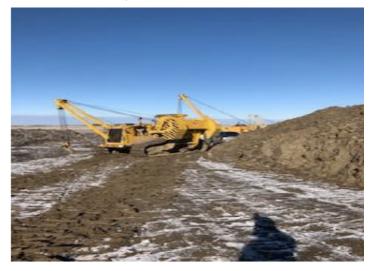
Tie in - SF 91 - Oct 3, 2018

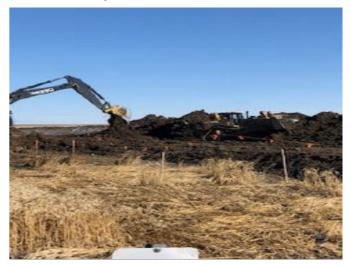
Digging ditch and plugging out – SF 92 - Oct 3, 2018

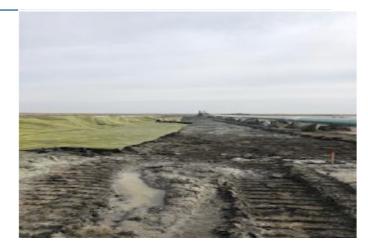
Prepping wetland area - km 152+960 - Oct 4, 2018

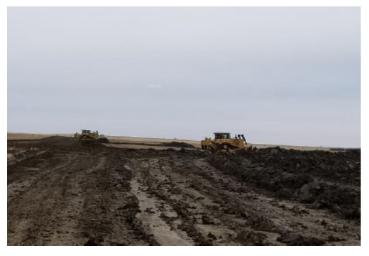
Moving dirt - km 249+900 - Oct 4, 2018

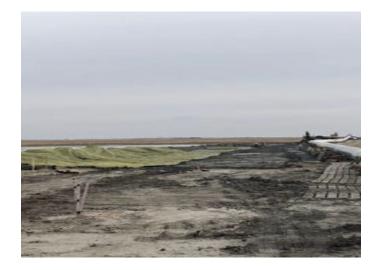
Crew laying geo tec at Heritage site – SF 92 - Oct 4, 2018

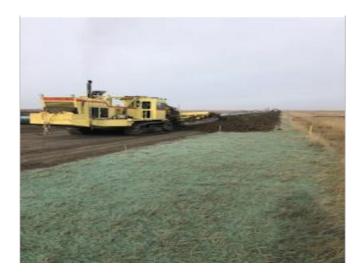
Digging ditch on mainline- km 154+900 - Oct 4, 2018

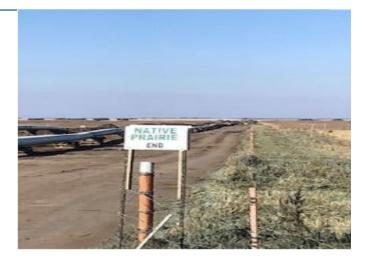
End of Native Prairie area – km 157+900 – Oct 5, 2018

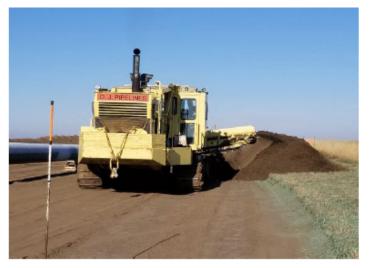
Ditching wheel - km 155+800 - Oct 5, 2018

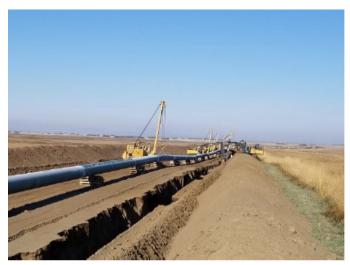
Lowering in - km 155+400 - Oct 5, 2018

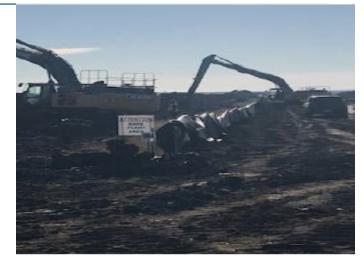
Excavator unloading swamp weights - km 153+100 - Oct 6, 2018

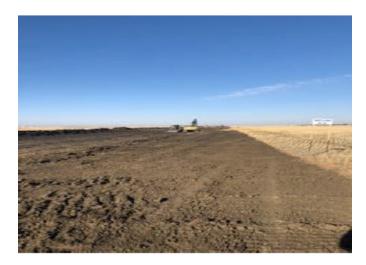
ROW being stripped - km 263+500 - Oct 6, 2018

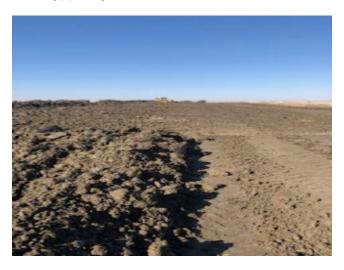
Topsoil being stripped - km 251+700 - Oct 6, 2018
