### **SGS MUSCOWPETUNG**

### **ABORIGINAL CONSTRUCTION MONITORING**

**WEEKLY REPORT**

FEBURARY 5<sup>TH</sup> TO FEBURARY 11<sup>TH</sup>, 2018

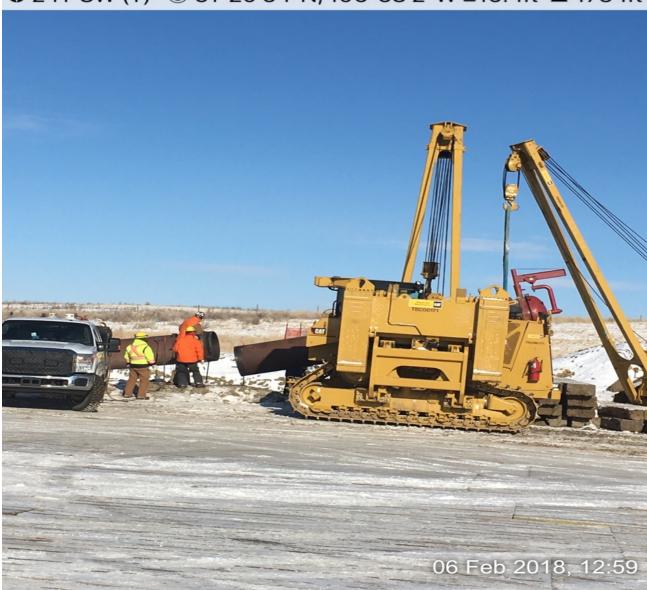
## **North East Elevation**

CUTTING TEST HEAD OFF AT EXIT POINT

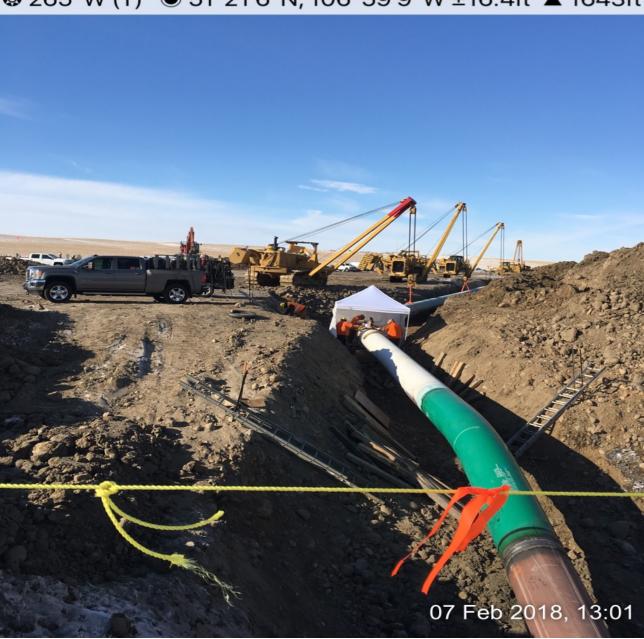
## **East Elevation**

TIE IN

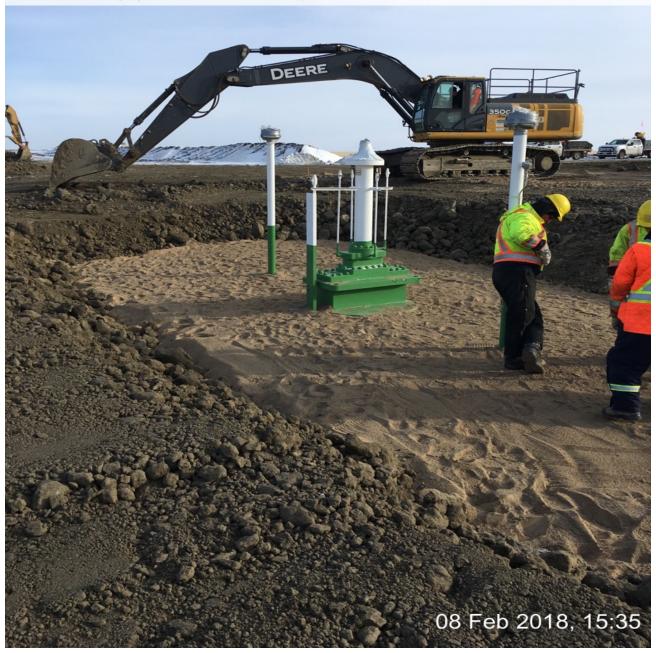
# **North West Elevation**

BACKFILLING VALVE NUMBER SEVEN

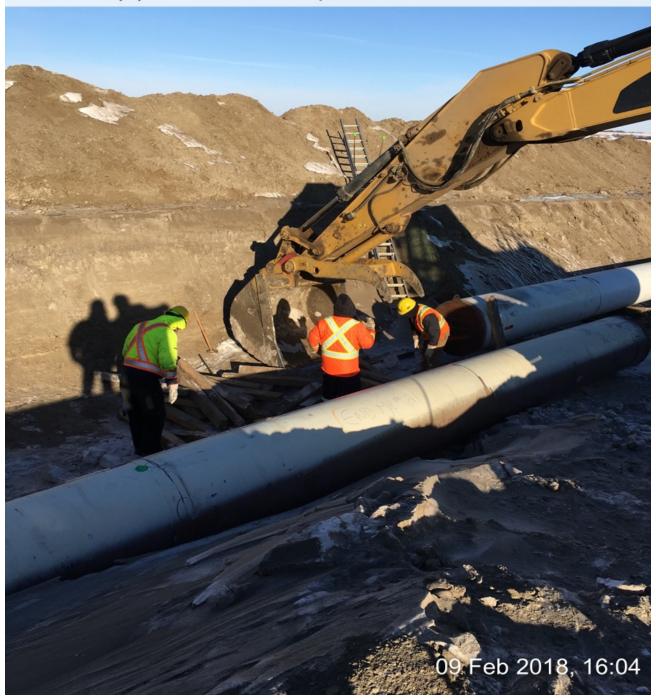
# **South West Elevation**

deficiency crew PICKING UP SKIDS

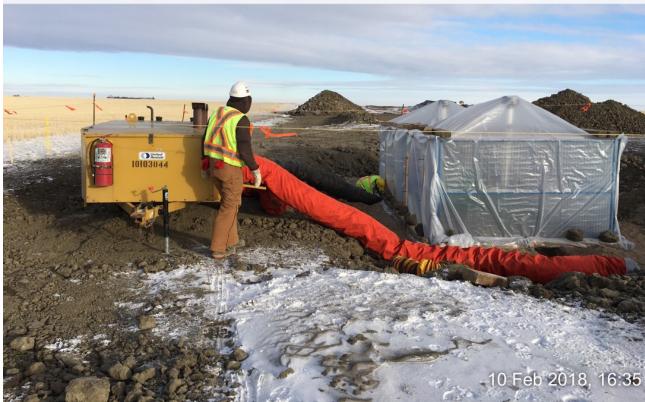
## **West Elevation**

**HOARDING**

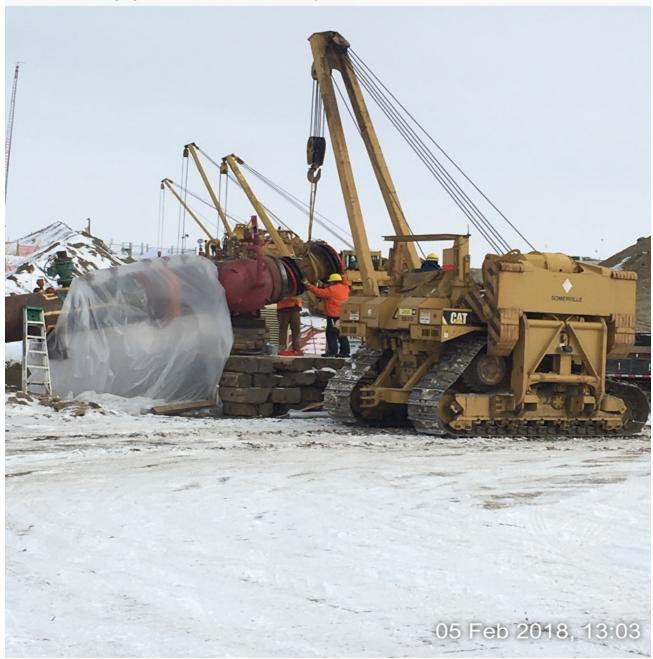
# **South West Elevation**

**INSTALLING PIGS AT TEST HEAD**

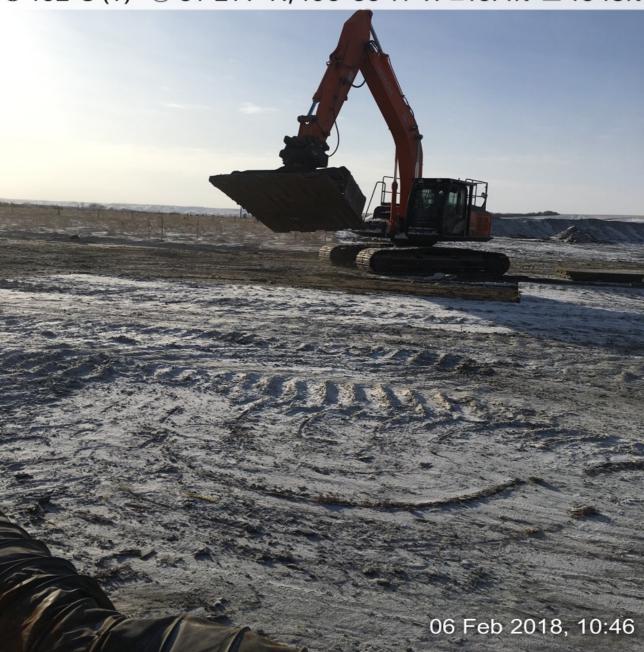
# North Elevation

PICKING UP RIGS MATS

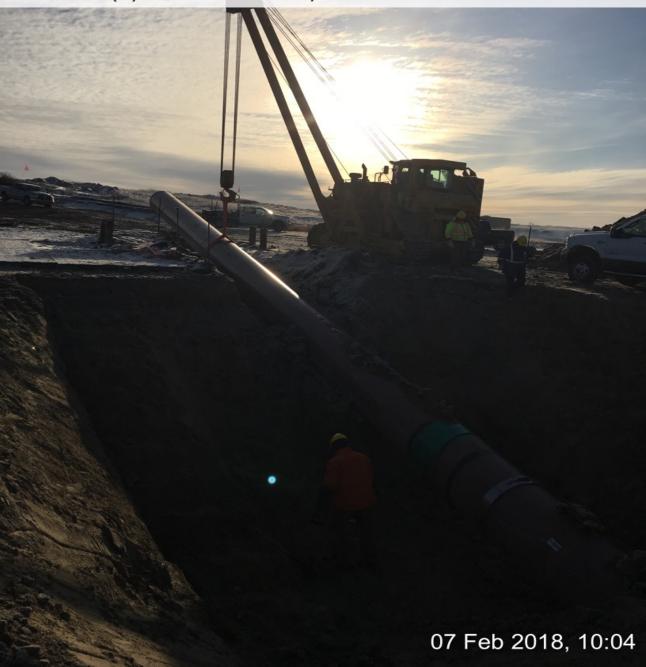
# **North West Elevation**

CUTTING OFF SECTION OF THE BORE

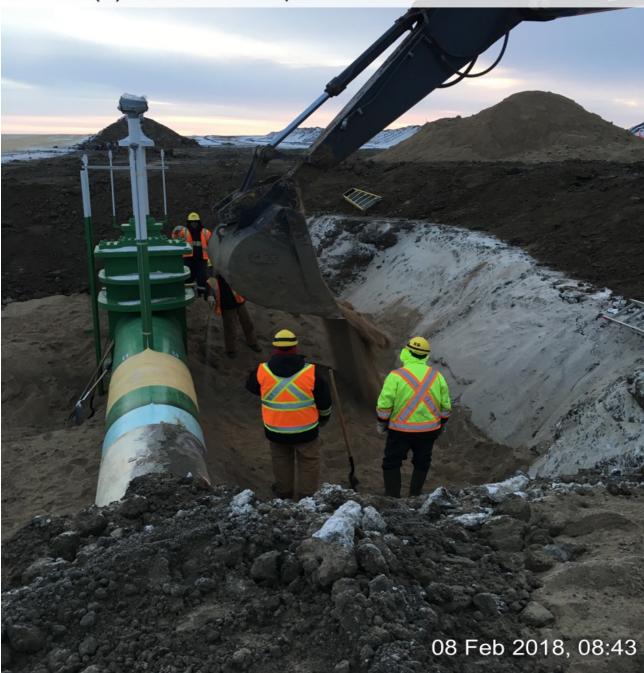
# **West Elevation**

BACKFILLING VALVE

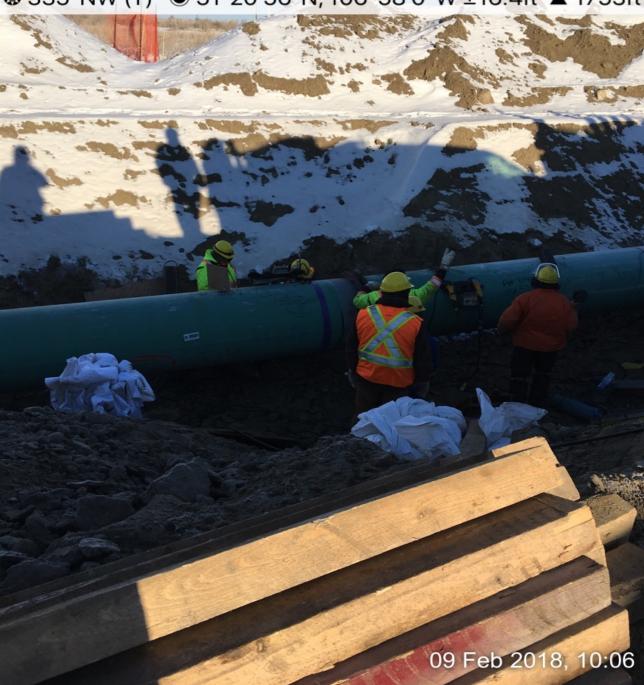
# **South East Elevation**

SPACING A TIE IN

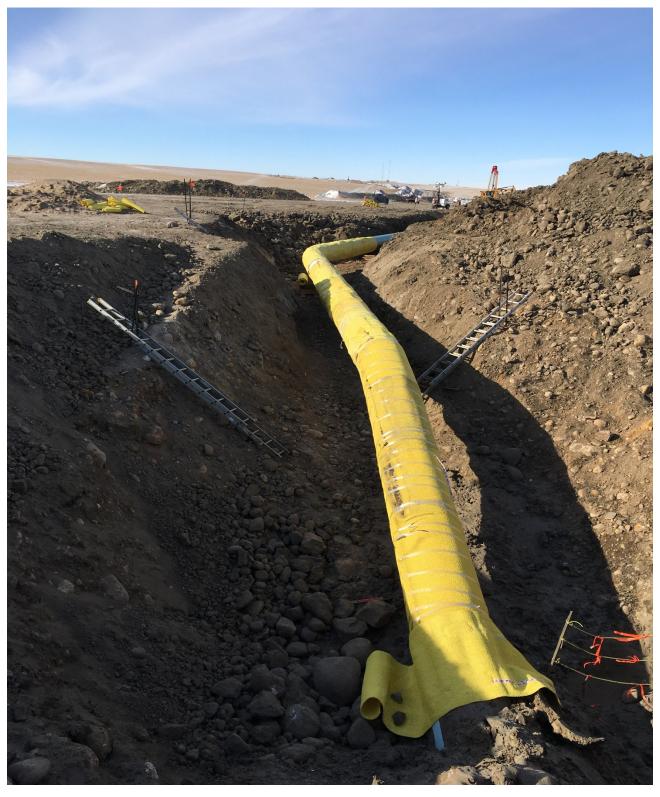
**ROCK SHIELD**

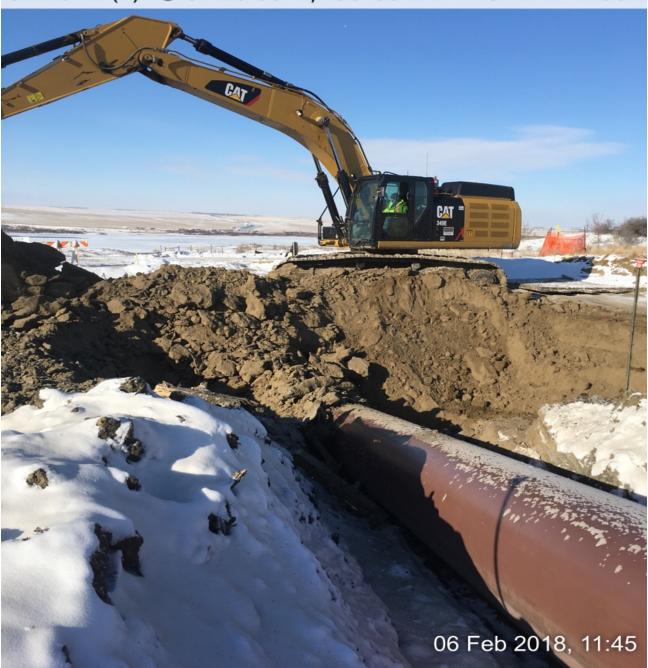
# **East Elevation**

**BACKFILLING DITCH LINE**

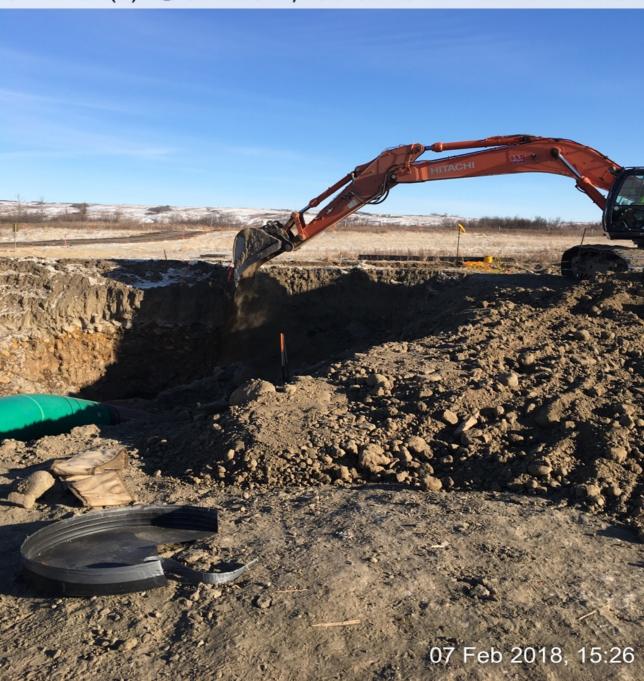
# **North West Elevation**

**BACKFILLING ENTRY POINT**
