SGS MUSCOWPETUNG

ABORIGINAL CONSTRUCTION MONITORING

WEEKLY REPORT

NOVEMBER 6TH TO NOVEMBER 12TH, 2017

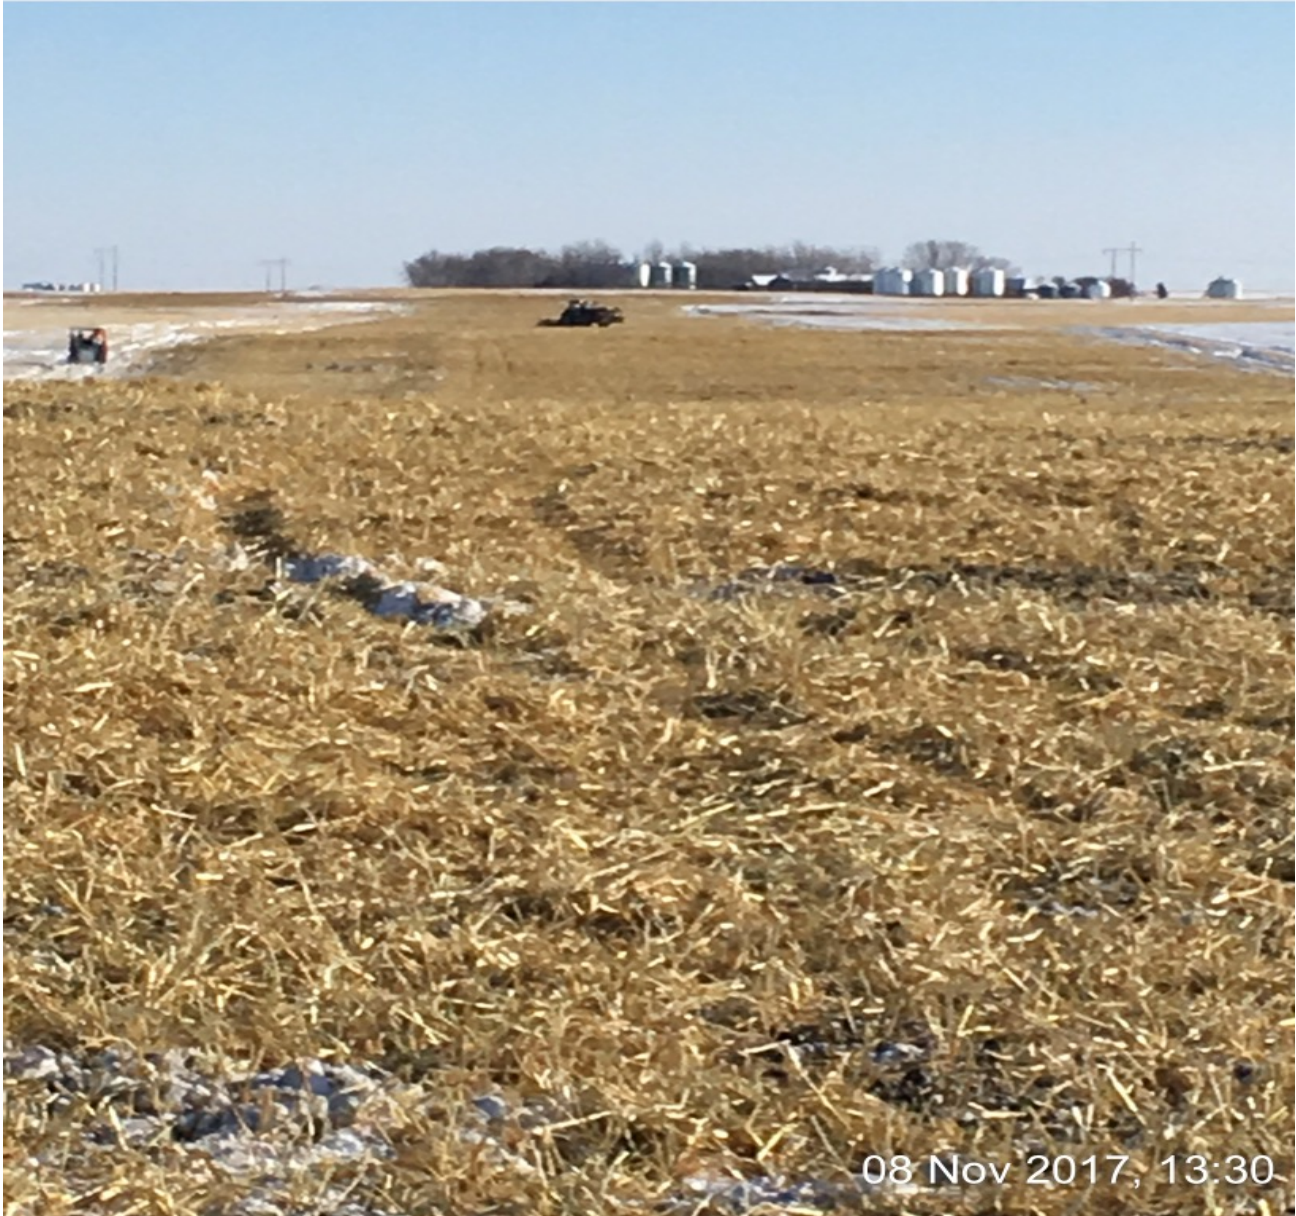
North West Elevation

They are completing the spreading and crimping of the straw over the right of way. This method will deter top soil erosion. To my observation they have performed a great job at doing the clean up.

CRIMPING OF STRAW. PROCESS TO DETER SOIL EROSION

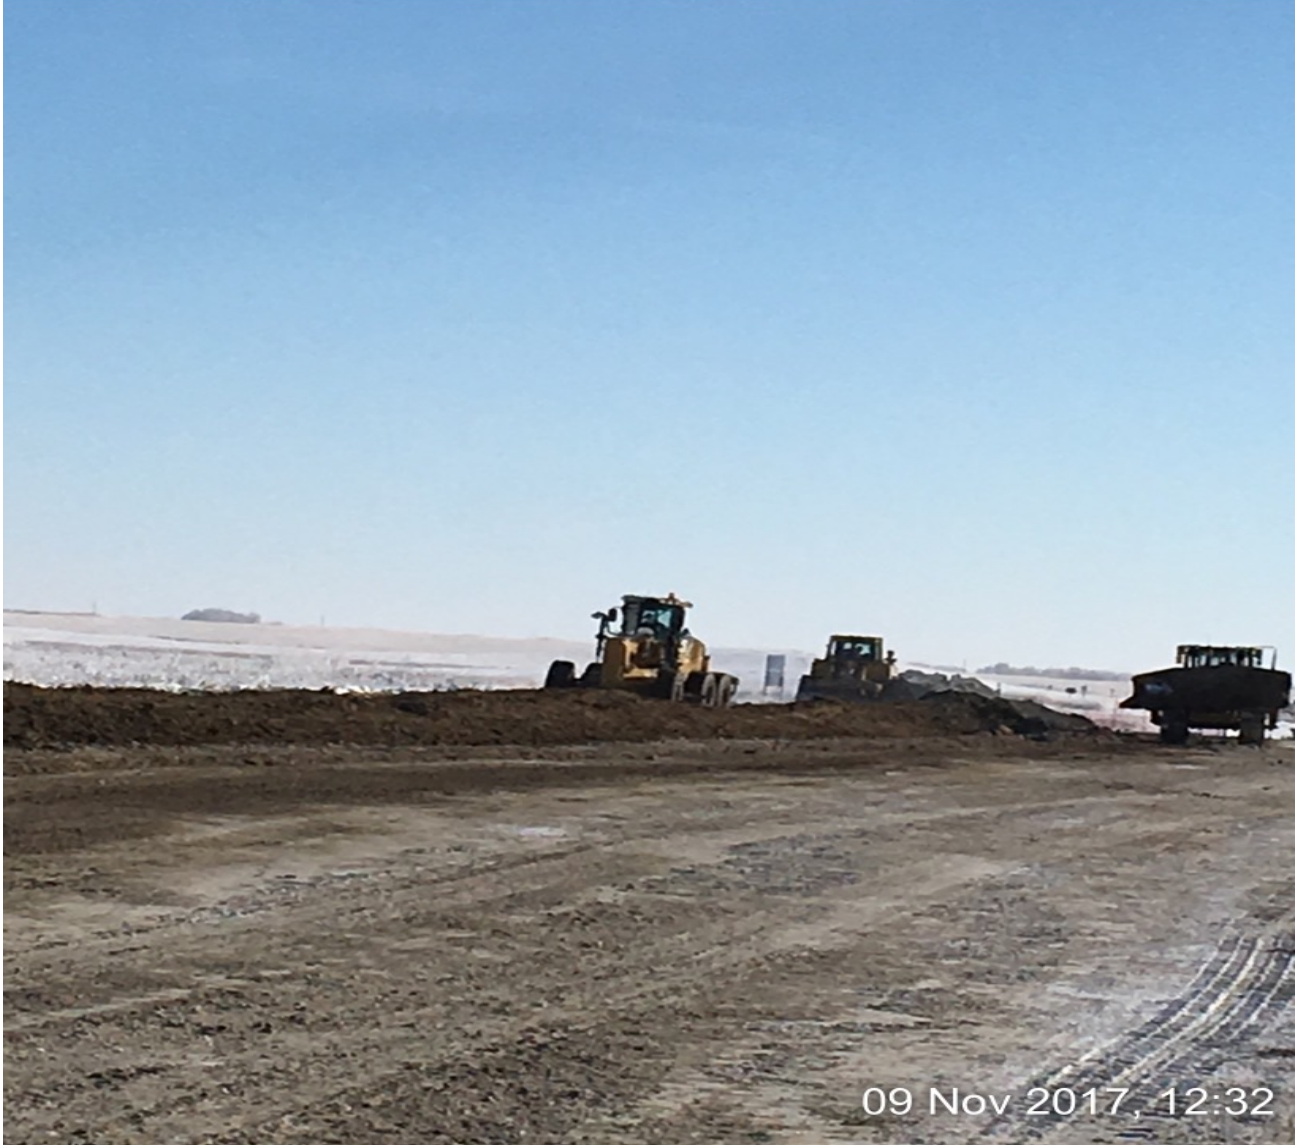
North Elevation

BACK END OF BACKFILL CREW

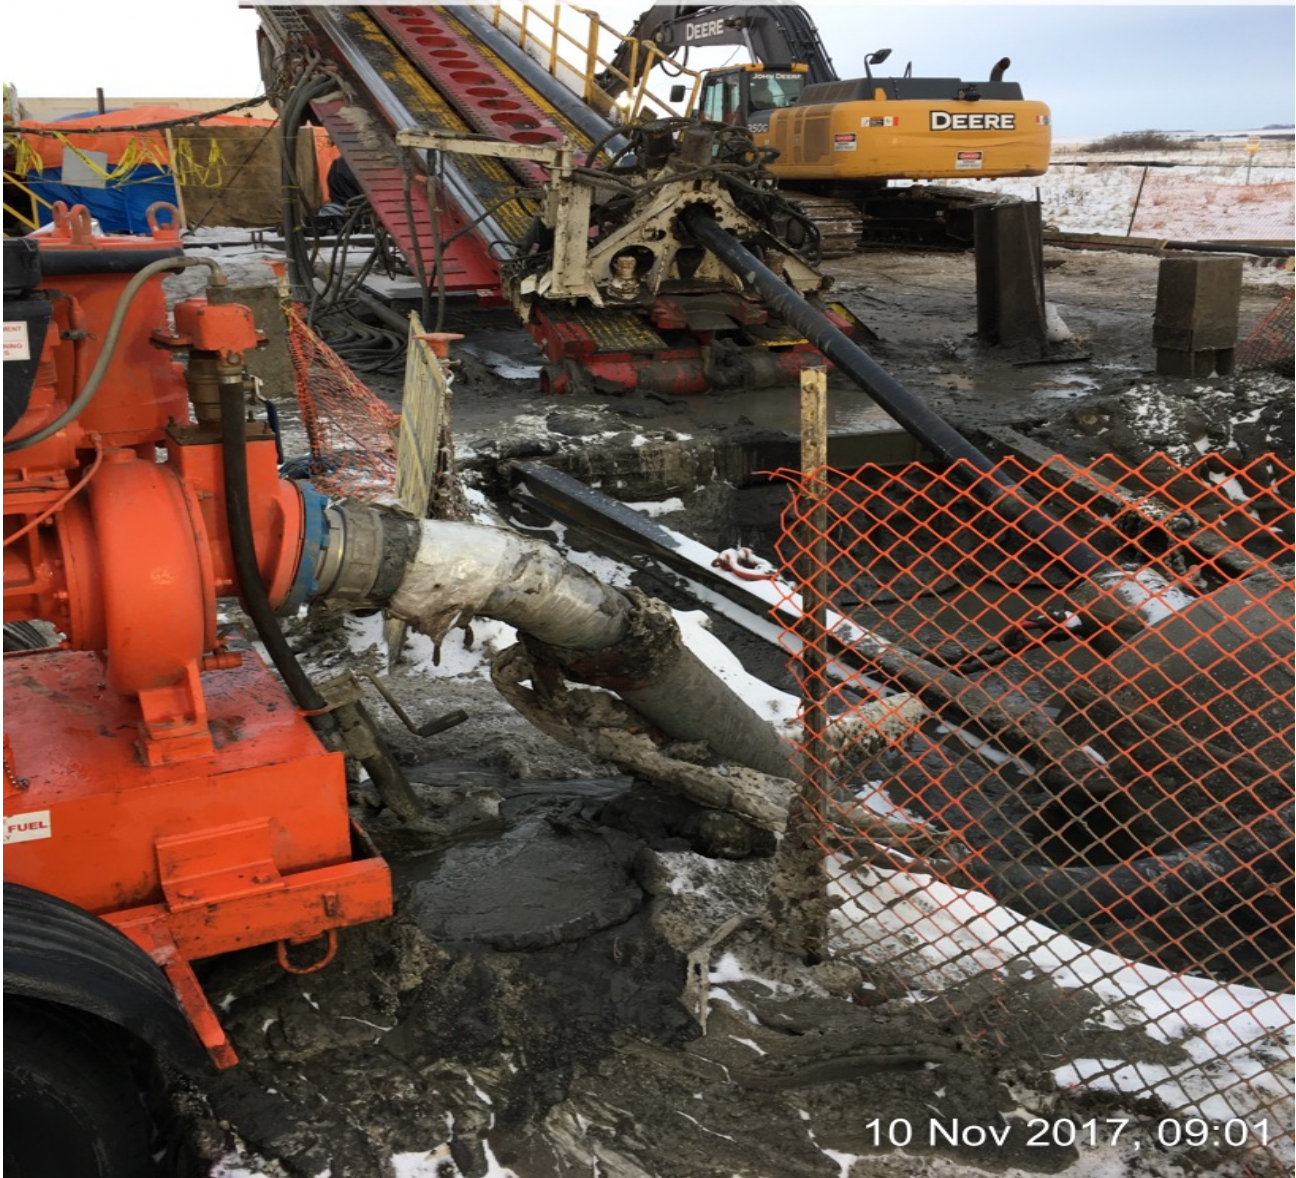
South East Elevation

The horizontal directional drilling at the South Saskatchewan River is still ongoing. They are currently at 672 metres as of Friday with a 24-inch reamer that is at point of the main current of the river. Everything is going well at this point.

HORIZONTAL DIRECTIONAL DRILLING AT SOUTH SASKATCHEWAN RIVER

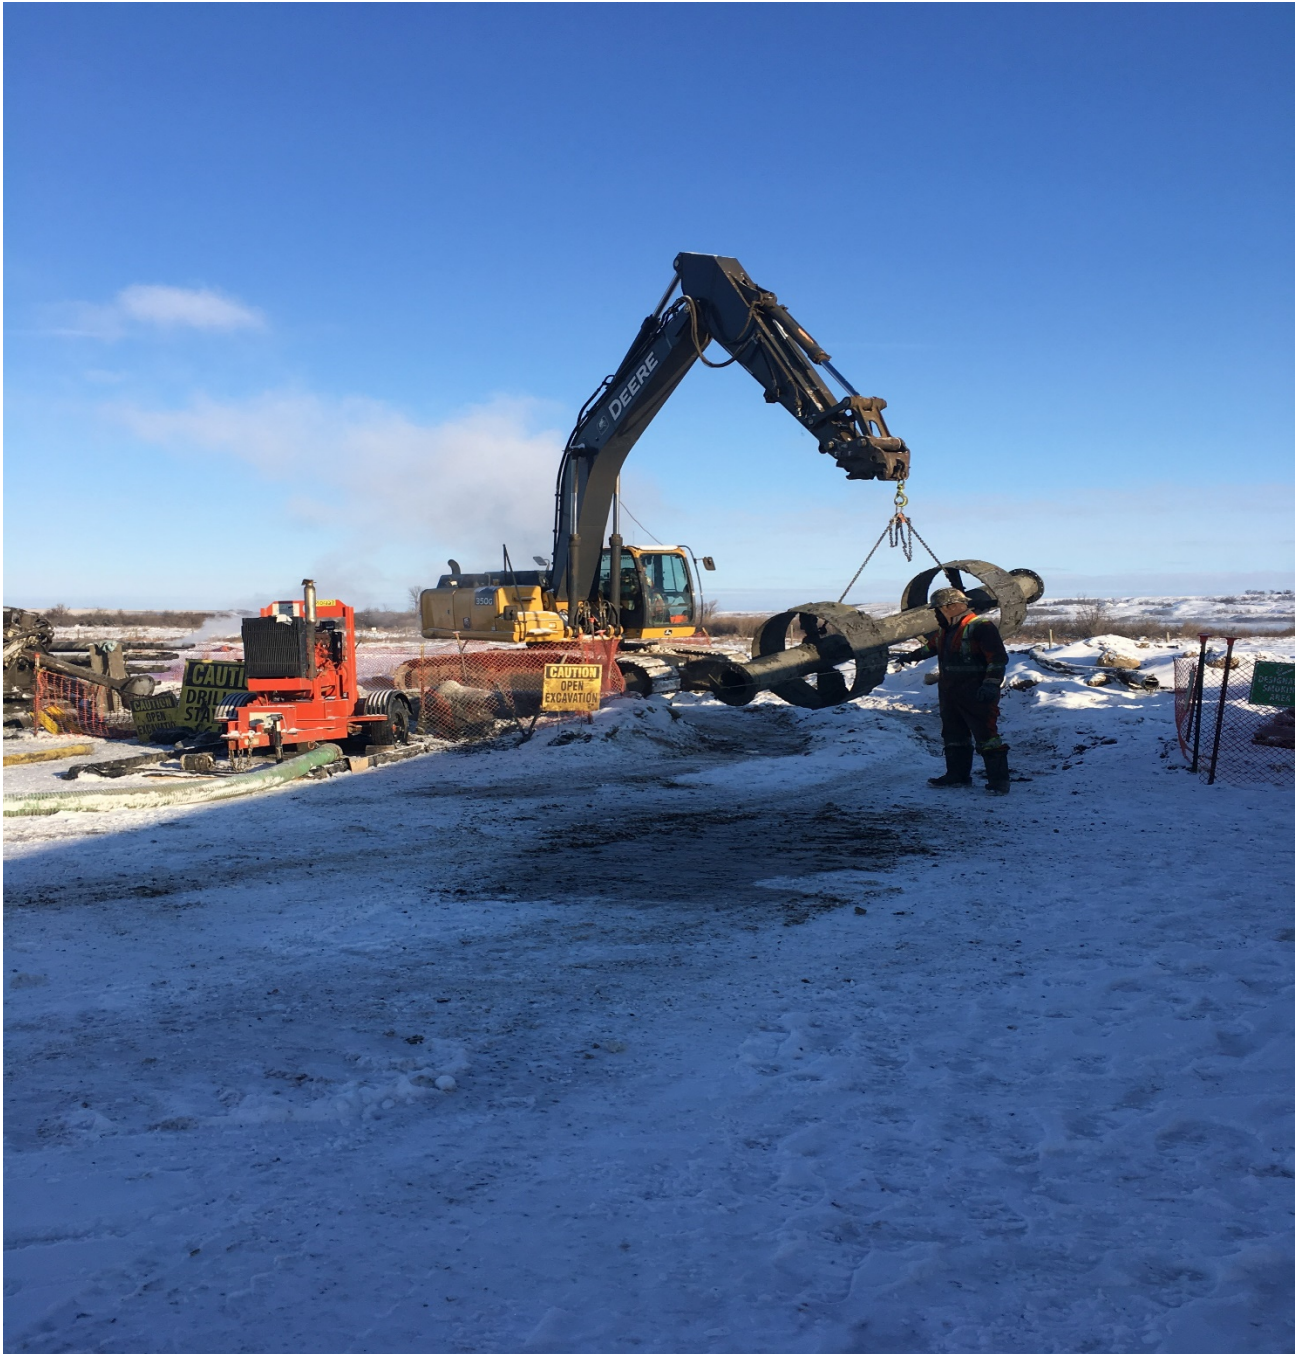
36-INCH RIPPER

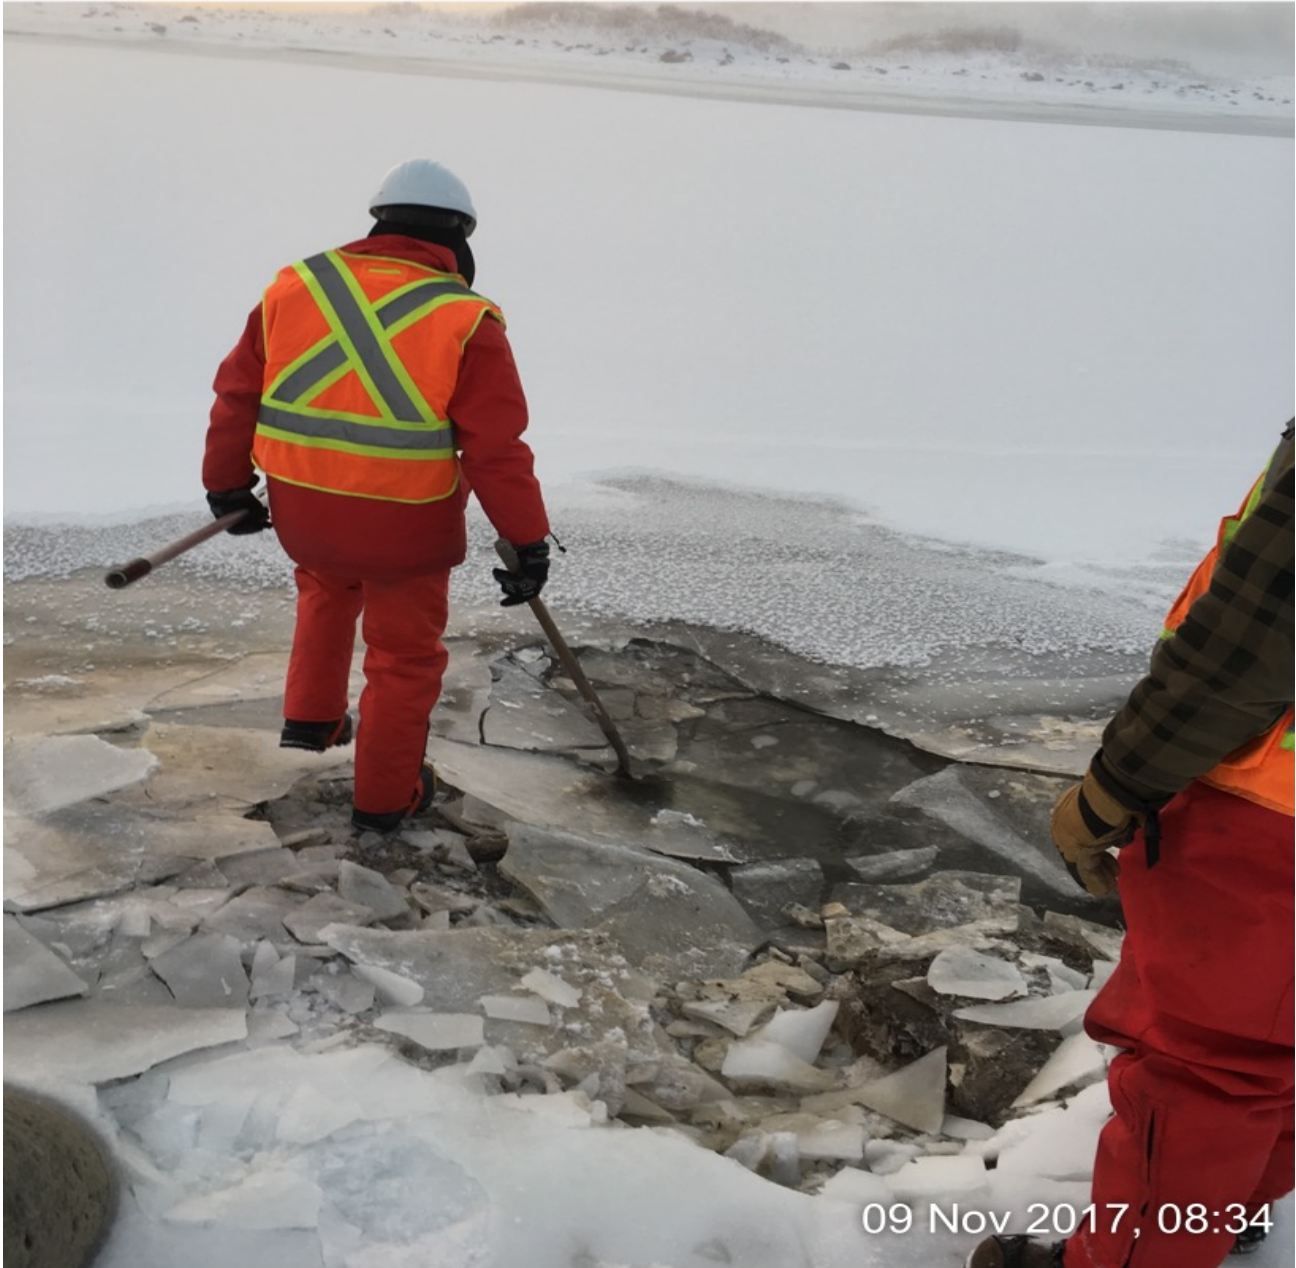
North Elevation

The testing of the water turbidity by Golder Associates remained consistent throughout the week. It is closely being monitored as they are underneath the river now. Testing of the turbidity of the water is performed every two hours throughout the day and there is constant communication between the Golder Associates and the drilling team.

COLLECTING WATER SAMPLES AT THE RIVER

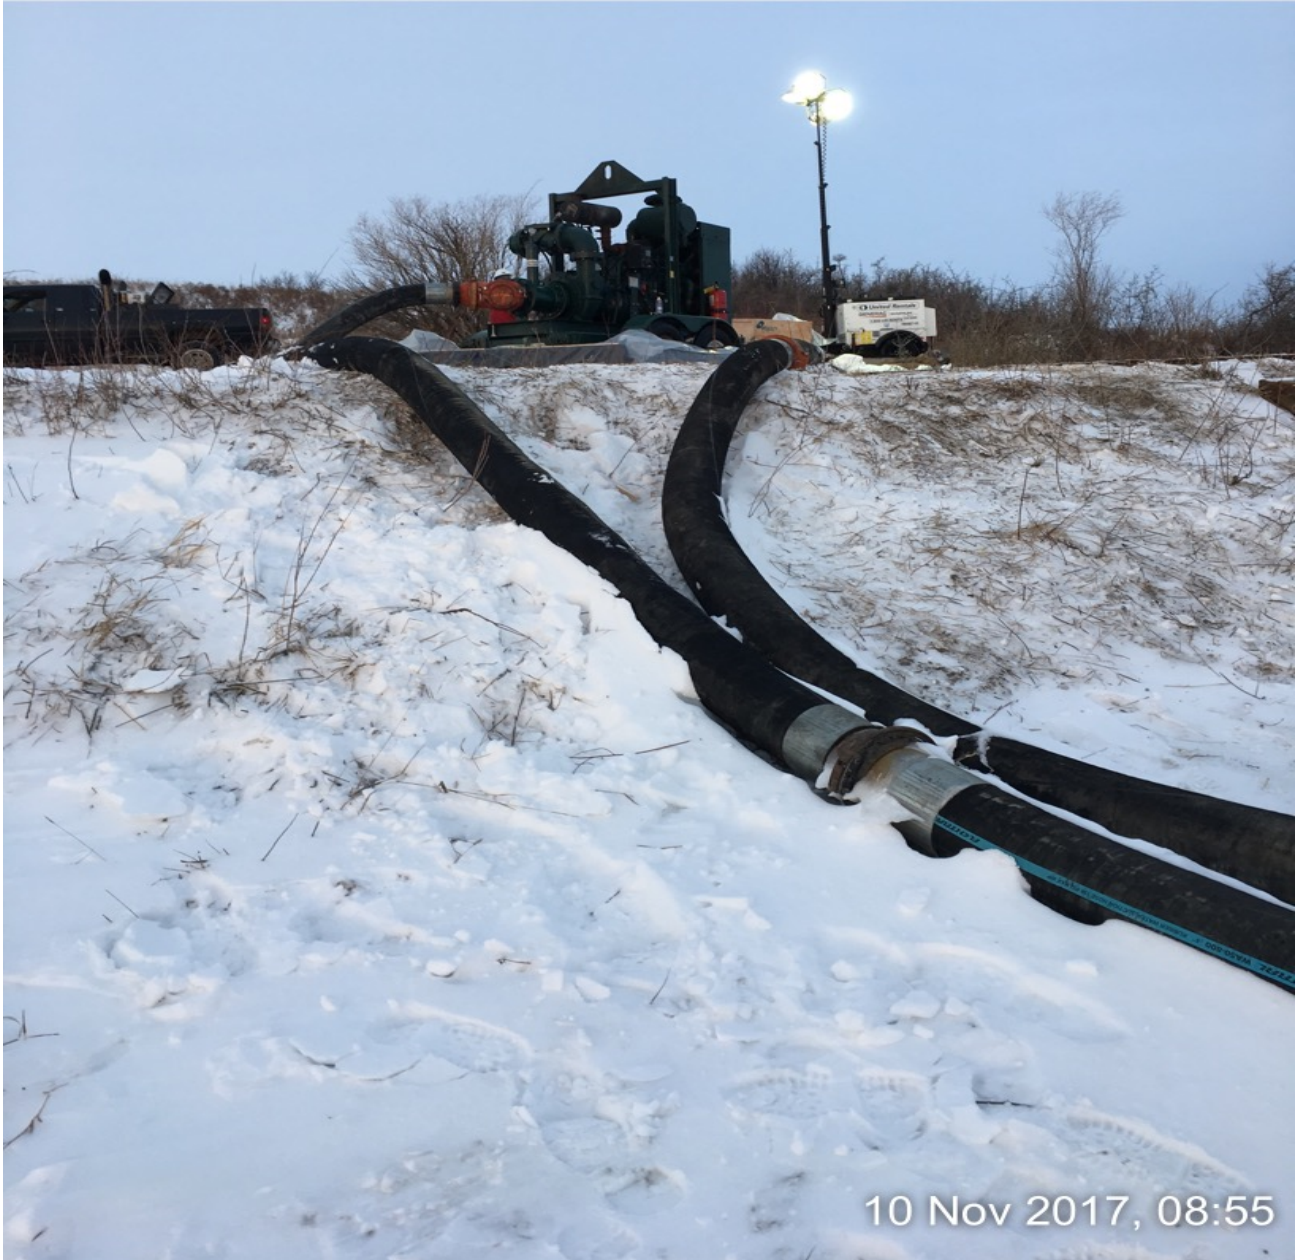
South East Elevation

They have started the process of hydro testing the mainline. The first step is to get water into the pipeline; they need approx. 7000 cubic metres of water which they are pumping from the river. This is ongoing now and I will update next week on the progress.

PUMPING WATER FROM THE RIVER INTO THE MAINLINE

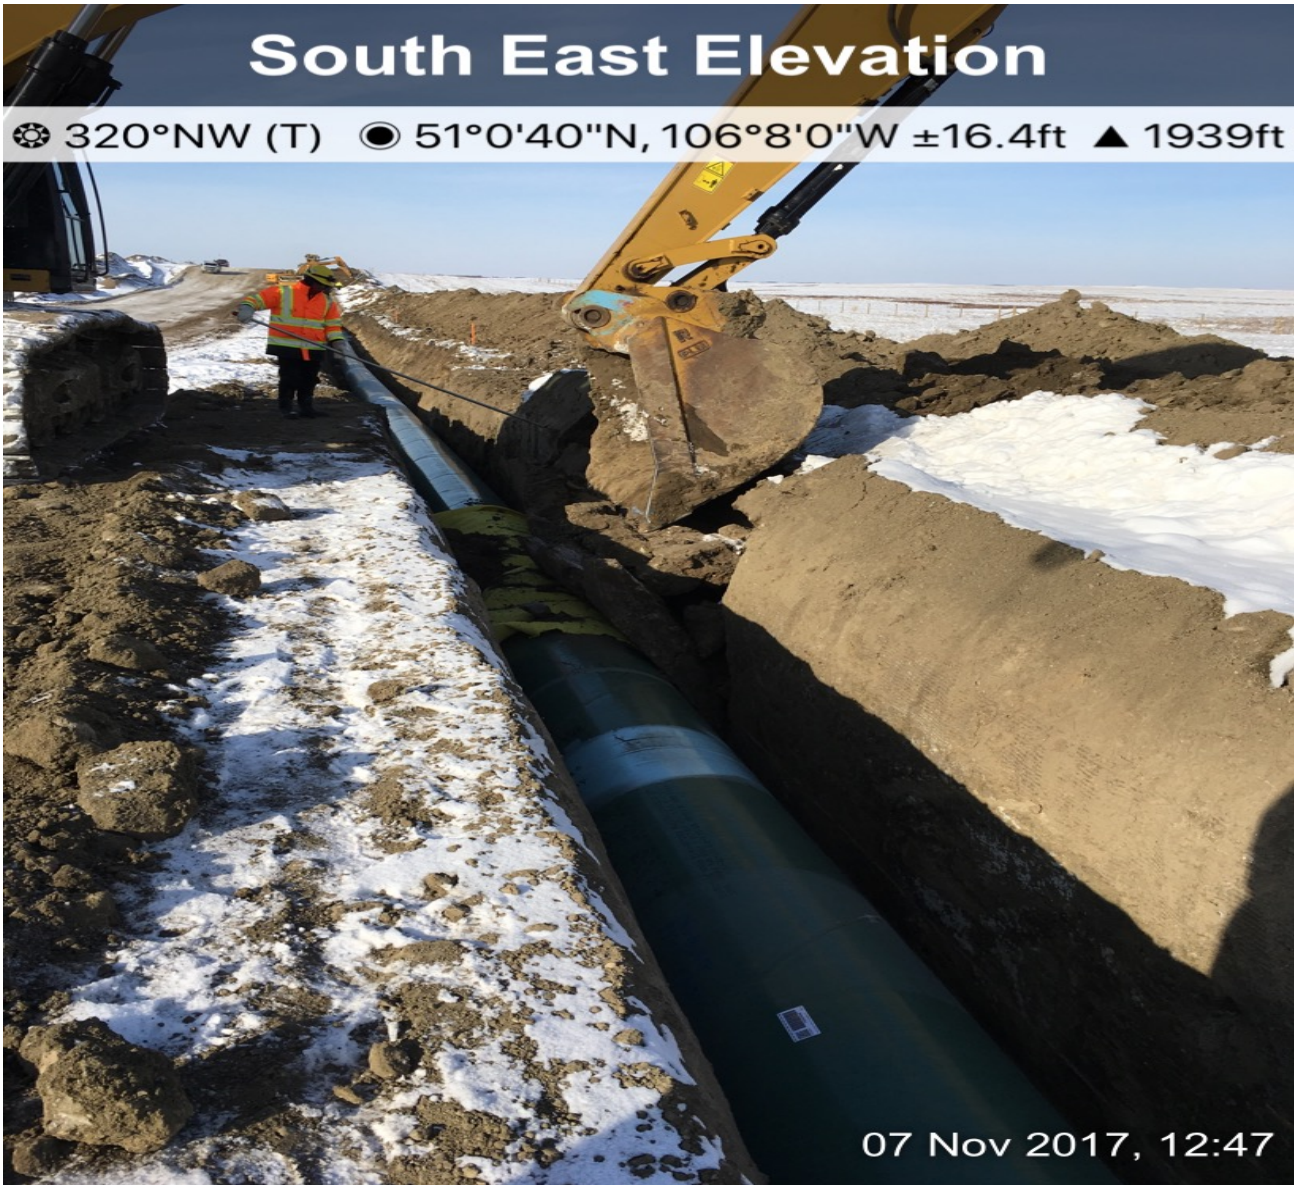
BACKFILL CREW

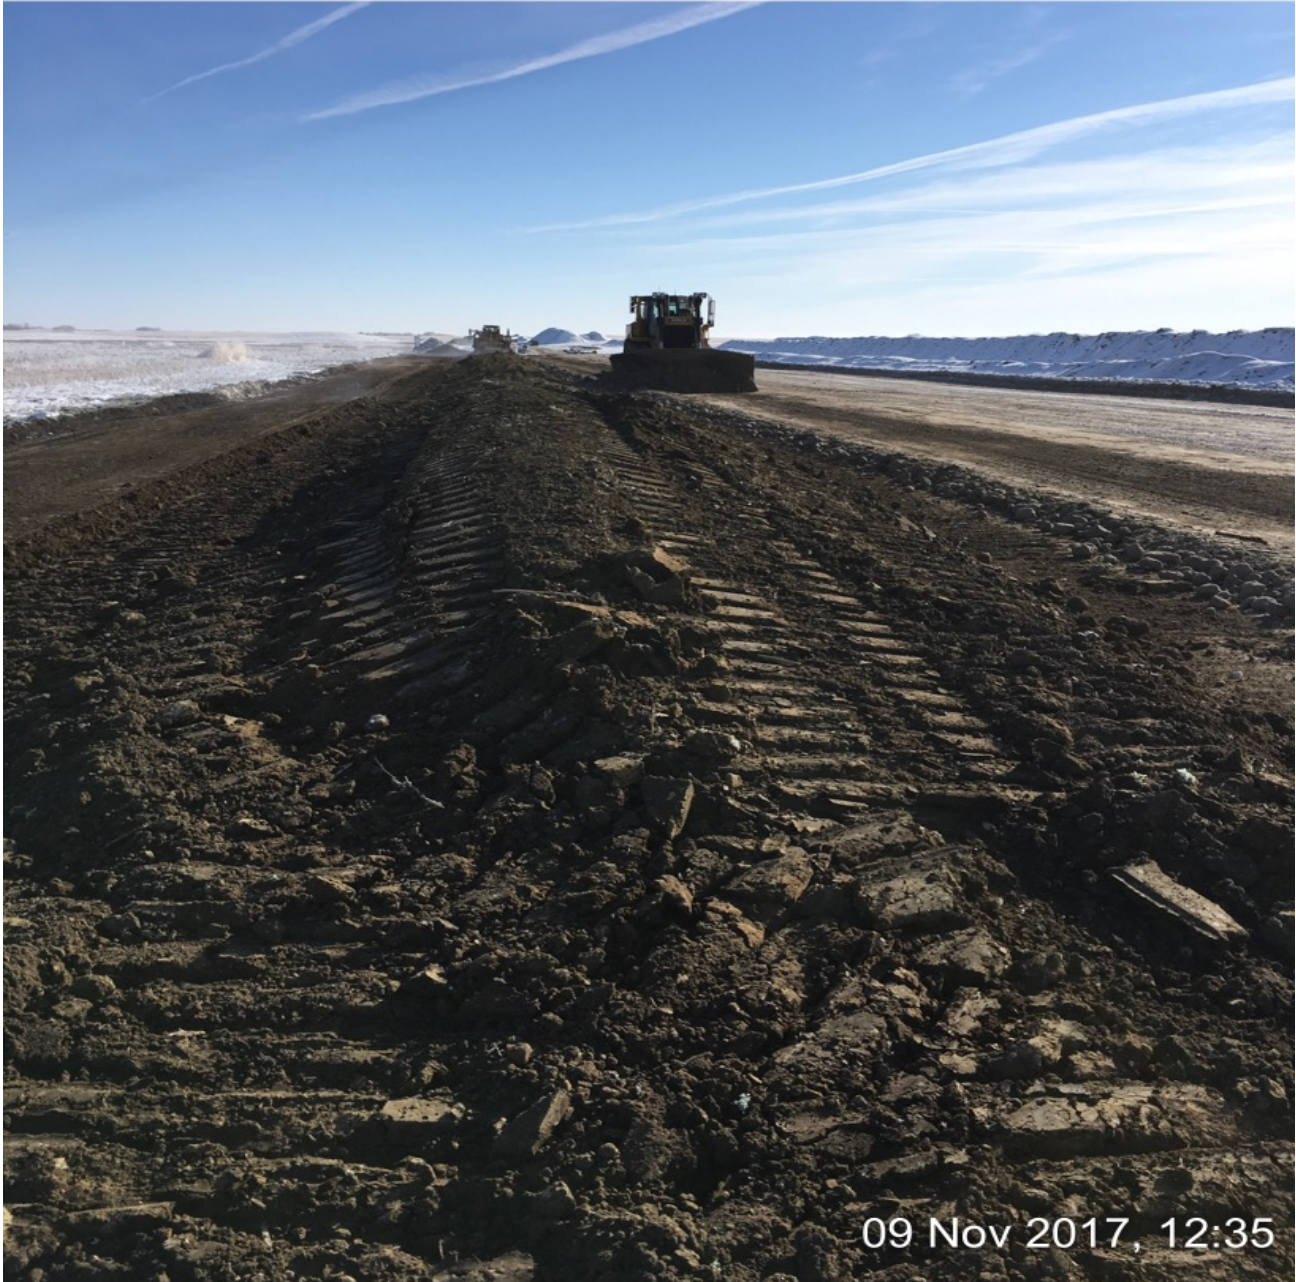
North West Elevation

LAST STEP OF THE BACKFILL PROCESS

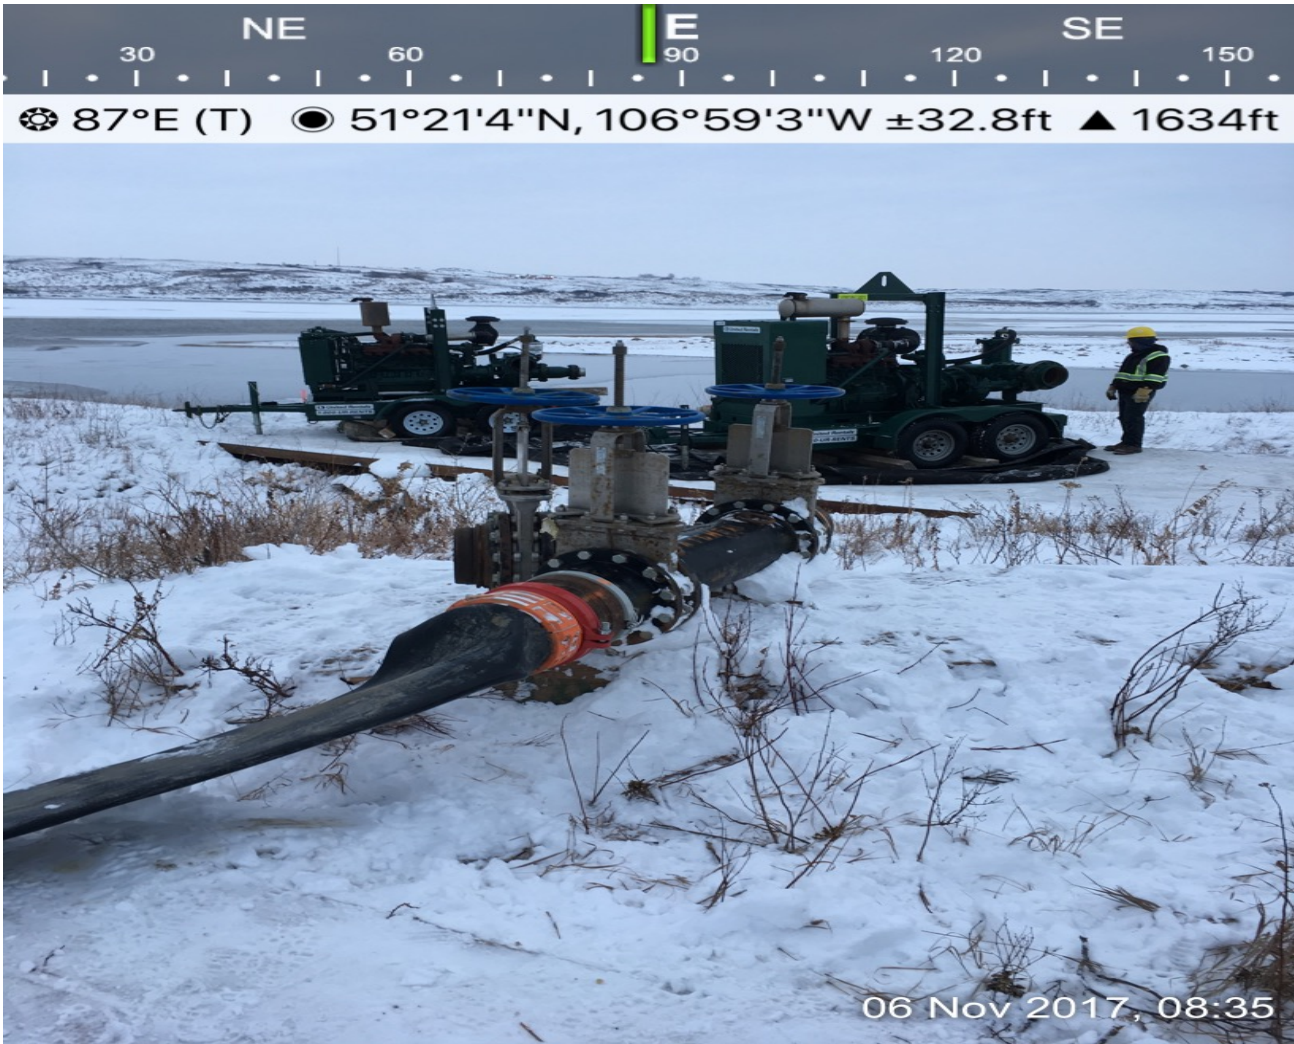
PUMPING WATER FROM THE RIVER INTO THE MAINLINE
