SGS MUSCOWPETUNG

ABORIGINAL CONSTRUCTION MONITORING

WEEKLY REPORT

SPREAD # 3

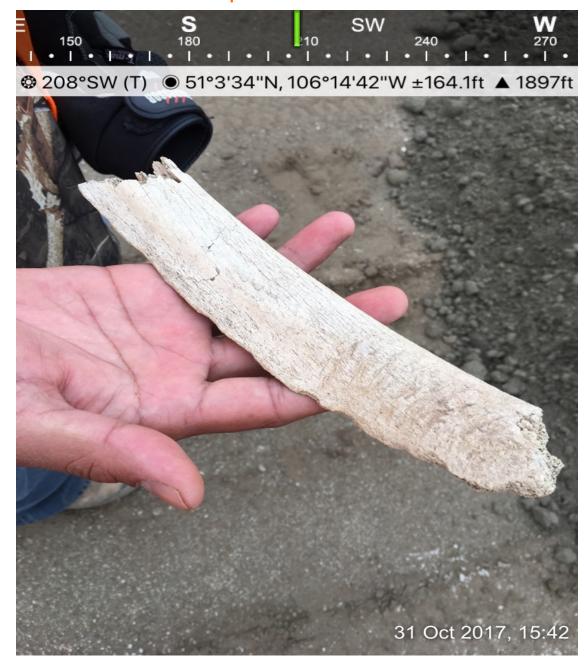
Myself and my colleagues have been observing the back-filing crew and ditching crew for any potential of artifacts or bones and there hasn't been any at this point. One rib bone was found by a Golder Associate staff member at a known traditional area. They have yet to identify the bone.

UNIDENTIFIED RIB BONE

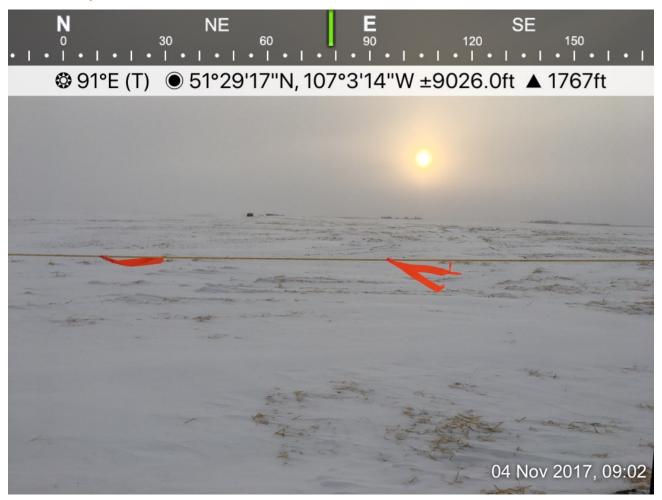
They have started the final clean up of the right of way from kick off. They have started spreading the straw over the right of way and crimping it into the soil. This is a process to protect the topsoil from wind erosion. As of Saturday, they have stopped the spreading of top soil over the right of way due to the amount of snow that has fallen. I have not come across any environmental issues at this time.

SPREAD AND CRIMPED STRAW ACROSS THE RIGHT OF WAY

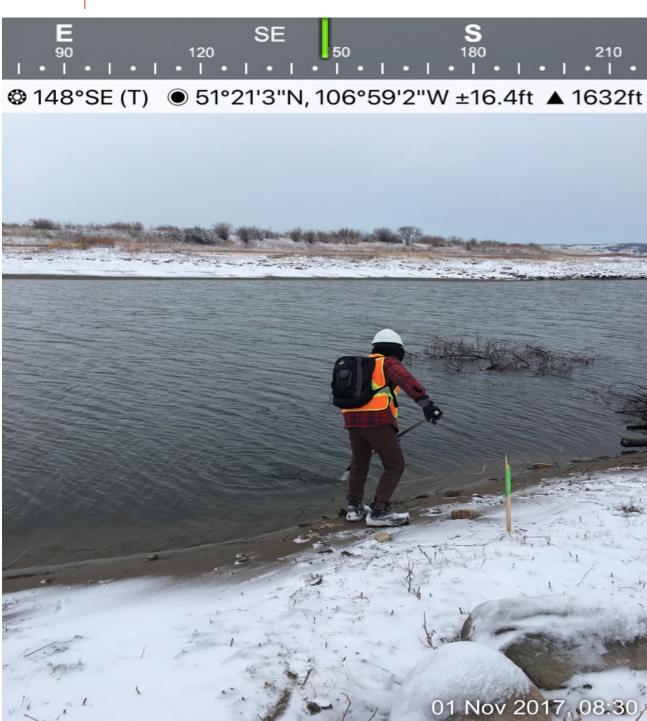
The result of testing of the water turbidity by Golder Associates remained the same until Friday. The turbidity was a bit high and Golder Associates staff member explained that this is due to the weather change (high winds and snow) which has agitated the river bottom causing the change. At this time there is no environmental concerns. We will be watching closely this week as the directional drilling will be going under the river.

COLLECTING WATER SAMPLES AT THE RIVER

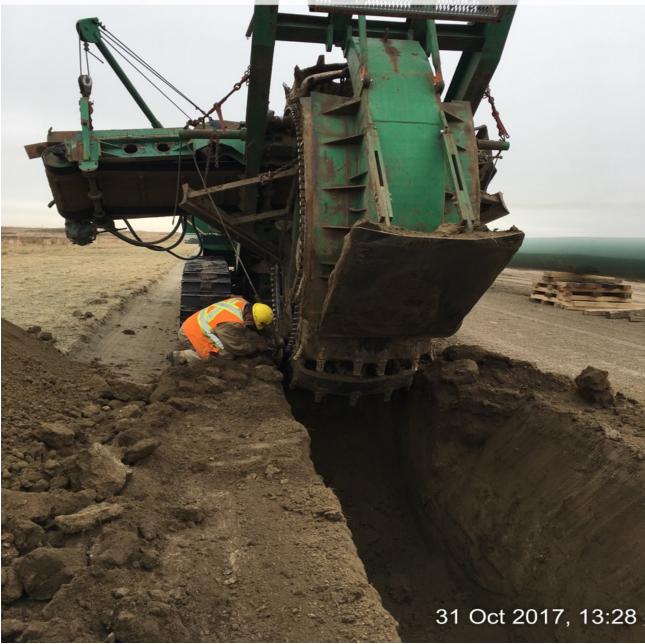
DITCHING MACHINE AT KNOWN TRADITIONAL AREA

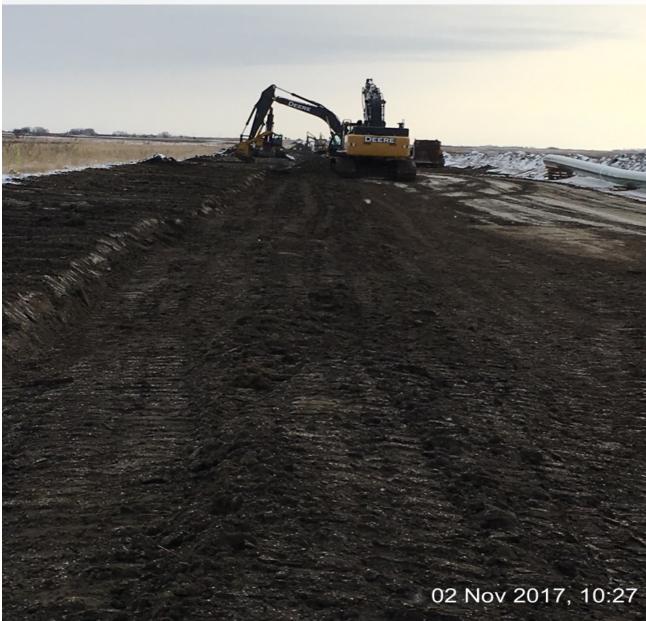
BACKFILLING CREW

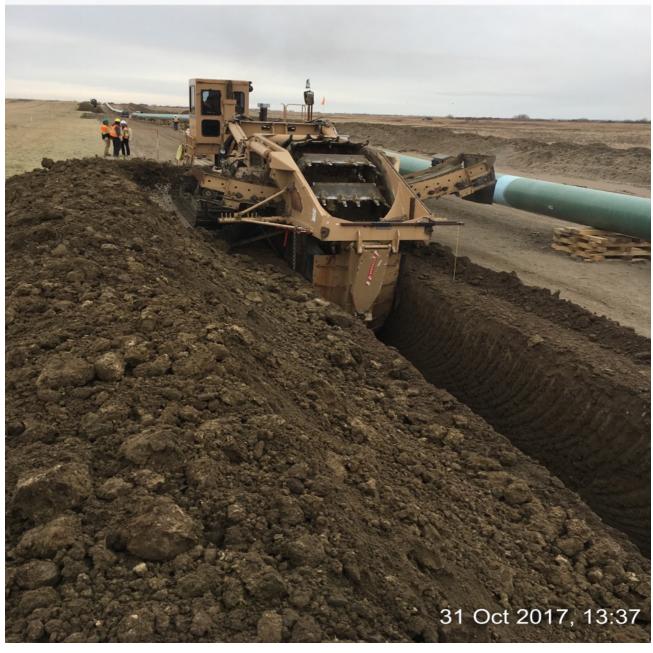
DITCHING CREW

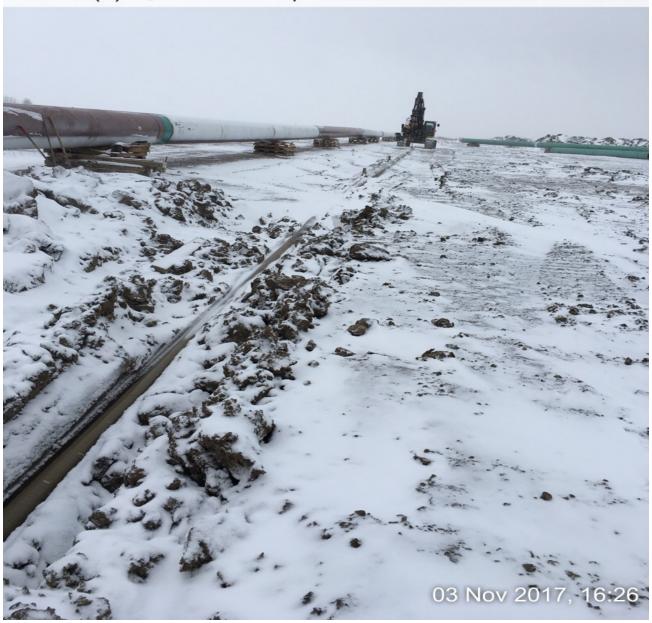
EXIT POINT OF CANAL

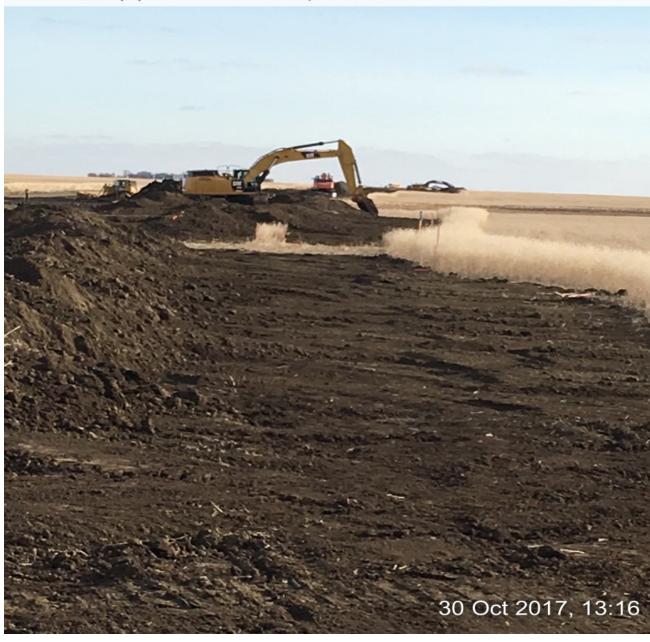
PULLING TOPSOIL BACK ONTO THE RIGHT OF WAY

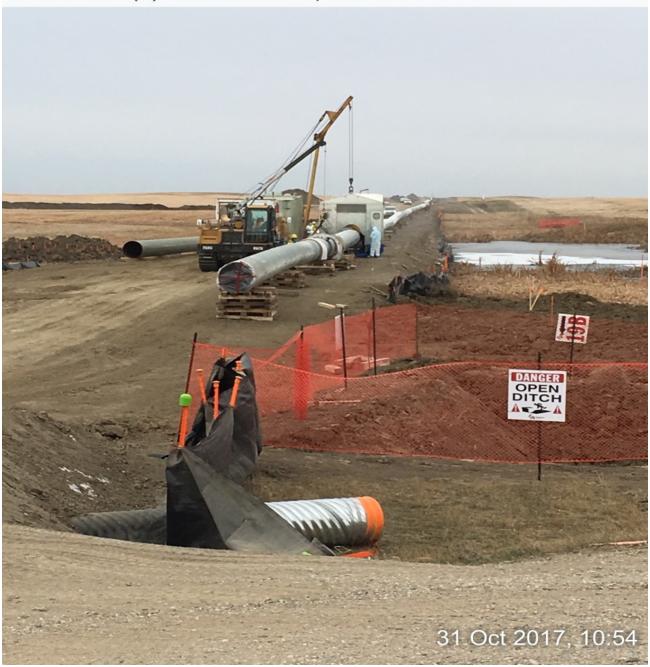
COATING CREW

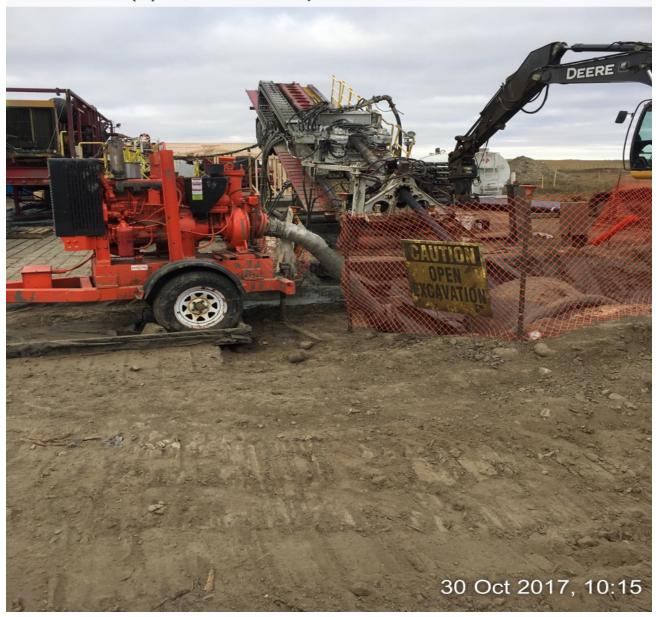
The horizontal directional drilling at the South Saskatchewan River is ongoing. They have started with 36-inch ripper to a 200 metres mark tripped back and installed a 24-inch reamer that will be used to the exit point. As of yesterday, they are at 272 metres in with the 24-inch reamer they are approaching the shore of the South Saskatchewan River.

HORIZONTAL DIRECTIONAL DRILLING AT SOUTH SASKATCHEWAN RIVER

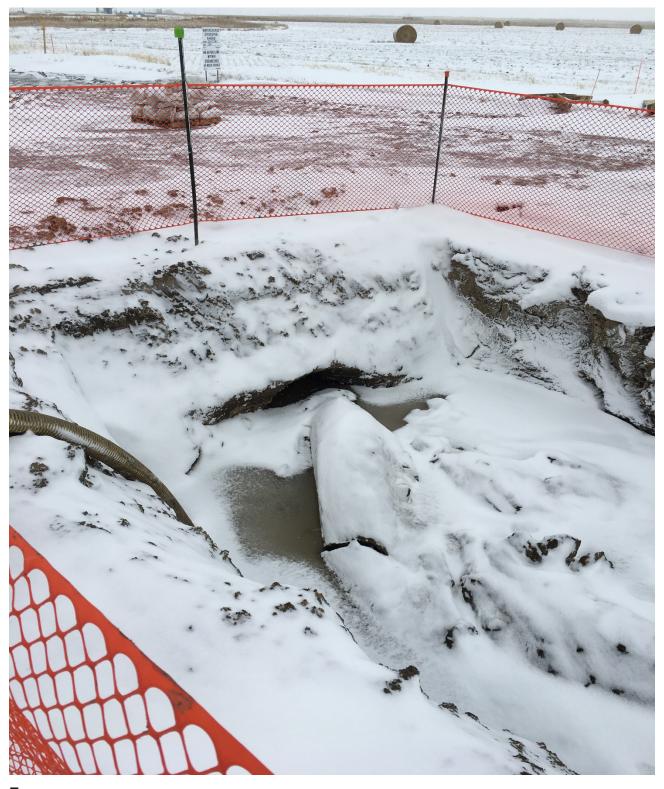
EXIT POINT OF CANAL

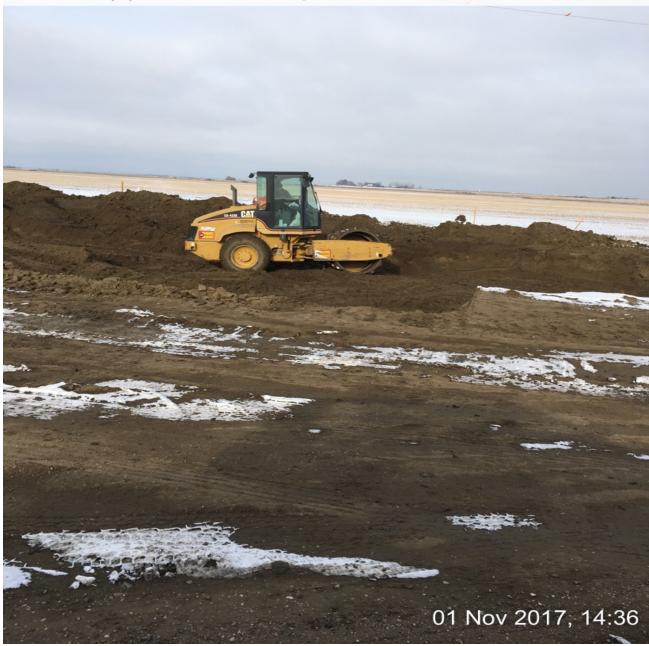
COMPACTION OF SOIL
