**SGS MUSCOWPETUNG**  
**ABORIGINAL CONSTRUCTION MONITORING**  
**WEEKLY REPORT**  
**SPREAD 3**  
**AUGUST 28<sup>TH</sup> TO SEPTEMBER 02<sup>ND</sup>**

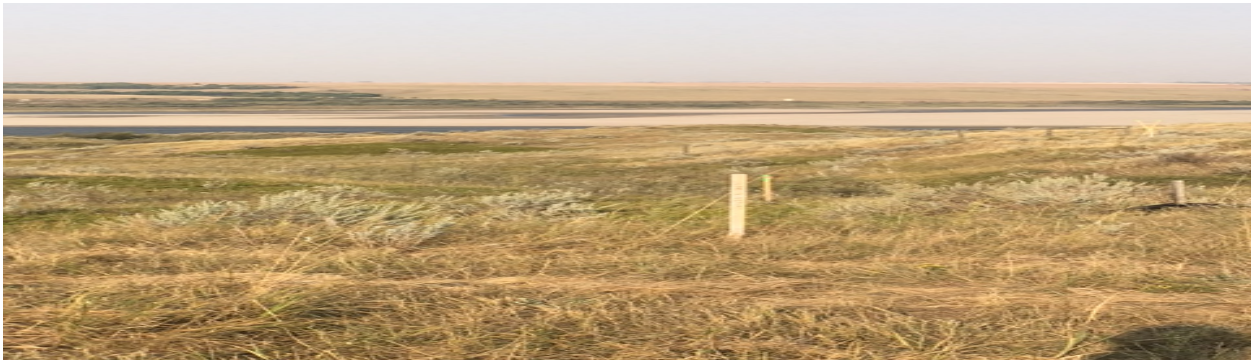
From kickoff KP 450+000 they started ditching and stringing pipe.

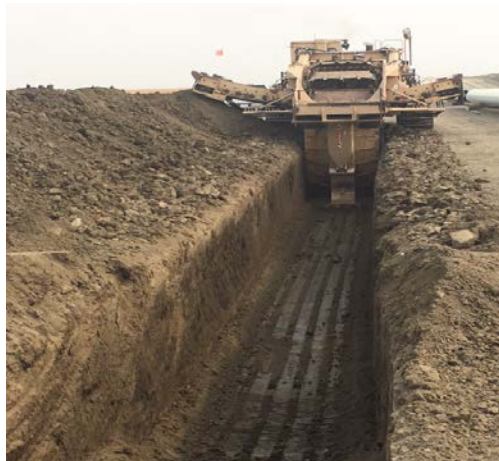
(Left) is a picture of equipment digging ditch.(Right) is a picture of Pipe beside the ditch waiting to be welded together and to be lowered into the ditch.
