SGS MUSCOWPETUNG

ABORIGINAL CONSTRUCTION MONITORING

WEEKLY REPORT

DECEMBER 11TH TO DECEMBER 17TH, 2017

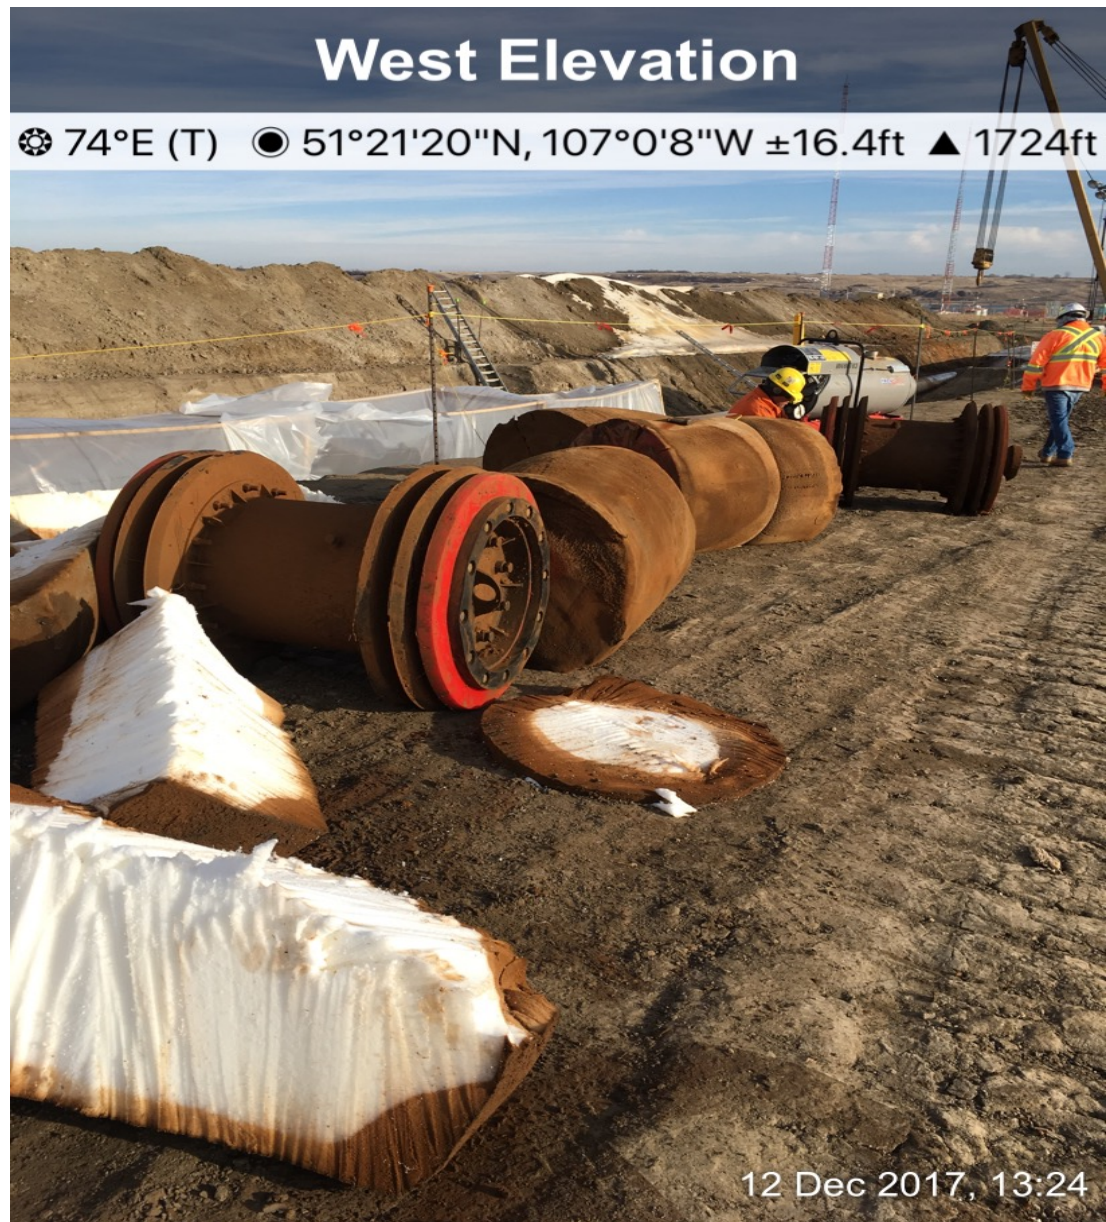
PIGS THAT CAME OUT OF THE MAINLINE AFTER HYDRO TEST

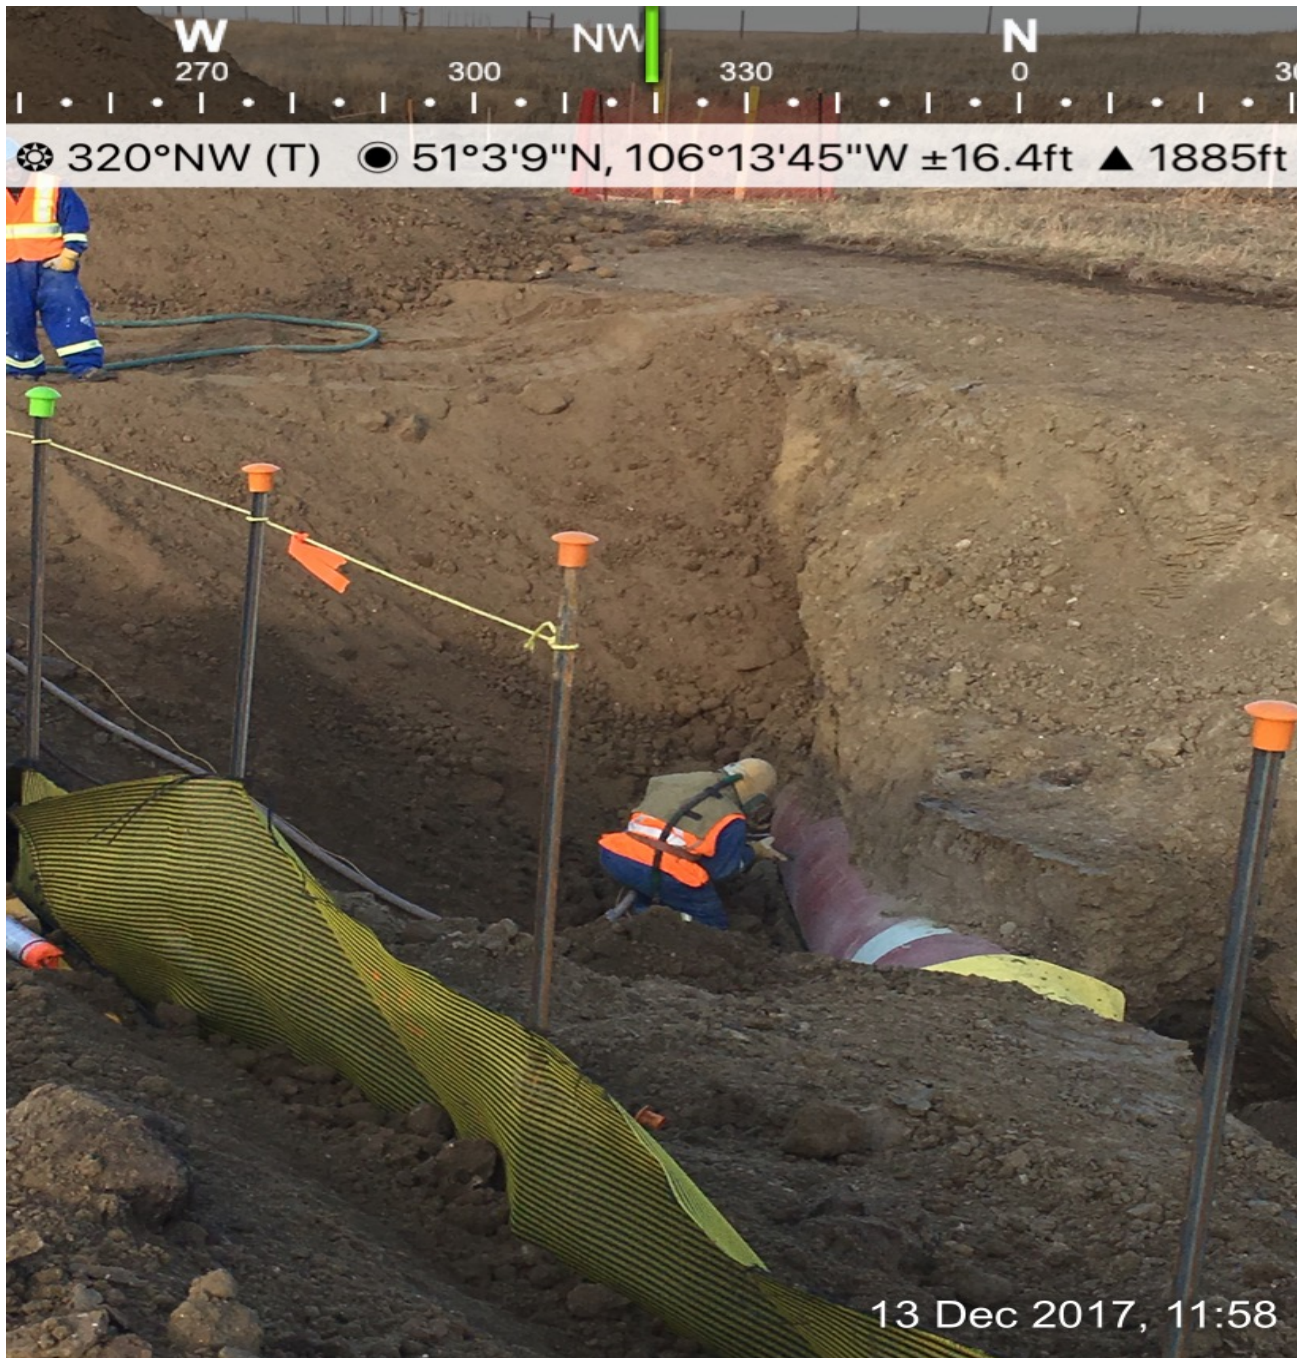
REPAIRING COATING

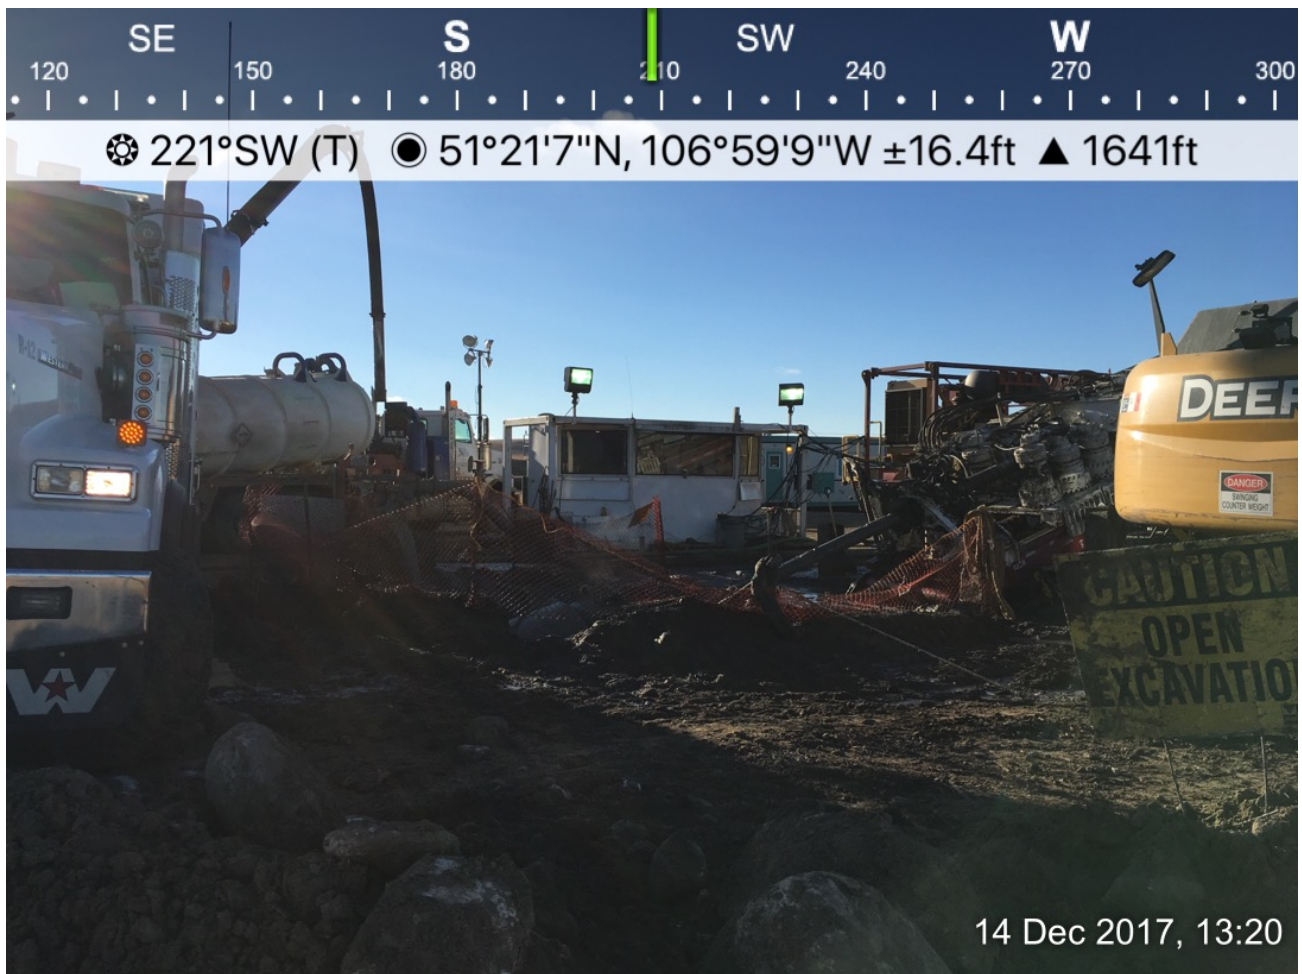
The horizontal directional drilling at the South Saskatchewan River is currently still ongoing process. Mears group had reached 650 metres with the 48-inch reamer then they had to trip back out and clean out the bore. As of yesterday, they were at 80 metres tripping back in.

TRIPPING BACK AT ENTRY POINT

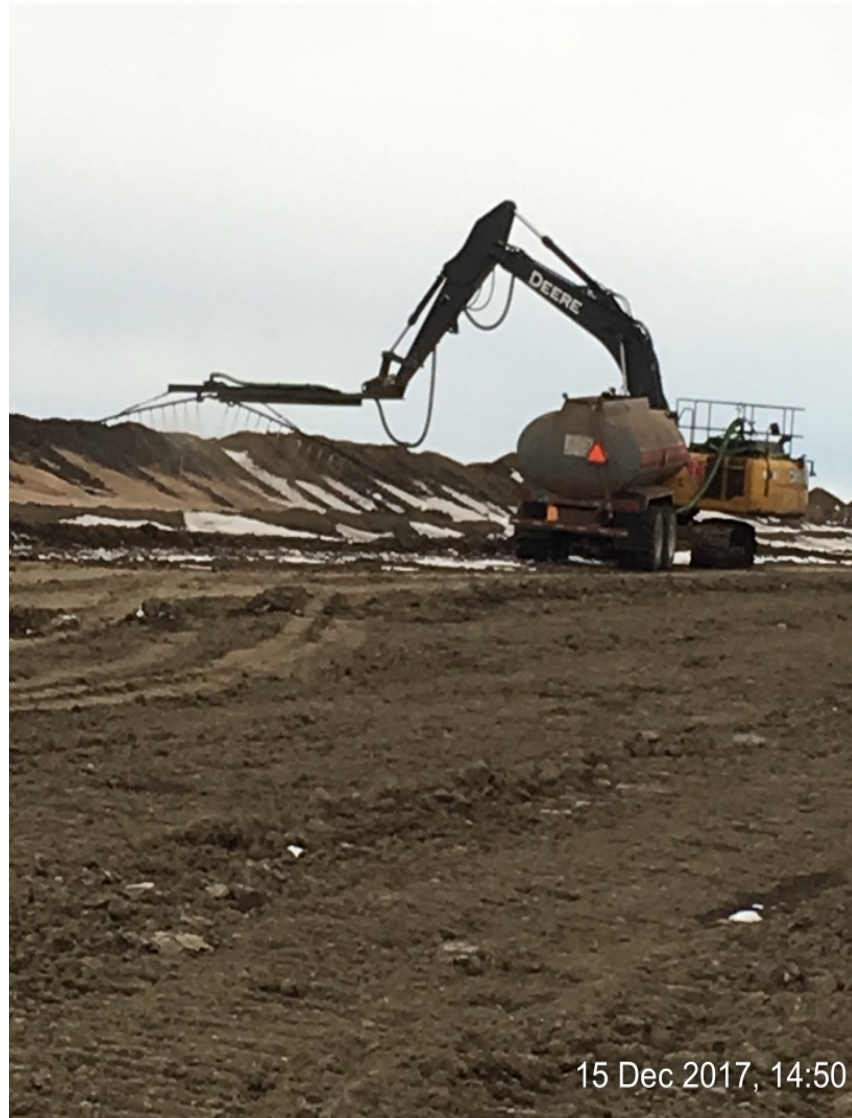
Currently Tackifying crew is still working on spraying down the top soil piles with tree sap/water solution this is a soil erosion prevention method.

TACKIFYING SOIL EROSION PREVENTION METHOD

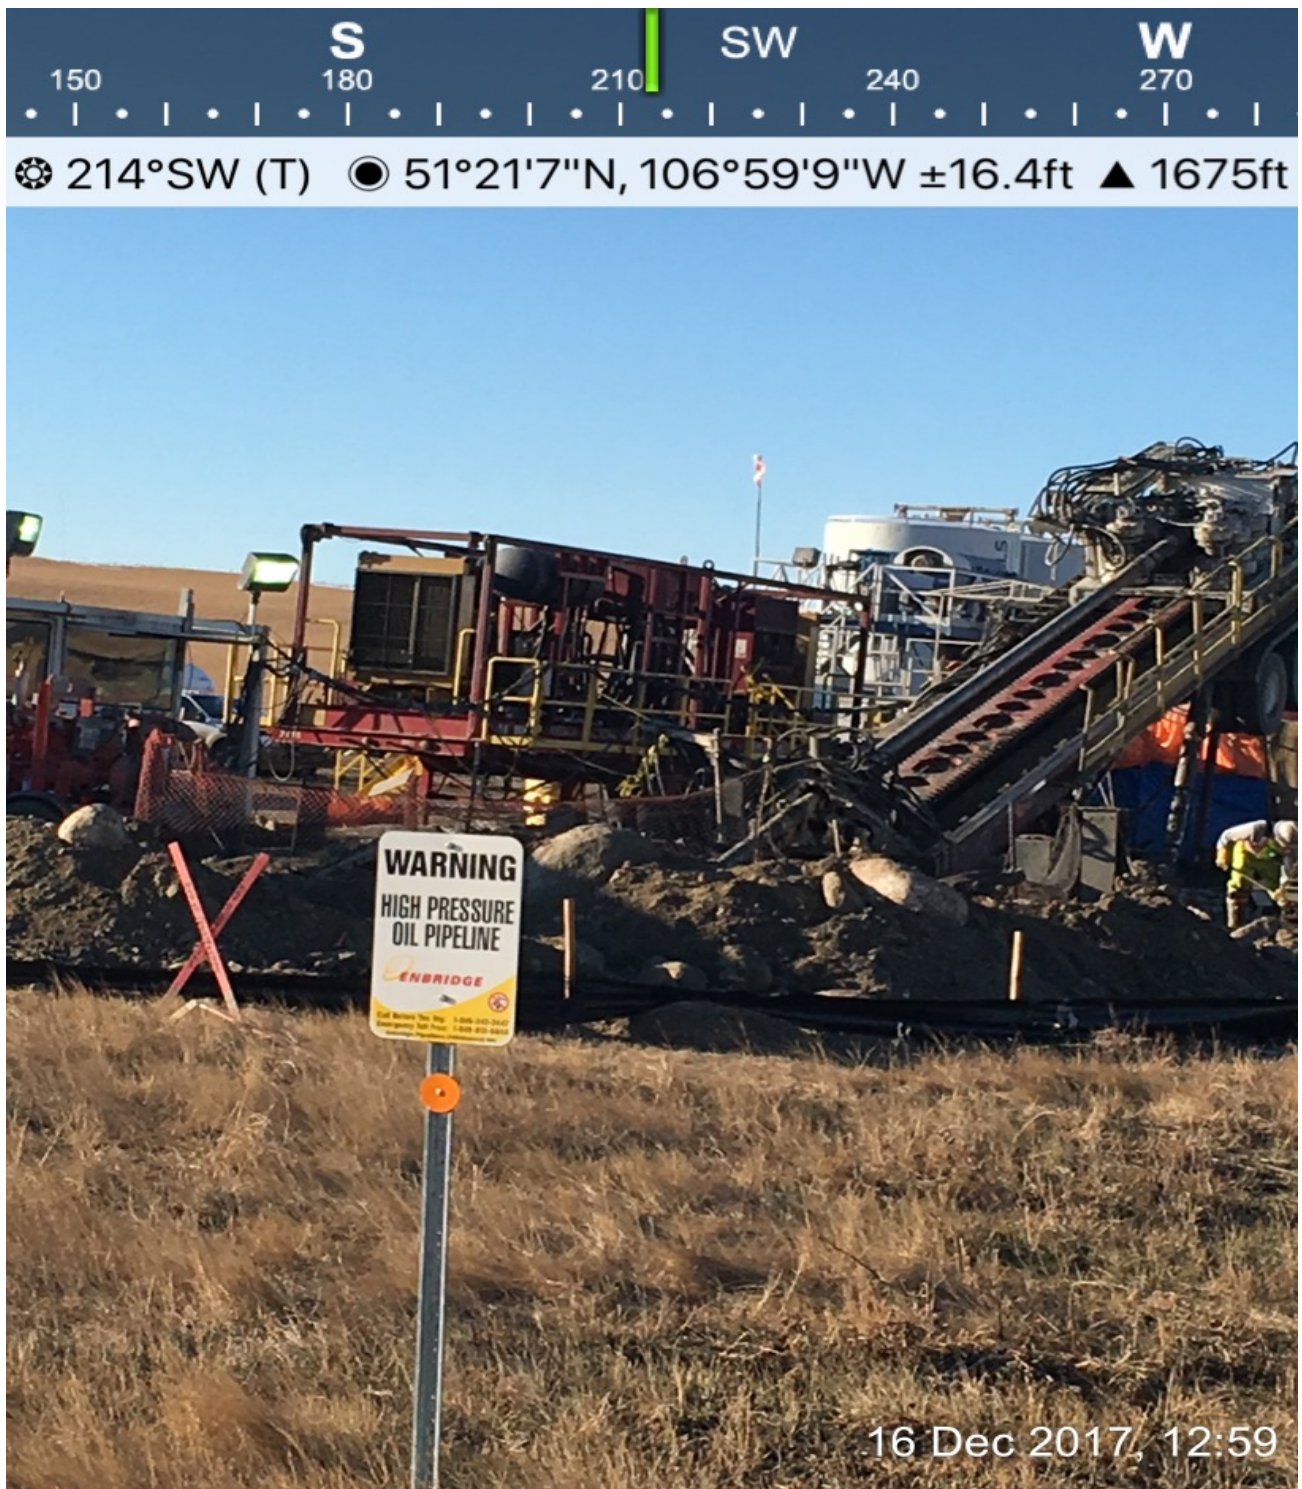
HORIZONTAL DIRECTIONAL DRILLING ENTRY POINT

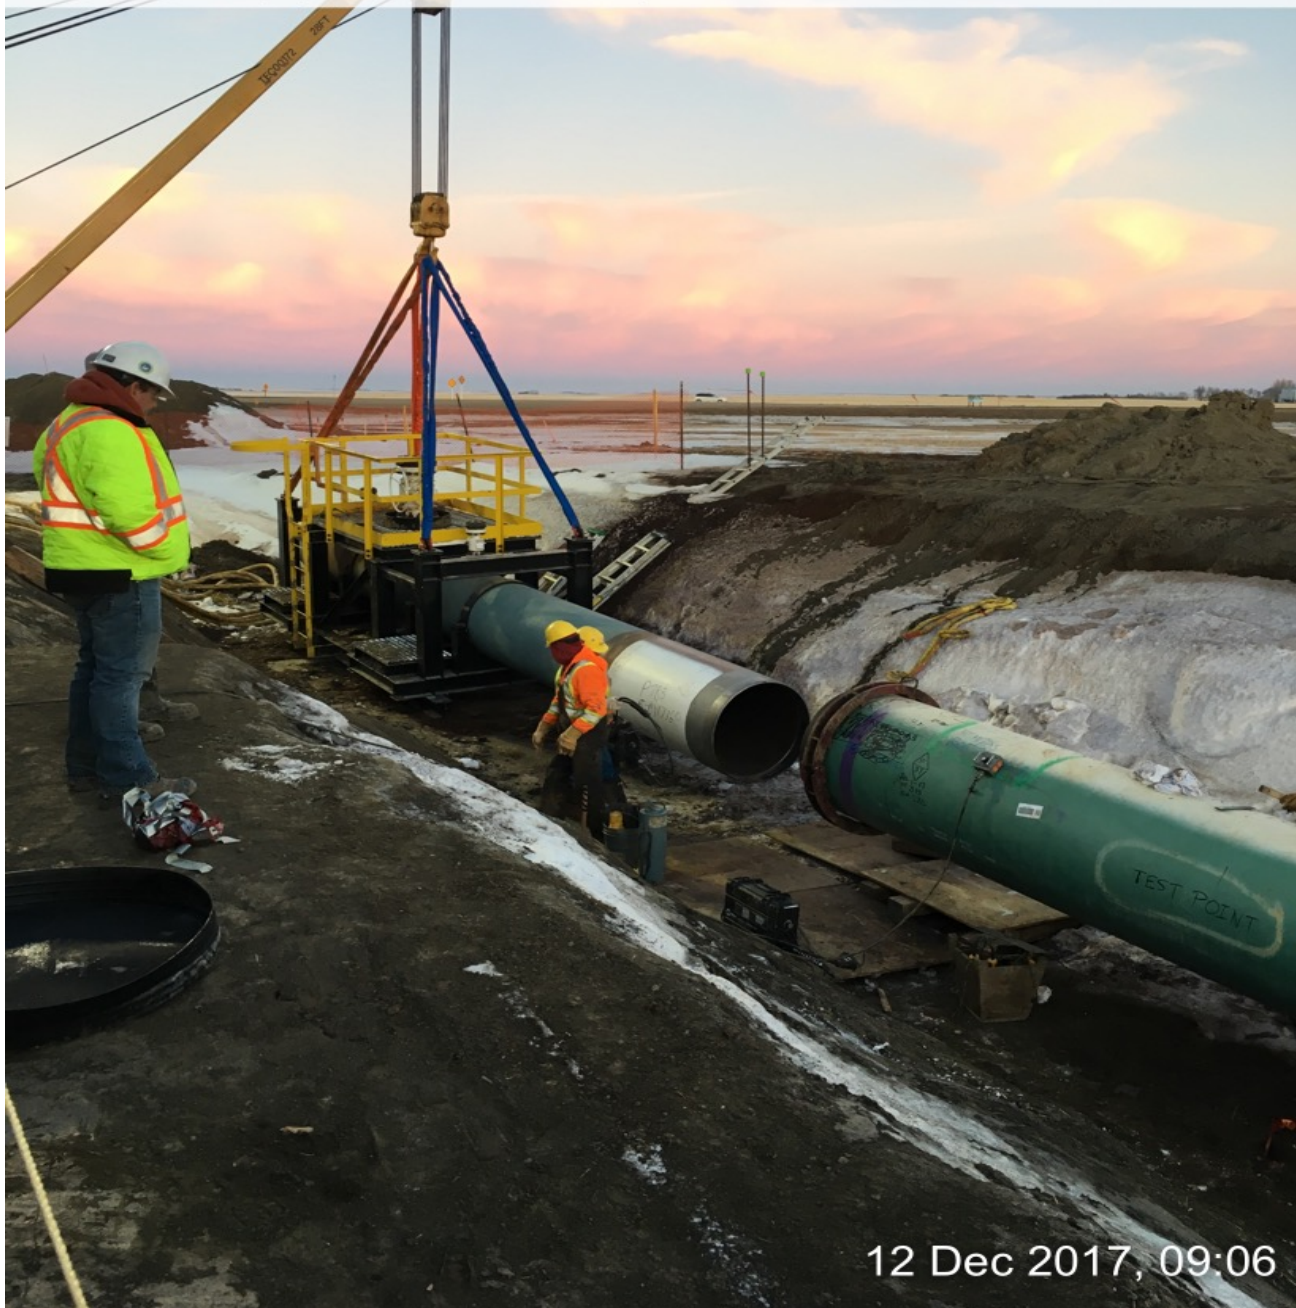
SETTING IN TEST HEAD TO BE WELDED FOR HYDRO TEST

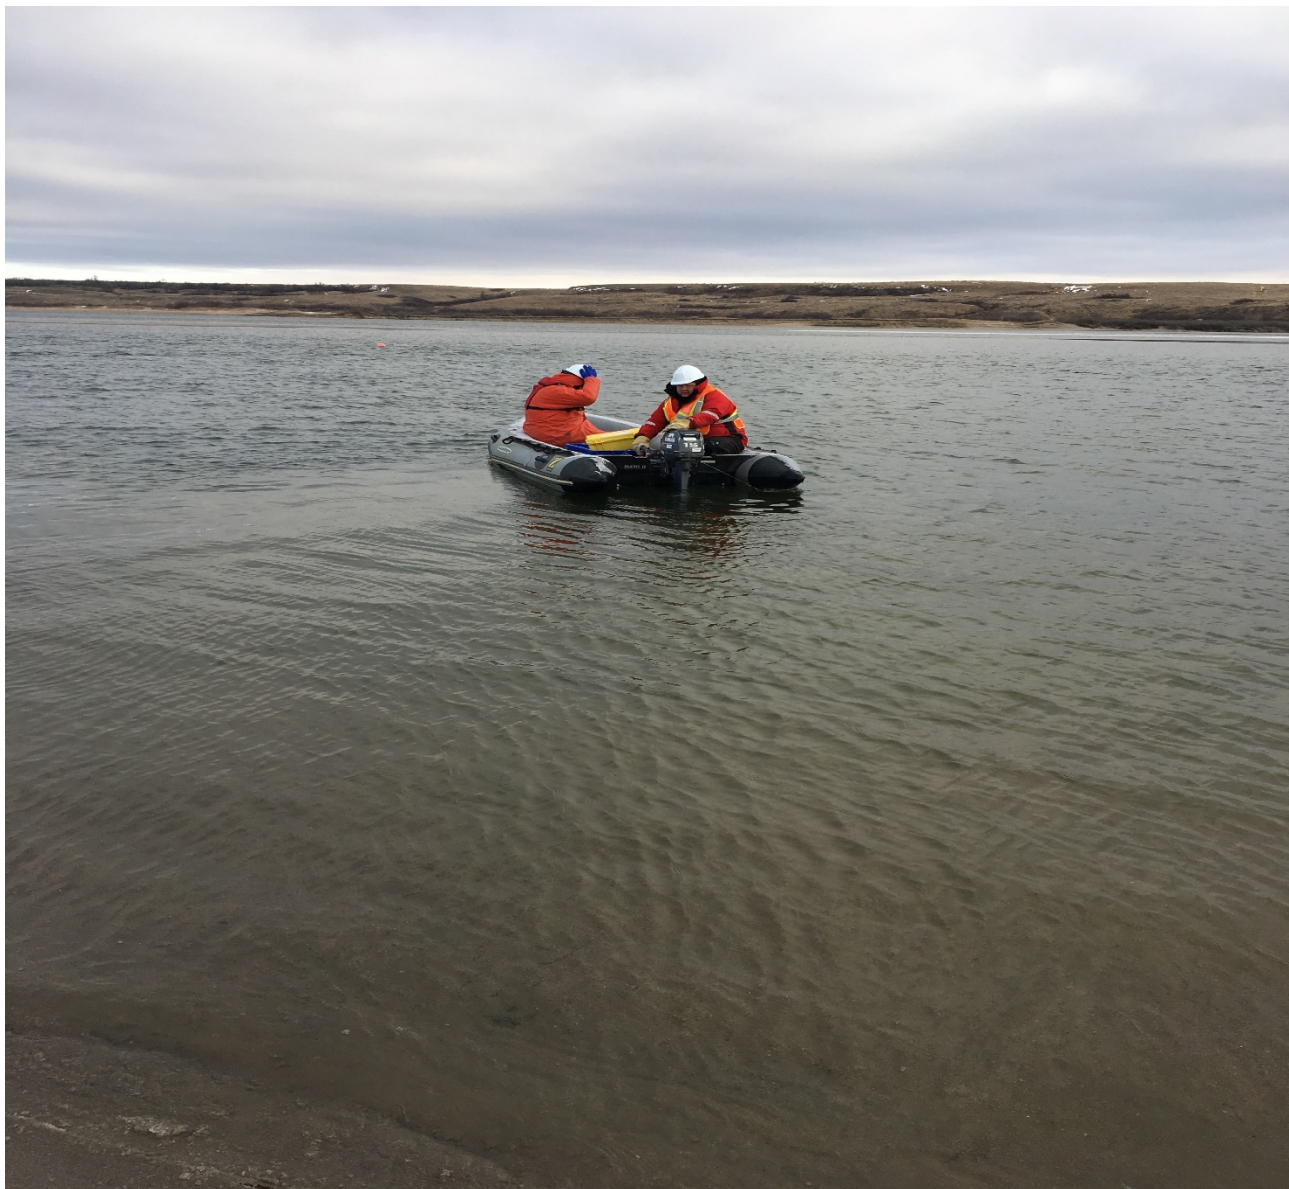
Testing of the water turbidity by Golder Associates is still ongoing and has remained consistent throughout the week.

GOLDER ASSOCIATES WATER SAMPLING

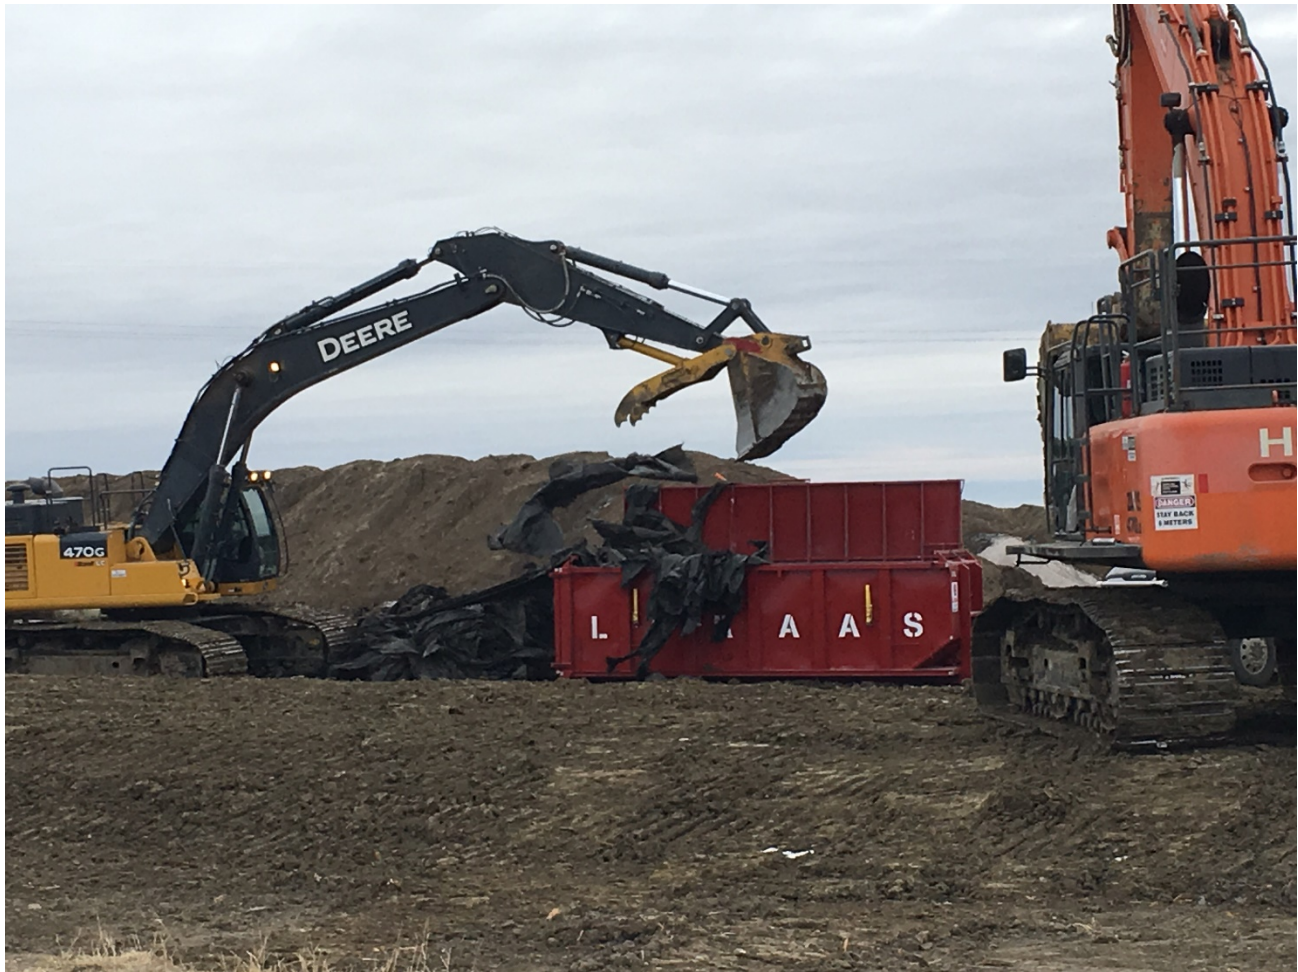
CLEANING UP GEOTECH

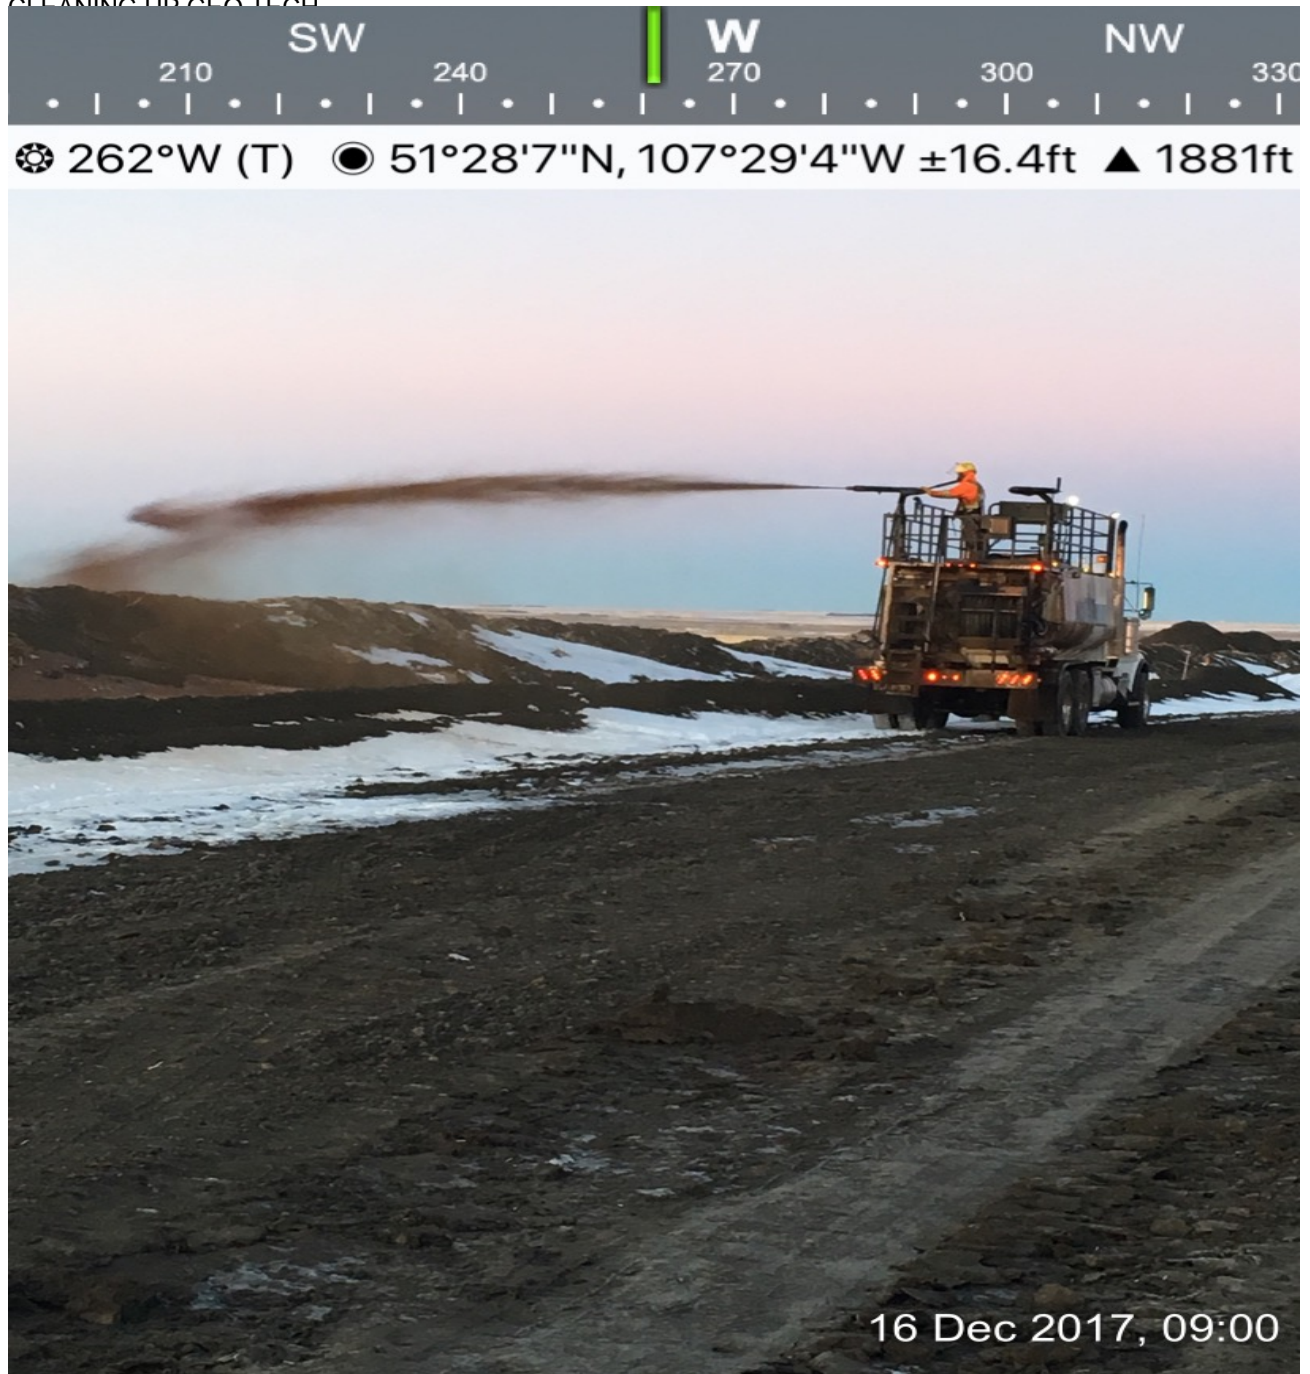
TACKIFYING SOIL ERROSION PREVENTION METHOD

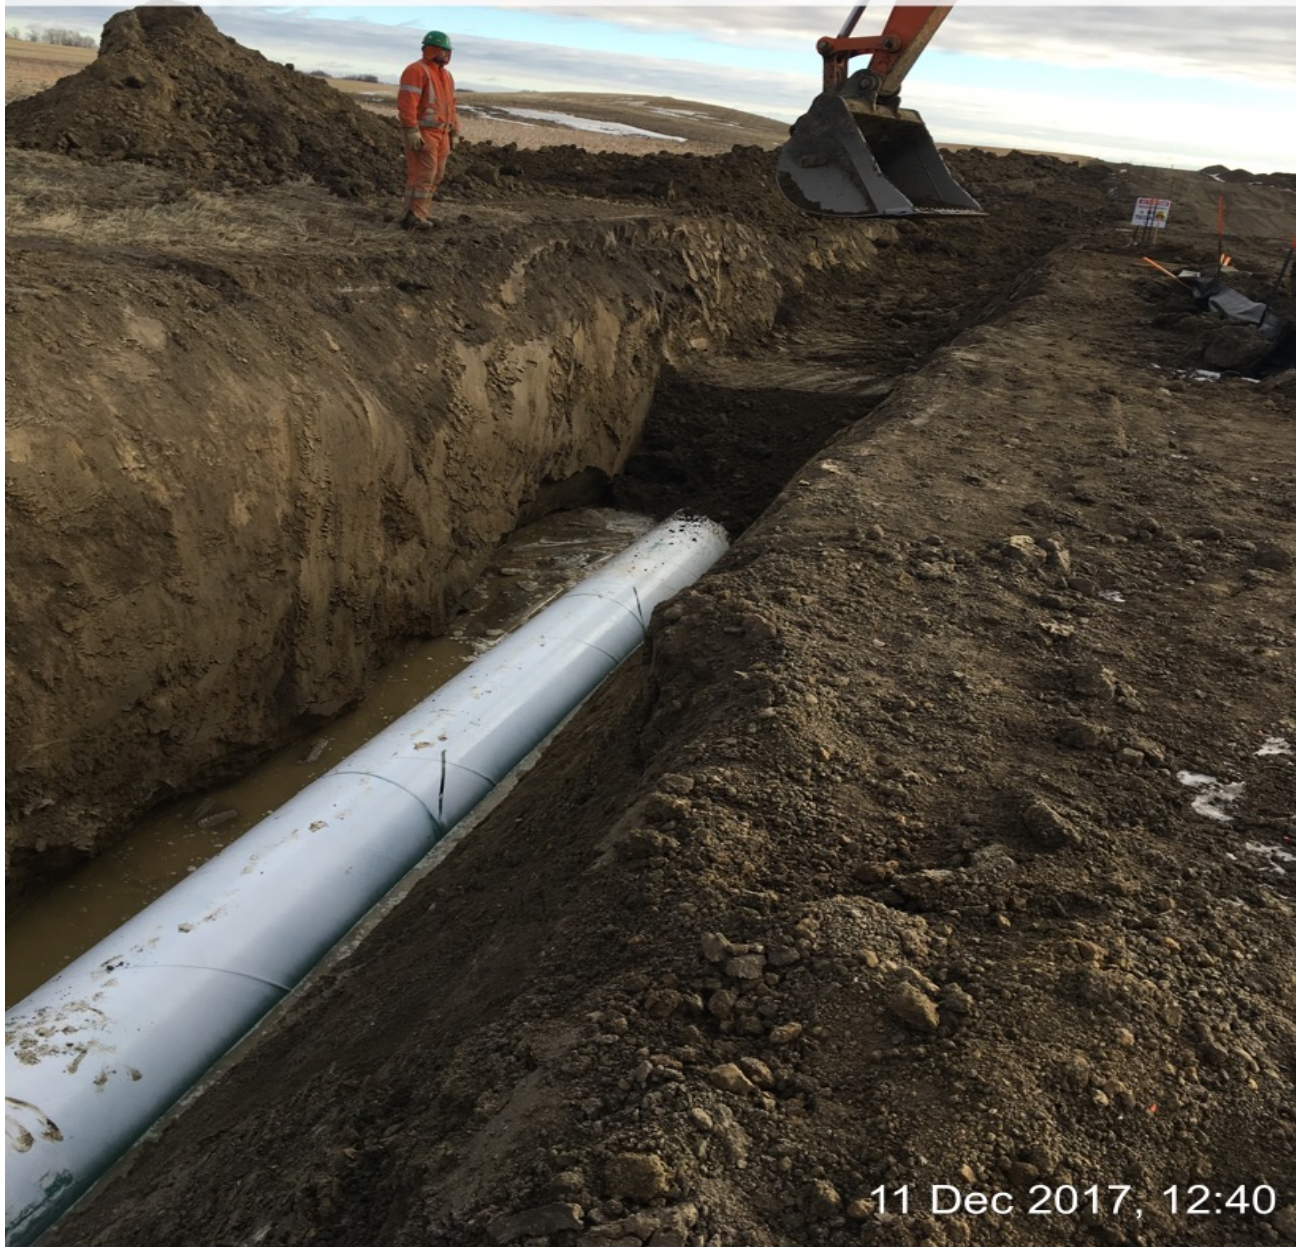
BACKFILLING WETLAND

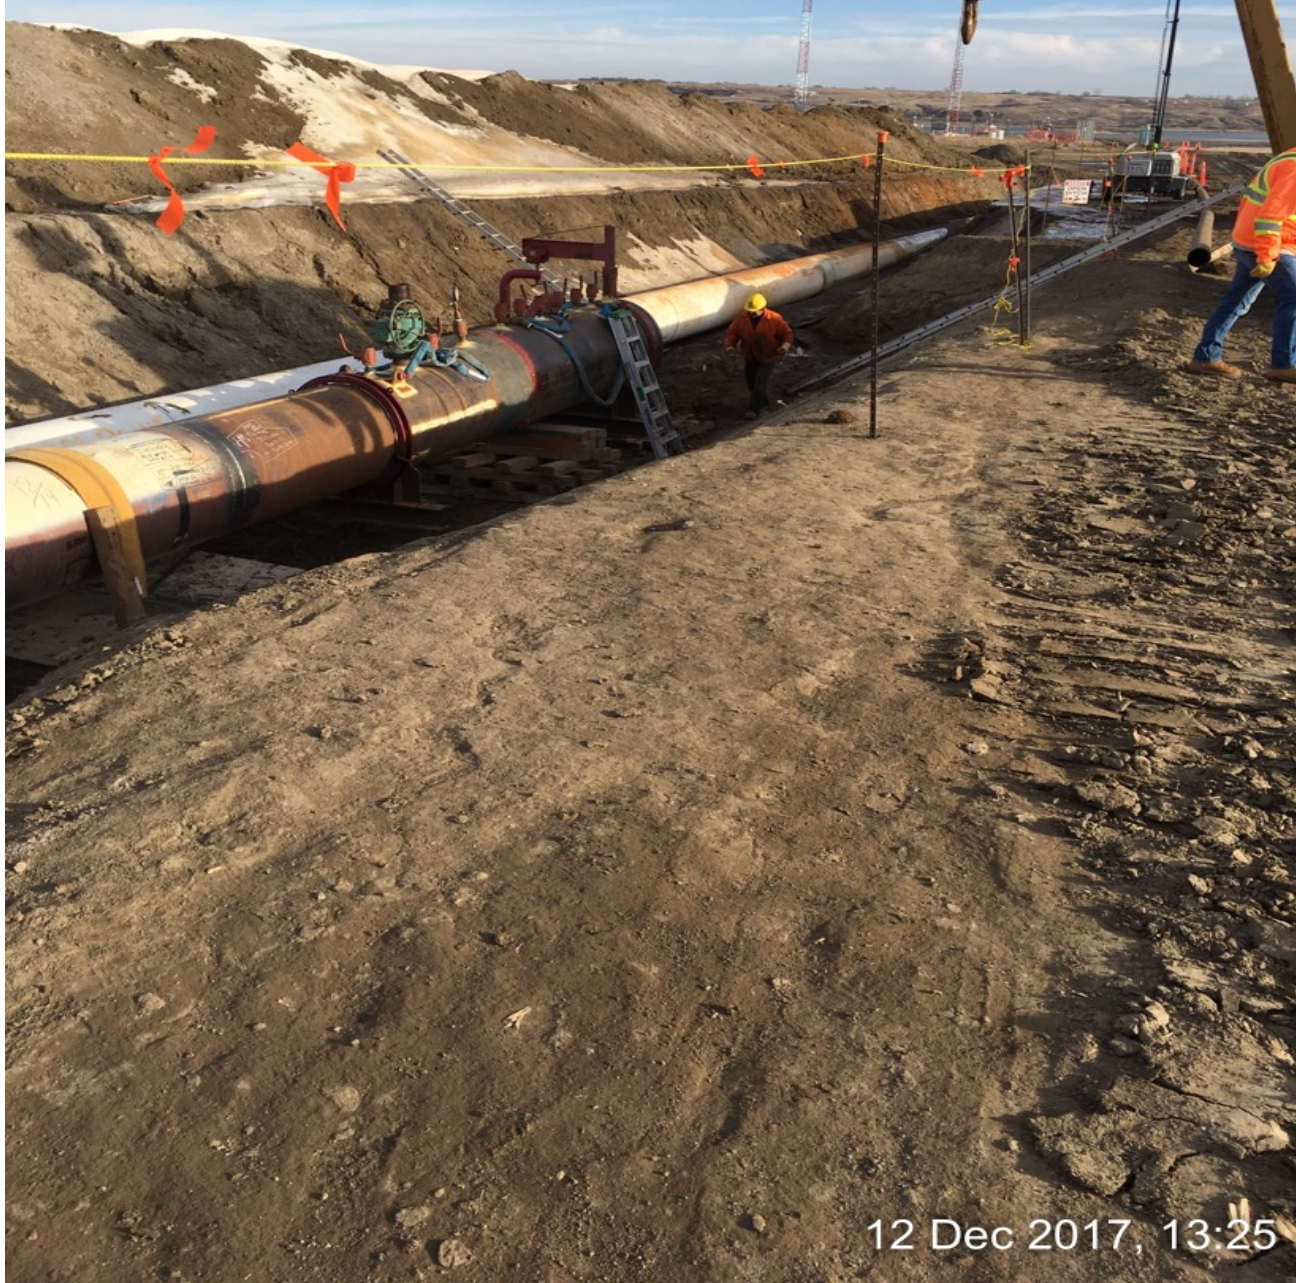
Currently on the hydro test they are still cleaning the pipe from kick off to road 36.

HYDRO TEST

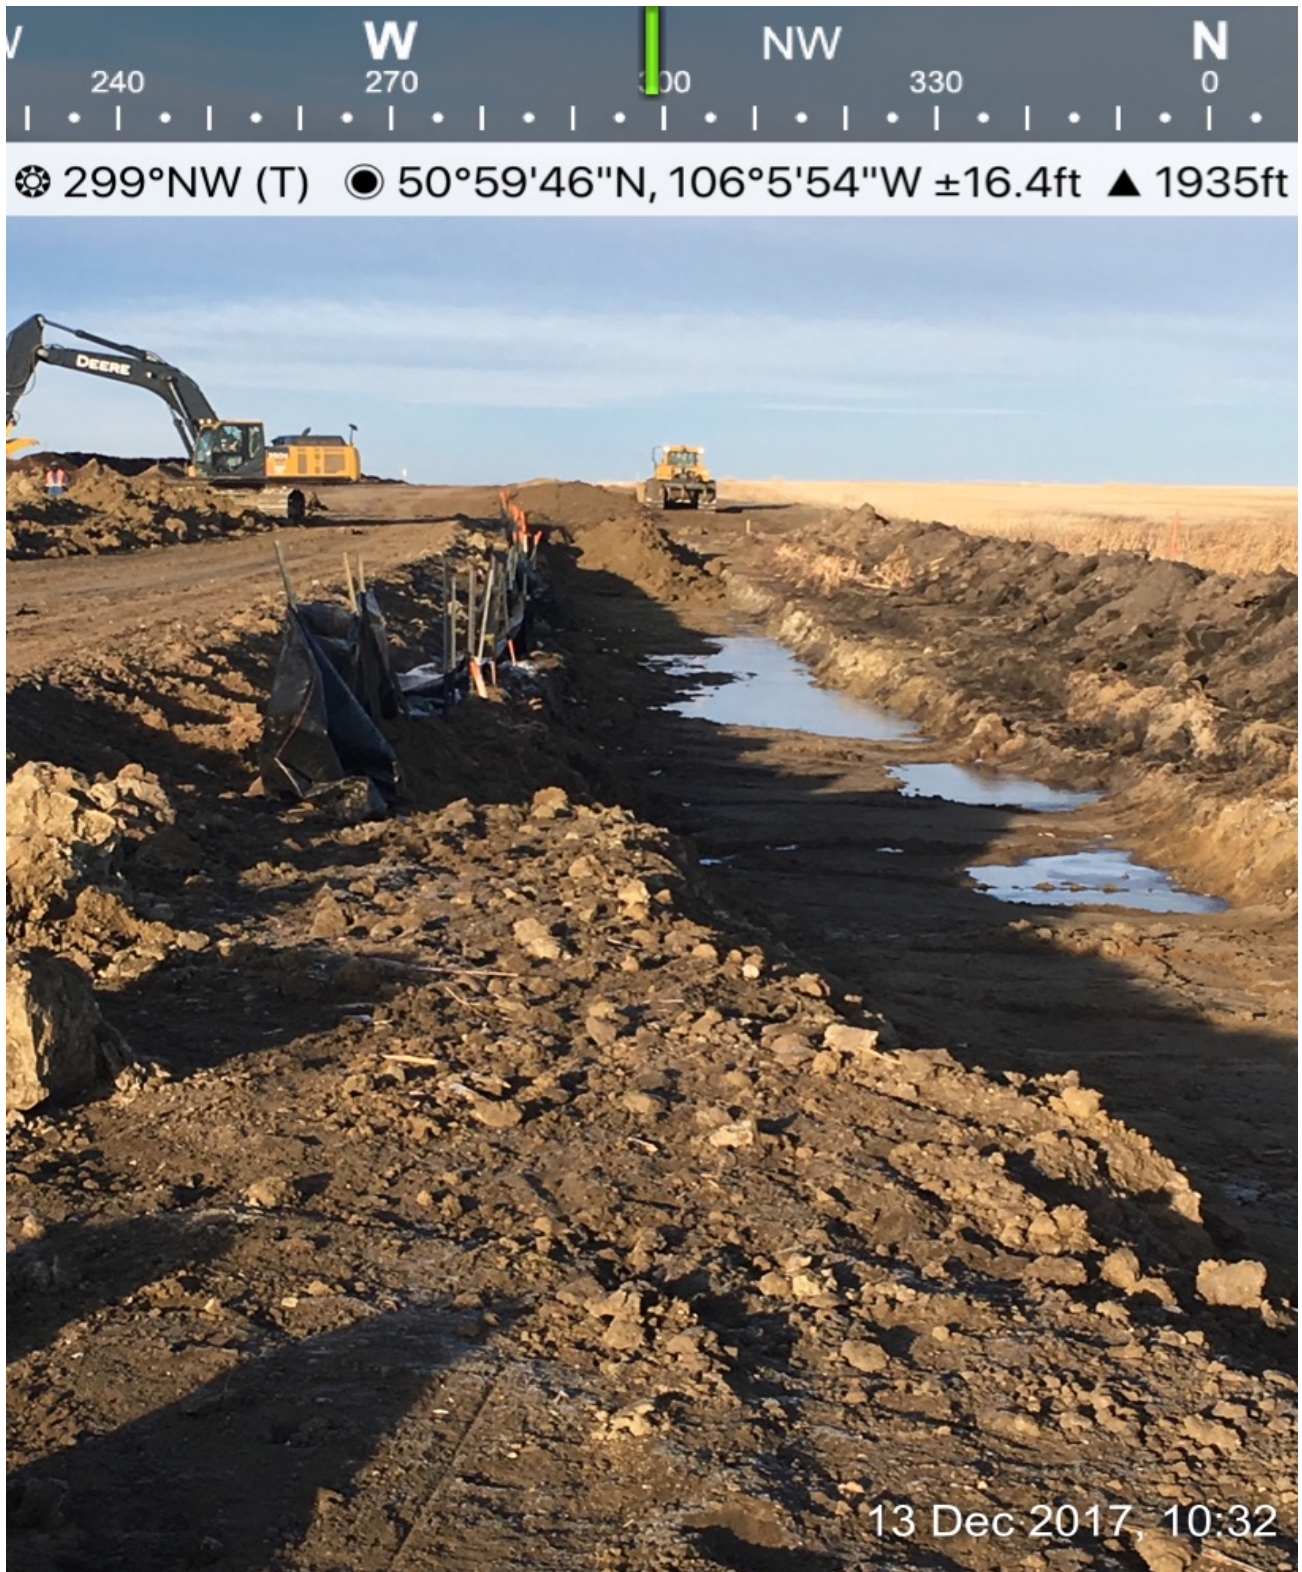
BACKFILLING WETLAND

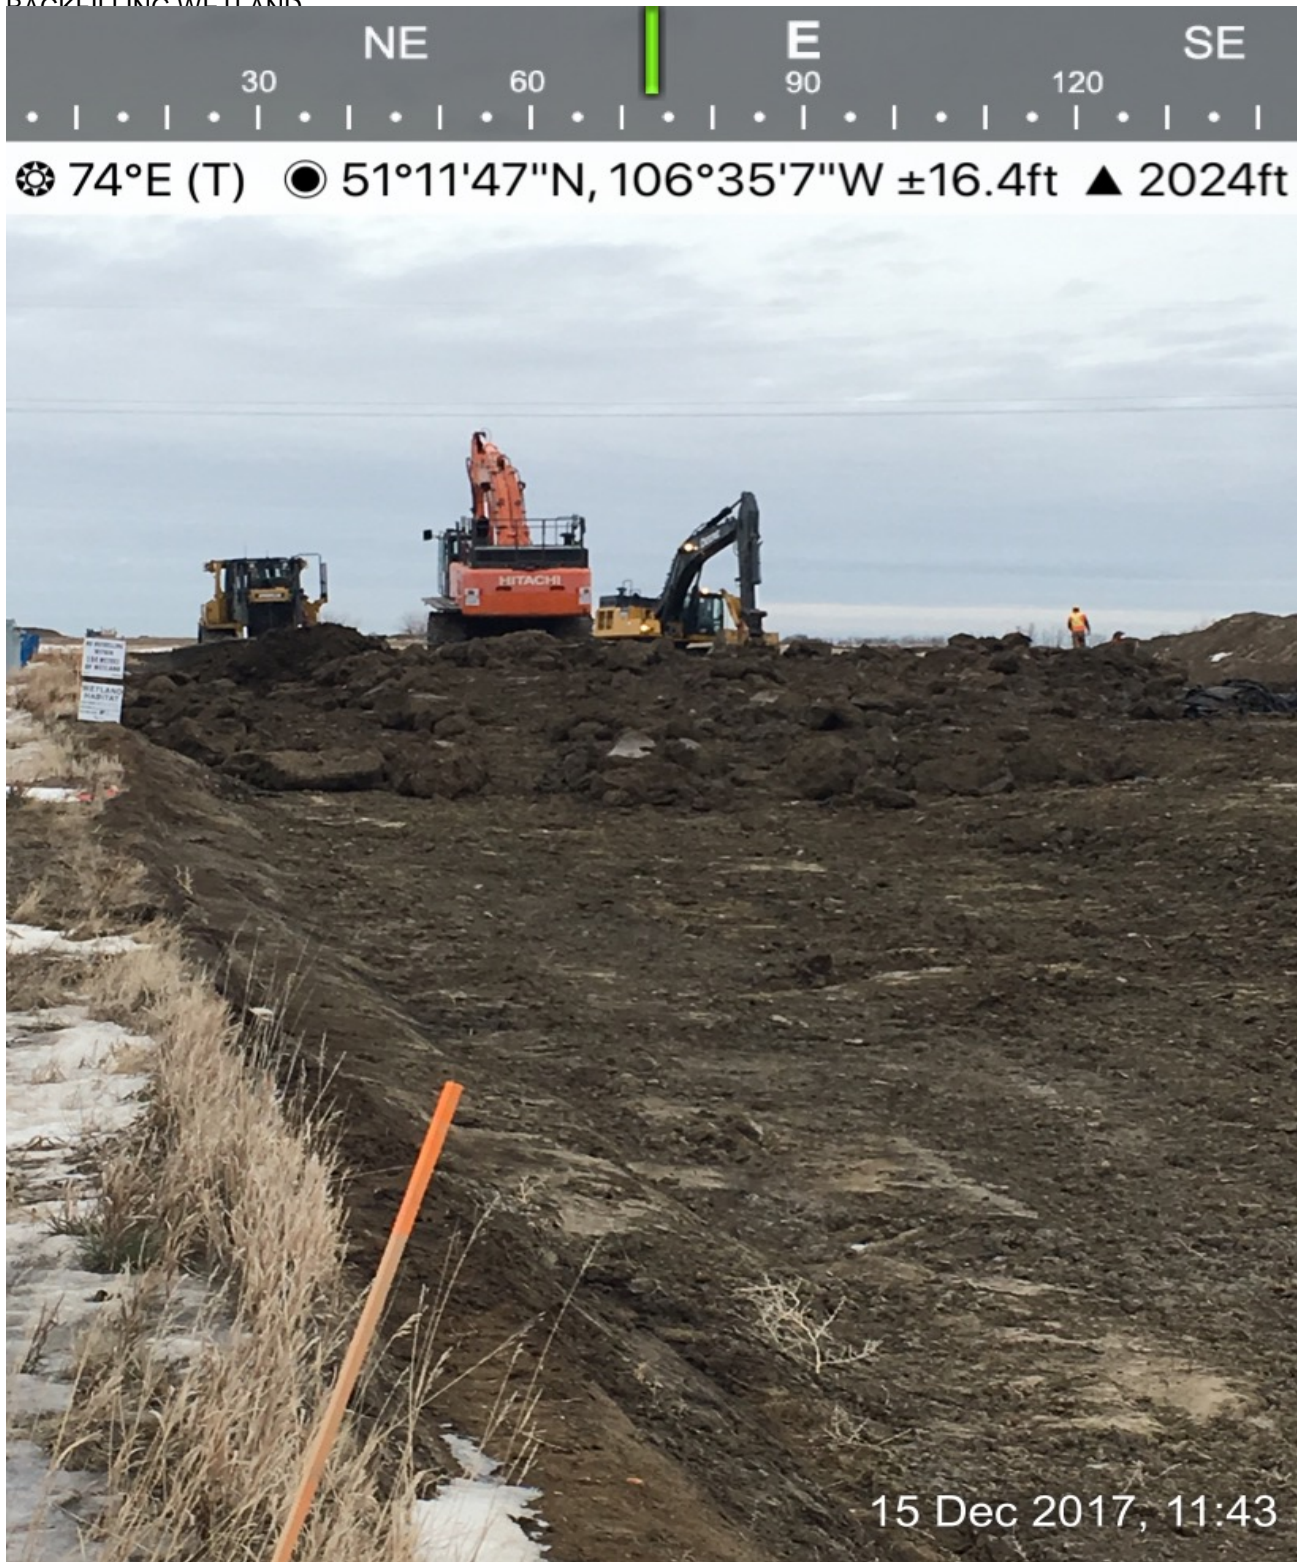
Backfilling has been all completed on spread three and cleaning up of the right of way is ongoing currently.

CLEANING UP RIGHT OF WAY
