SGS MUSCOWPETUNG

ABORIGINAL CONSTRUCTION MONITORING

WEEKLY REPORT

JANUARY 22ND TO JANUARY 28TH, 2018

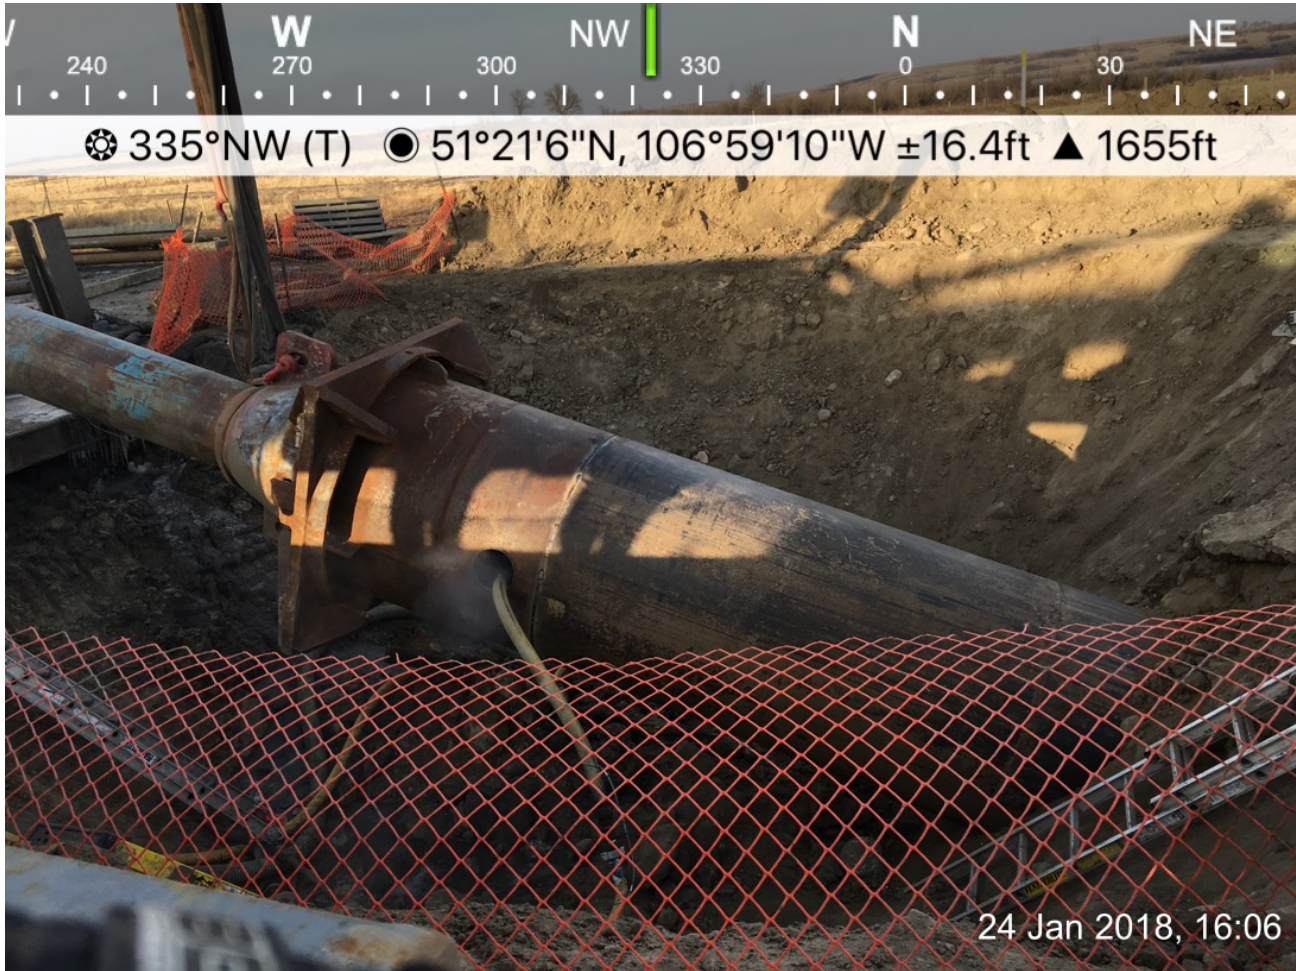
Hammering out the casing

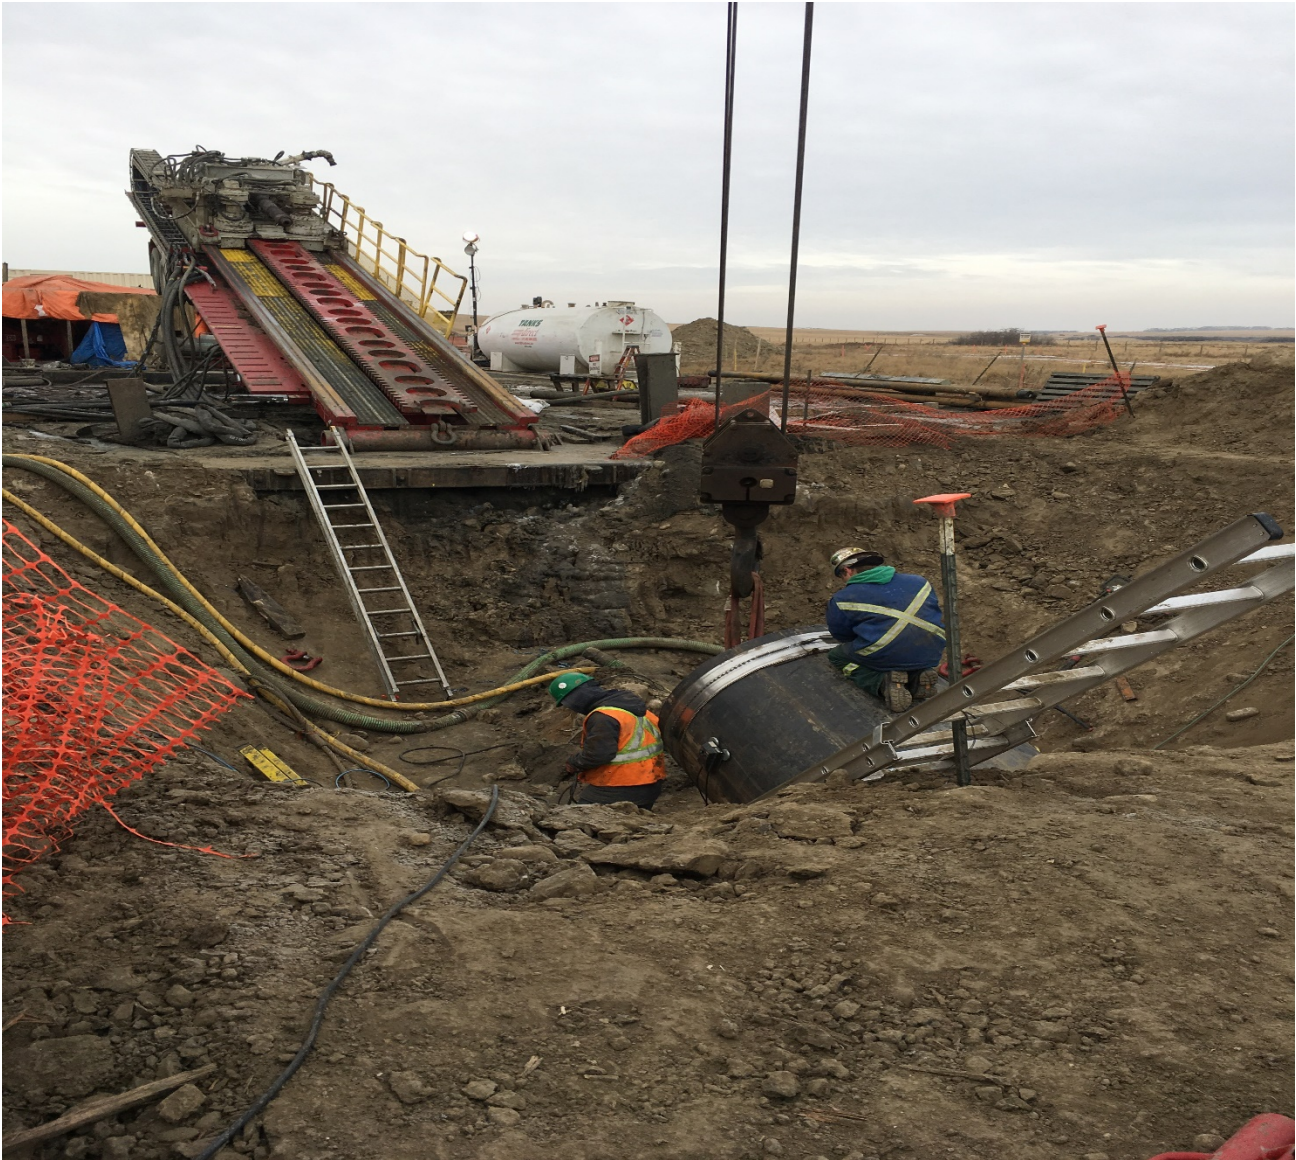
Just finished cutting out some of the casing

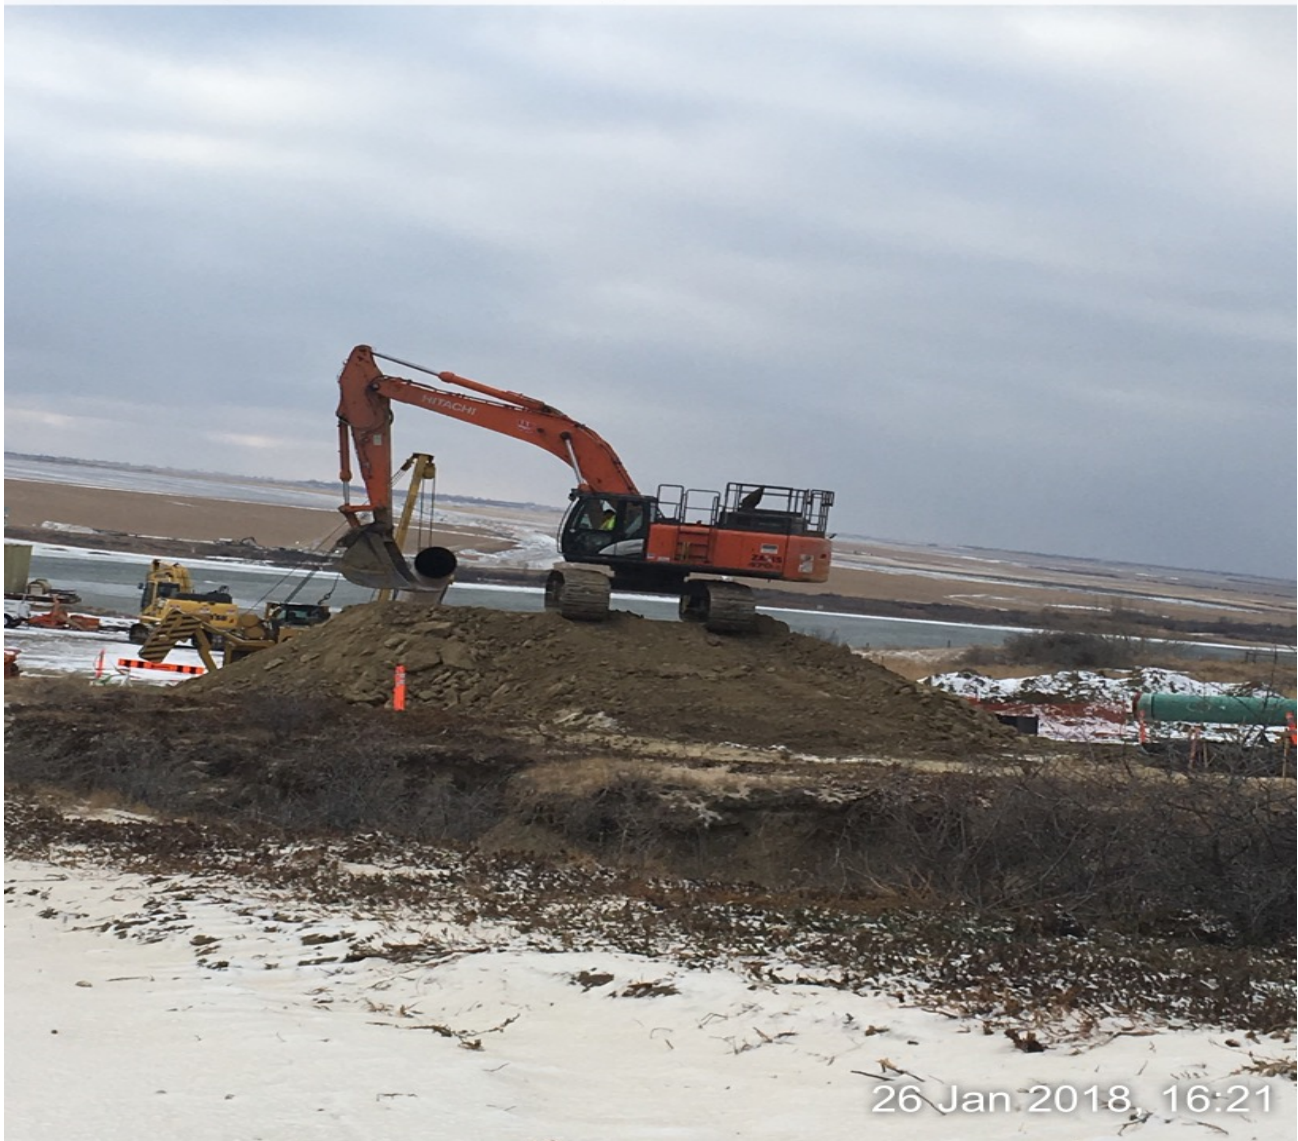
Building a pad at exit point so they can weld on the hammer head

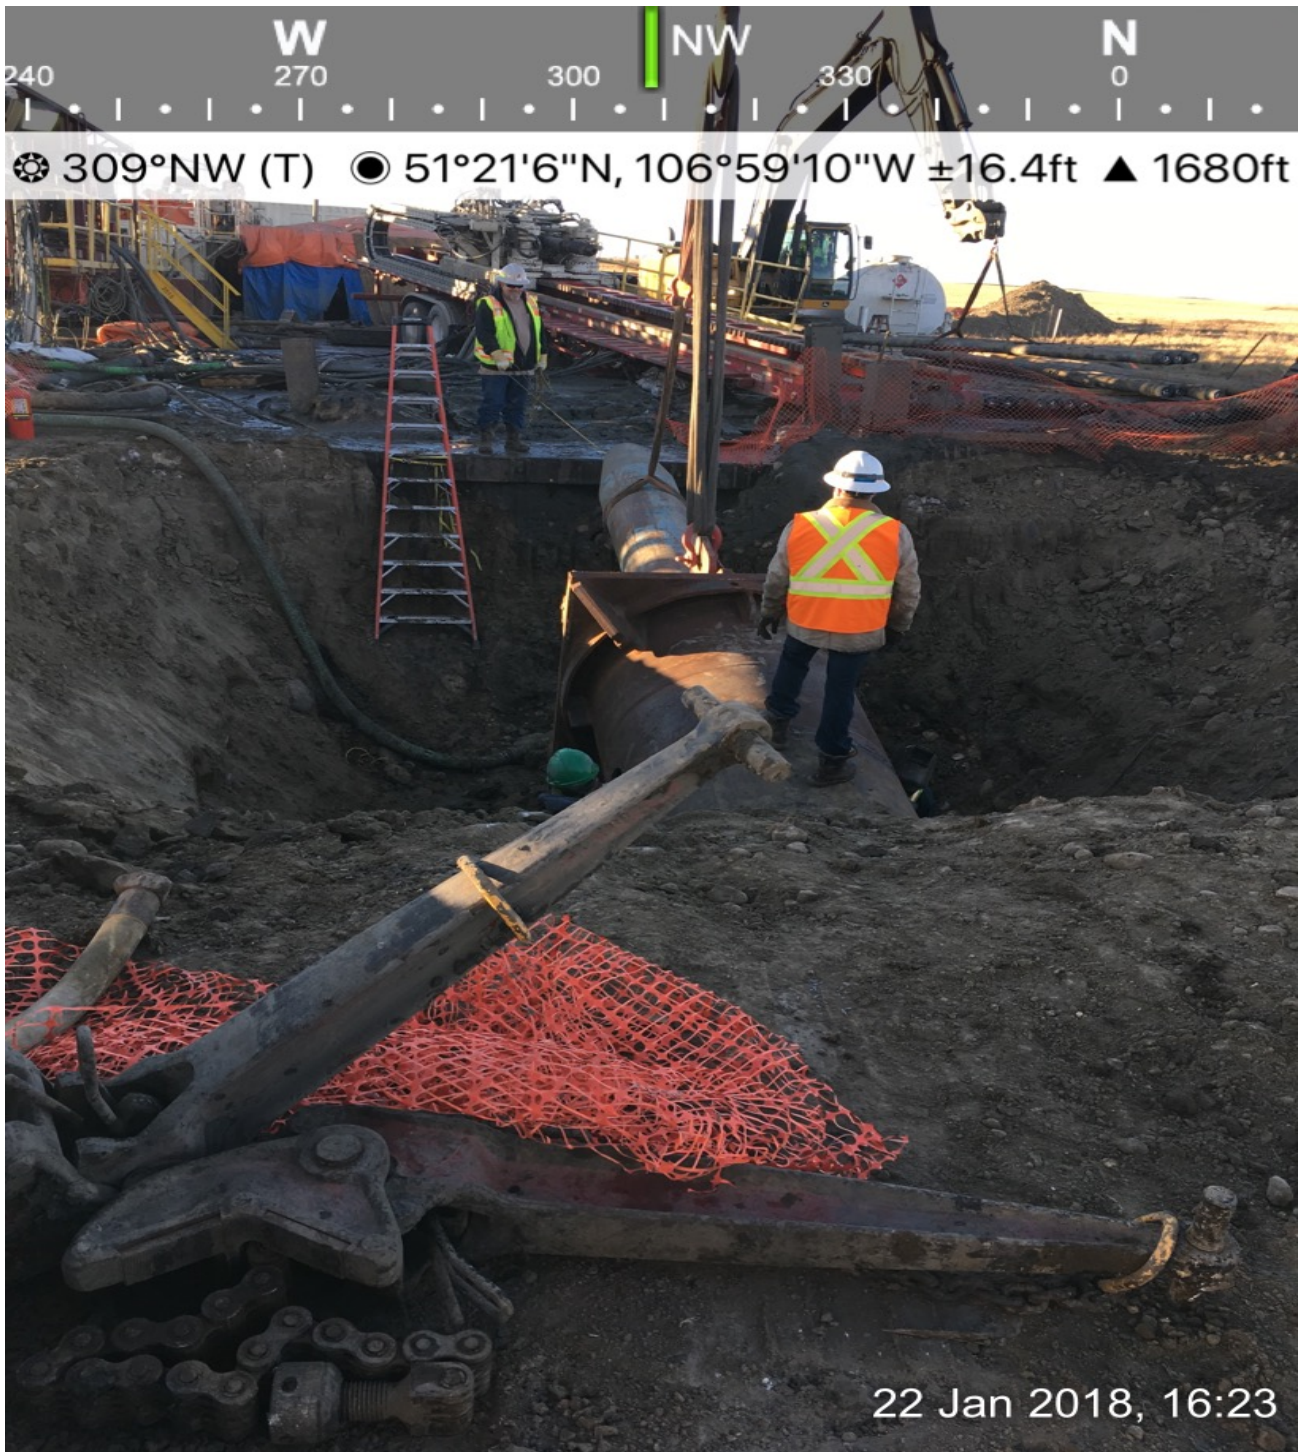
Hammering out the casing

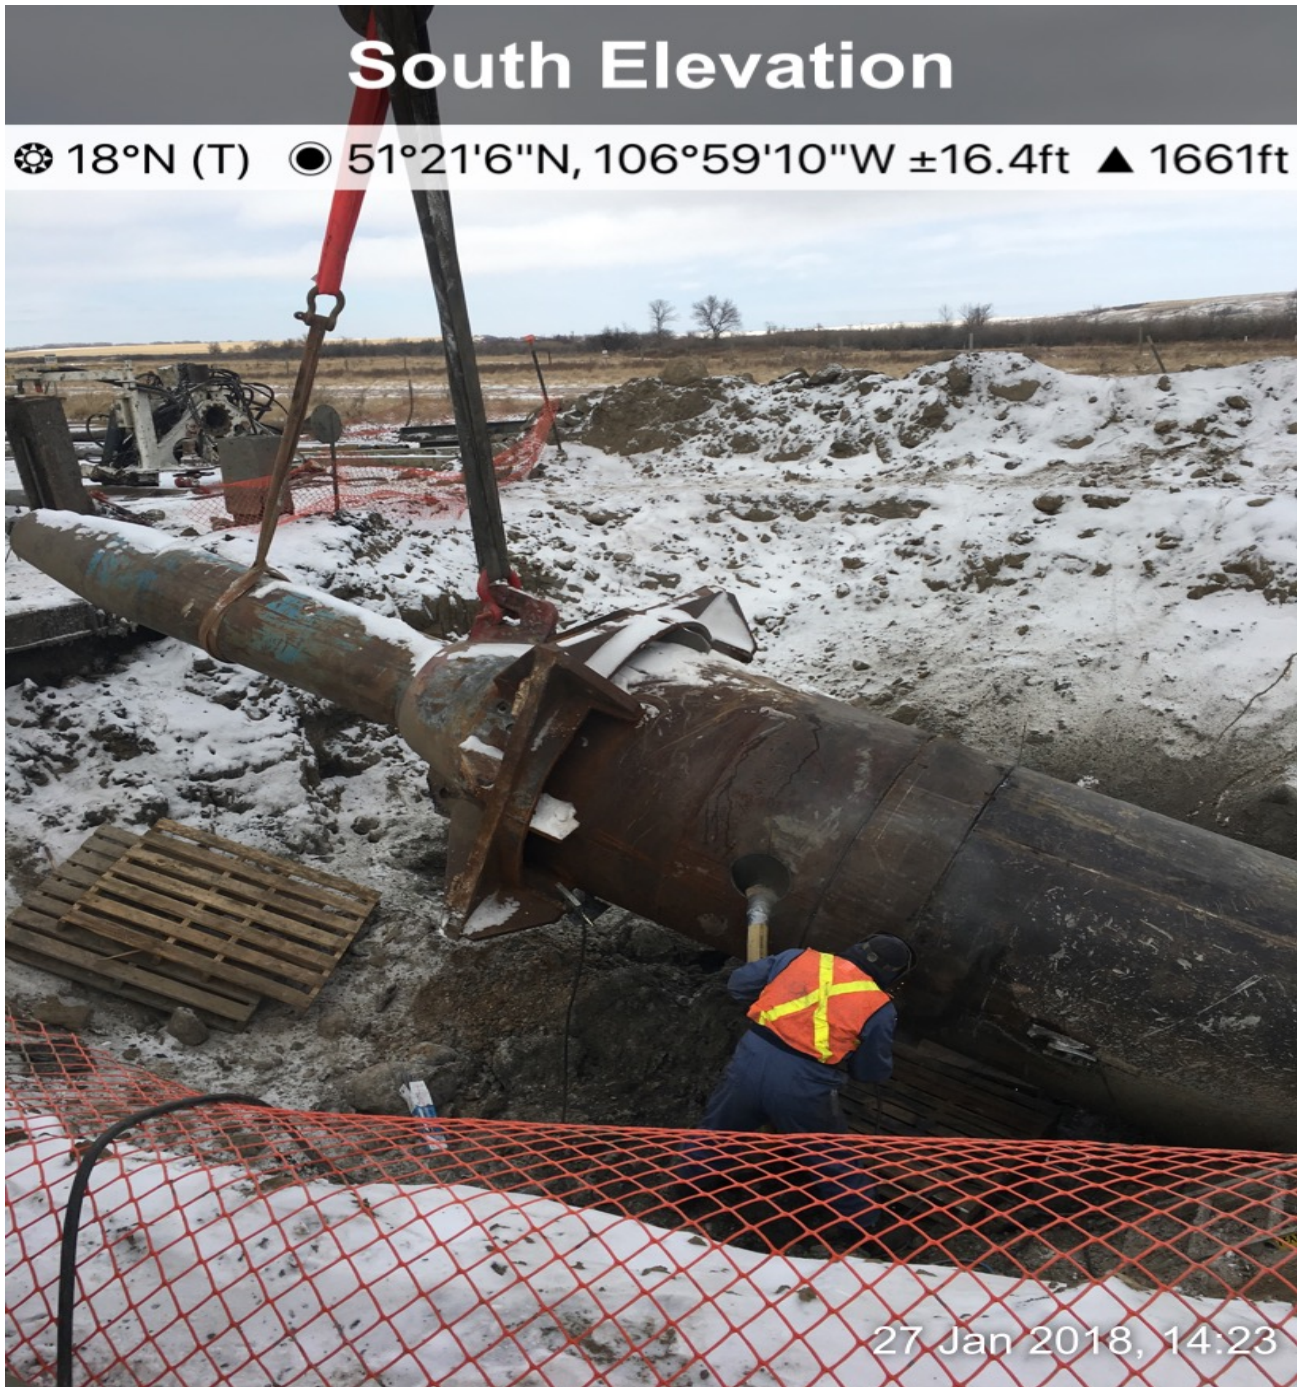
Hammering out of the casing

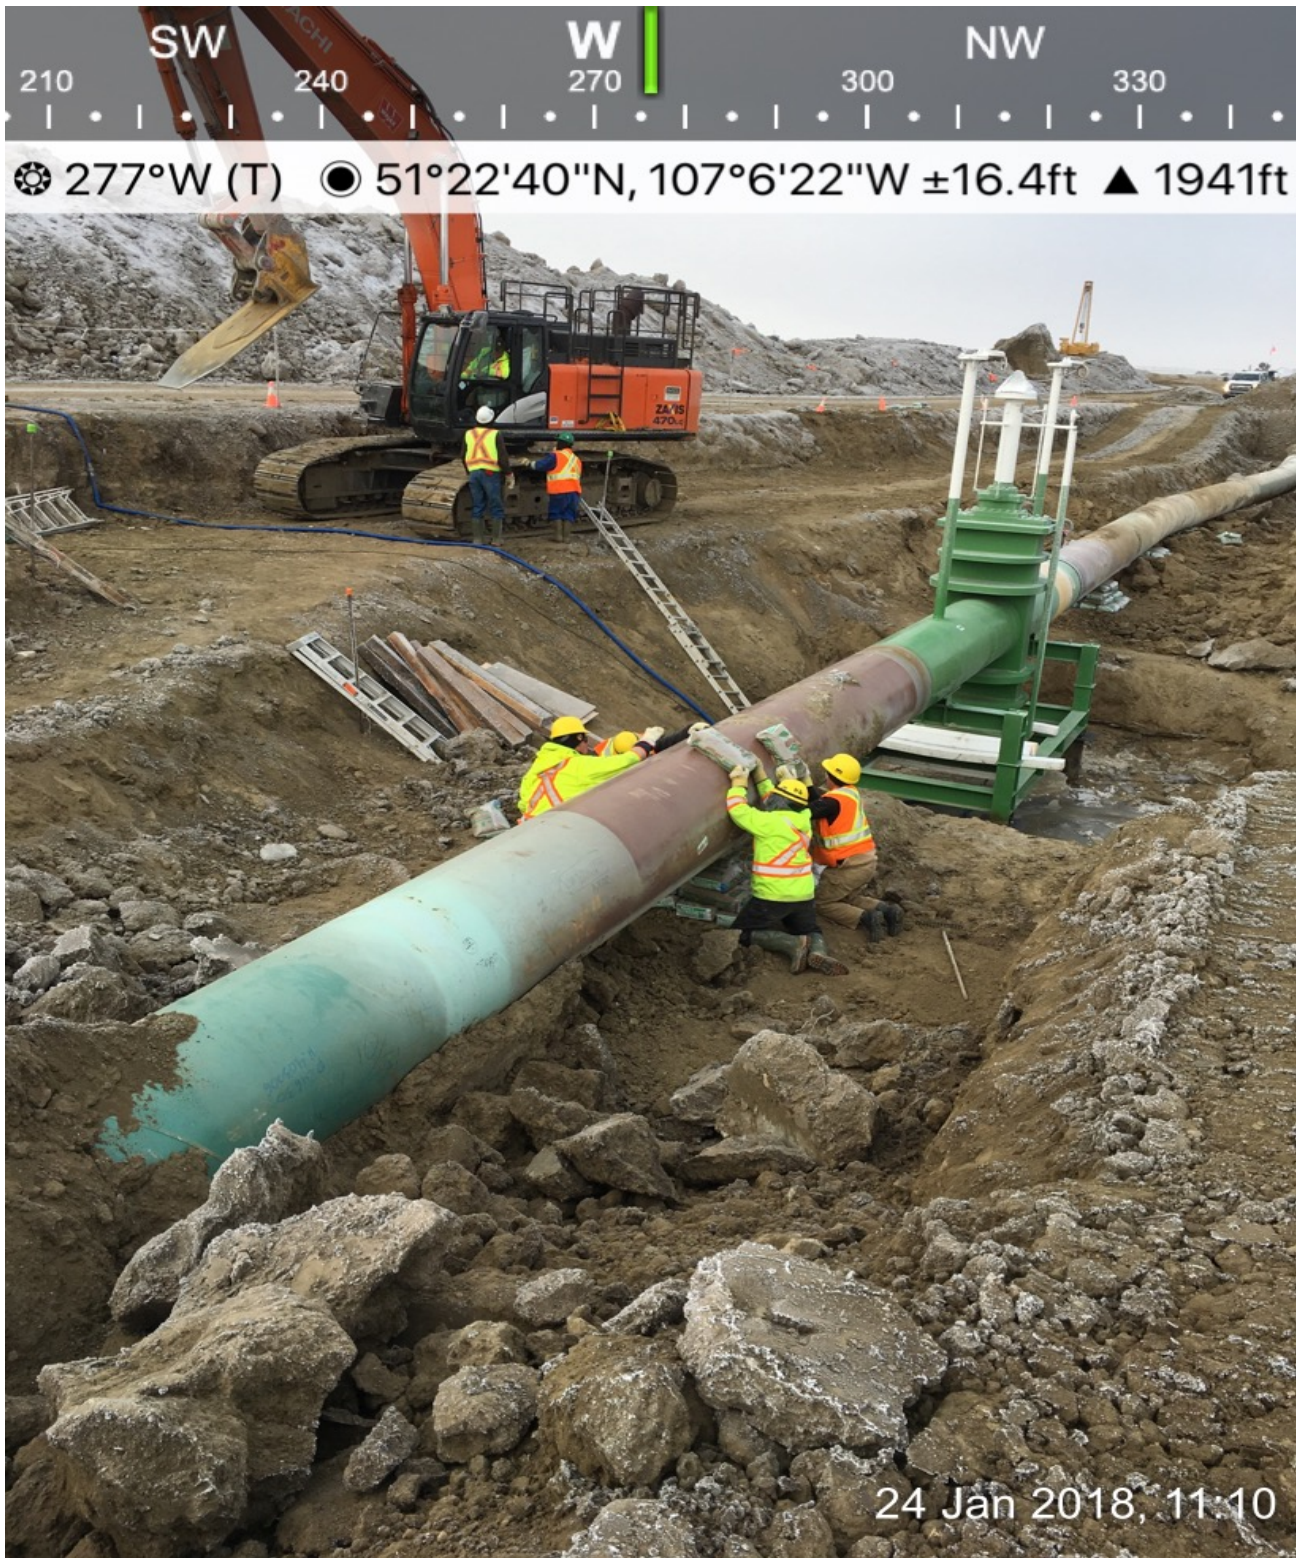
INSTALLING SAND BAGS FOR SUPPORT

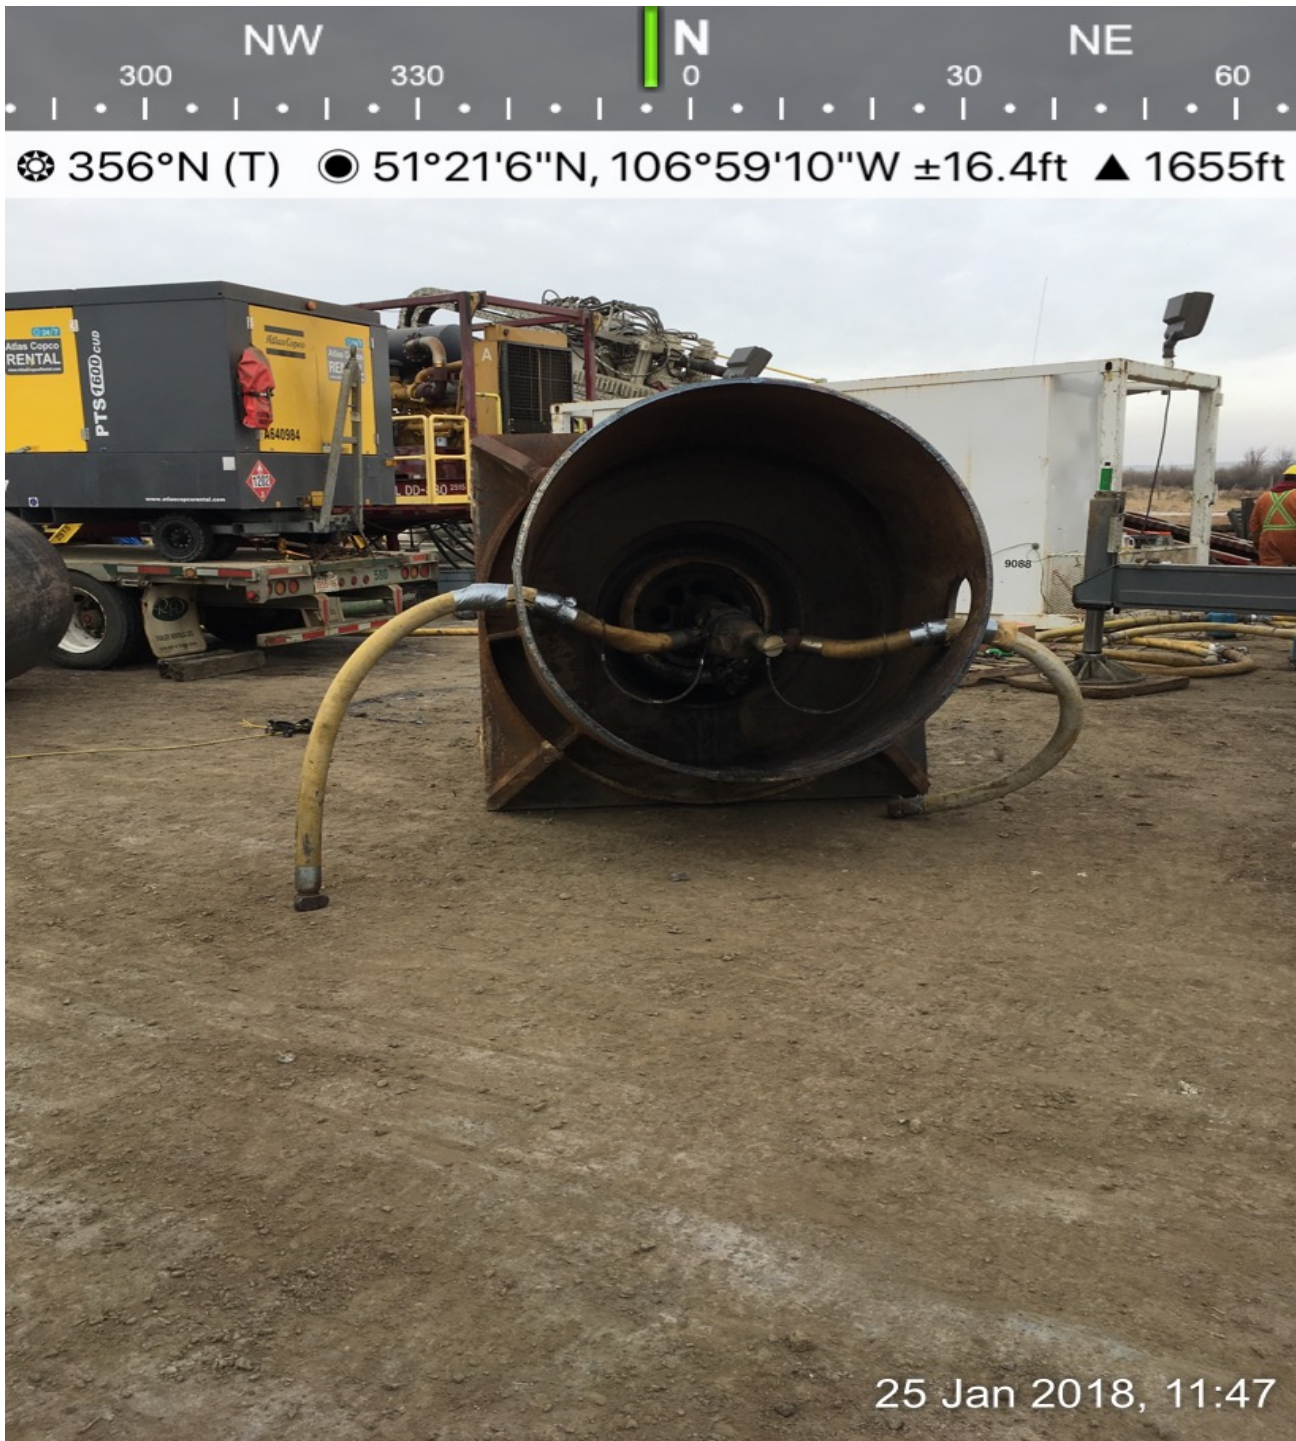
INSIDE VIEW OF THE HAMMER HEAD

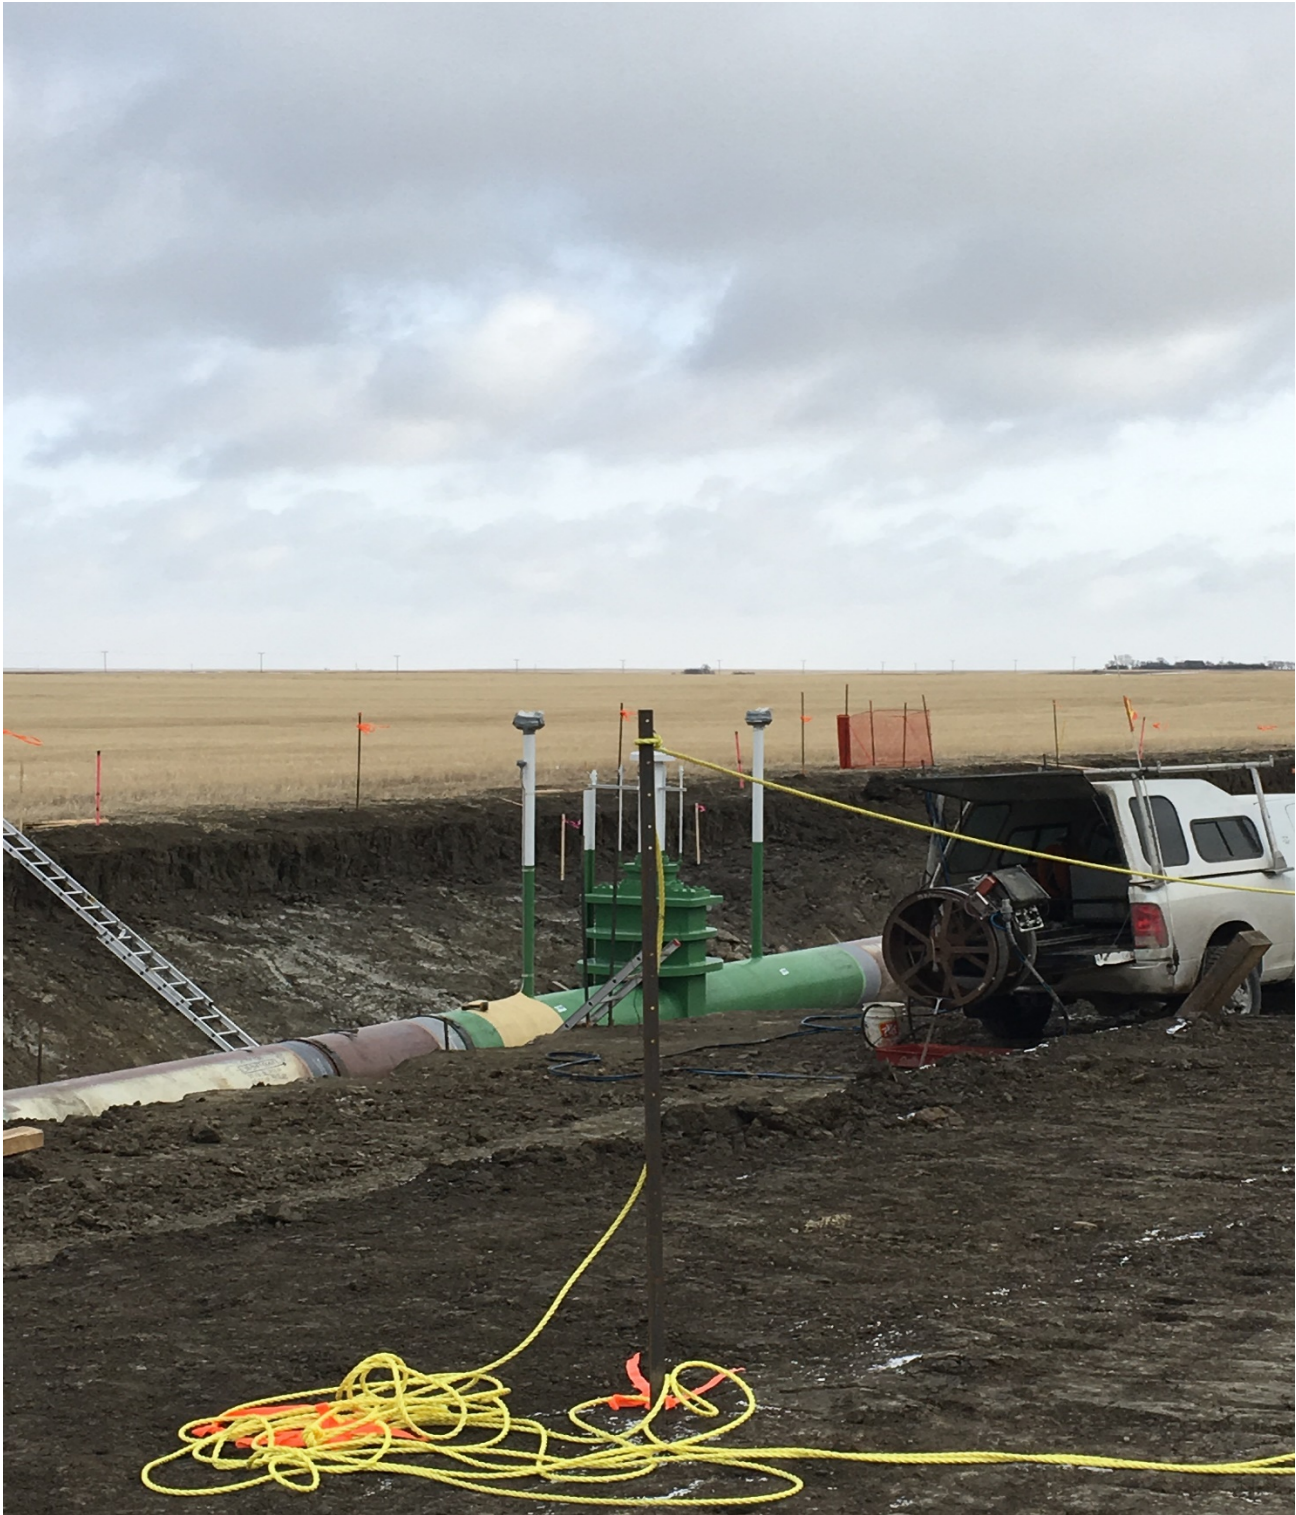
SCANNING WELD ON VALVE

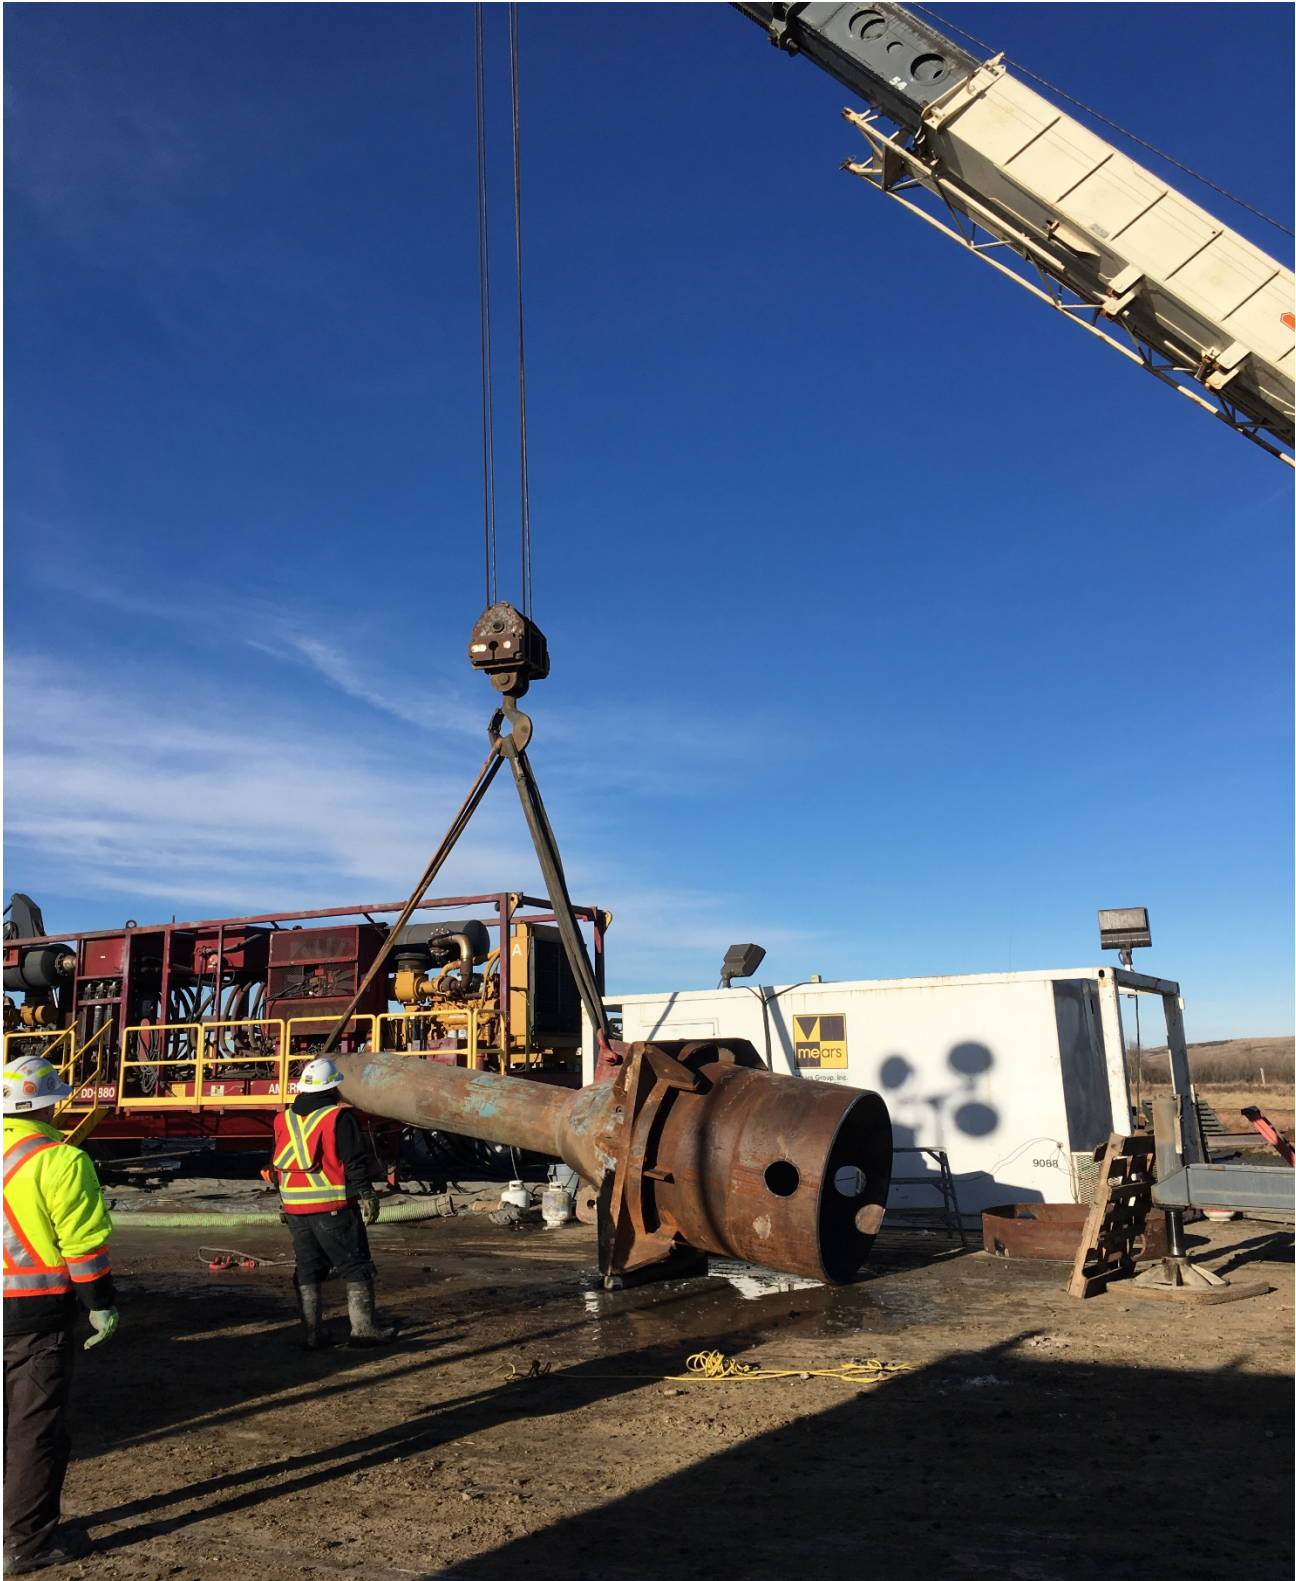
HAMMER HEAD

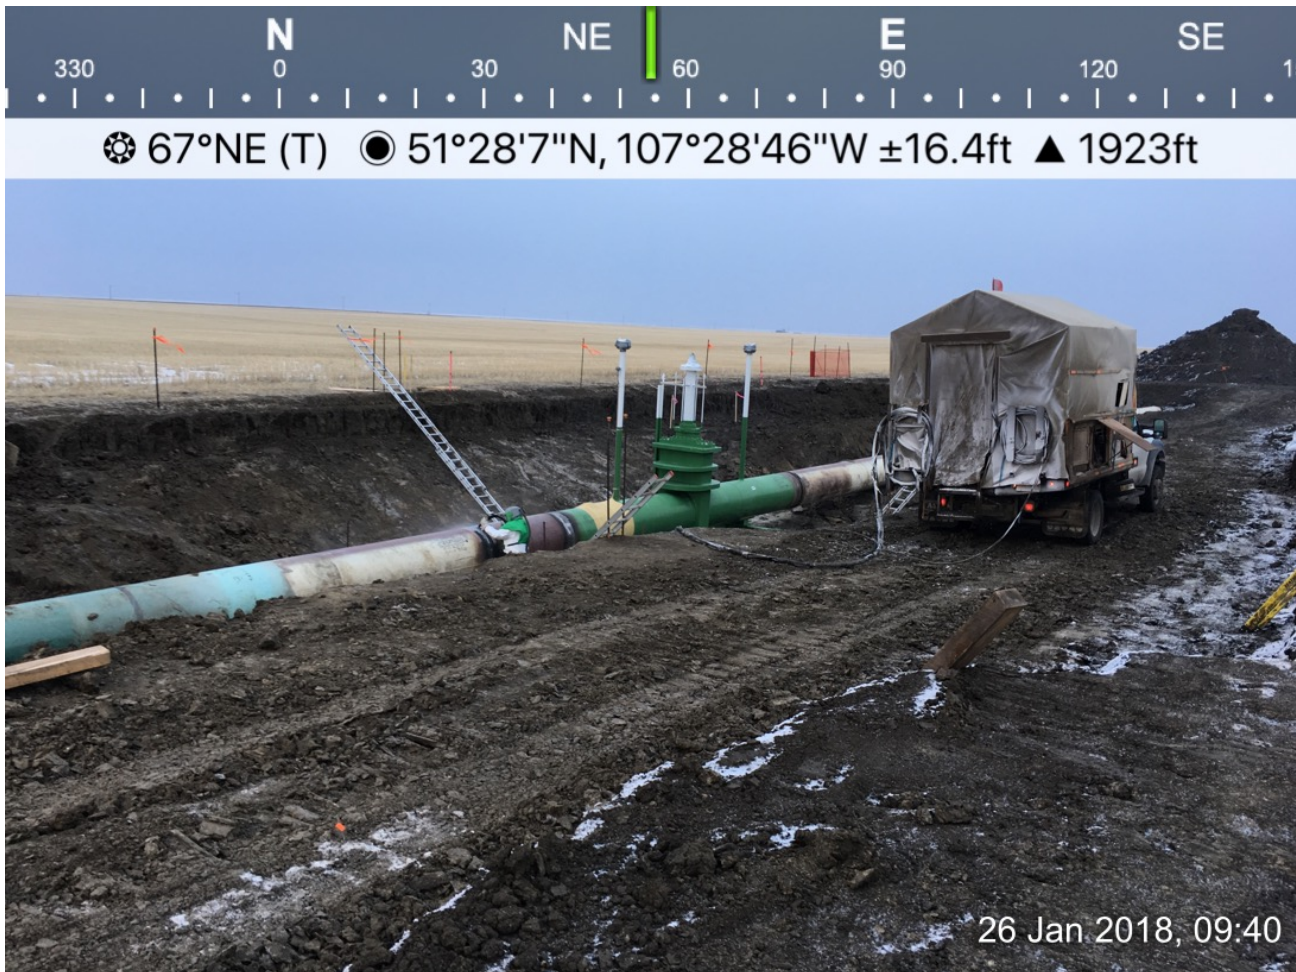
SAND BLASTING WELD

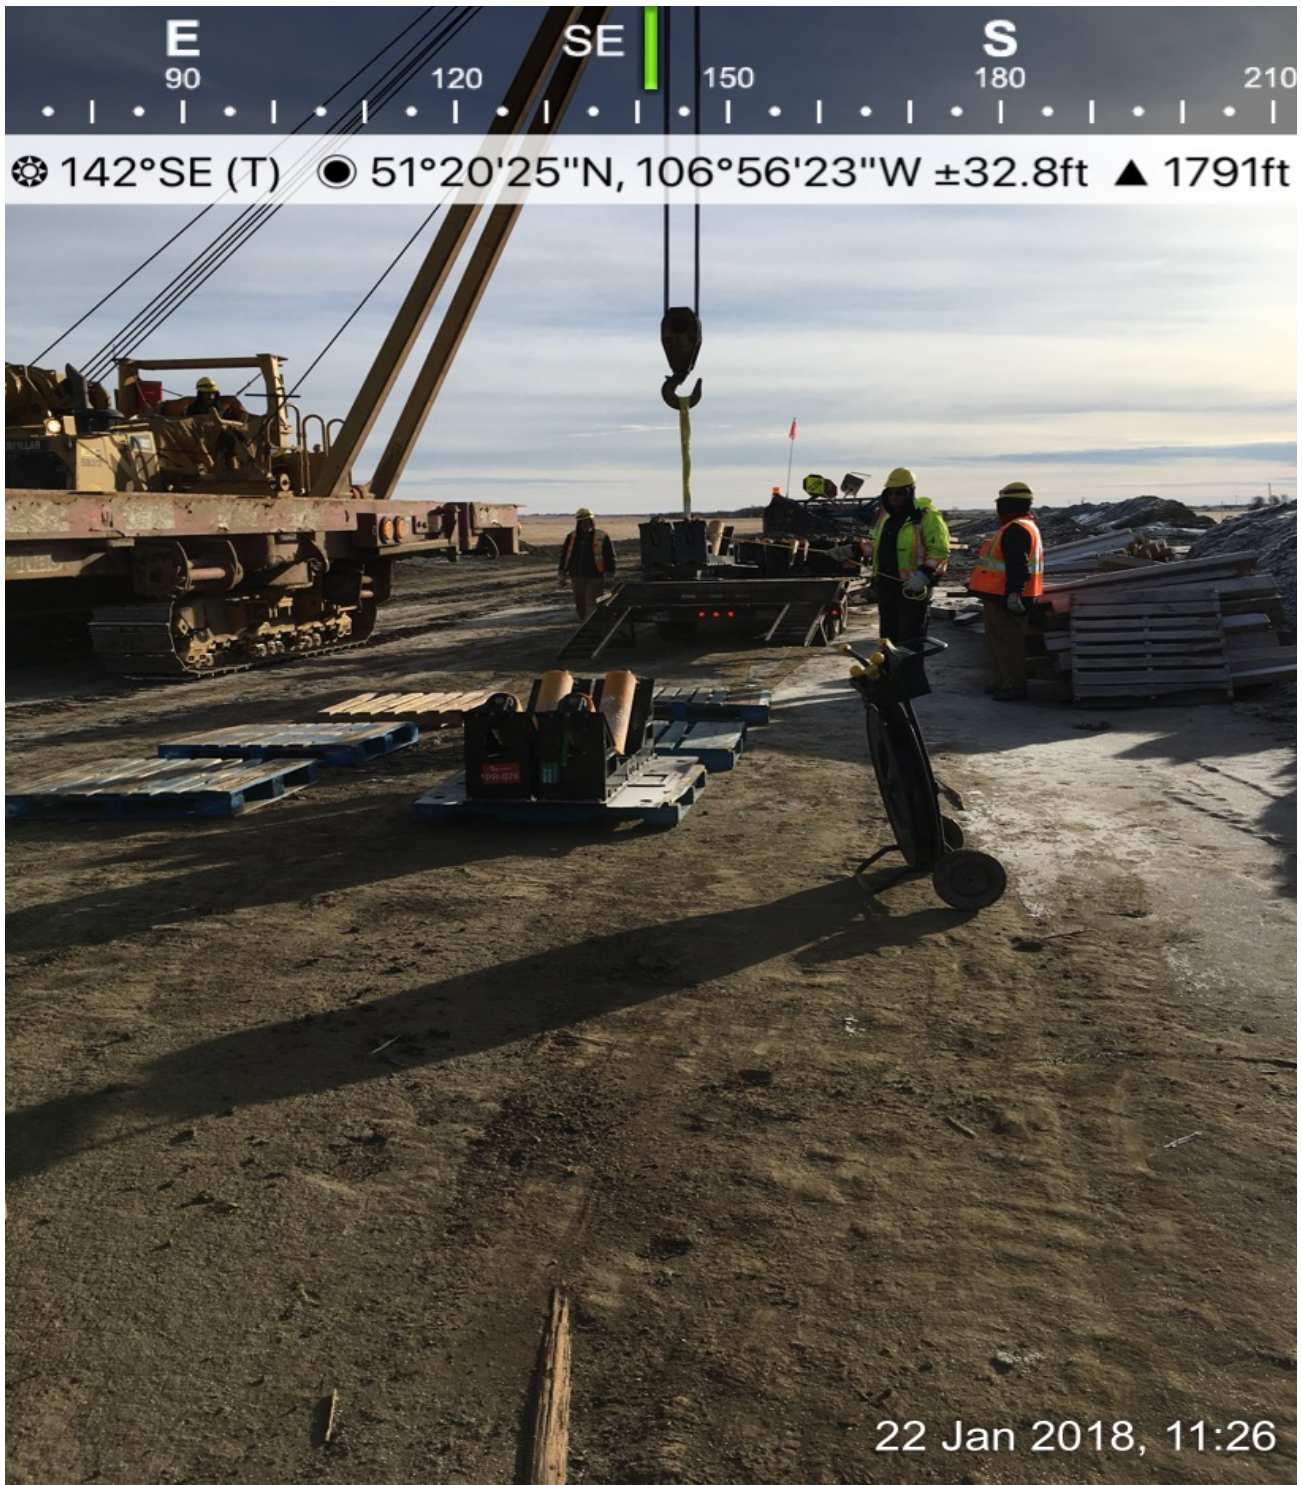
UNLOADING ROLLERS

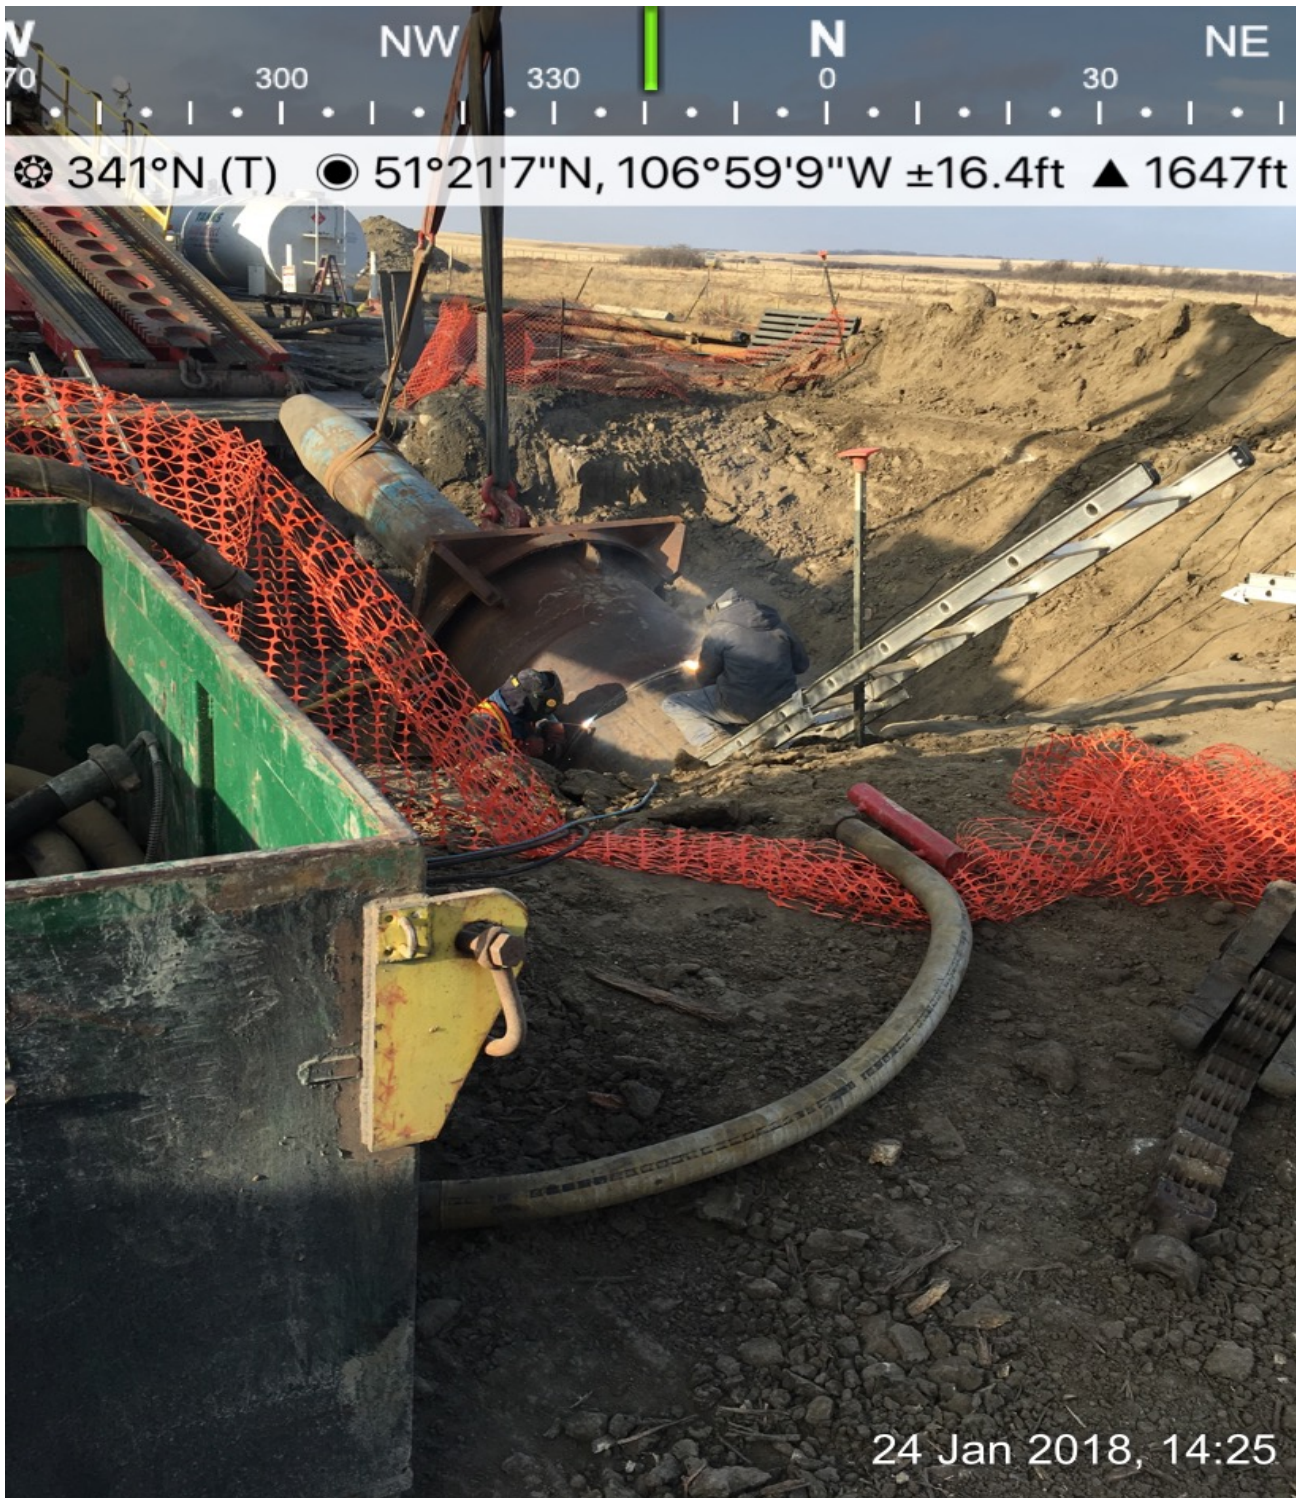
WELDING ON HAMMER HEAD
