SGS MUSCOWPETUNG

ABORIGINAL CONSTRUCTION MONITORING

WEEKLY REPORT

SPREAD # 3

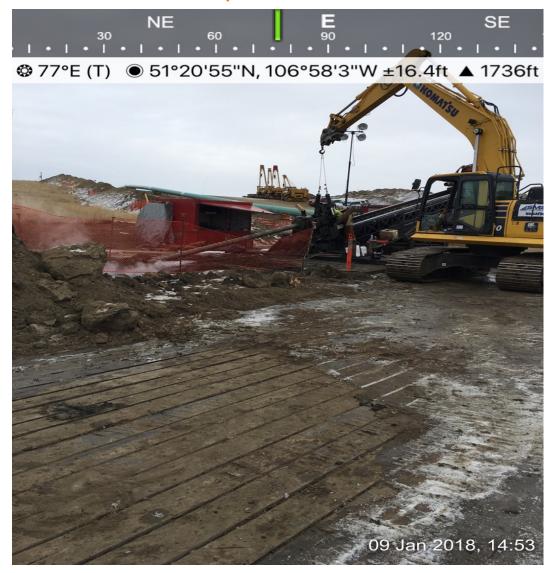
The horizontal directional drilling at the South Saskatchewan River is continuing. Mears group had reached 1100 metres with the 48-inch reamer as of Saturday. They are close to reaming out currently.

Exit point of Horizontal Directional Drilling

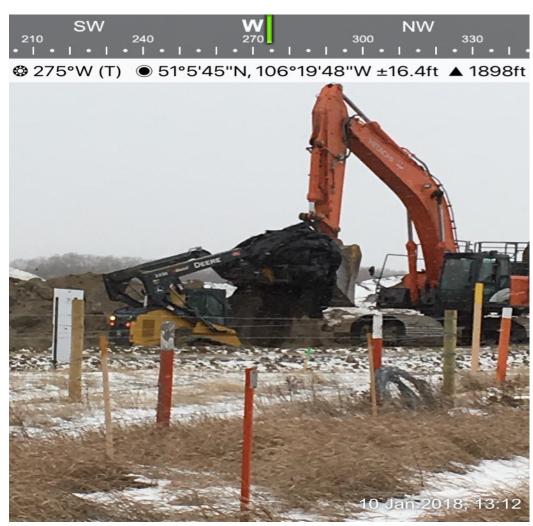
Removing Geotech material from access approach

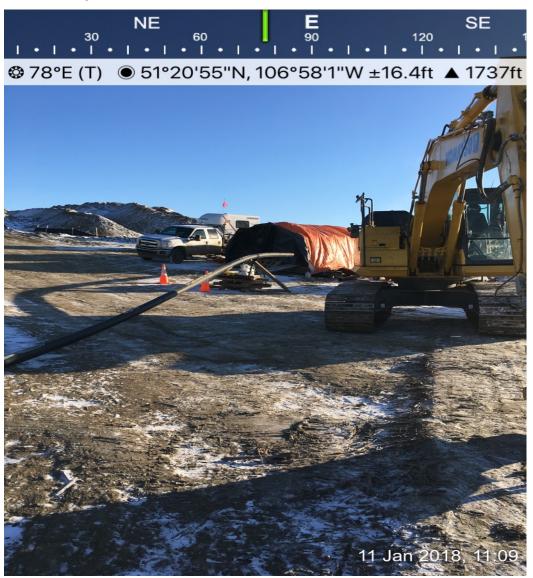
INFUSING BUOYANCY LINE INTO BORE SECTION

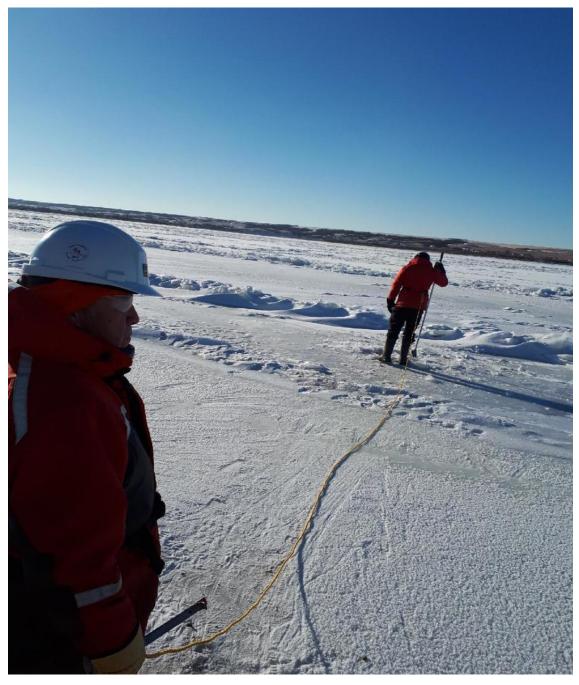
Golder Associates are still testing the turbidity of the water on the east side of the river and it remains consistent throughout the week.

WATER SAMPLING

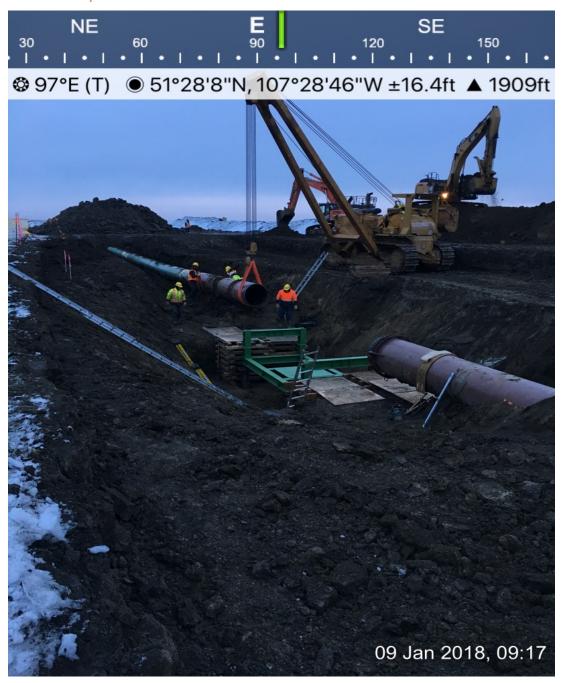
There was an installation of a valve on the mainline this week that was completed and there were no issues. They are currently working on excavating the location where the next valve will be installed on the mainline.

VALVE SITE

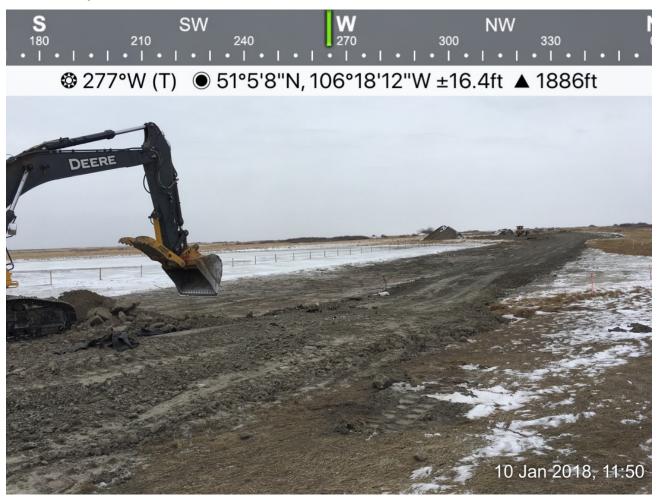
Reclamations of wetlands is ongoing; there are only a few remaining in spread three. Some wetlands have been completed. Topsoil and grating back the soil is looking good and there are no concerns. Temporary access approaches have been removed and cleaned up. Crews have also been working on making water ways on the soil piles.

WETLAND RECLAMATION

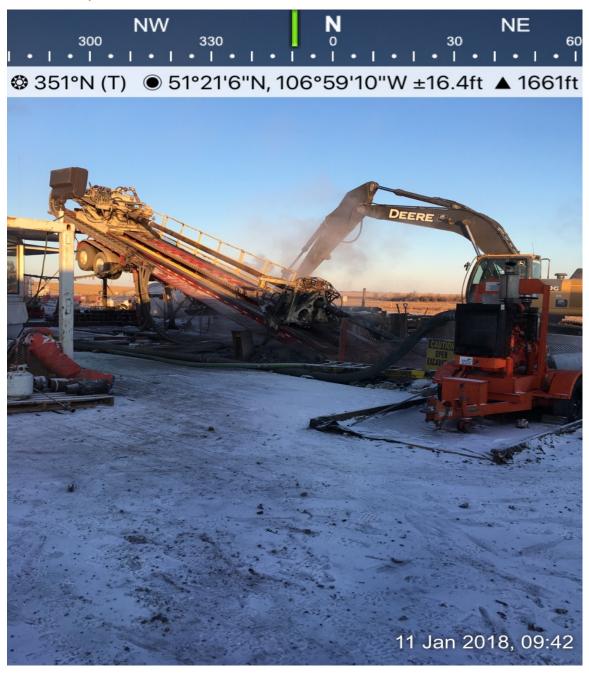
ENTRY POINT OF HORIZONTAL DIRECTIONAL DRILLING

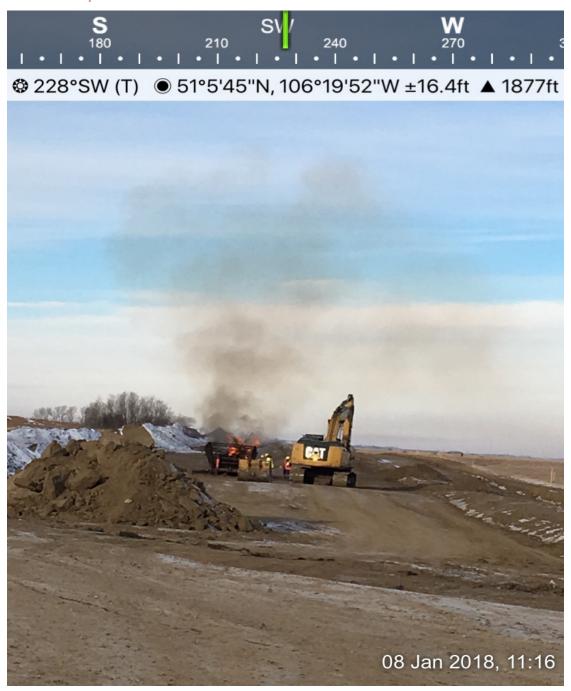
THE CLEANING UP OF THE RIGHT OF WAY

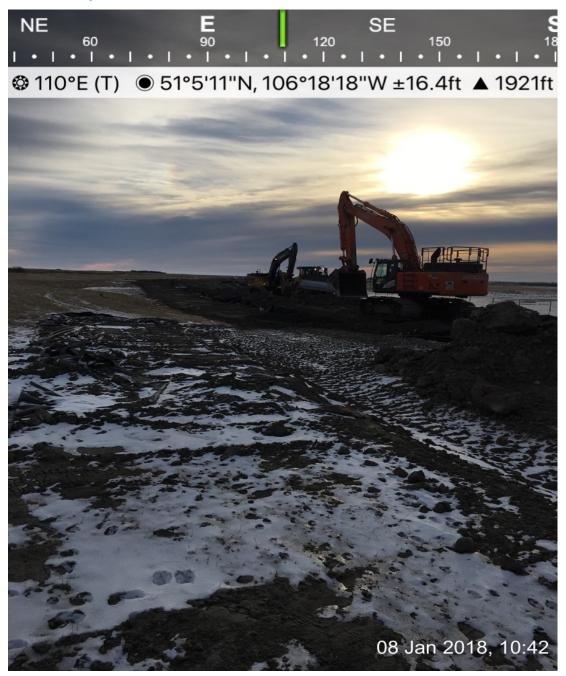
RECLAMATION OF WETLANDS

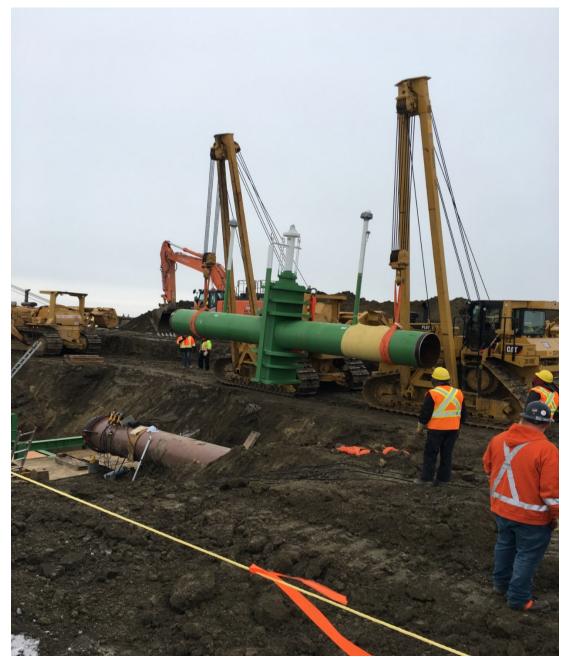
INSTALLATION OF VALVE

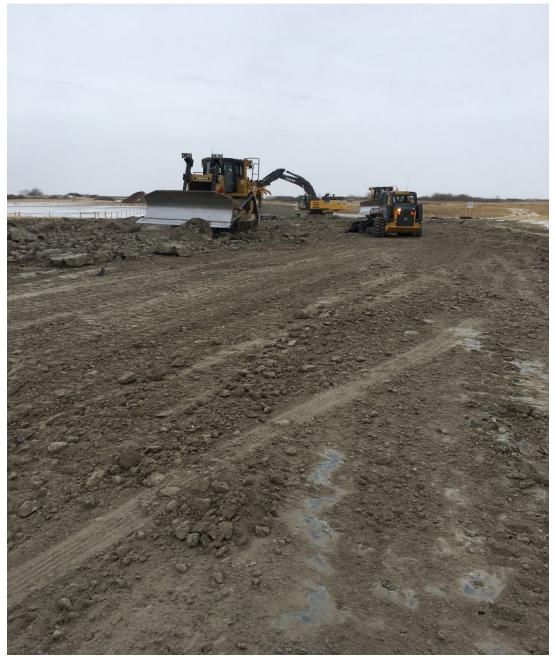
RECLAMATION OF WETLANDS

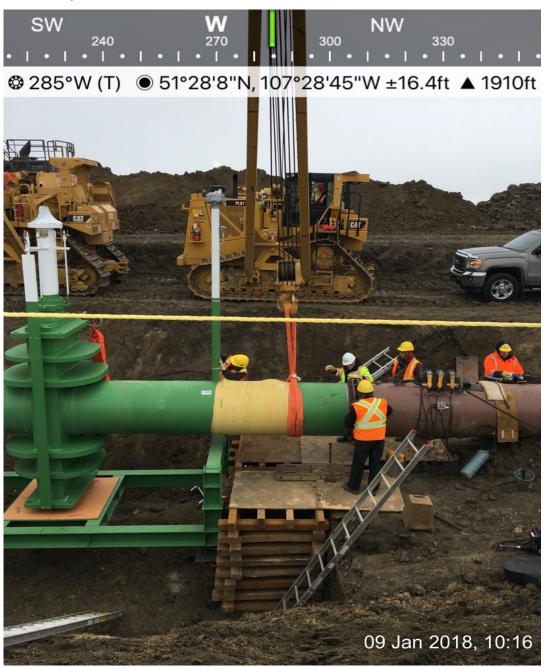
VALVEINSTALLATION

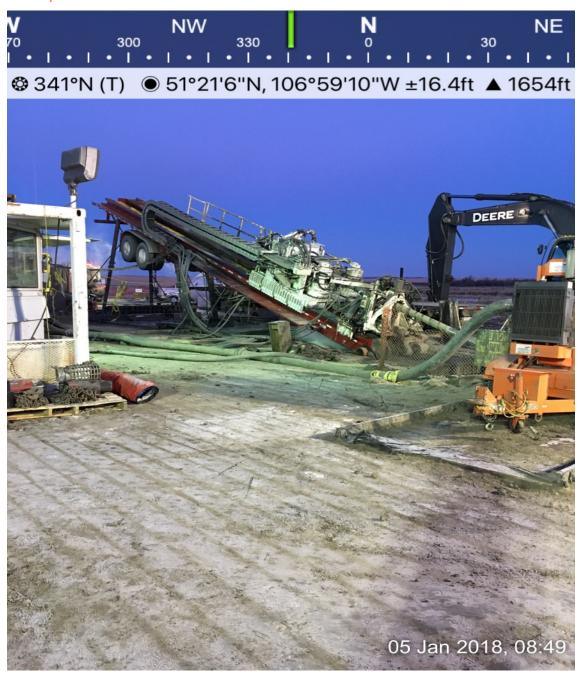
ENTRY POINT OF HORIZONTAL DIRECTIONAL DRILLING
