SGS MUSCOWPETUNG

ABORIGINAL CONSTRUCTION MONITORING

WEEKLY REPORT

NOVEMBER 20TH TO NOVEMBER 26TH, 2017

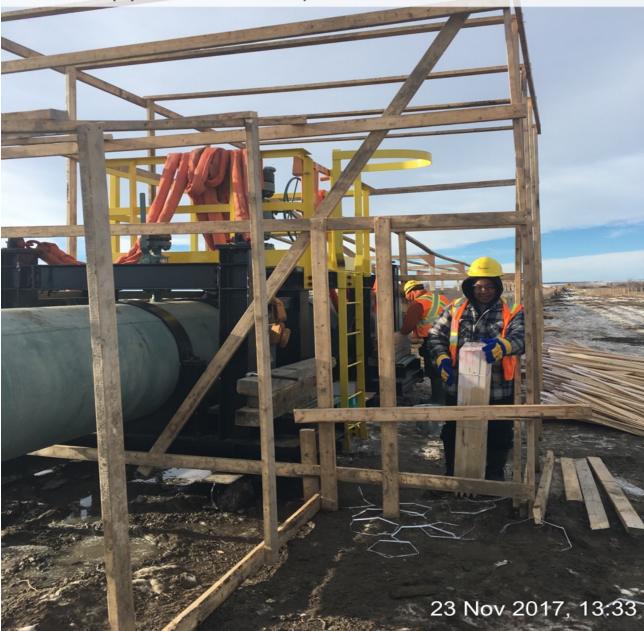
East Elevation

CREW WORKING ON HOARDING THE PIPE

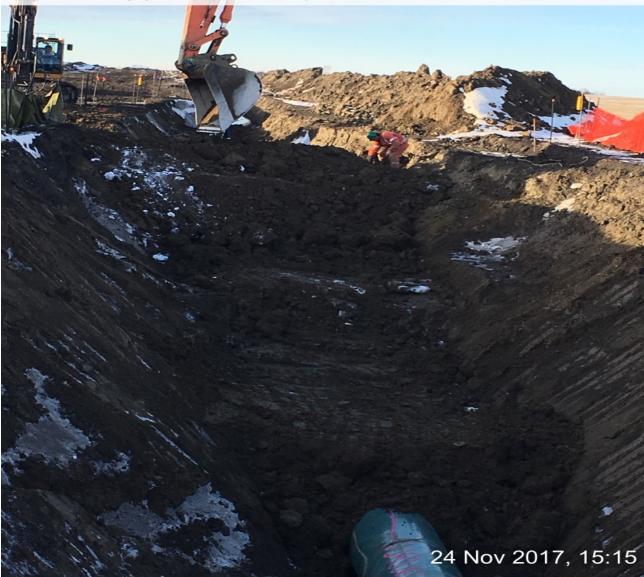
South East Elevation

BACKFILLING AND PACKING SOIL ON HOTLINES

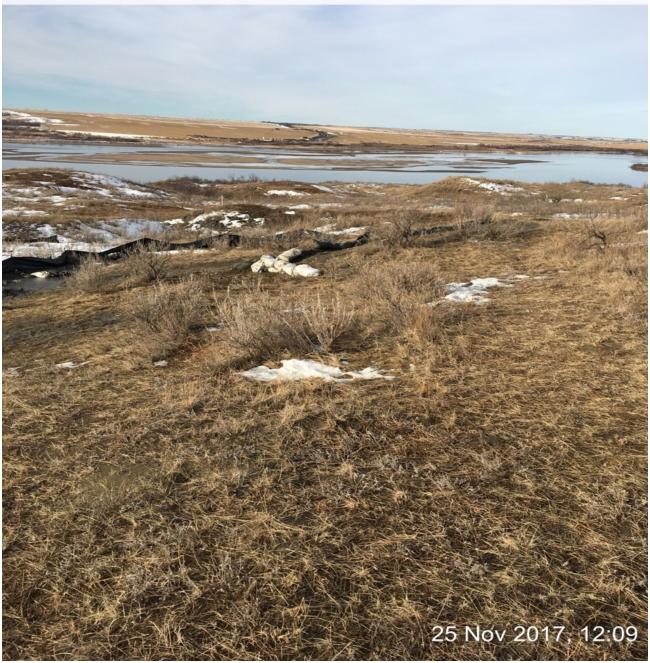
East Elevation

VISUAL OBSERVATION DURING FRACK WALK

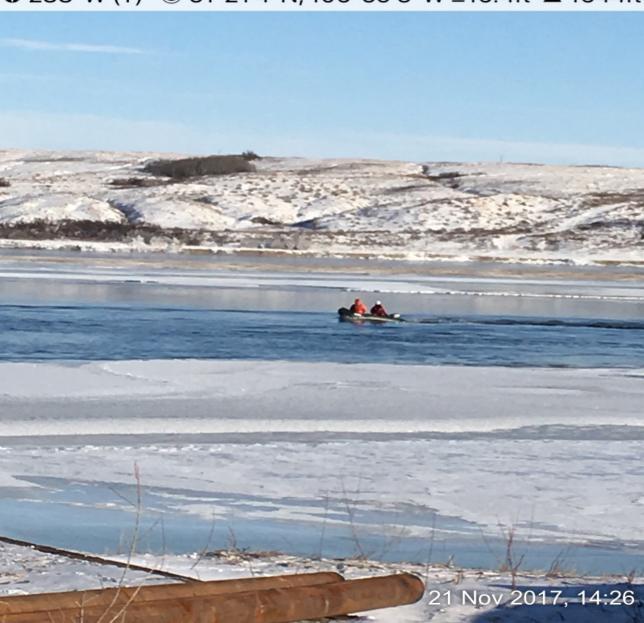
East Elevation

Currently the testing of the water turbidity by Golder Associates is ongoing and has remained consistent throughout the week. It is closely being monitored as they are underneath the river now. Testing of the turbidity is performed every two hours throughout the day and there is constant communication between the Golder Associates and the drilling team.

GOLDER ASSOCIATES GOING OUT ON WATER TO OBTAIN WATER SAMPLES

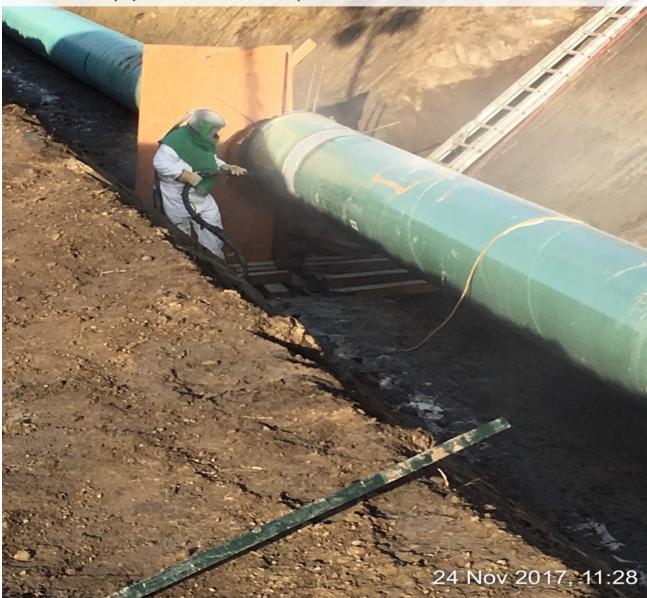
South Elevation

SAND BLASTING A TIE IN

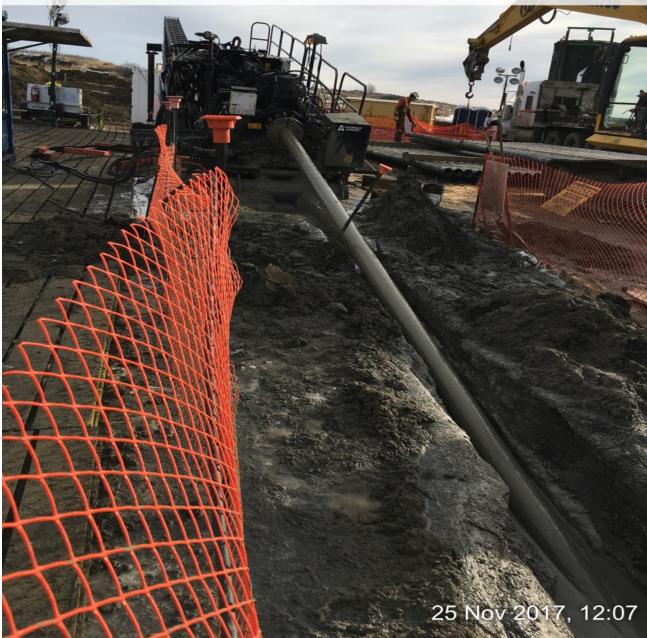
West Elevation

The horizontal directional drilling at the South Saskatchewan River is still ongoing. They have reached 891 metres with the 36-inch reamer early in the week. They had to trip back all week to clean out the bore hole. Now they have tripped back in and drilling two days ago and were at 1000 metres with the 36-inch reamer. They have reached the east bank of the river and have started doing frack walks. There are no concerns currently. They should be reaching the exit point within the next few days and they will be closely monitoring for any fracks.

EXIT POINT OF HORIZONTAL DIRECTIONAL DRILLING

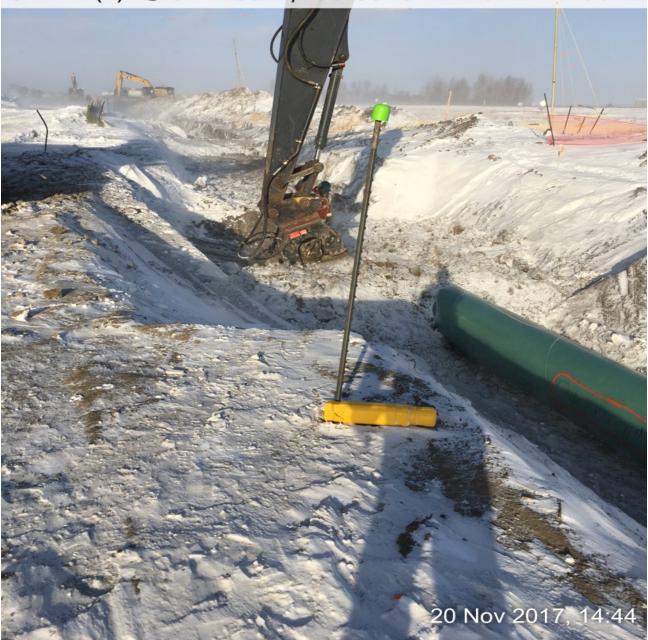
South Elevation

HOE PACKING OF BACKIFF SOIL

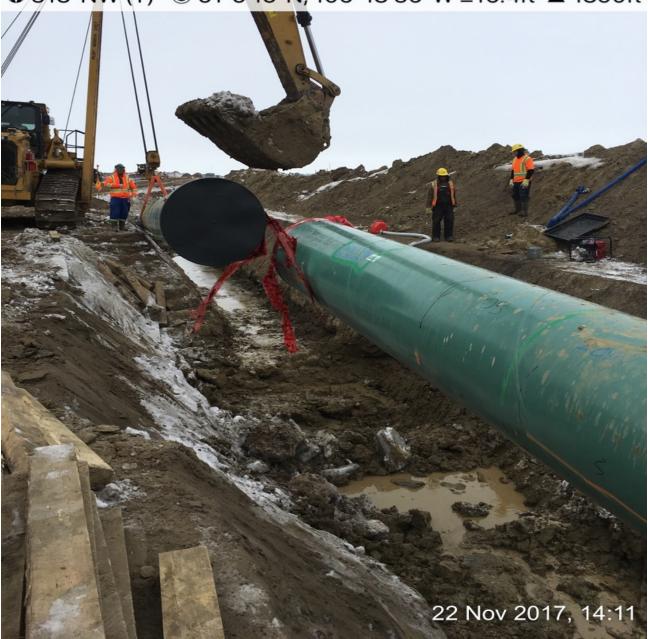
South East Elevation

CREW WORKING ON A TIE IN

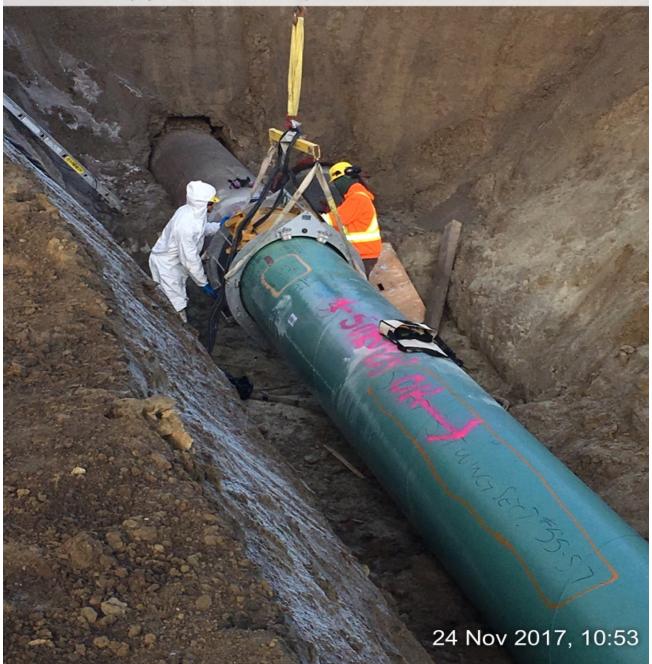
South East Elevation

HEATIN GUP BEFORE A TIE IN
