SGS MUSCOWPETUNG

ABORIGINAL CONSTRUCTION MONITORING

WEEKLY REPORT

NOVEMBER 27TH TO DECEMBER 3RD, 2017

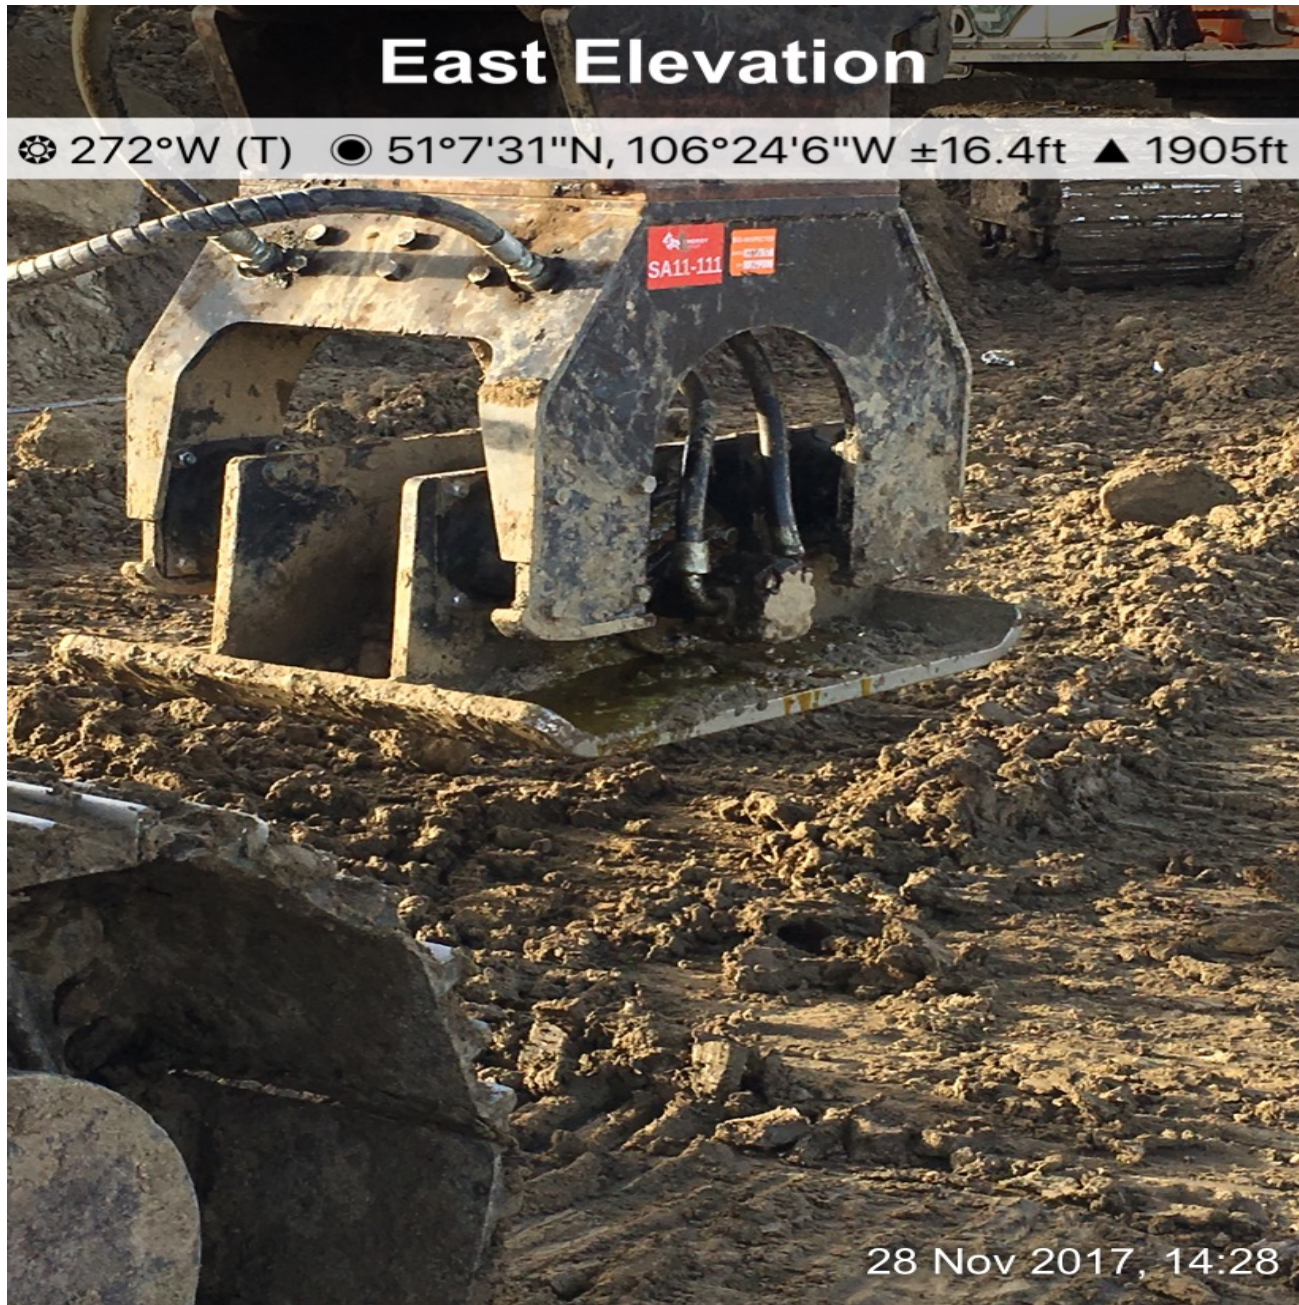
FLUID LEAK THROUGH HYDRAULIC HOSE WAS CONTAINED IMMEDIATELY

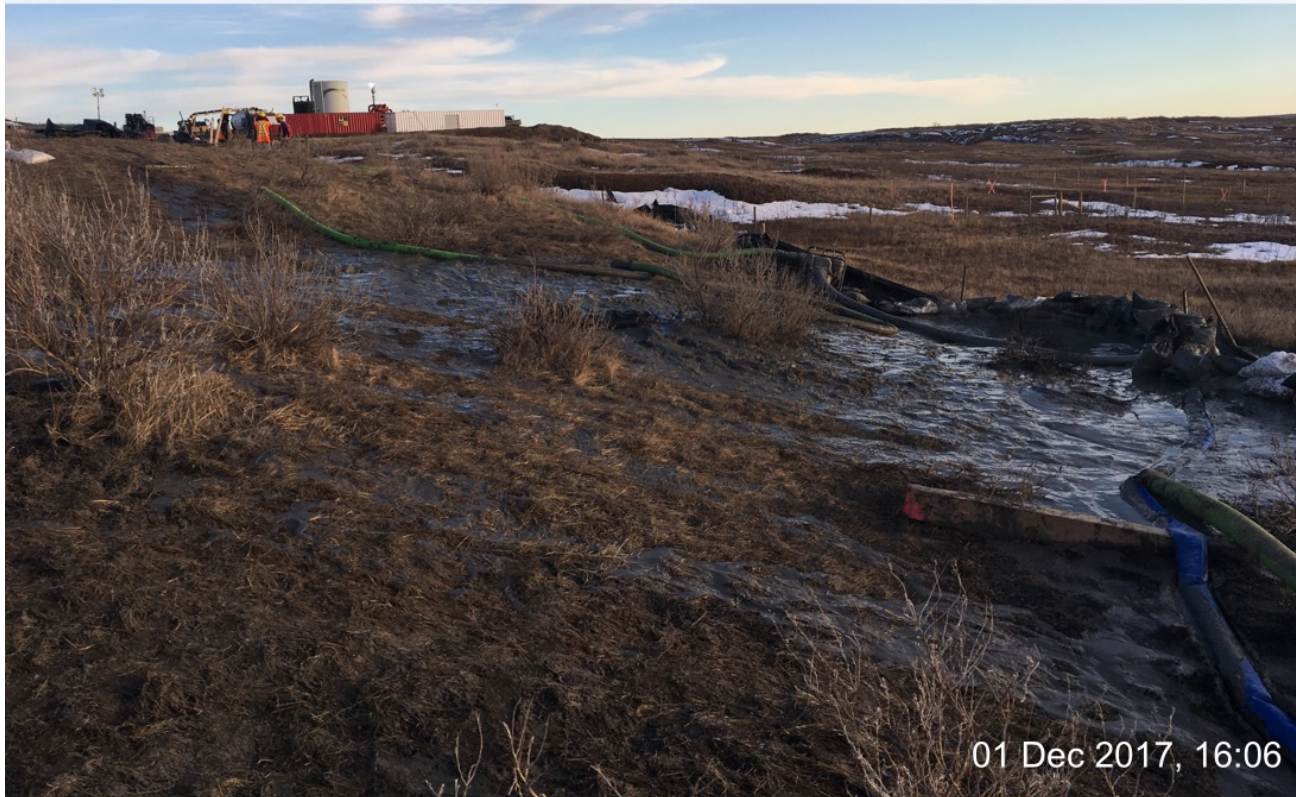
The horizontal directional drilling at the South Saskatchewan River is still ongoing. They have reached 1275 metres with the 36-inch reamer. Issues with new fracks and losing too much fluid and mechanical issues have delayed the drilling process but crews have been ready for the fracks and have all been contained. So, they decided to trip back as of yesterday and plan is to drill from exit point in the next few days.

FLUID FROM FRACK

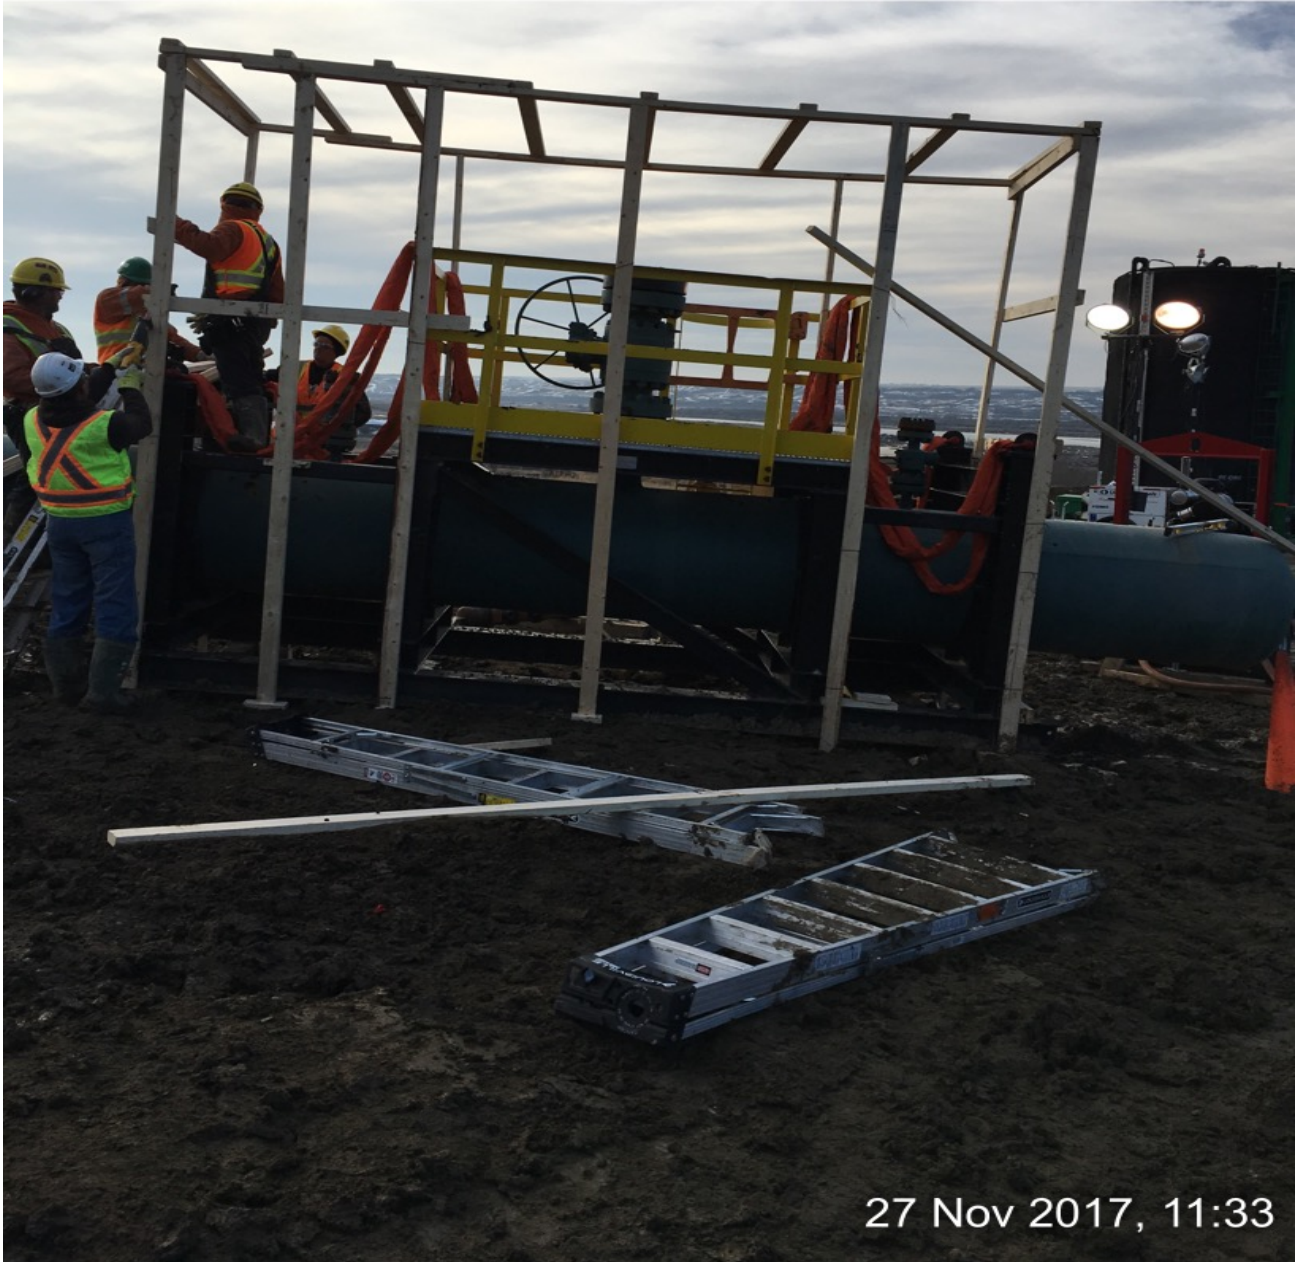
FRAMING HOARDING OVER A TEST HEAD

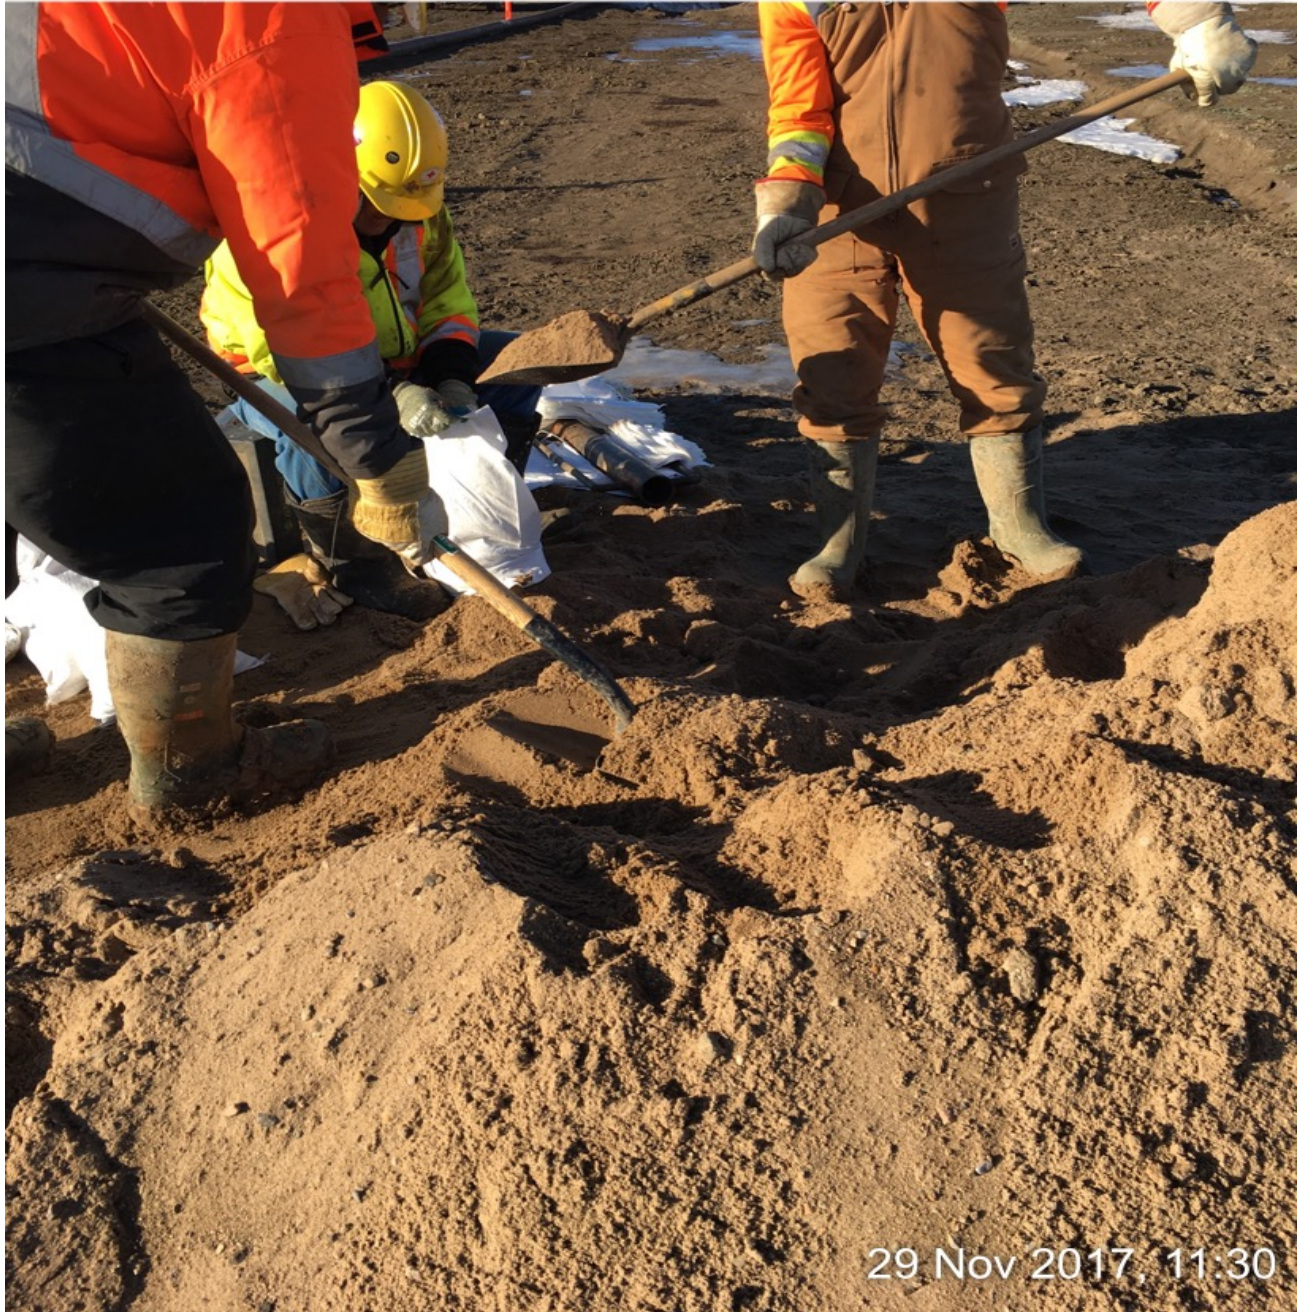
FILLING SAND BAGS FOR DIVERTING WATER

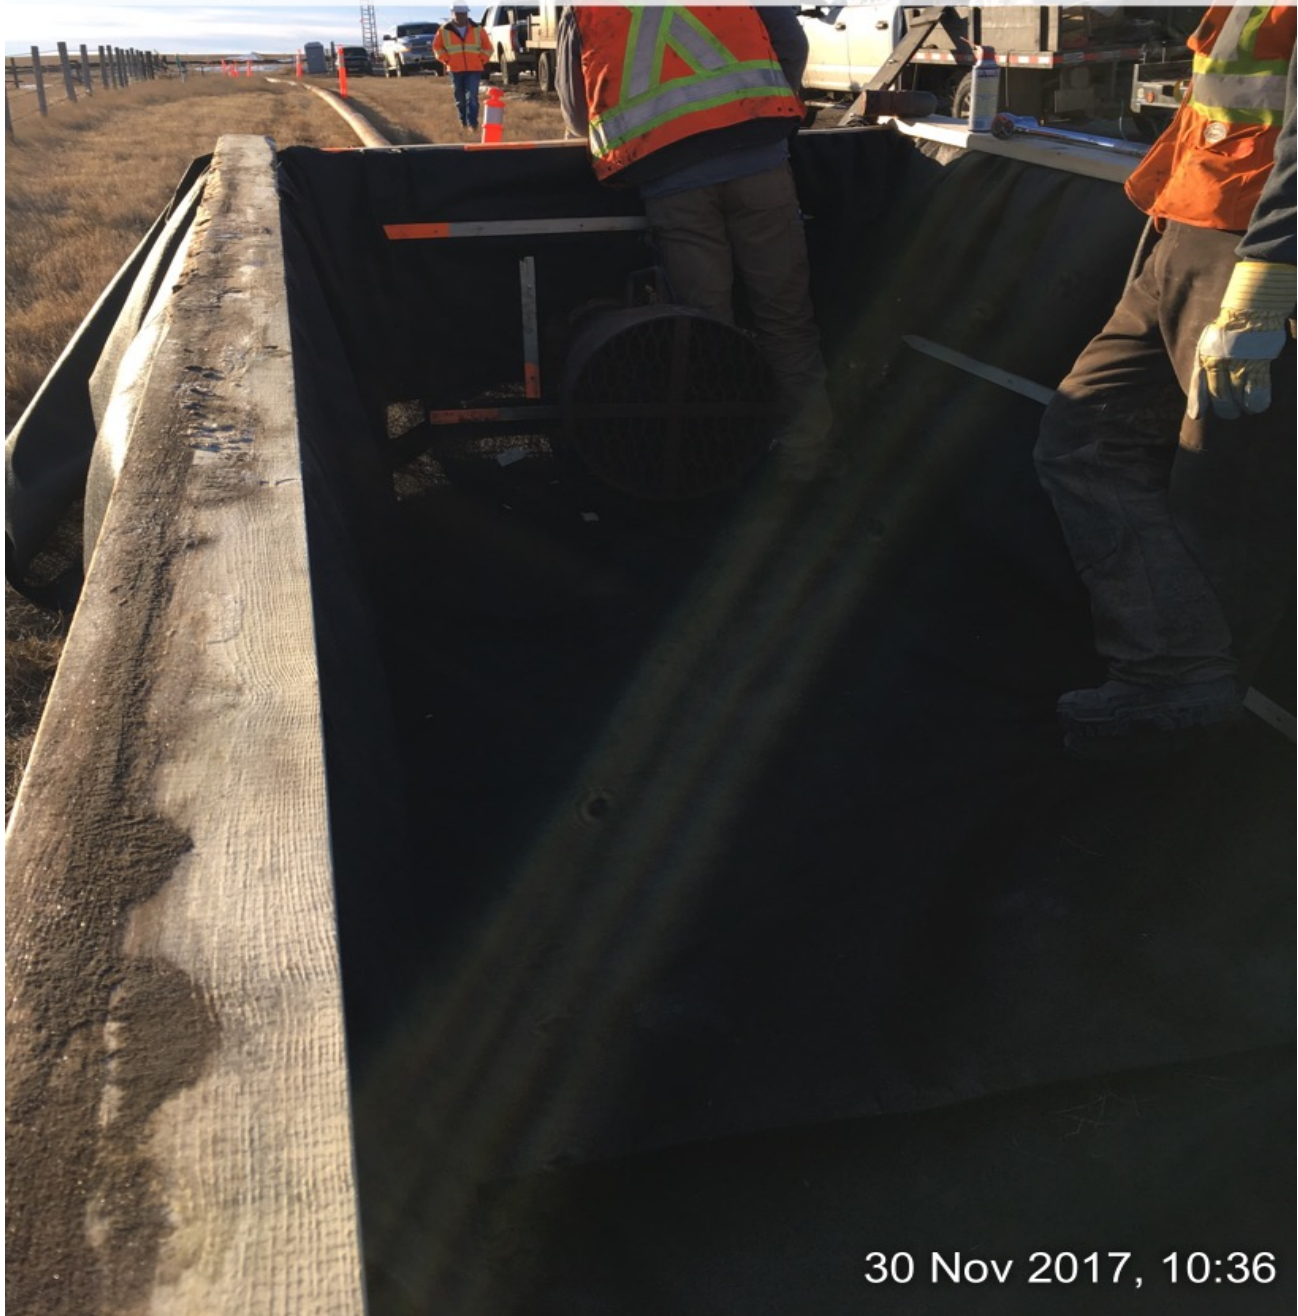
Hydro testing of the mainline has been completed of the first three phases of the mainline. They will be de-watering the mainline this week. They have made a filtering box which the water will flow through before its released into the field.

FILTERING BOX FOR DE-WATERING

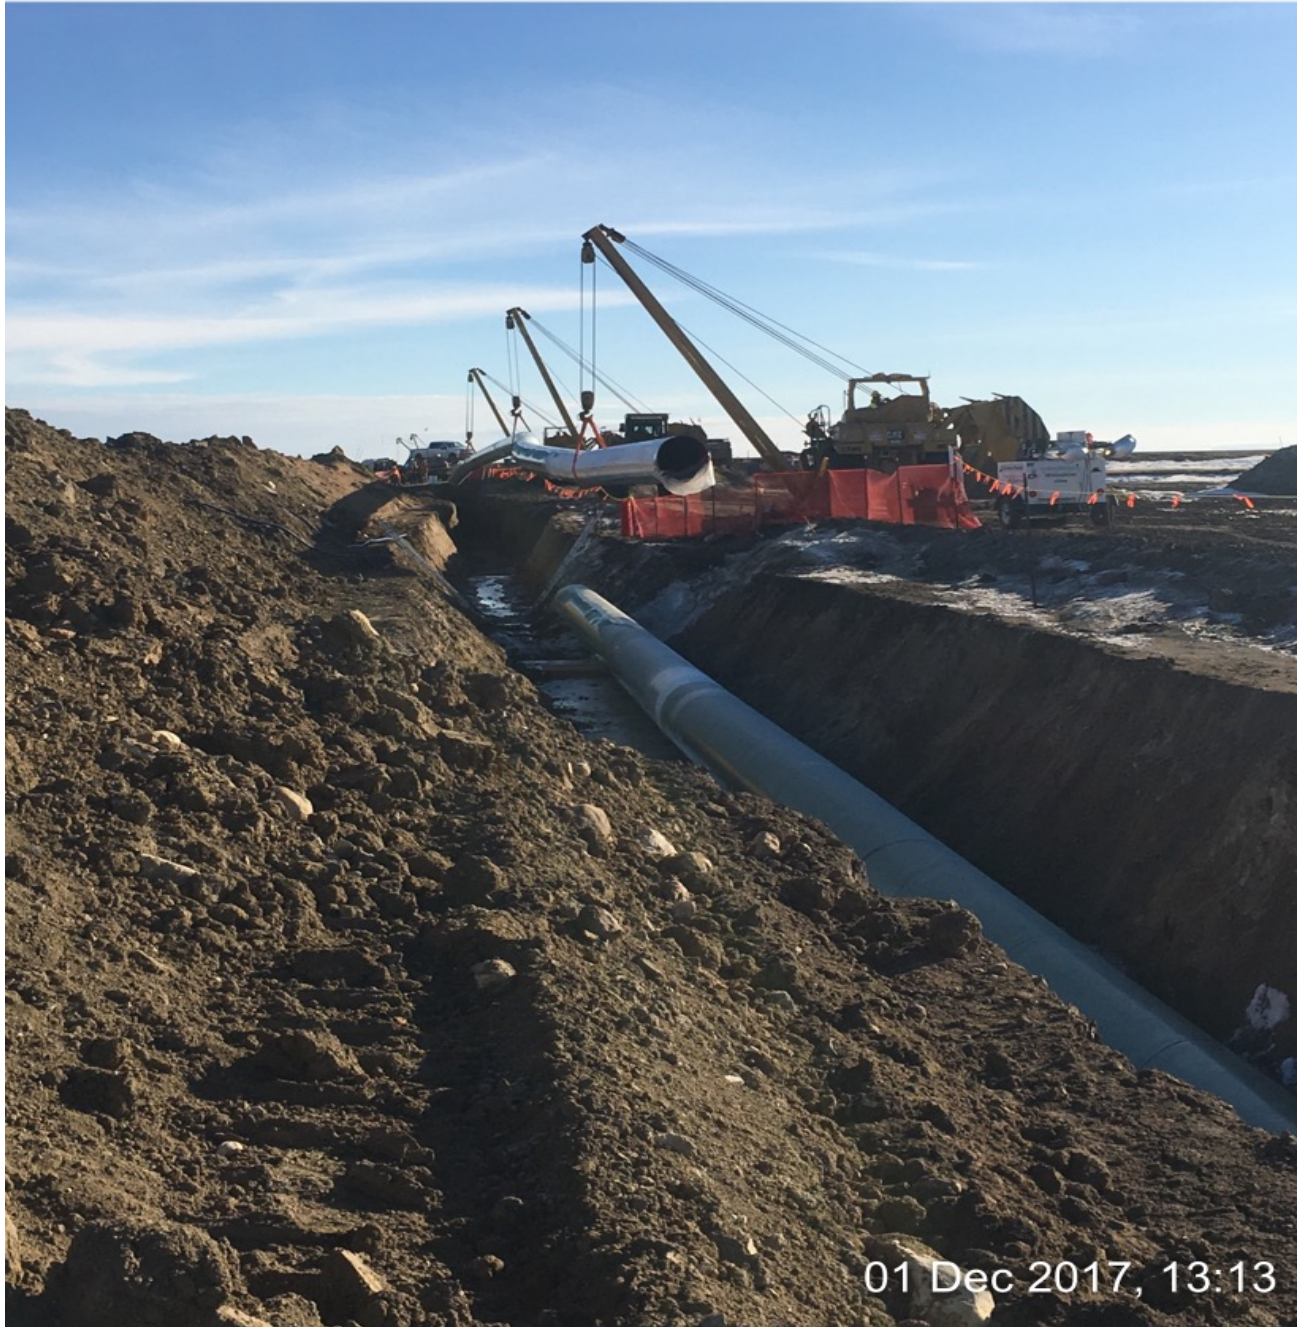
LOWERING IN SECTION OF PIPE FOR TIE IN

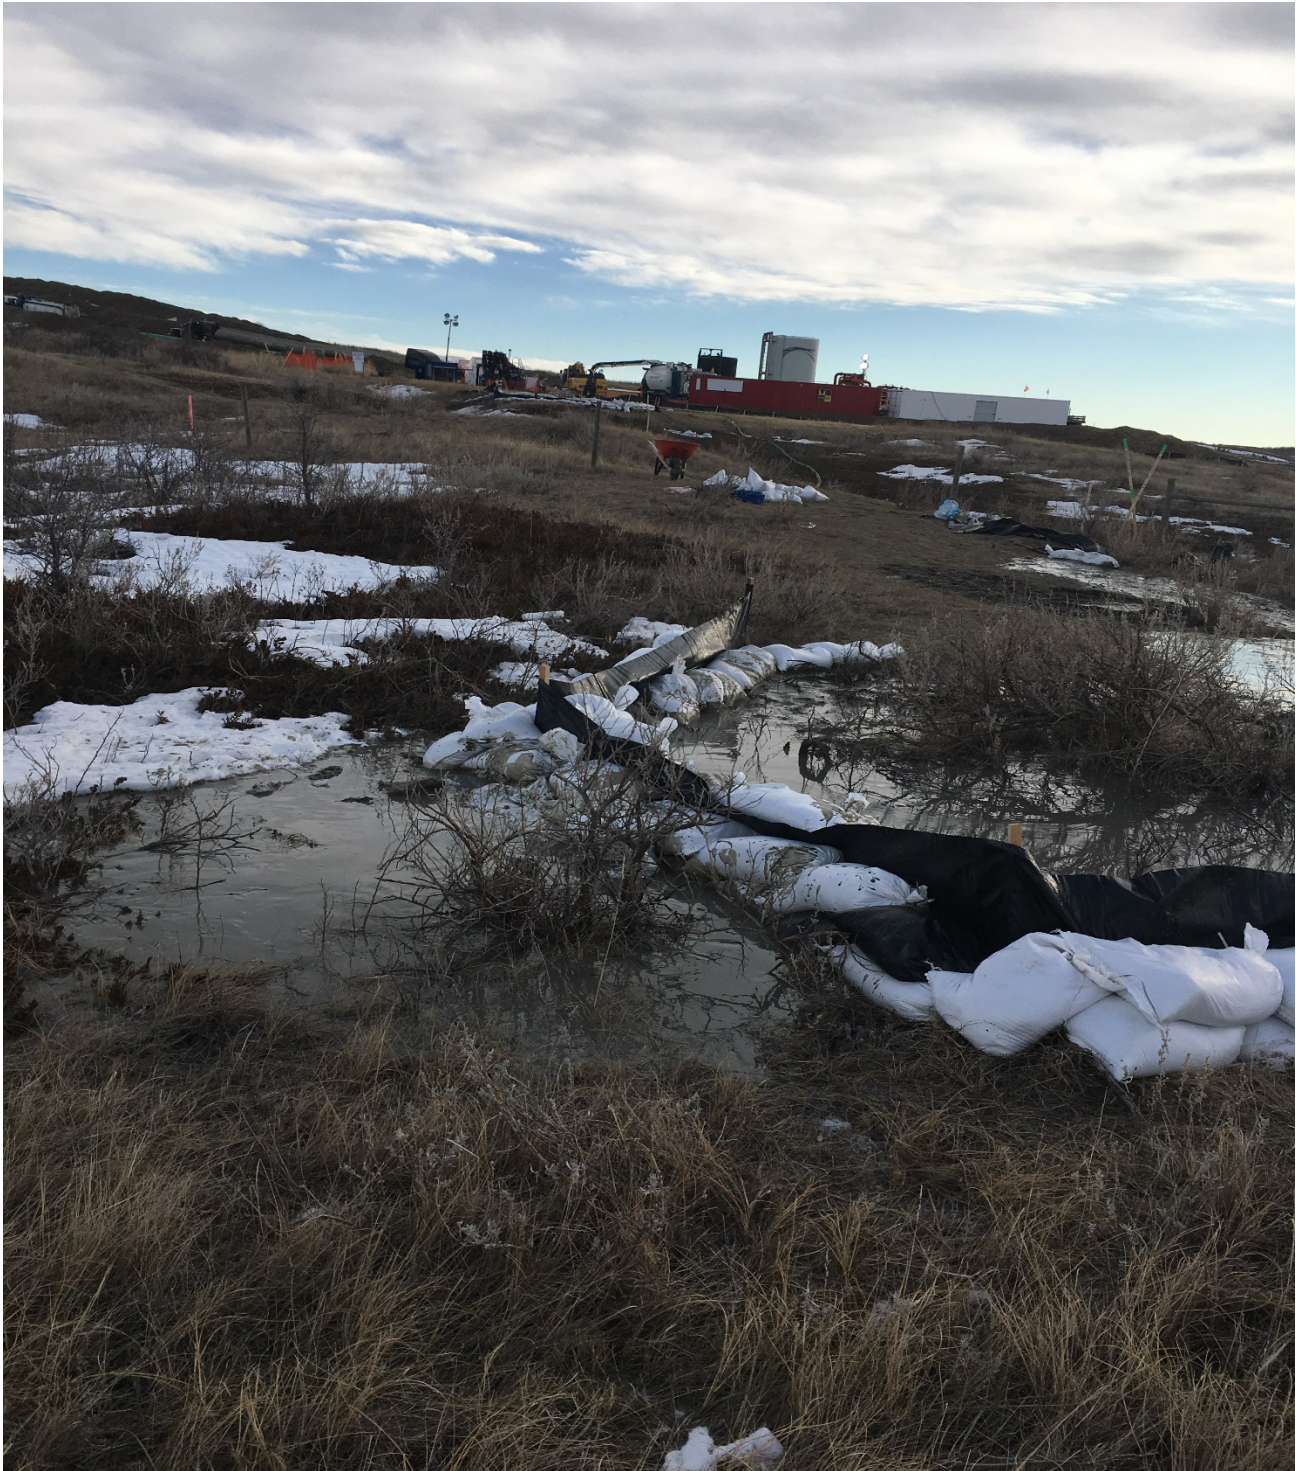
FRACK FLUID

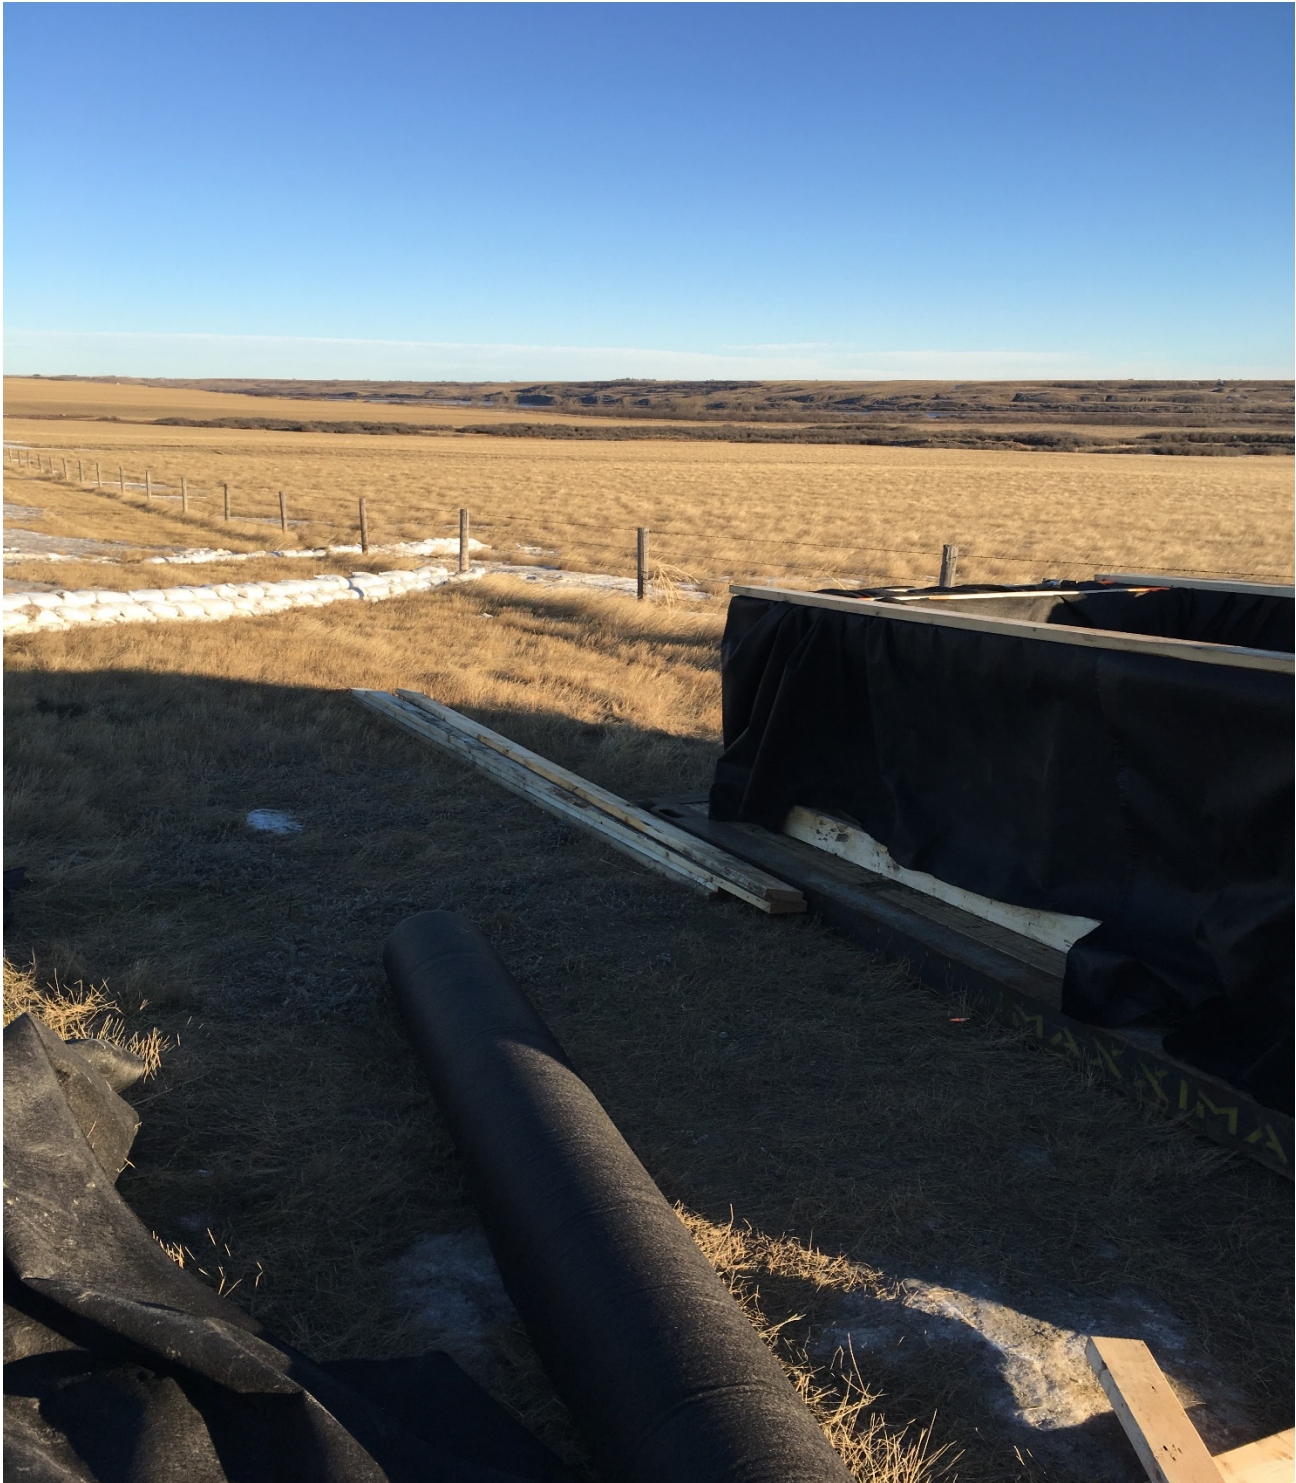
POINT OF DE-WATERING MAINLINE

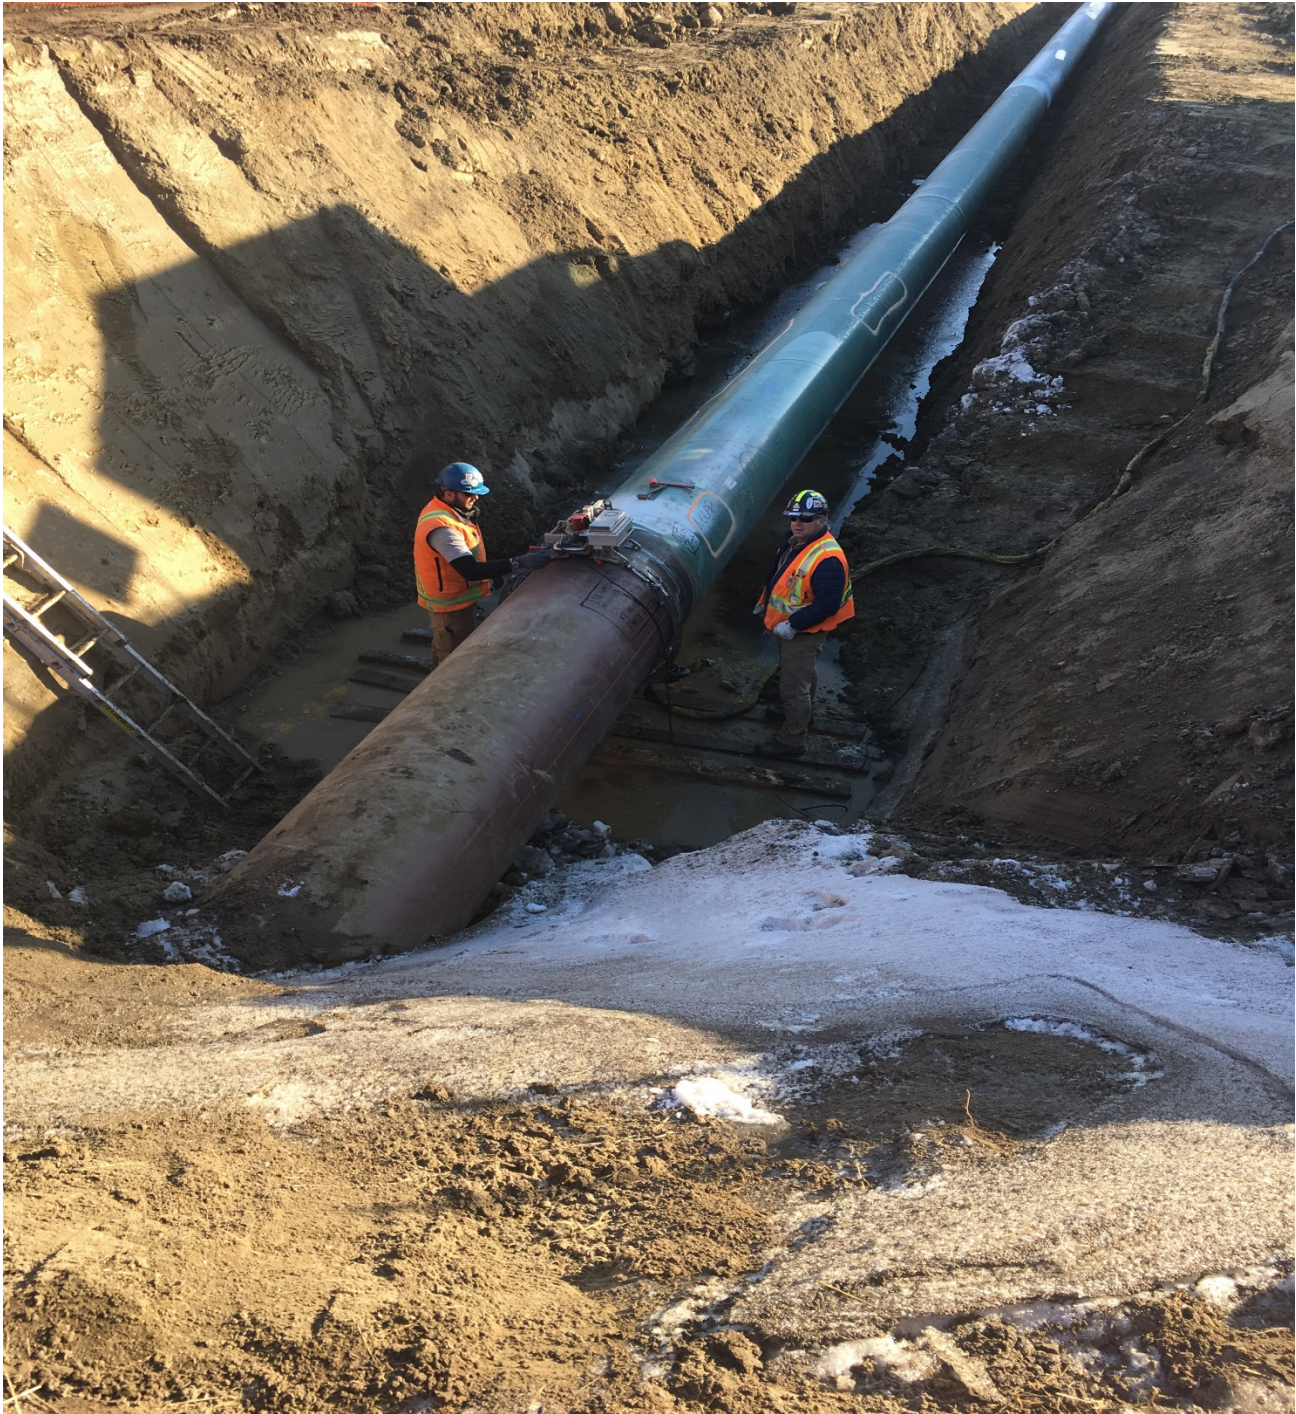
X-RAY OF WELD

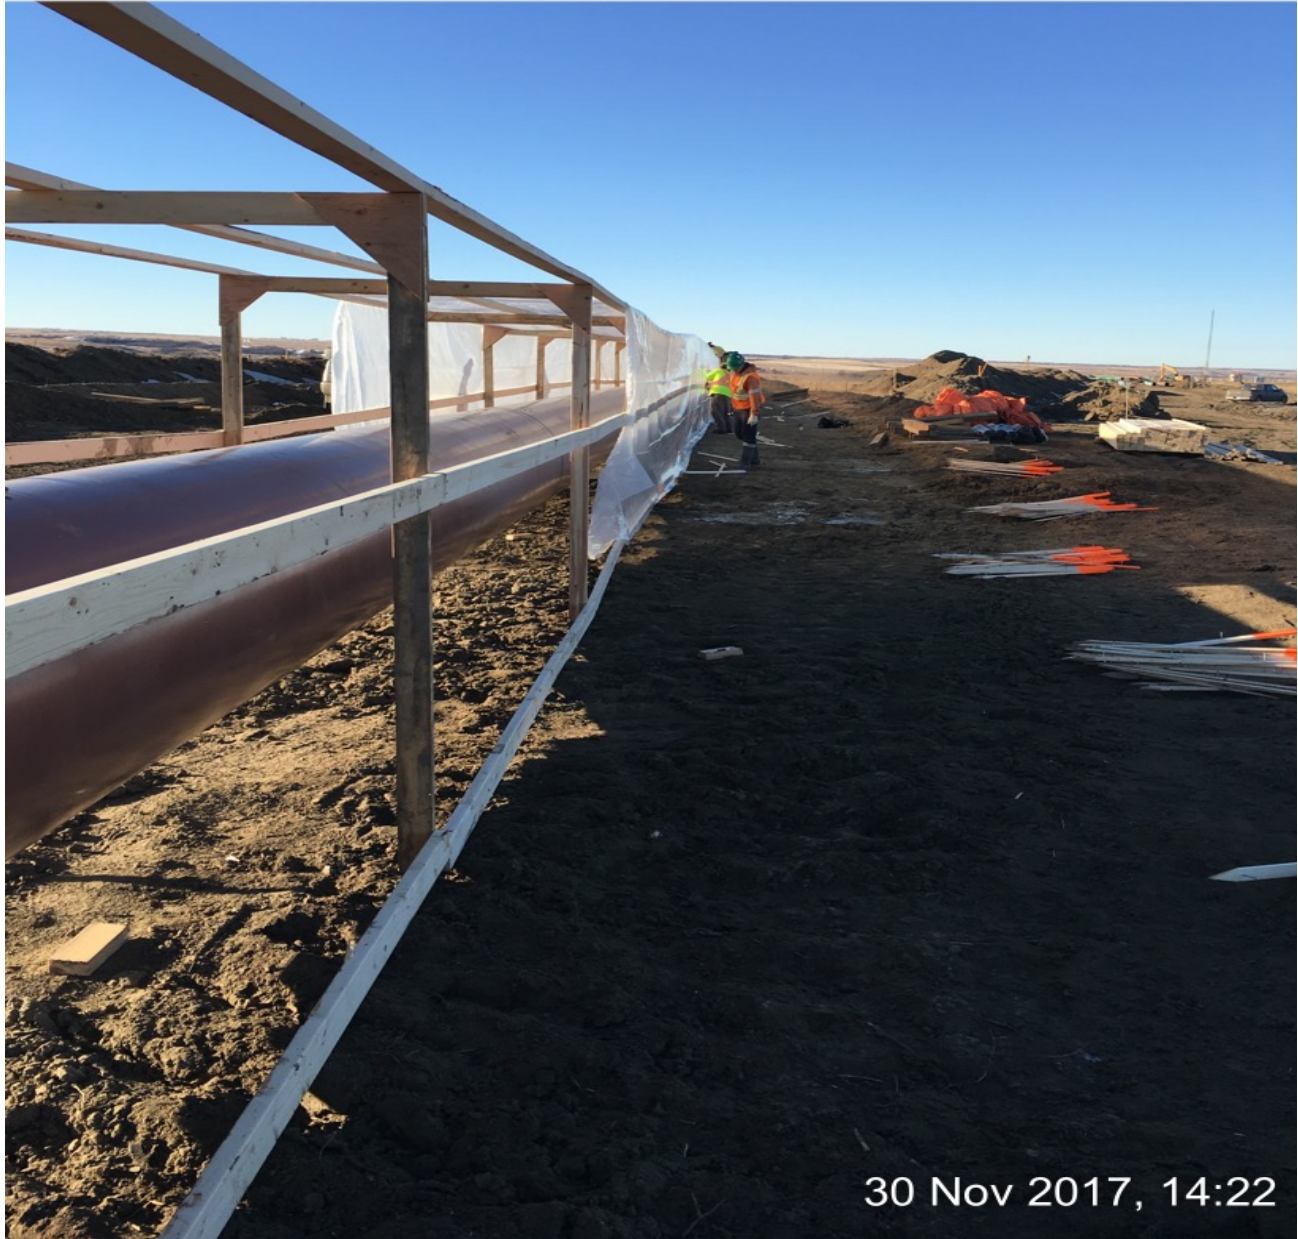
INSTALLING POLY OVER HOARDING FRAME

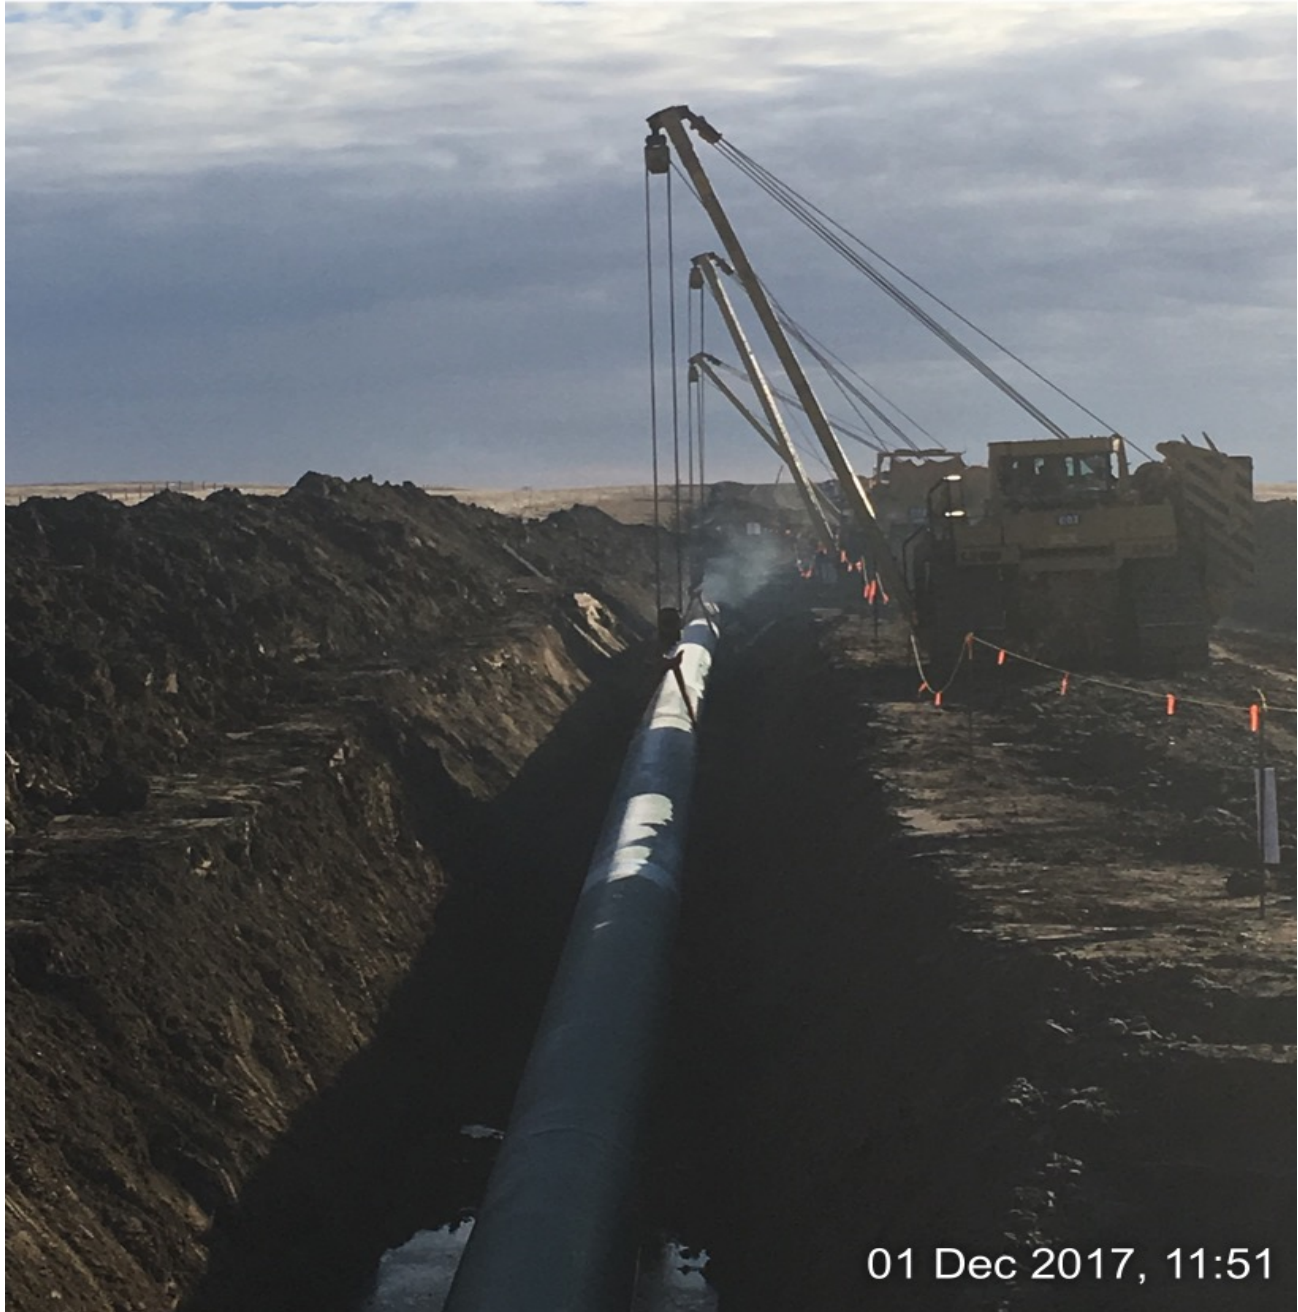
WELDING OF A TIE IN

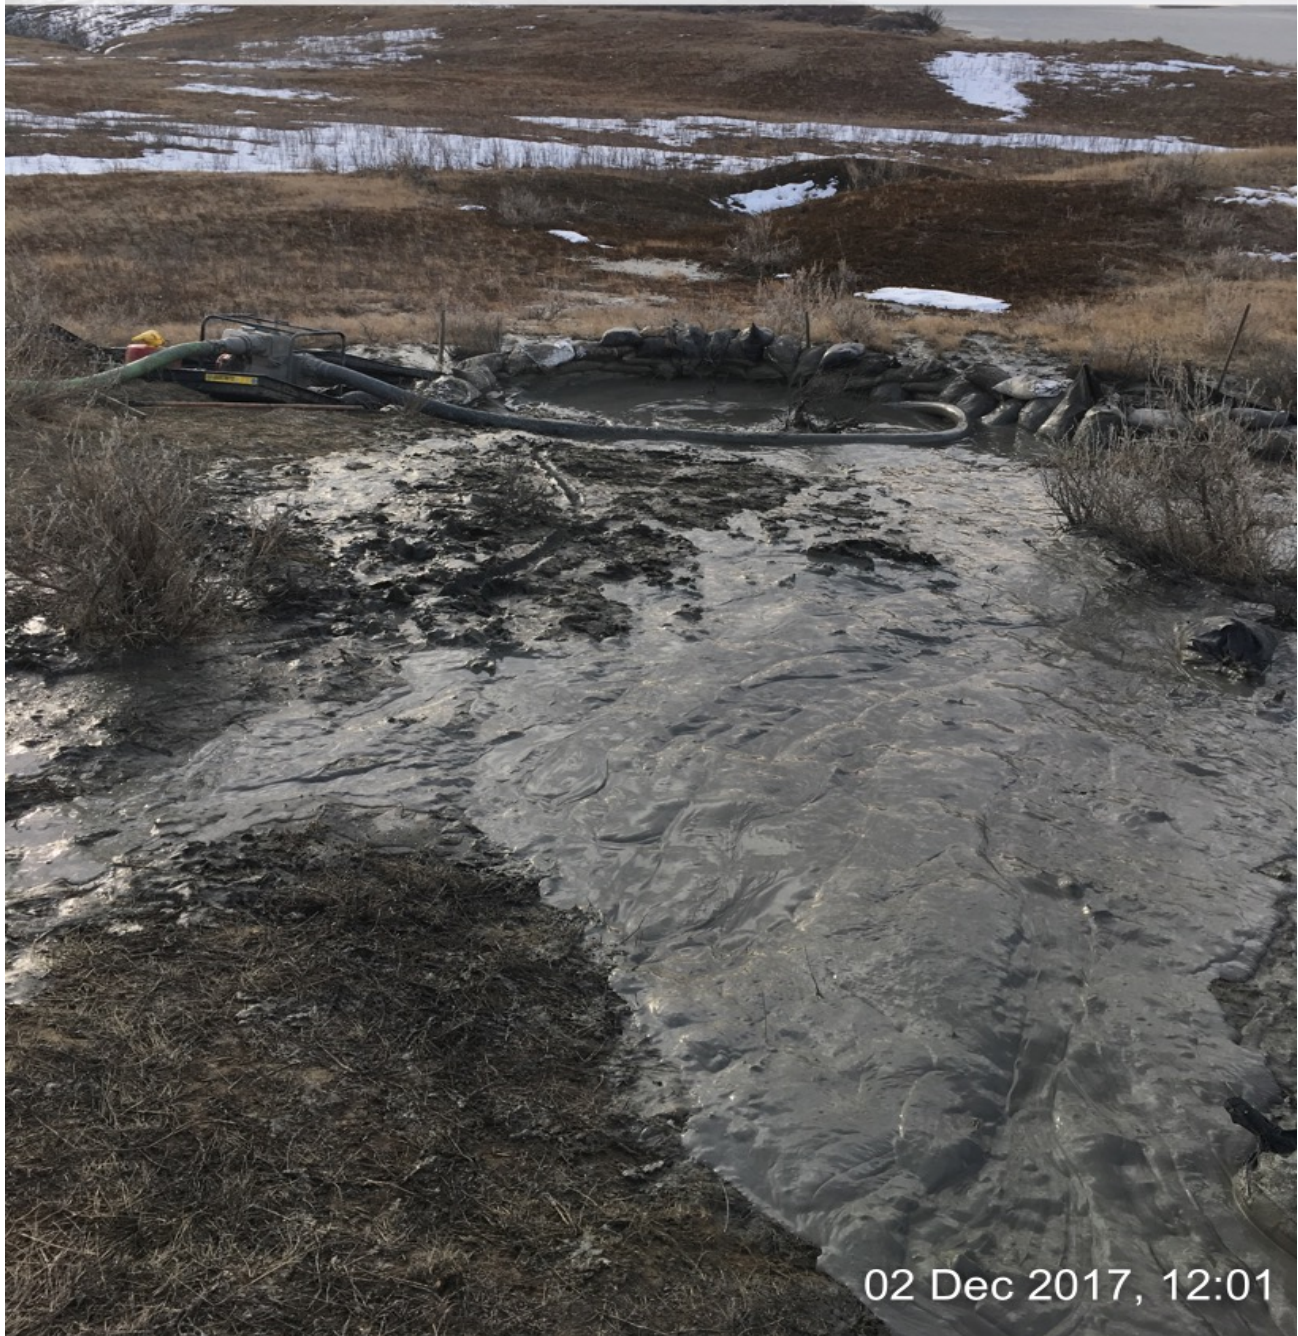
FRACK FLUID

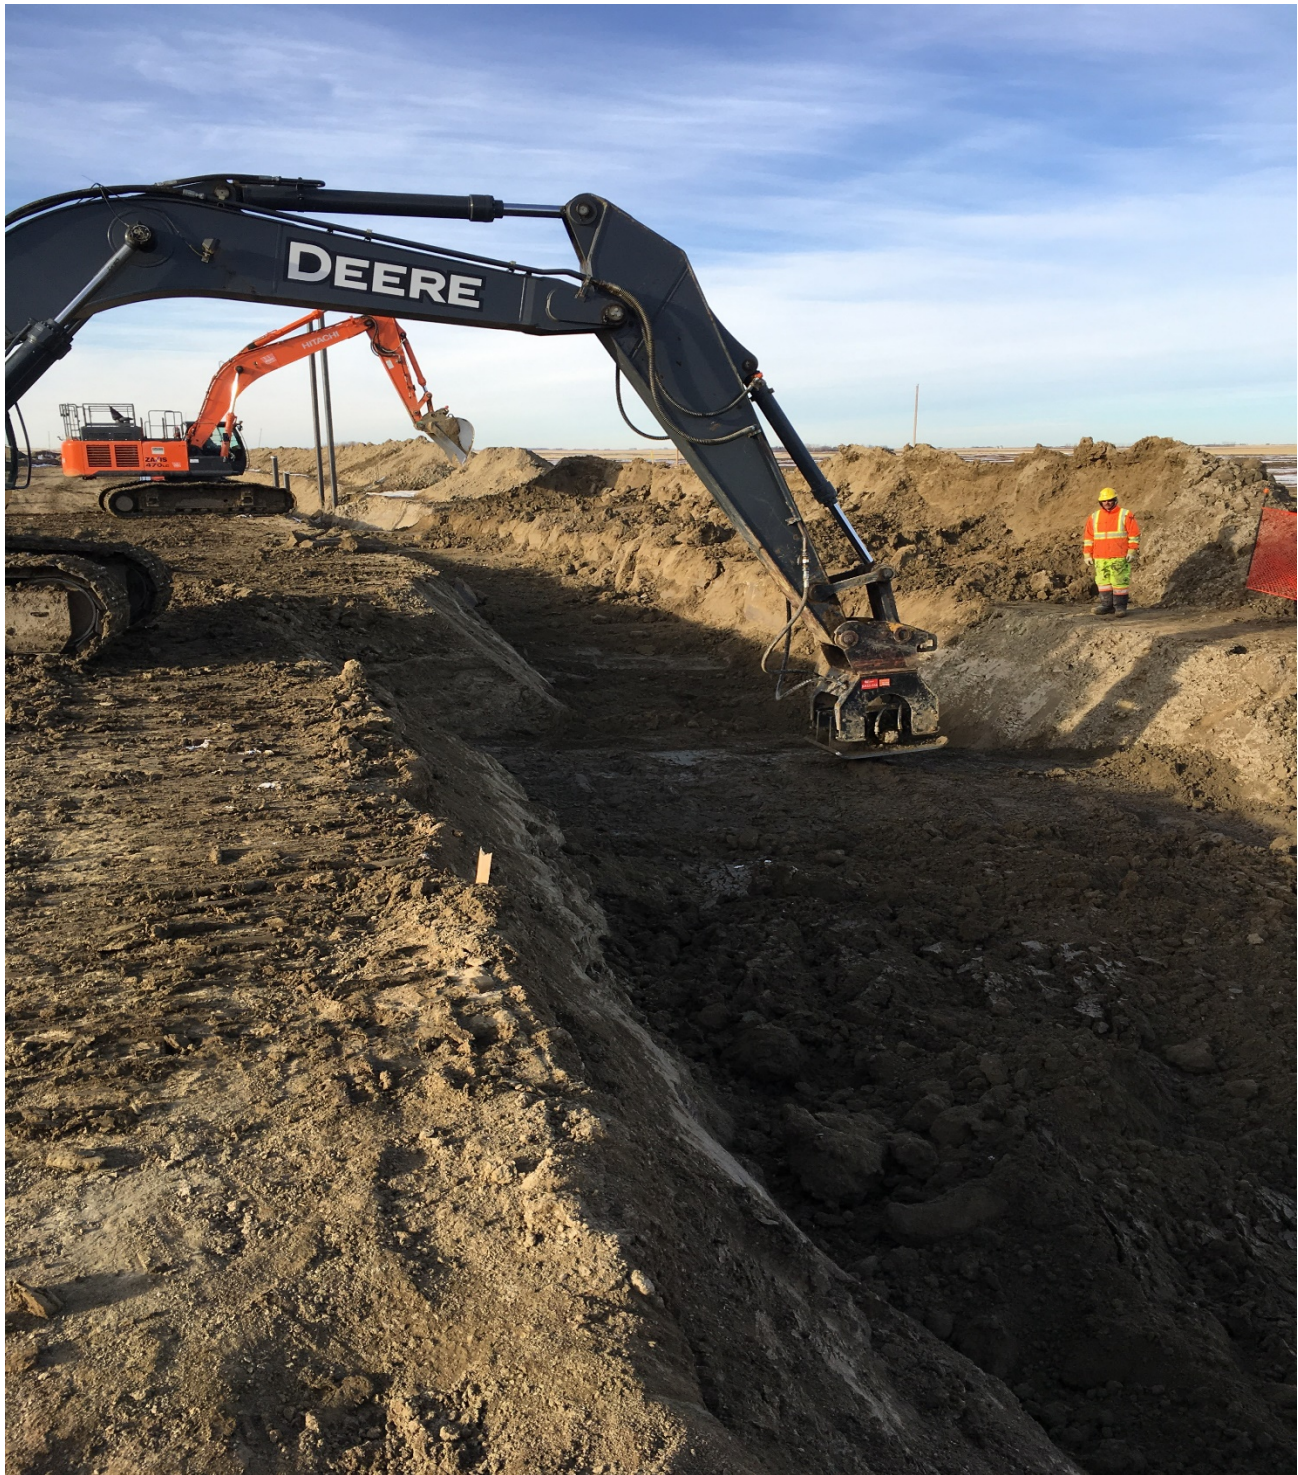
PACKING IN DIRT IN A BELL HOLE (BACKFILLING AND COMPACTION)
