SGS MUSCOWPETUNG

ABORIGINAL CONSTRUCTION MONITORING

WEEKLY REPORT

OCTOBER 9th TO OCTOBER 15TH 2017

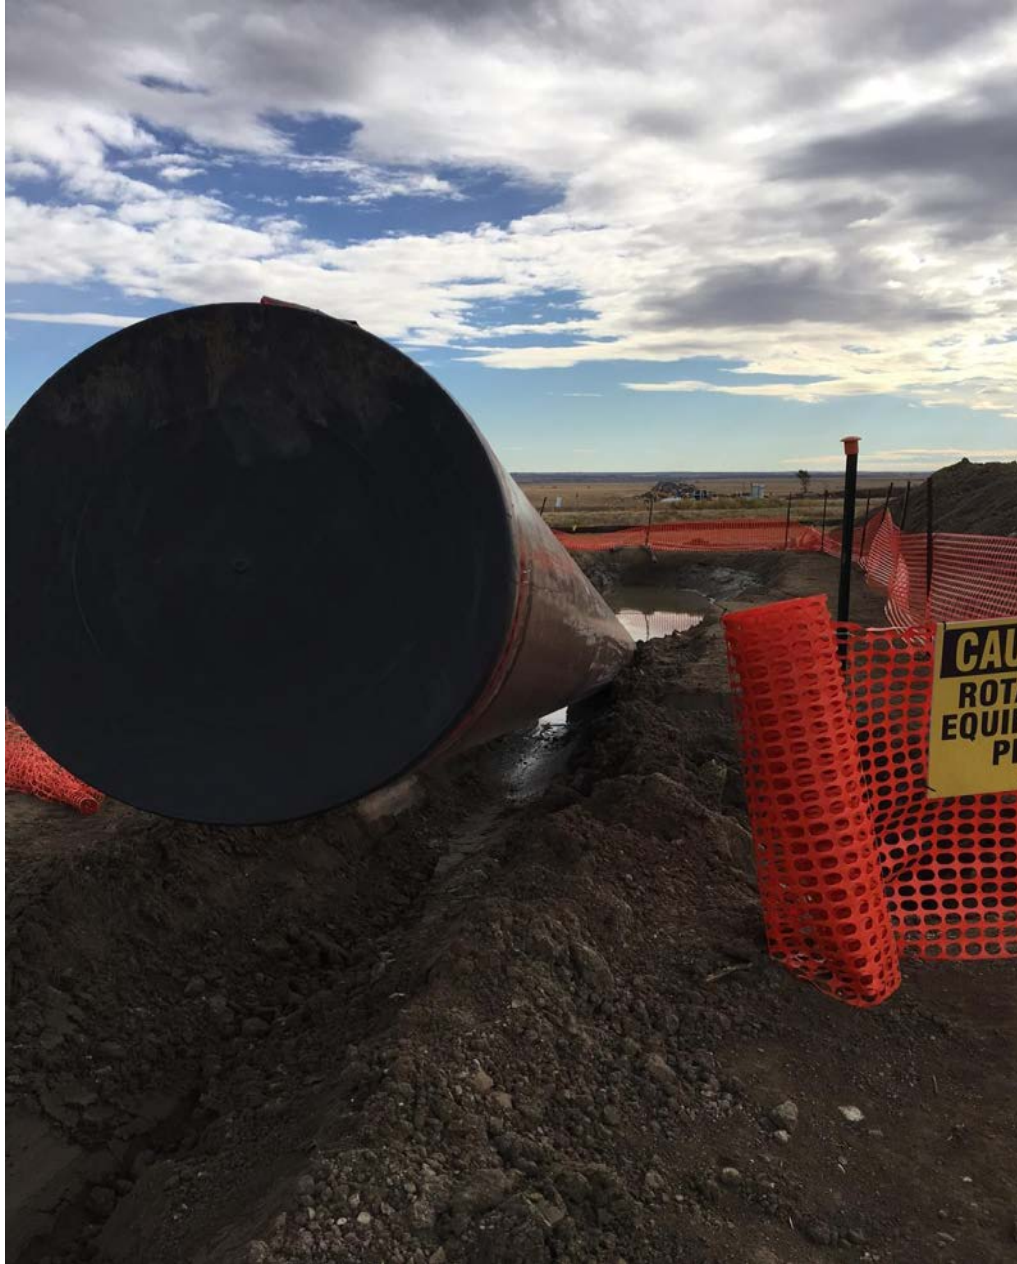
Continued from the previous week majority of my time is still focused on the directional drilling at RD 34 SSKP-330+778 WM1 Canal and the site of directional drilling of the South Saskatchewan Crossing. Directional drilling at RD 34 is completed. The pipe has been pulled thru the bore and the turbidity in the water sampling of the canal by Golder Associates was good. The directional drilling at the South Saskatchewan River is 1370 metres long and they're at 855 metres with their pilot drill. They are approximately half way across and they're 57 metres underneath the river.

Pipe that was pulled thru (RD 34)

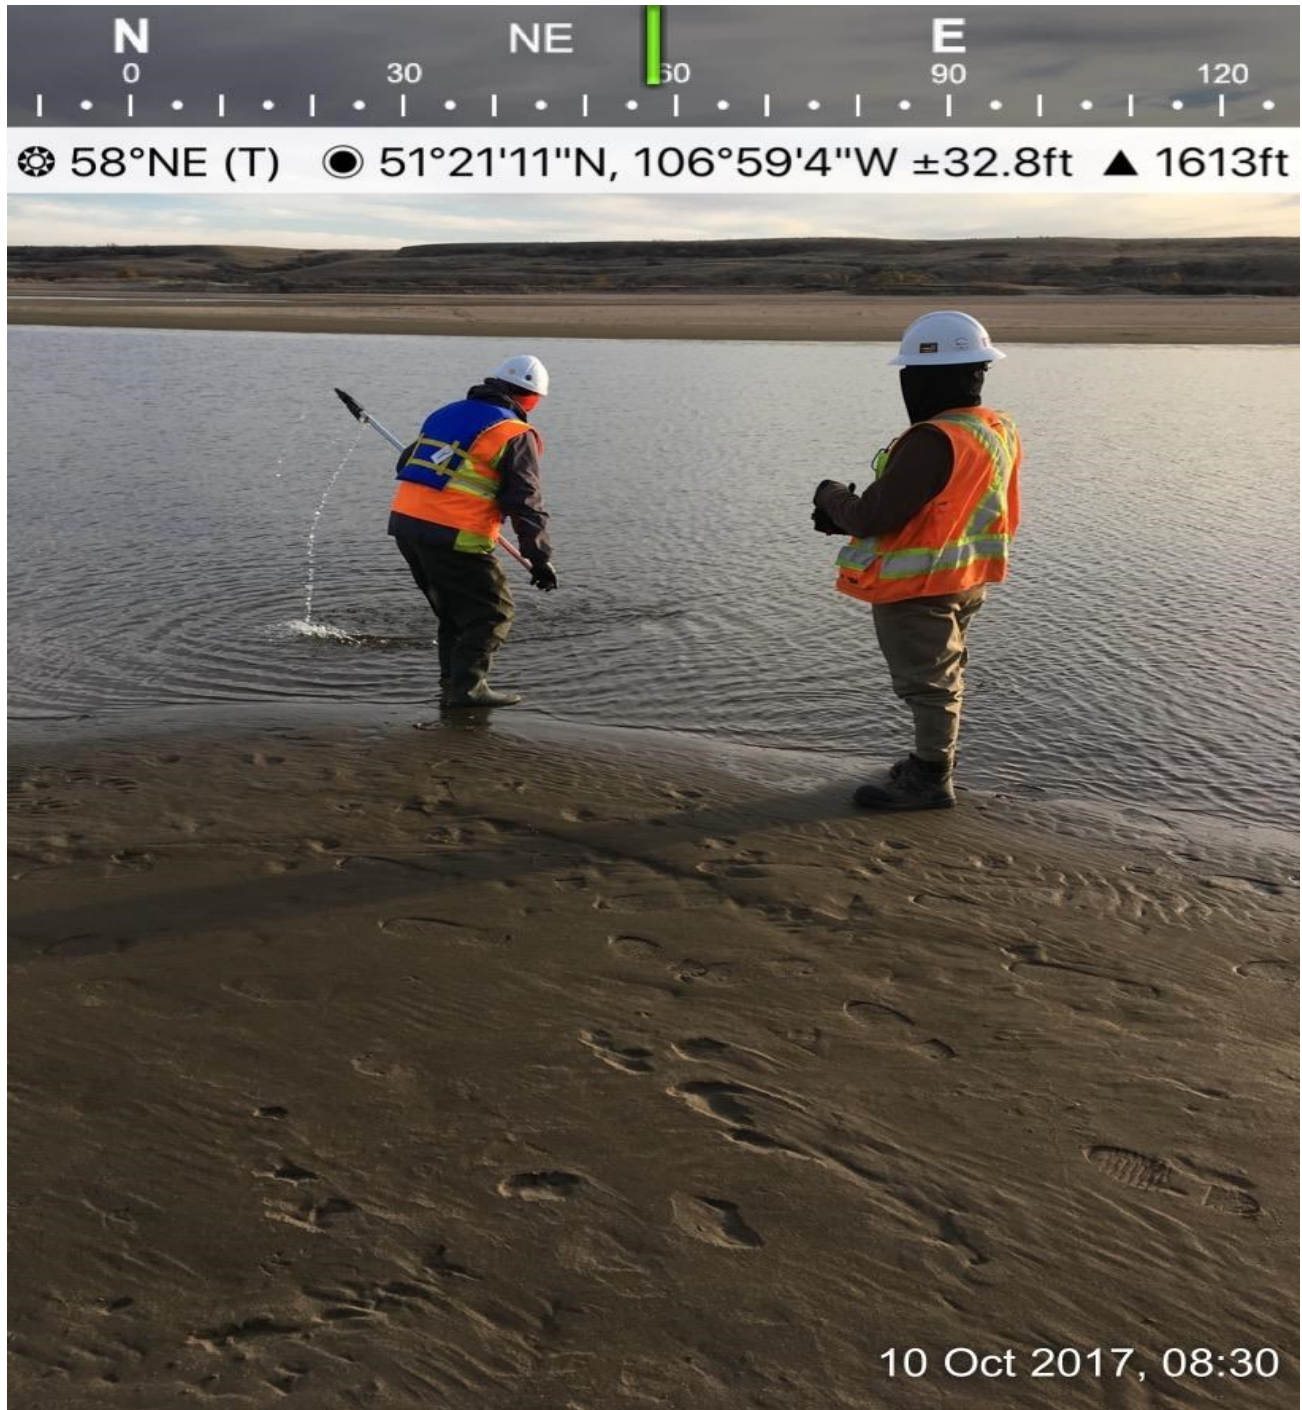
Retrieving water samples at South Saskatchewan River

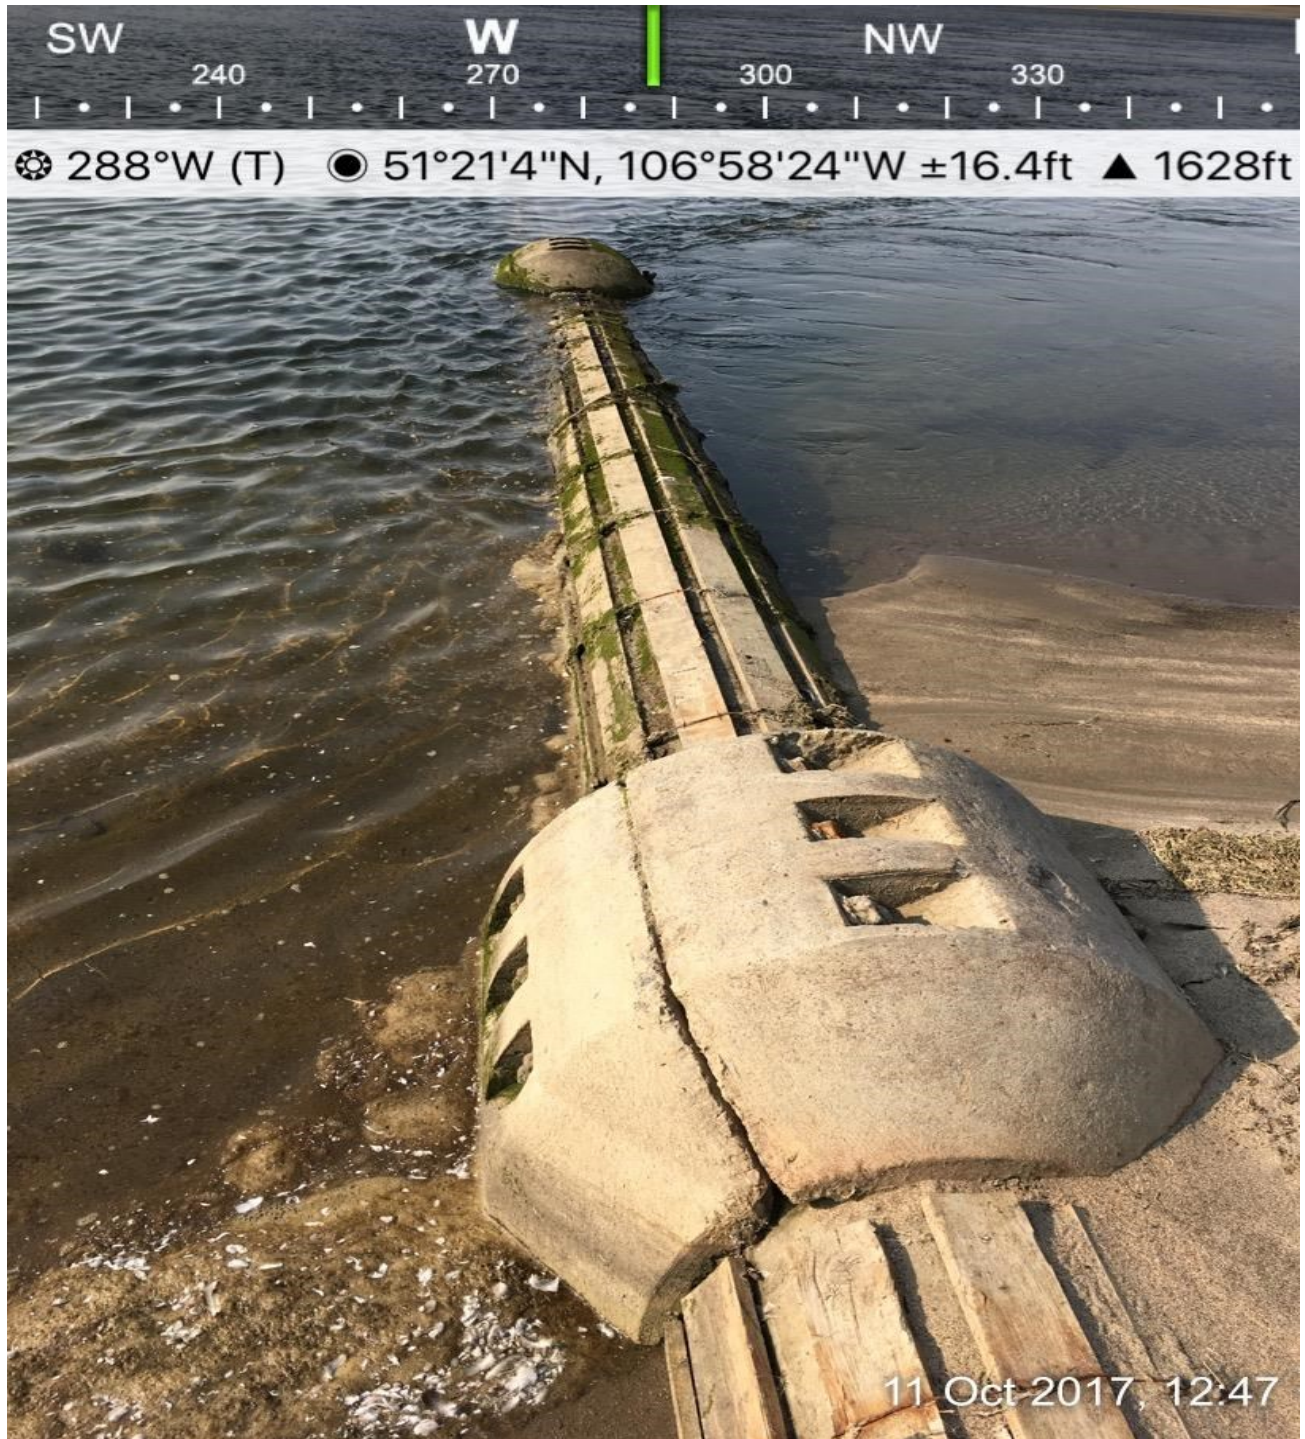
East end of South Saskatchewan River existing pipeline.

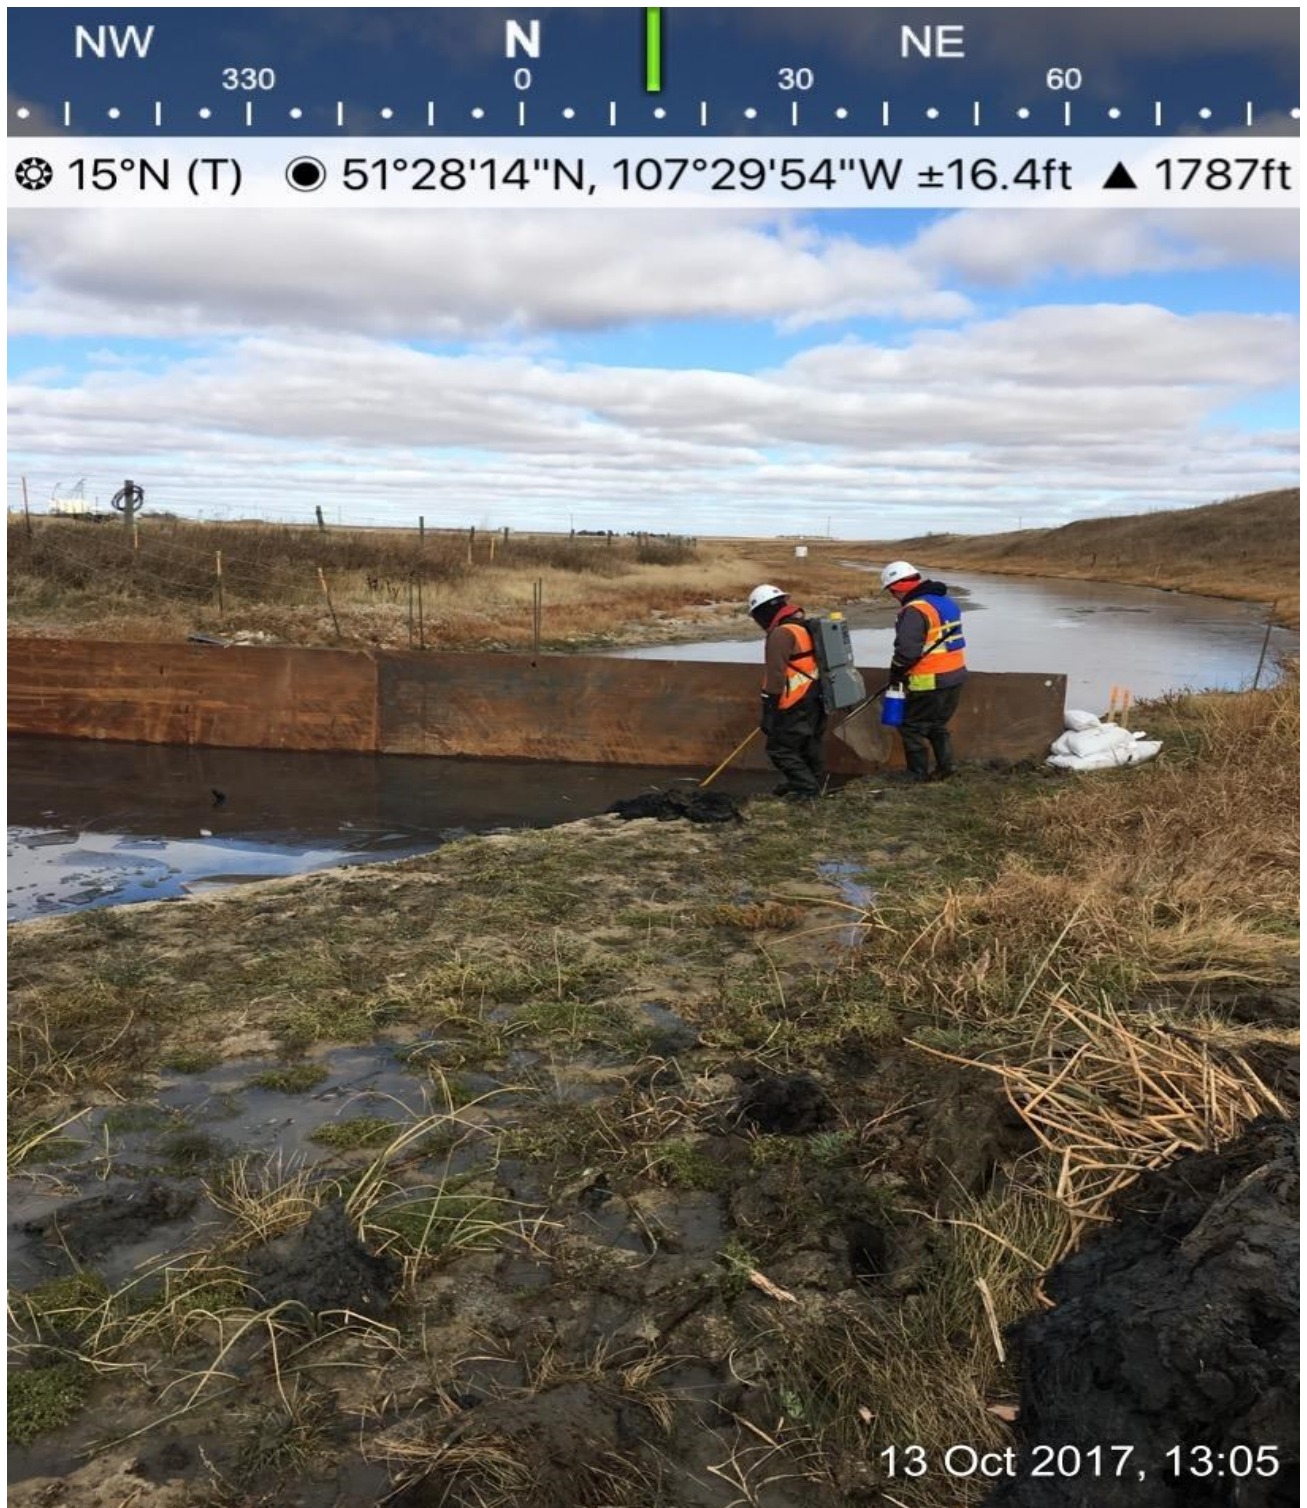
At McDonald Creek there was a potential of fish being in the creek so they did the mitigation process of the diverting the flow of the creek with pumps and hoses. They barricaded the right away of the creek with the steel plates. Then Golder associates used electro fish system throughout the inside of the barricade but there was no evidence of fish.

Using electro fish device at McDonald Creek with barricade in the picture.

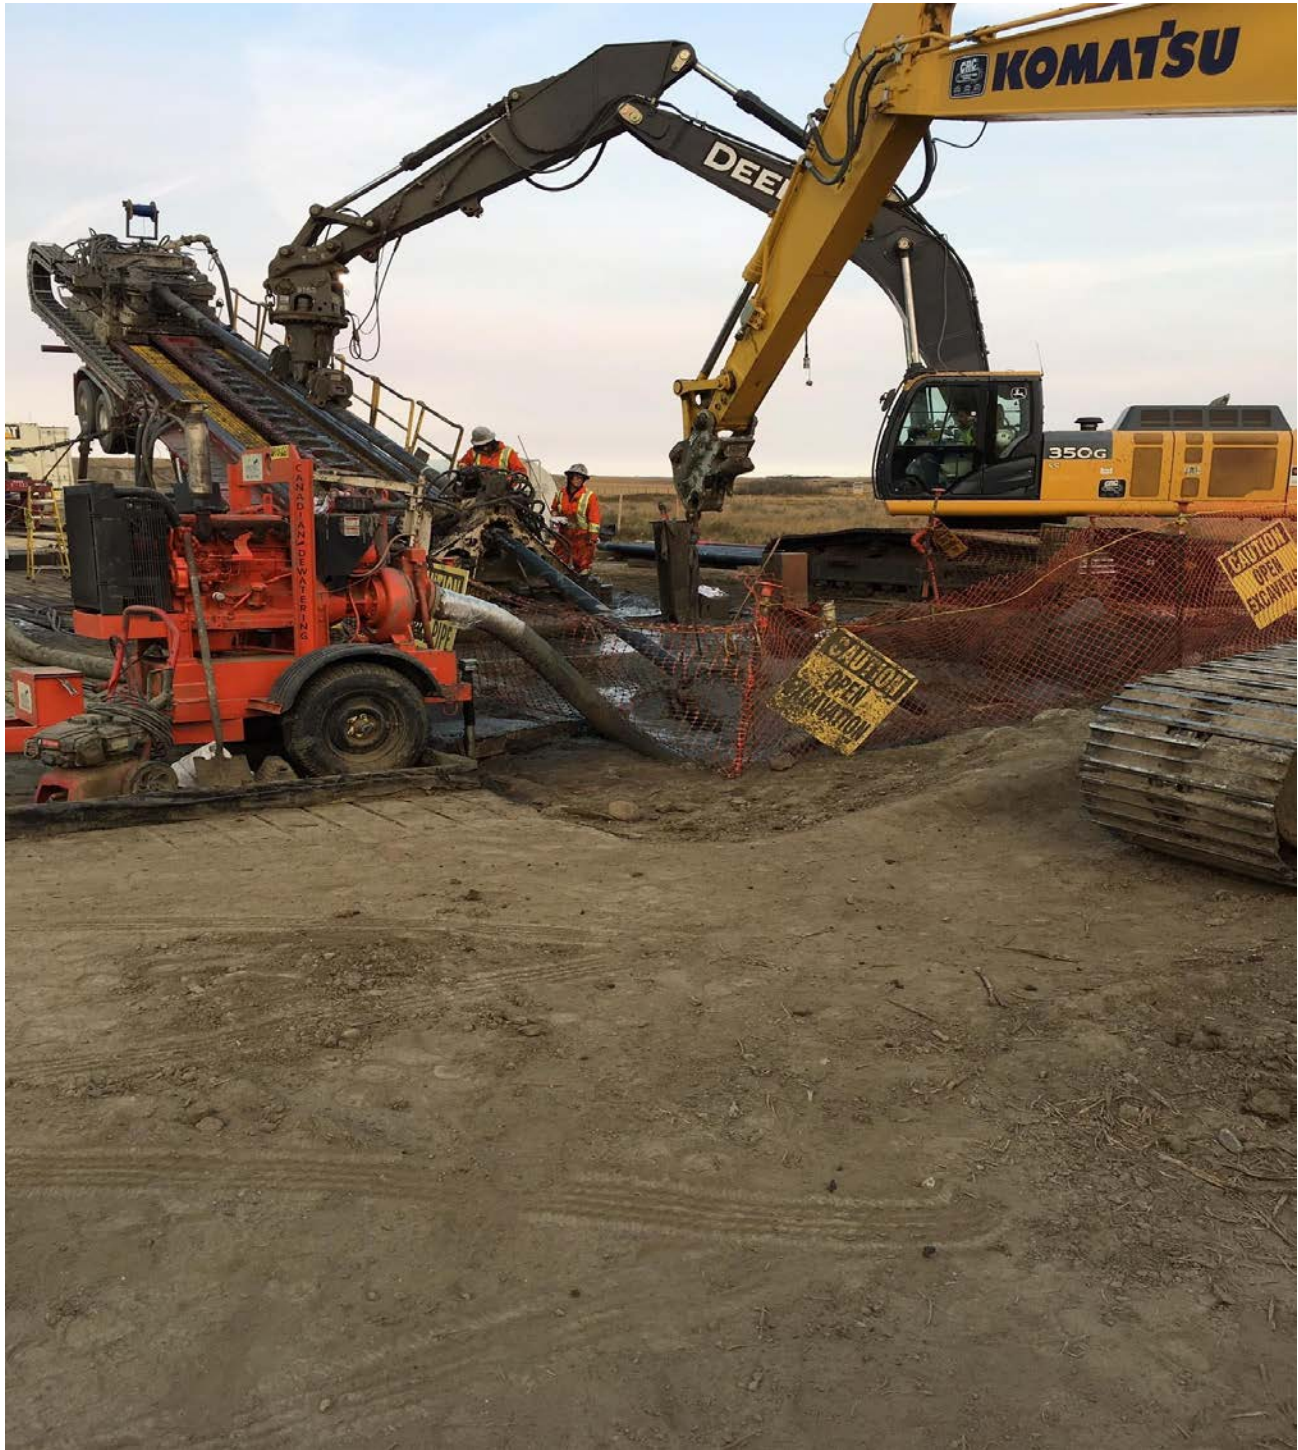
Directional Drilling at South Saskatchewan River

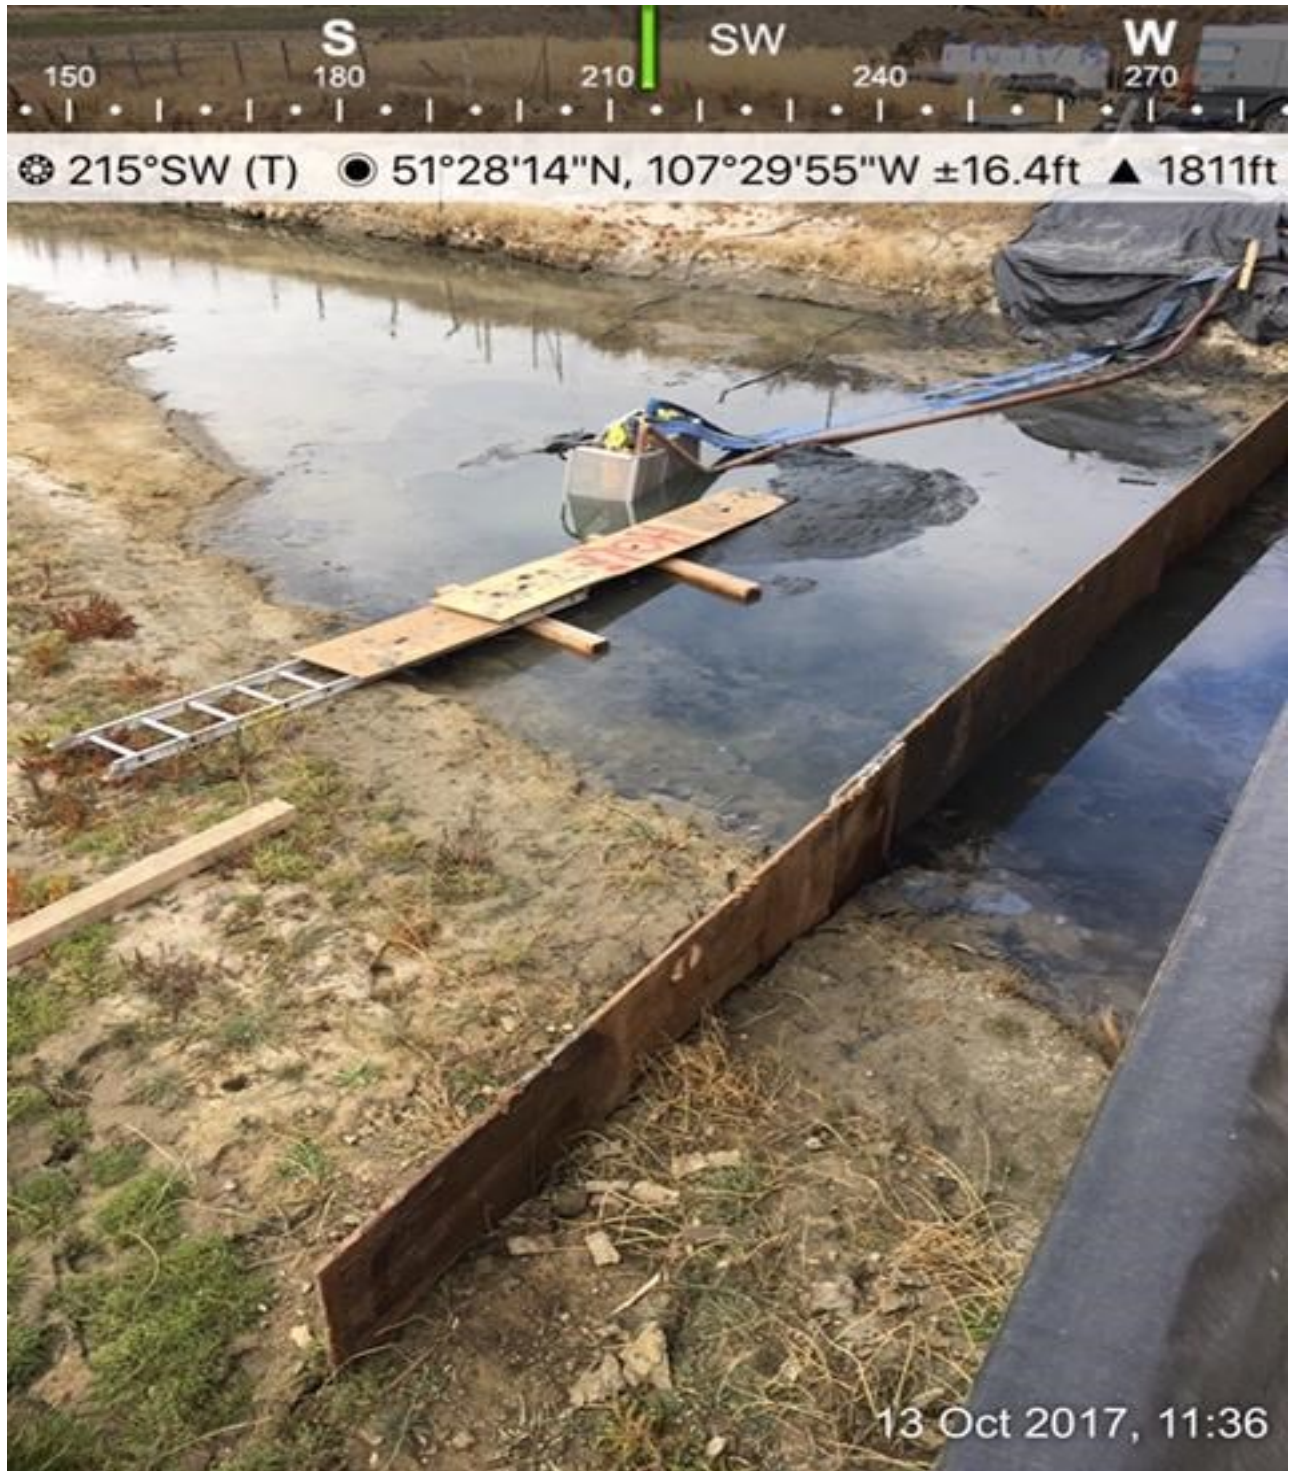
Barricade at McDonald Creek
