SGS MUSCOWPETUNG

ABORIGINAL CONSTRUCTION MONITORING

WEEKLY REPORT

OCTOBER 23RD TO OCTOBER 29TH, 2017

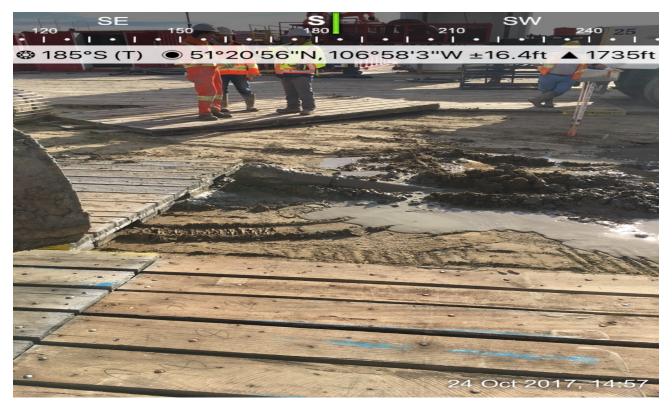
Pilot reamer of the horizontal drilling exit point at South Saskatchewan River

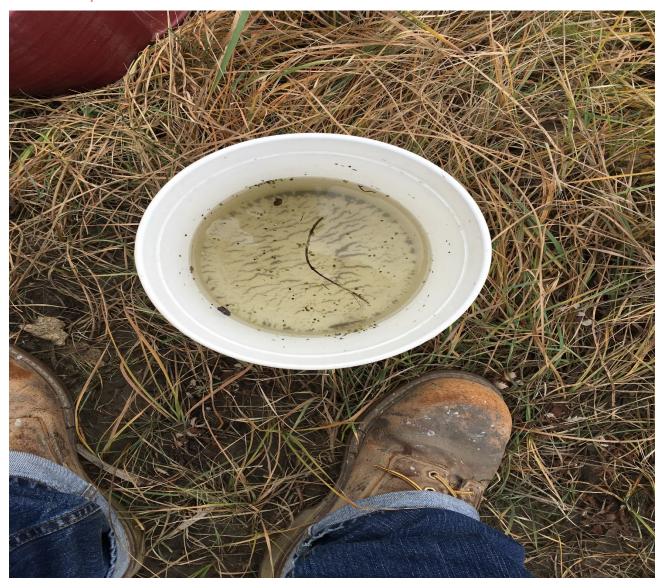
There was a fish assessment at a creek crossing by Golder Associates whom discovered brown sickle fish down stream from the creek. It was determined that there was a potential for fish where the pipeline is going to cross the creek. They isolated where the creek crossing is going to be and a fish salvage was performed and one brown sickle fish was salvaged. They used the electro fish device to perform the fish salvage.

One brown sickle fish that was salvaged at the creek crossing

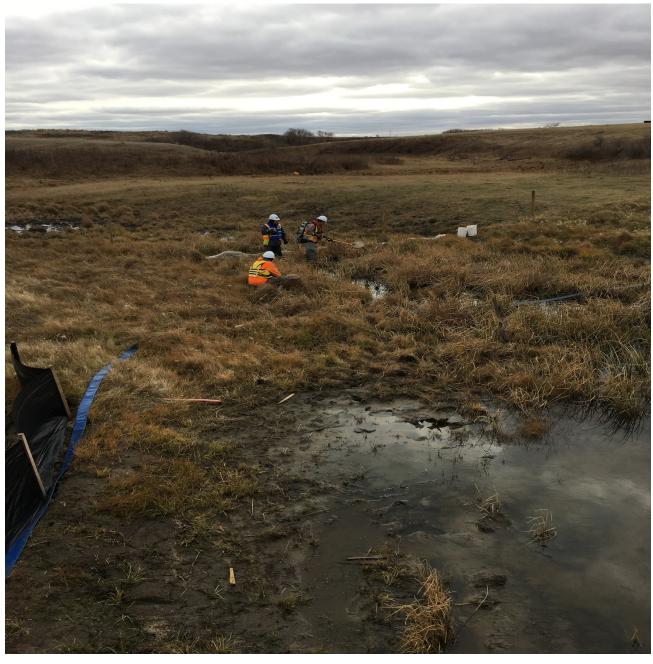
performing a fish salvage

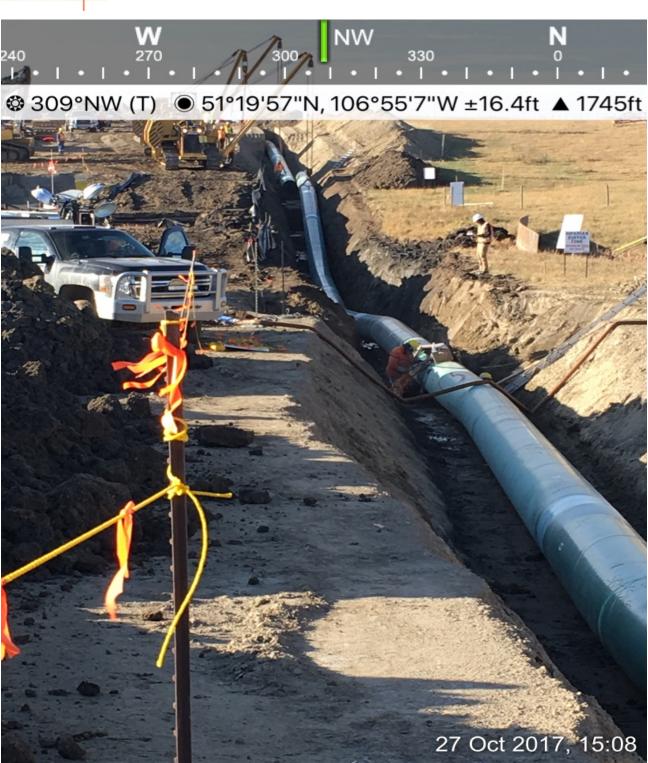
Welding up pipe at the creek crossing

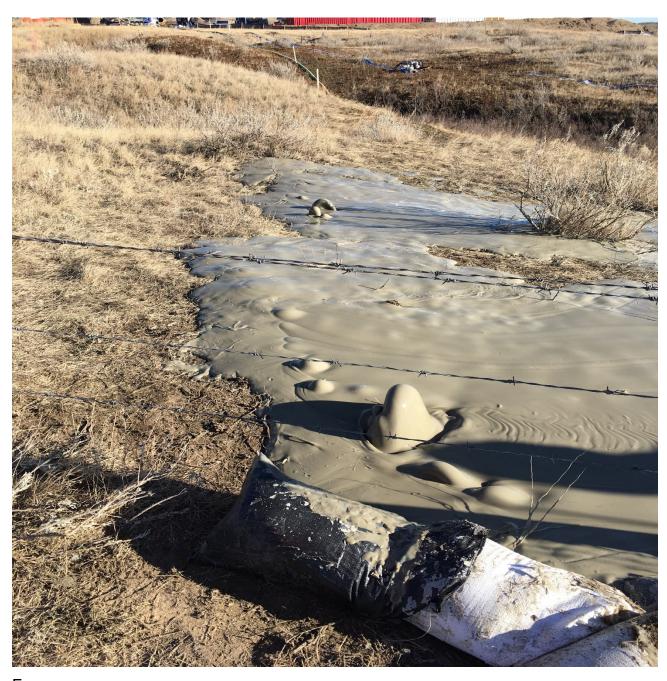
The horizontal directional drilling at the South Saskatchewan River with the pilot reamer has been completed. There was a few fracks that happened at approx. 300m of the exit point. The drilling fluid from the fracks was contained by installing Geotech and sandbag dykes. It was cleaned up as much as possible with pressure spray wash and hydro vacuuming it out. End of the week they were preparing to start the 24-inch diameter reamer.

FRACK OCCURRING NEAR EXIT POINT.

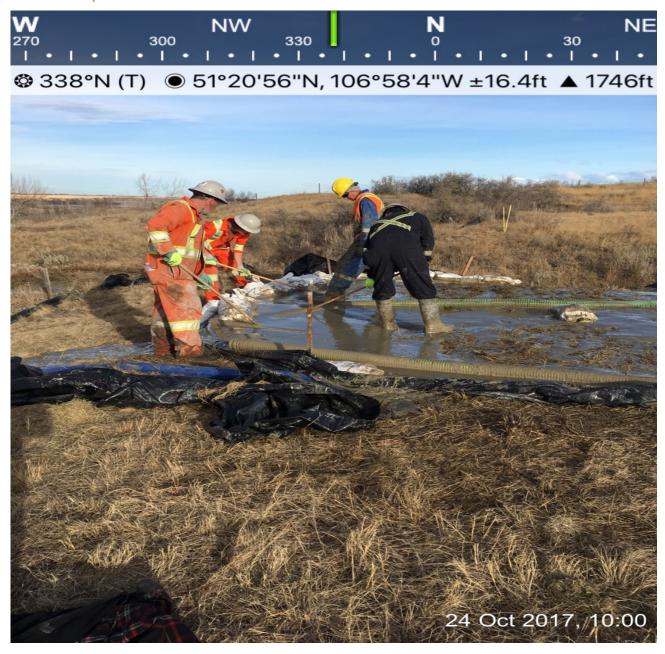
CLEANING UP THE FLUID FROM A FRACK
