SGS MUSCOWPETUNG

ABORIGINAL CONSTRUCTION MONITORING

WEEKLY REPORT

OCTOBER 16TH TO OCTOBER 22ND, 2017

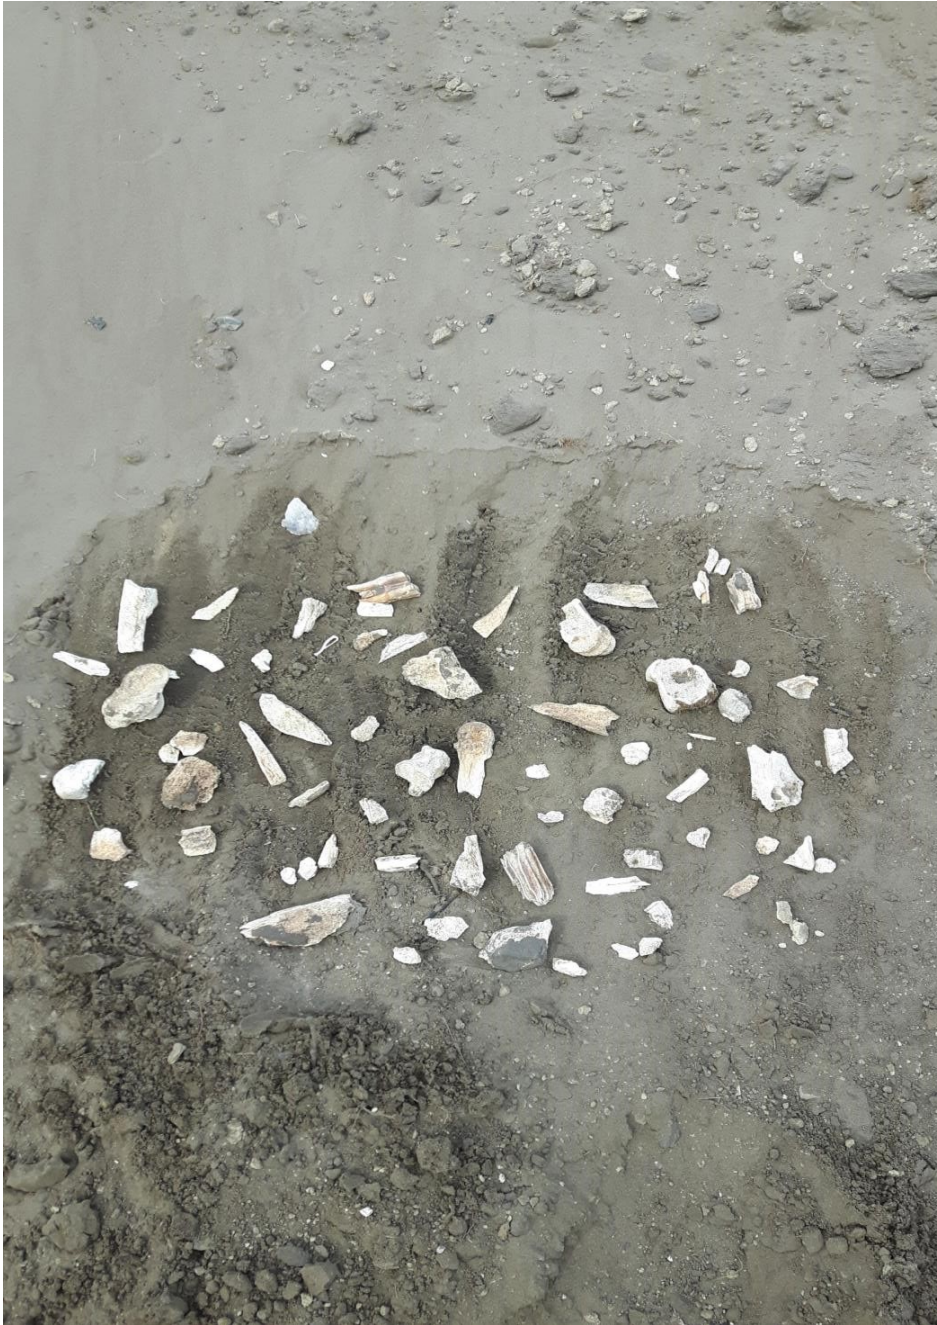
My colleagues had met with an archaeologist at SSKP 390.957 RD 65 they had assisted them at looking at top soil stripping at a bell hole. They found fragments of buffalo bones they might be potential of other artifacts but this will be determined later in the week as the weather wasn't cooperating with us.

Buffalo Fragments

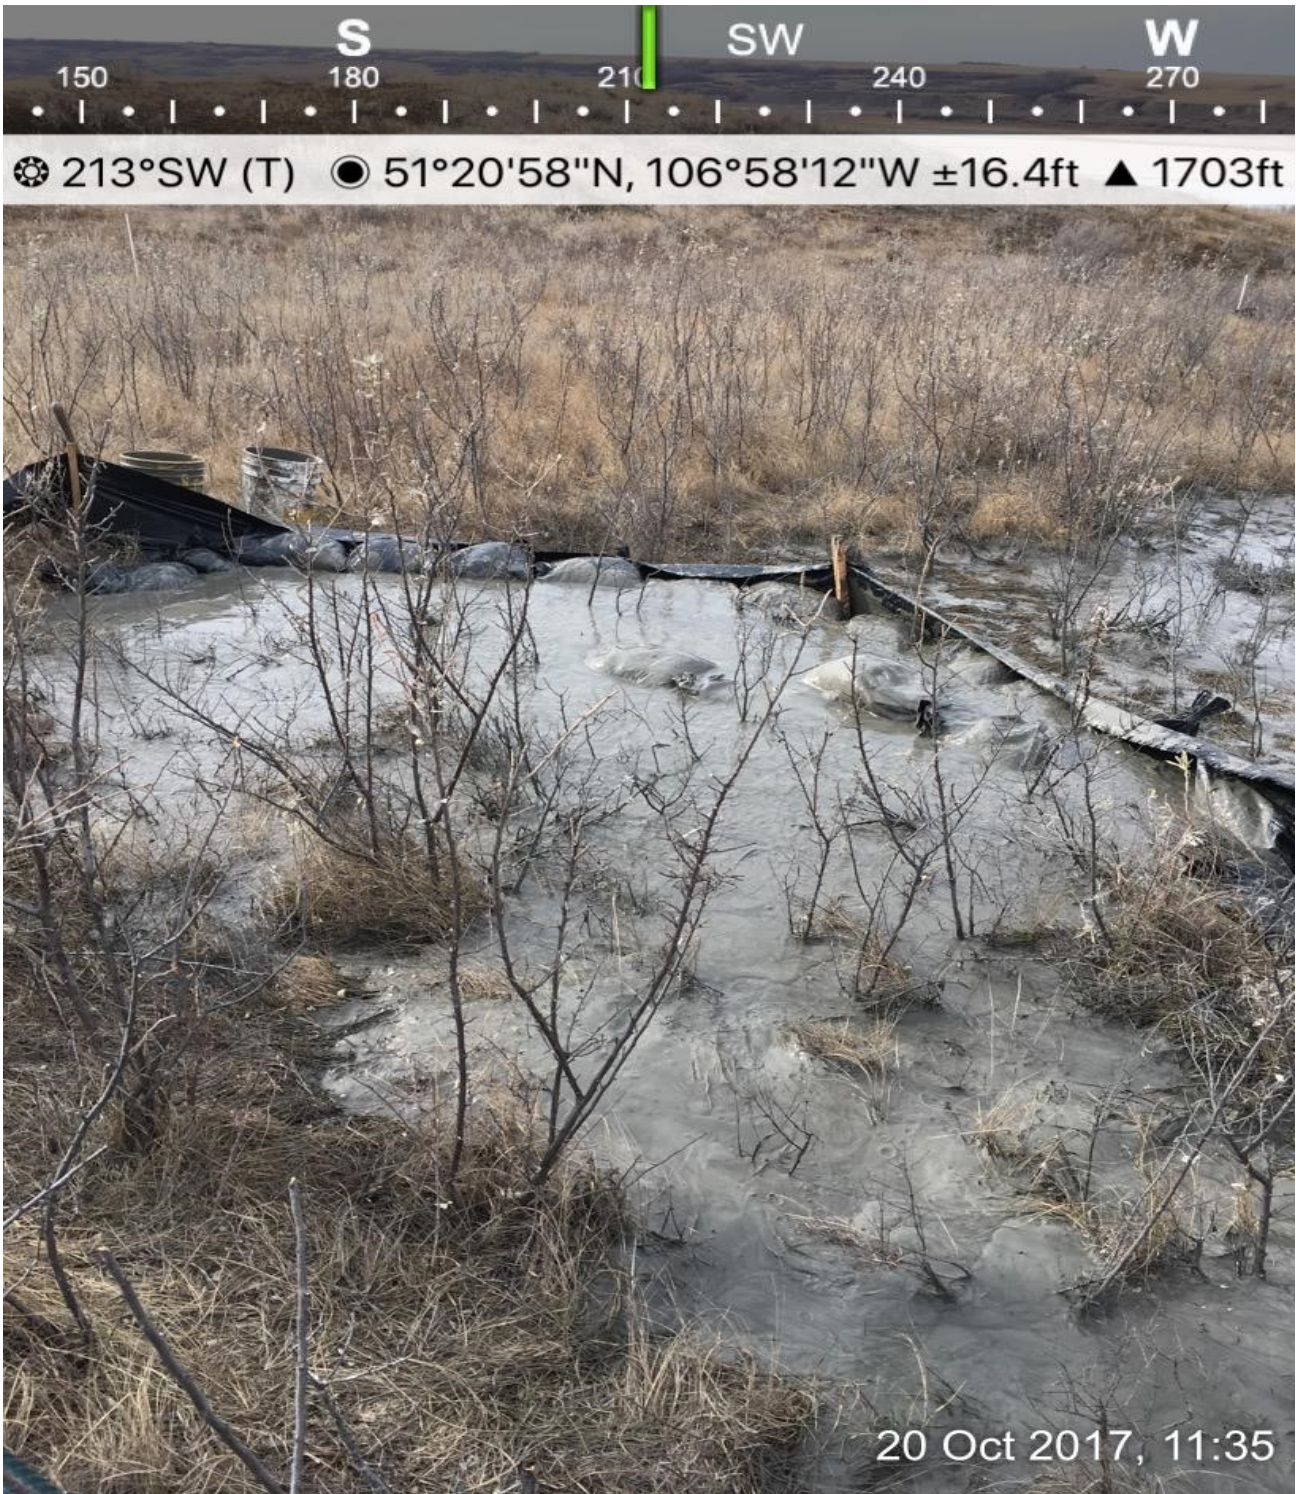
Site of Frack process of being cleaned up.

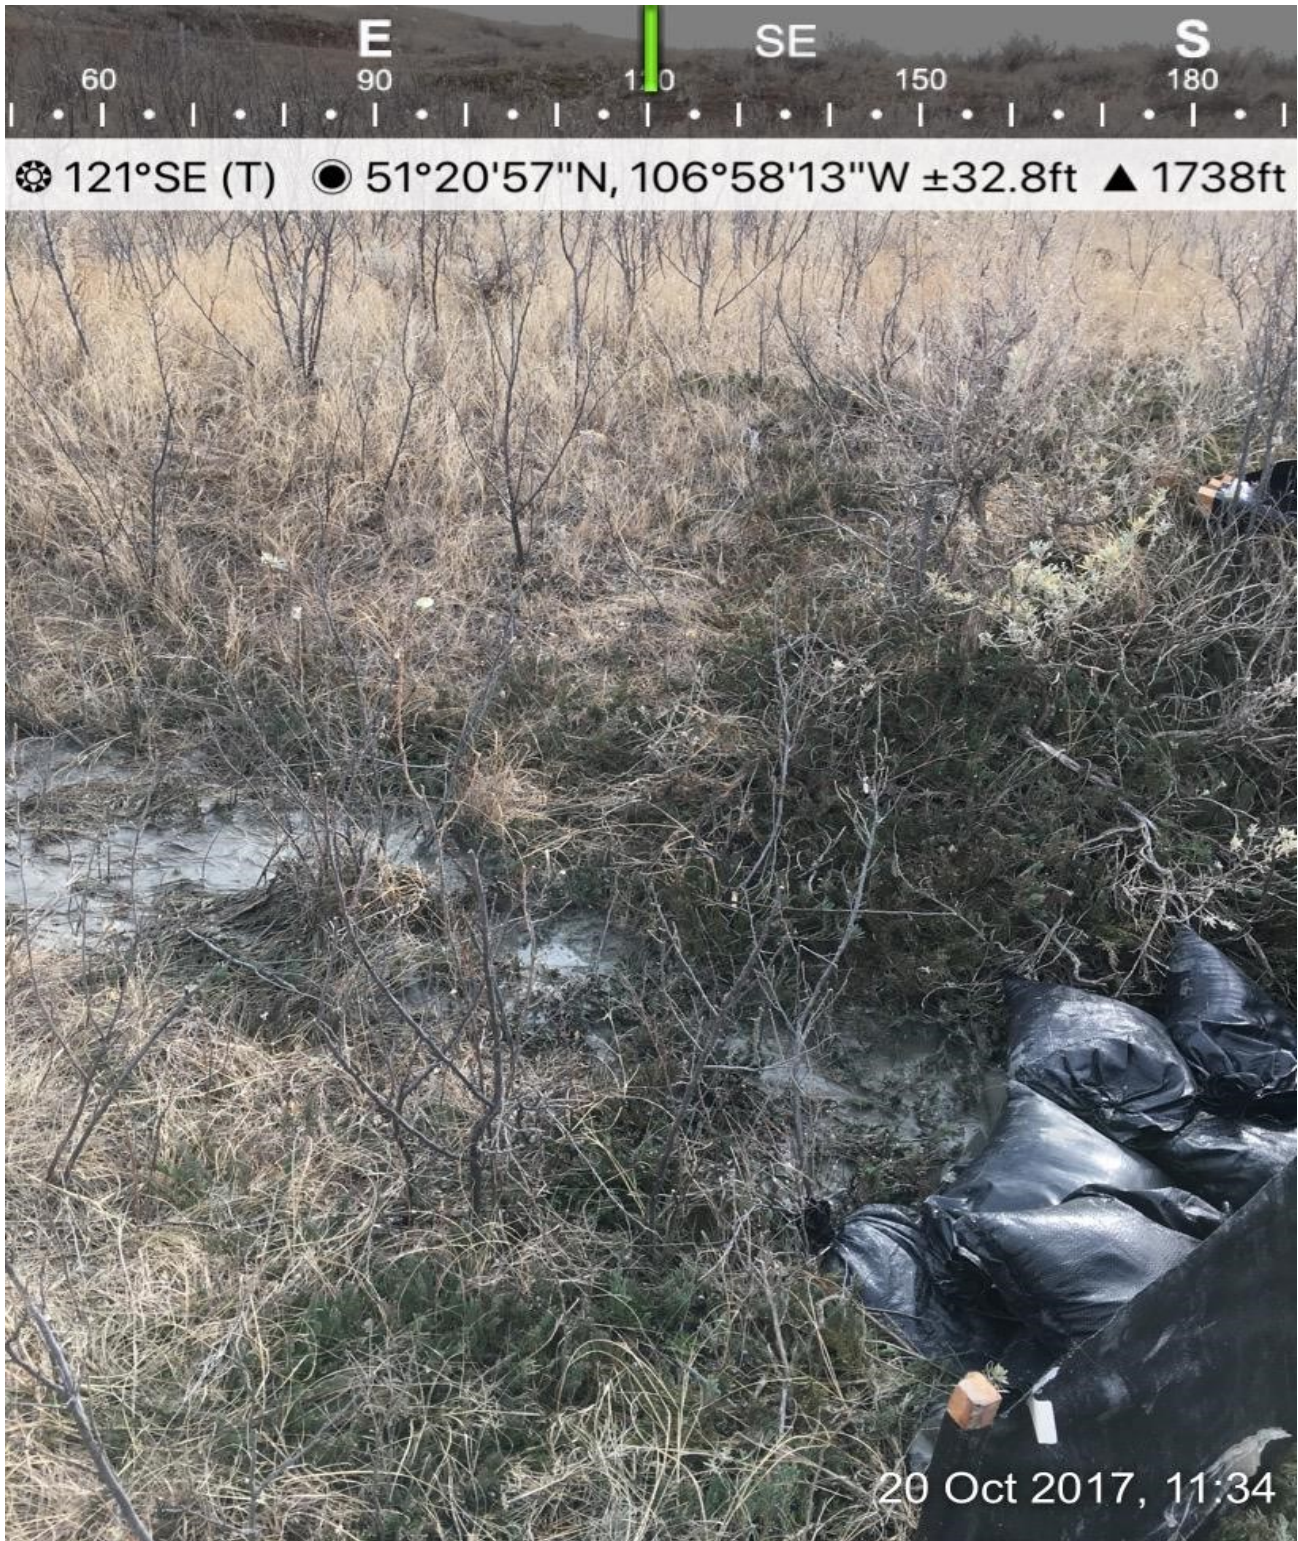
Site of frack

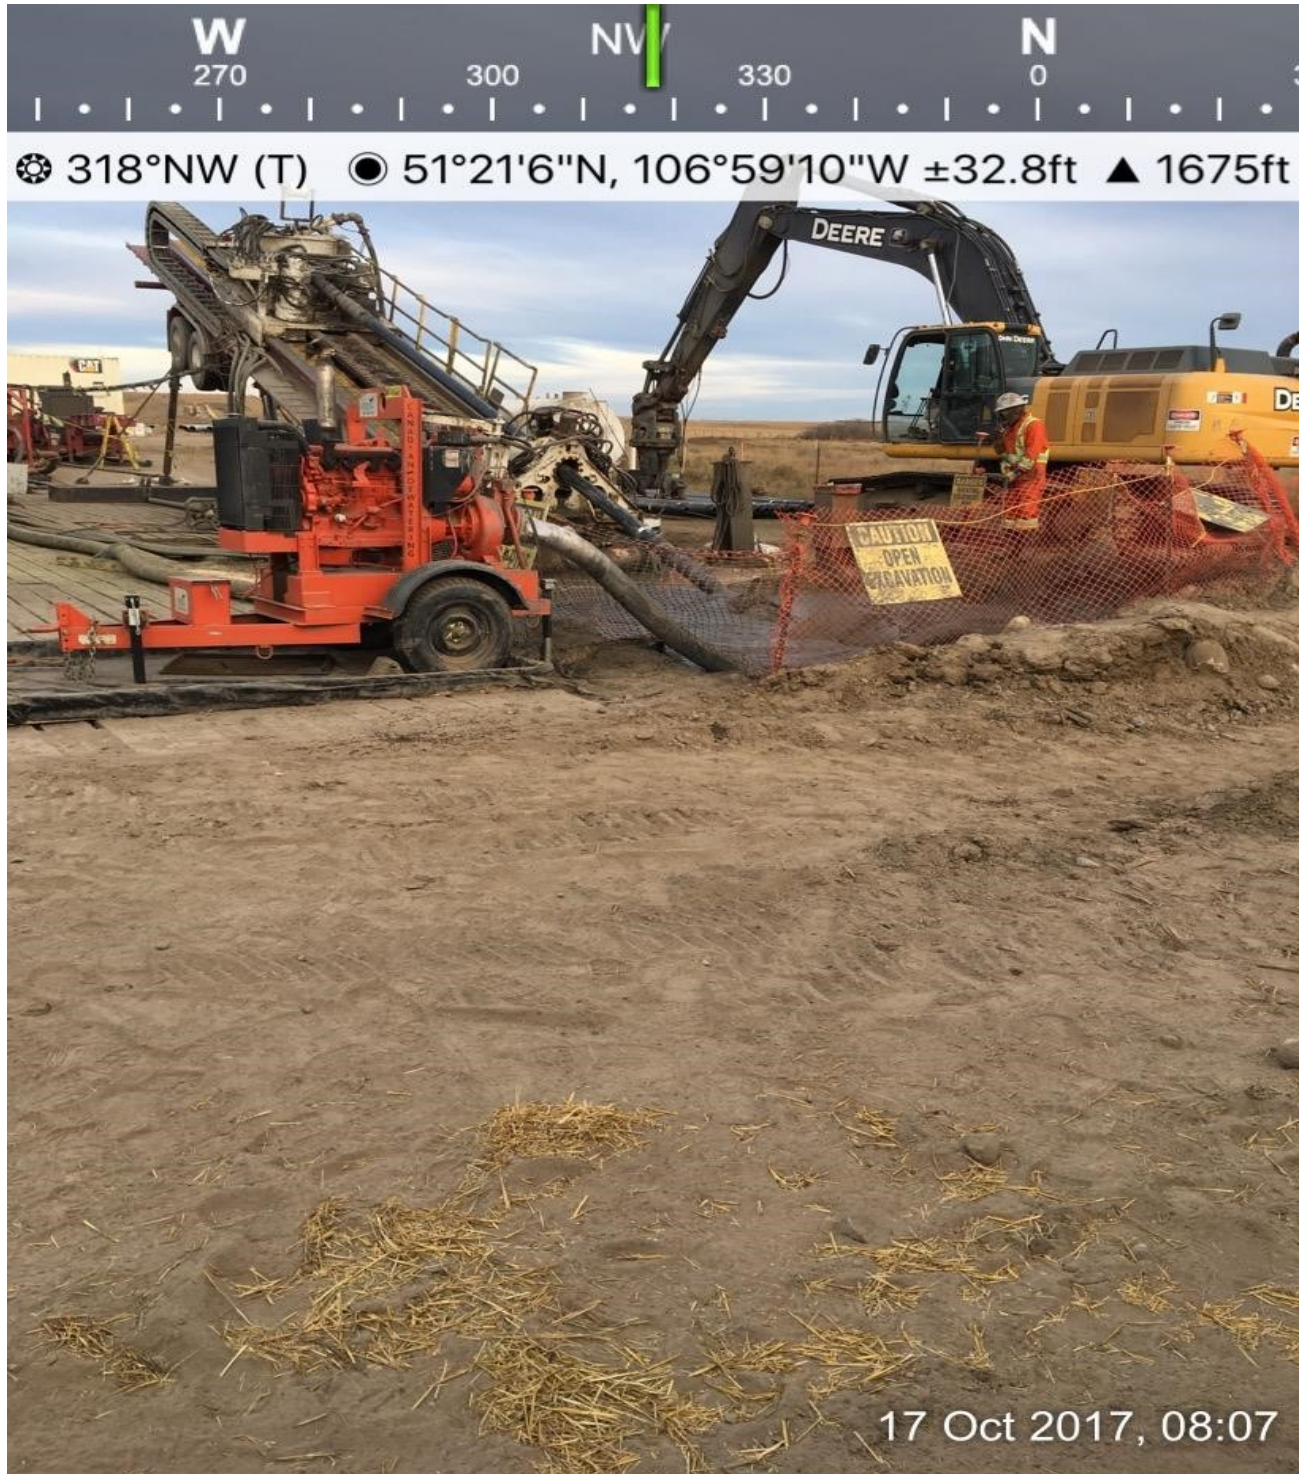
Horizontal directional drilling rig at South Saskatchewan River

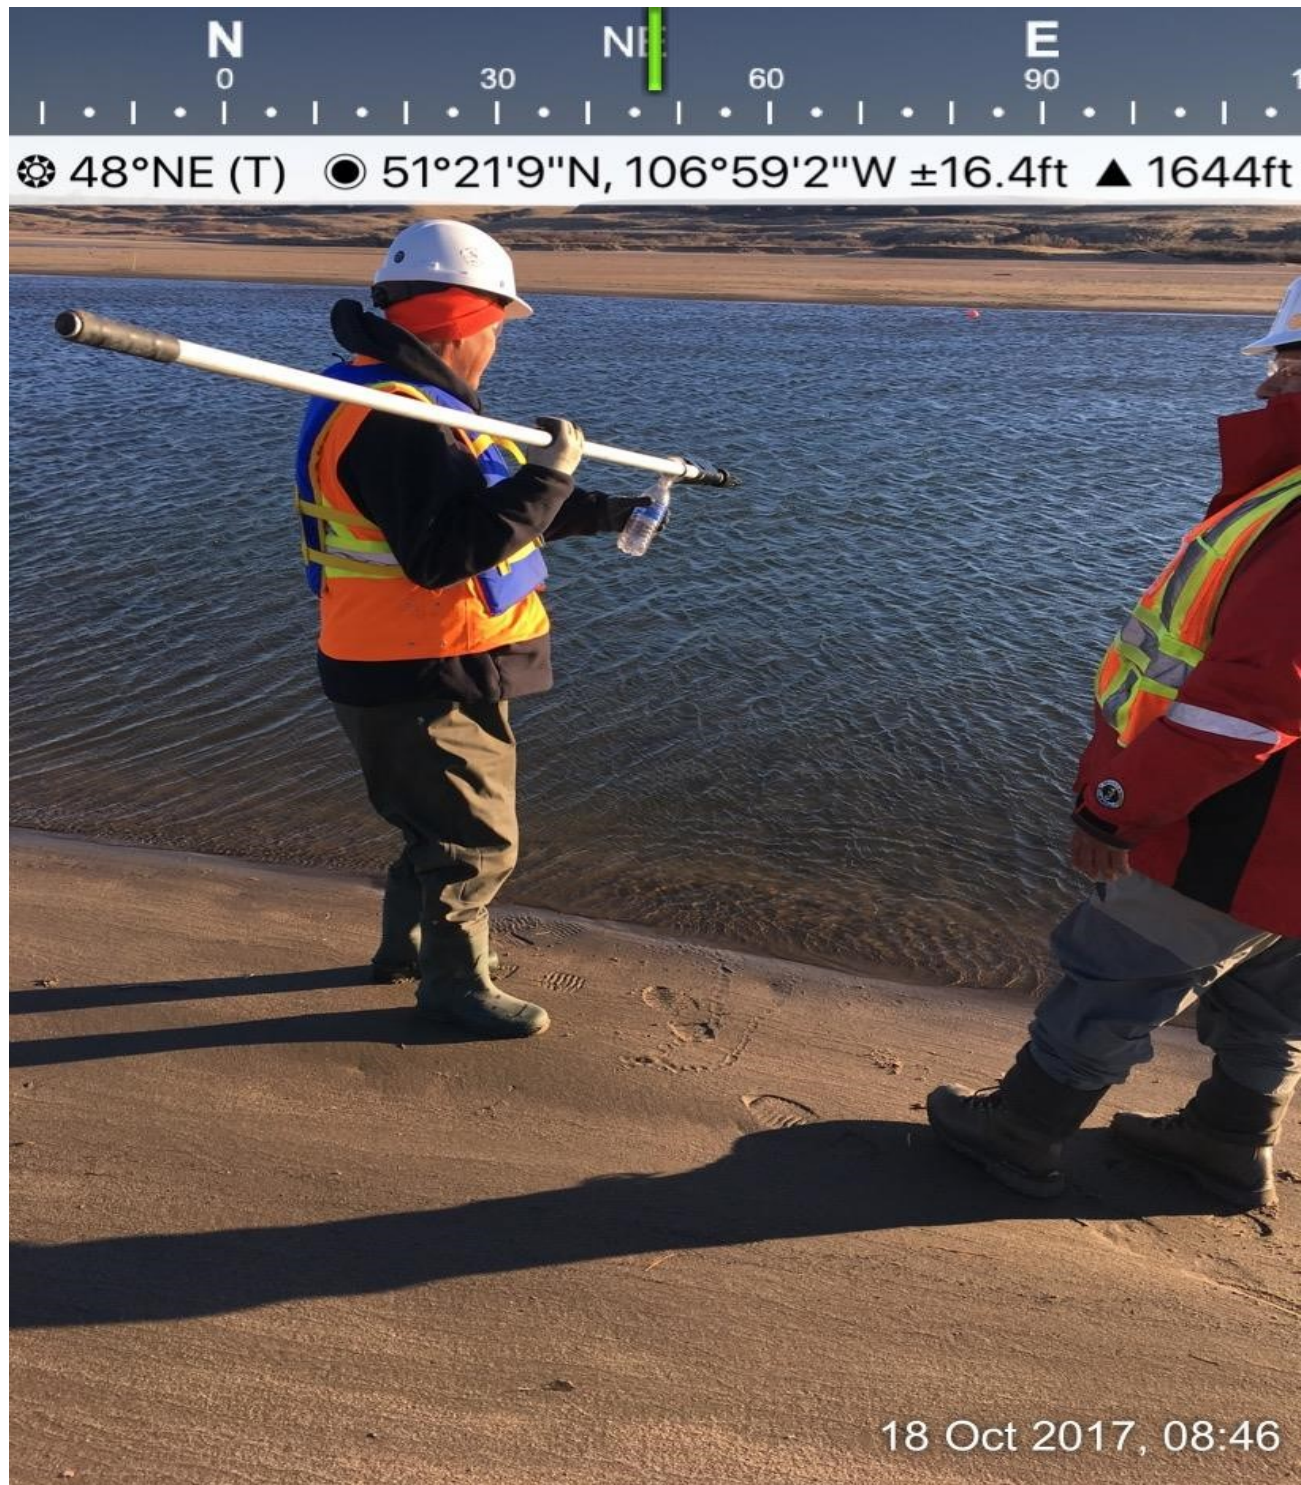
Water sampling at South Saskatchewan river from Golder Associates has remained the same, no change in the turbidity in the water.

Retrieving water samples at South Saskatchewan River

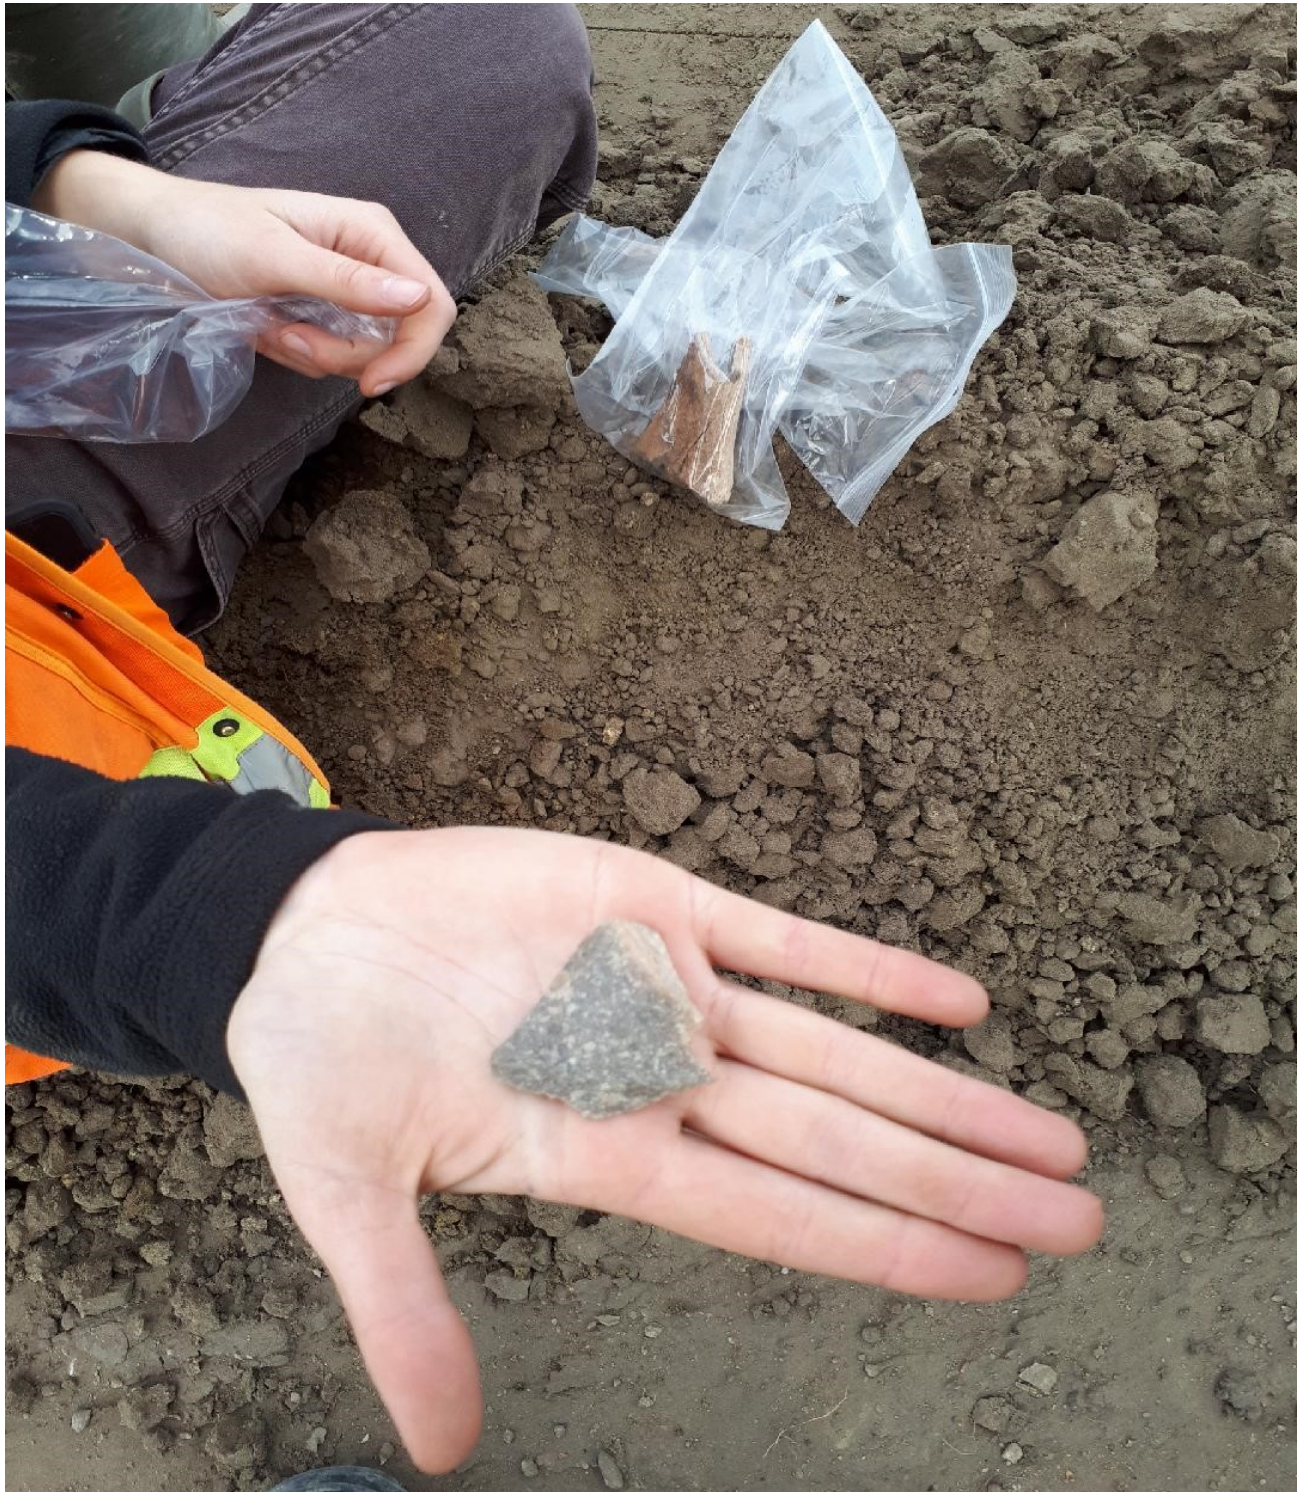
Unknown (arrowhead?)
